London Gateway Clearance Programme Obstruction Removal at Sea Reach No 1

Watching Brief Assessment Report

Ref: 88631.01
July 2014

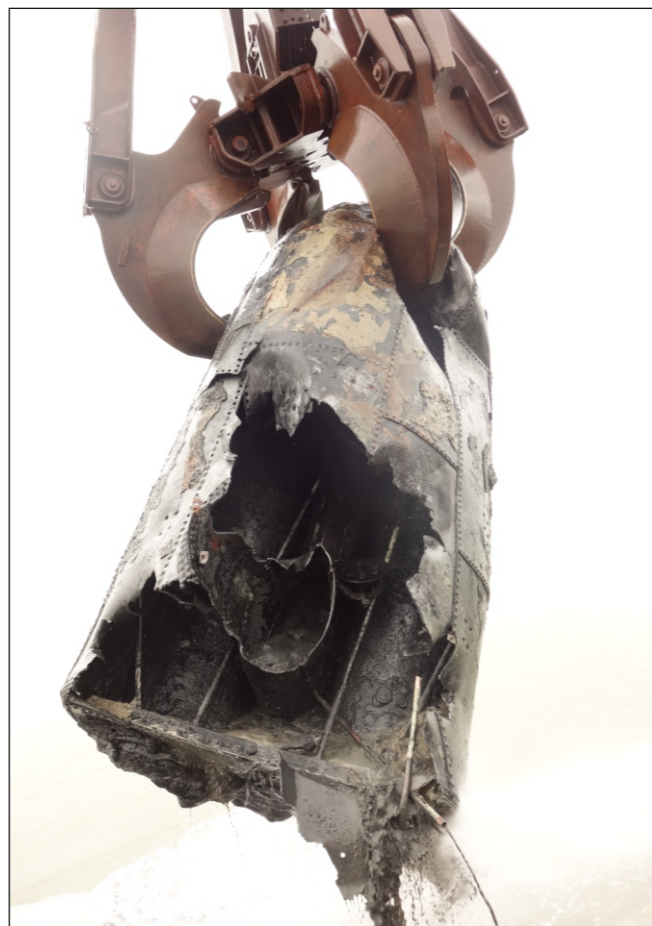
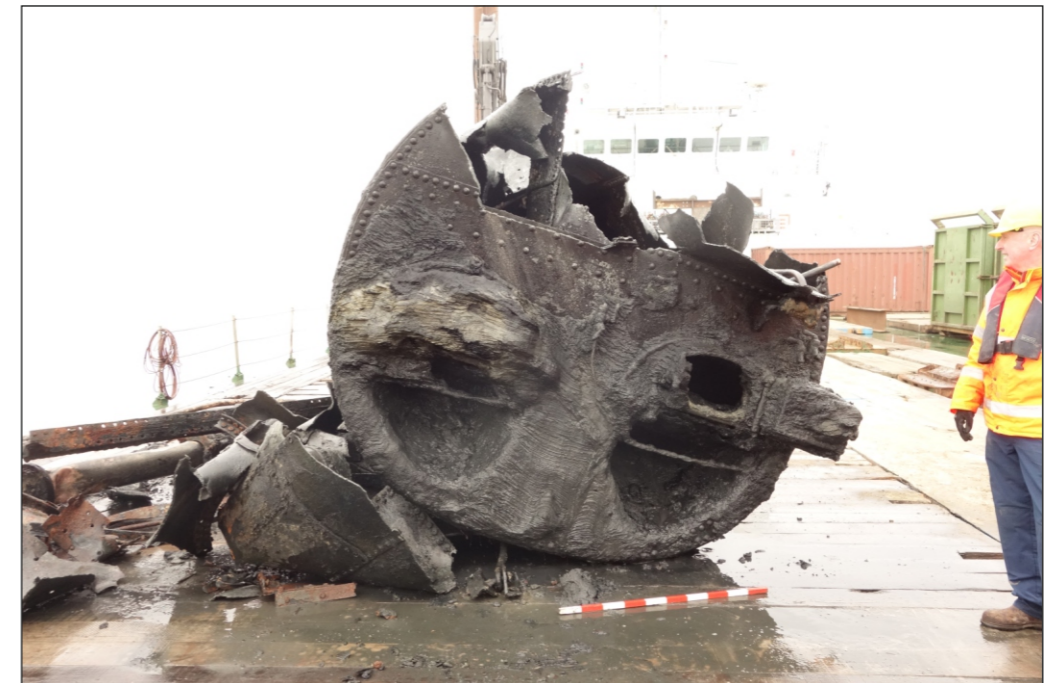
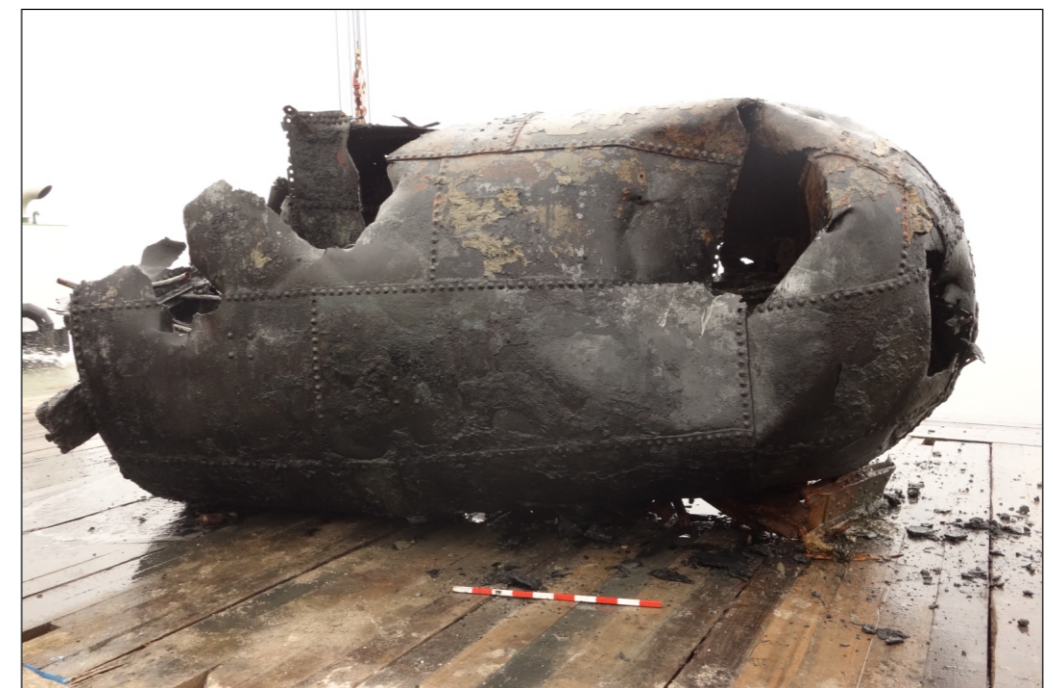
A: Top view

B: Front view

C: Side view

Boiler plan from Smith's Dock Journal May 1933: 71.
 This material is for client report only © Wessex Archaeology.
 No unauthorised reproduction.

- **WA3007, WA3009:** Two identical horizontal double return flue boilers (**Plate 1**). These are made of iron. The furnace ends contain two firebox access hatches with the hatch-door still *in situ*. The end shape is roughly circular (diameter 2.6m, thickness 9mm) tapering to a convex shaped end. A few stays and plates are joined with single riveting, as is the central smoke uptake. The dimensions are 4.7 x c. 2.6m. The boilers seemed to be fairly complete at the time of the recovery which excludes a boiler explosion as a cause of sinking. According to George Dickinson, Honorary Secretary of the Markham Grange Steam Museum Association and author of '*Climbing out of the Port Hole - The Rebuilding of Reliant's Port Engine*', these boilers are relatively early (George Dickinson, pers. comm.).

- 6.1.6 All the manufacturer marks found on the firebricks are consistently from the Newcastle area and this indicates the Tyne, or possibly the Wear, as potential areas of construction for the boilers. It is also possible that the bricks were replaced during the boilers life time.

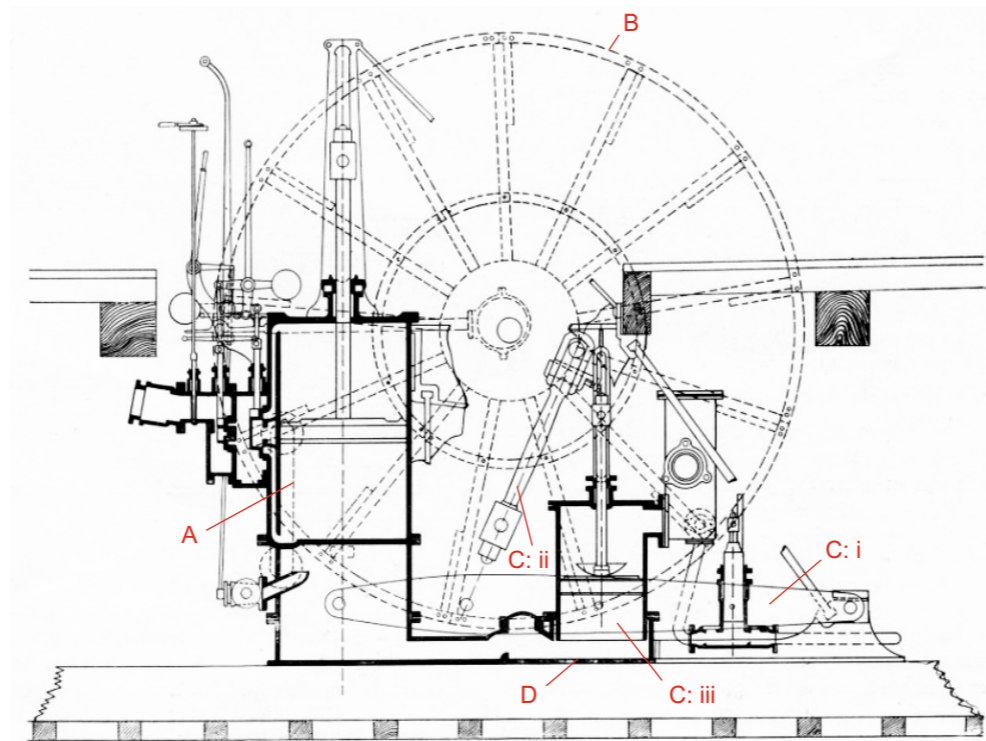
D: WA3210 bedplate

Plan from Smith's Dock Journal May 1933: 70.
This material is for client report only © Wessex Archaeology.
No unauthorised reproduction.

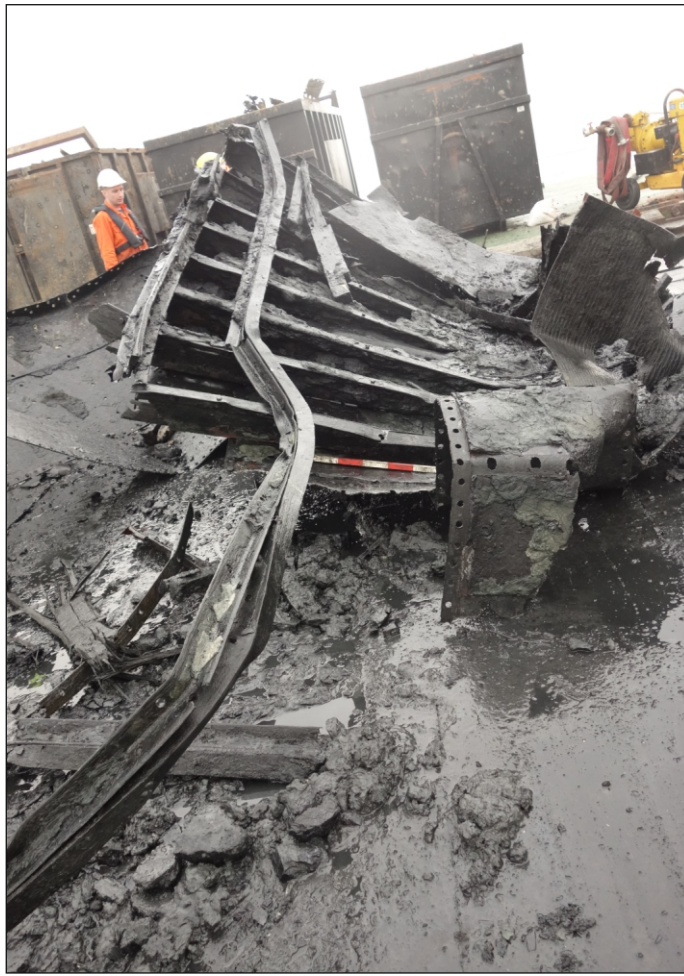
A: WA3152

- **WA3152:** A long section (c. 5 x 9 x 1.7m) of hull with riveted plating. Visible were nine floors, the keelson and two side keelsons, wash plates, a grated iron plate and possible ceiling planking. The turning of the plates at one end suggests this is a garboard strake and indicates that the section broke along the keel bar (Thomas 1991: 50). The keel bar is missing. The shell is internally covered by bitumen and butt plates are present. On the keelson there is a possible pulley or an attachment for a pillar (**Plate 4**).

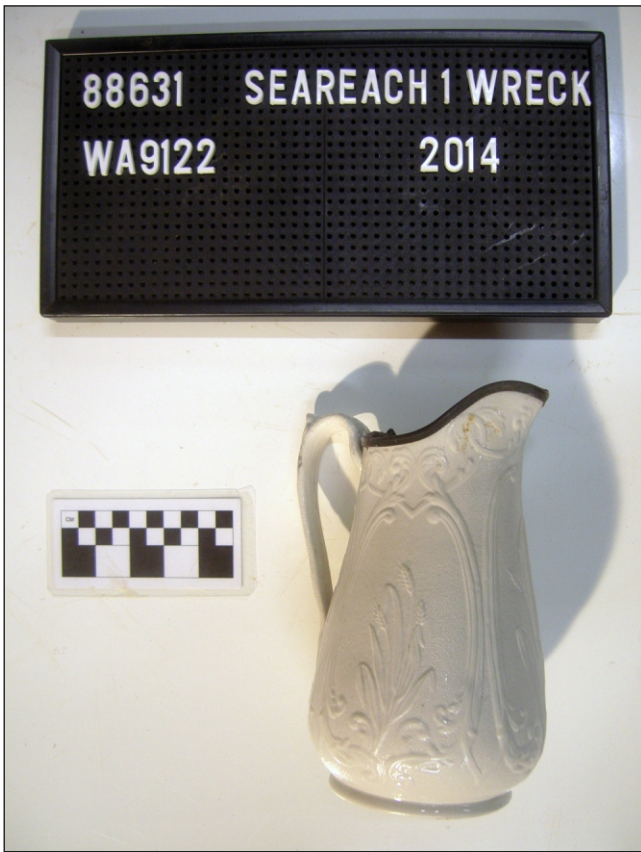
Plate 5: WA9122 whiteware jug

- *Miscellaneous sherds (one complete vessel, plus eight sherds)*: the complete vessel is a whiteware jug (**WA9122**), of the kind used in washstand jug and bowl sets, with moulded decoration. A metal (tin or pewter?) trim has been added to the rim, and originally supported a metal lid, now missing. On the base is a relief 'Staffordshire knot', with the monogram WB 24, possibly the mark of William Brownfield of Cobridge, Staffordshire, during the period 1850-71 (Godden 1964: 10) (**Plate 5**).
