# London Gateway Clearance Programme: Wreck Site of 19th Century Paddle Steamer, Sea Reach No. 1.

Post-clearance Assessment Report

Ref: 88631.03  
October 2015

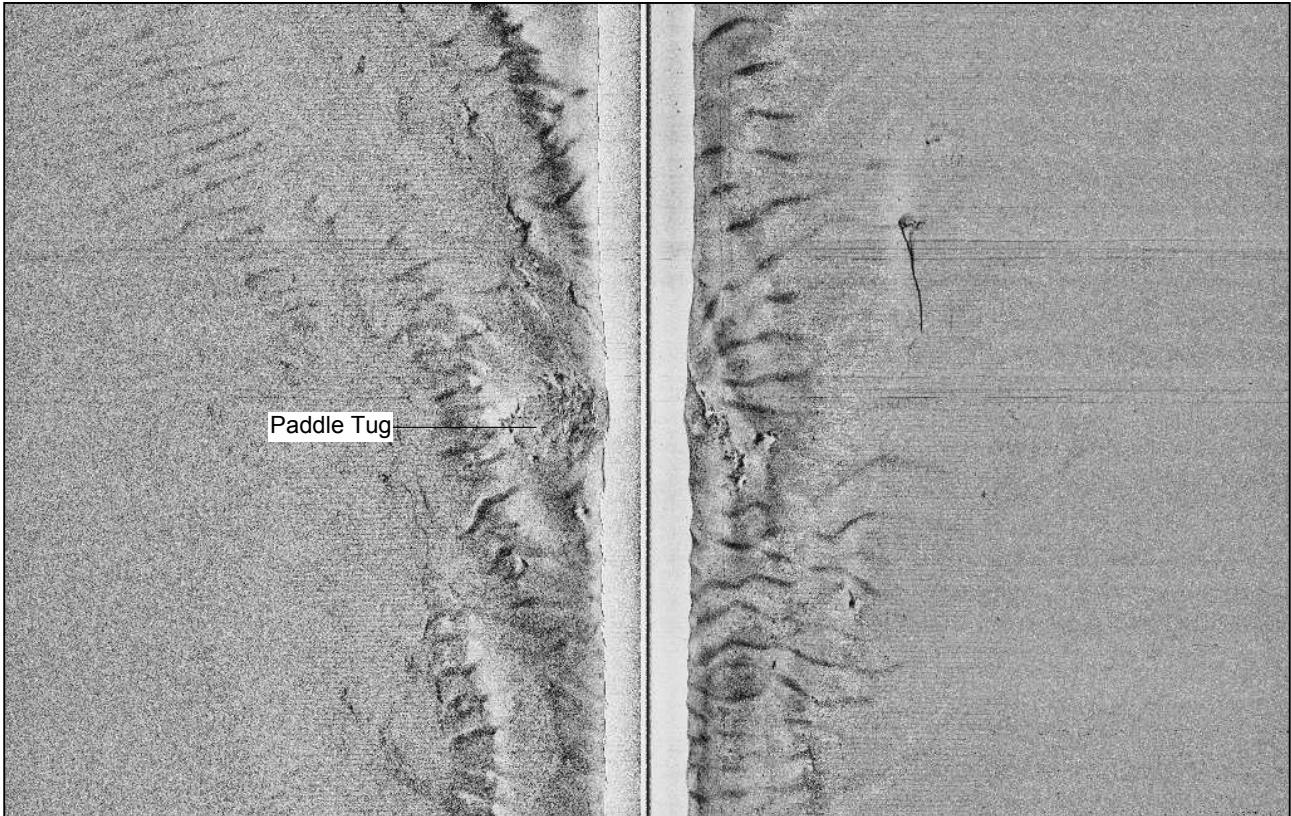
A. 2002 Sidescan Sonar Data

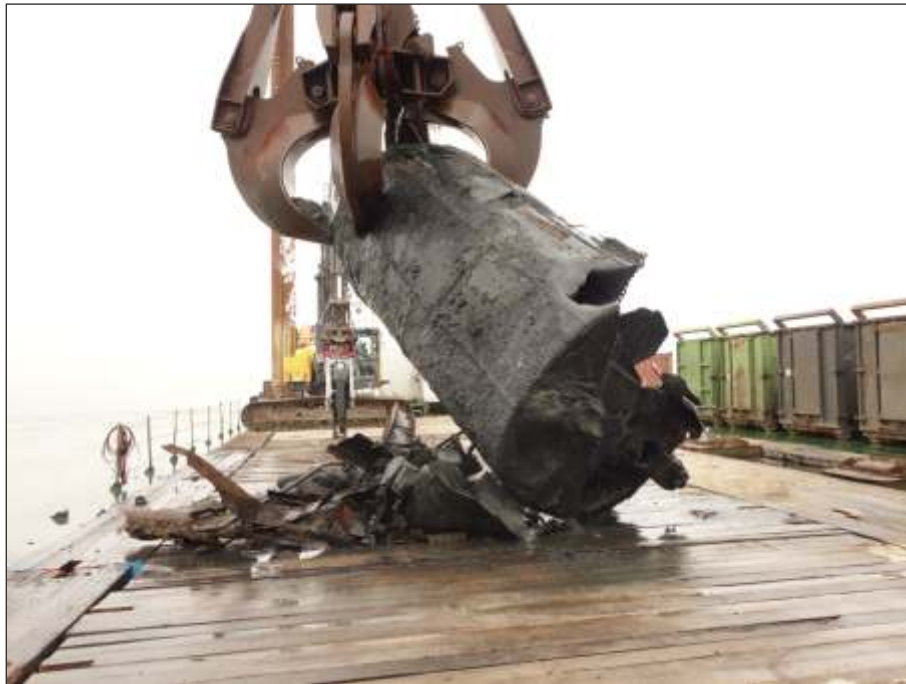
Plate 1: Boiler, WA3007, held within the grab's teeth having been recovered from the site

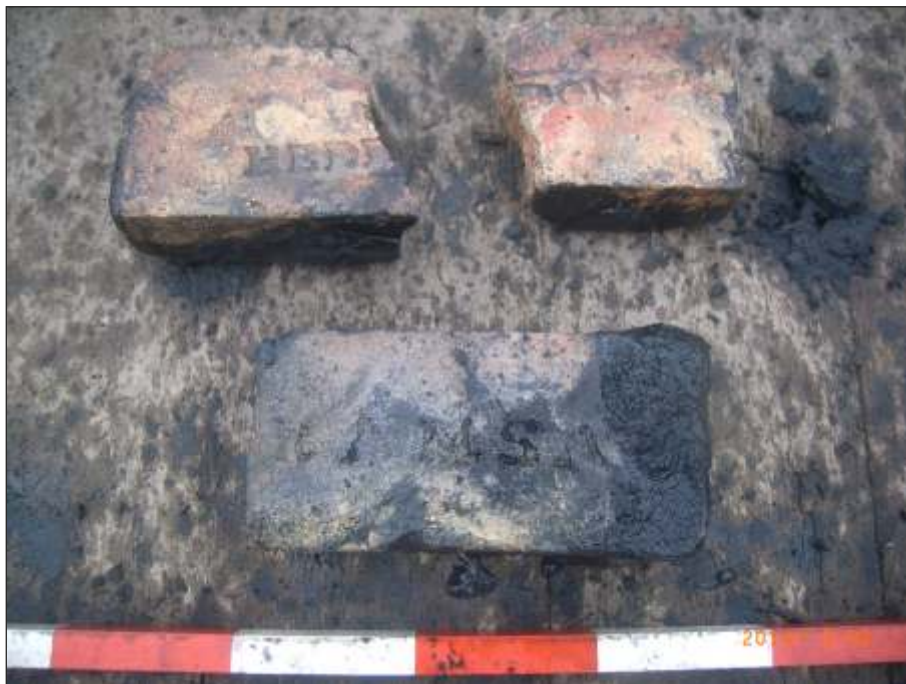
Plate 2: Firebricks with Tyne and Wear manufacturer's marks; 'Heddon' and 'Ramsay', WA3010

- 6.1.4 All the manufacturer's marks visible on the recovered firebricks originate from the Newcastle upon Tyne and Gateshead regions, potentially indicating the area within which the boilers were constructed. Conversely, it is possible that these bricks were replacements made during each boiler's life time.

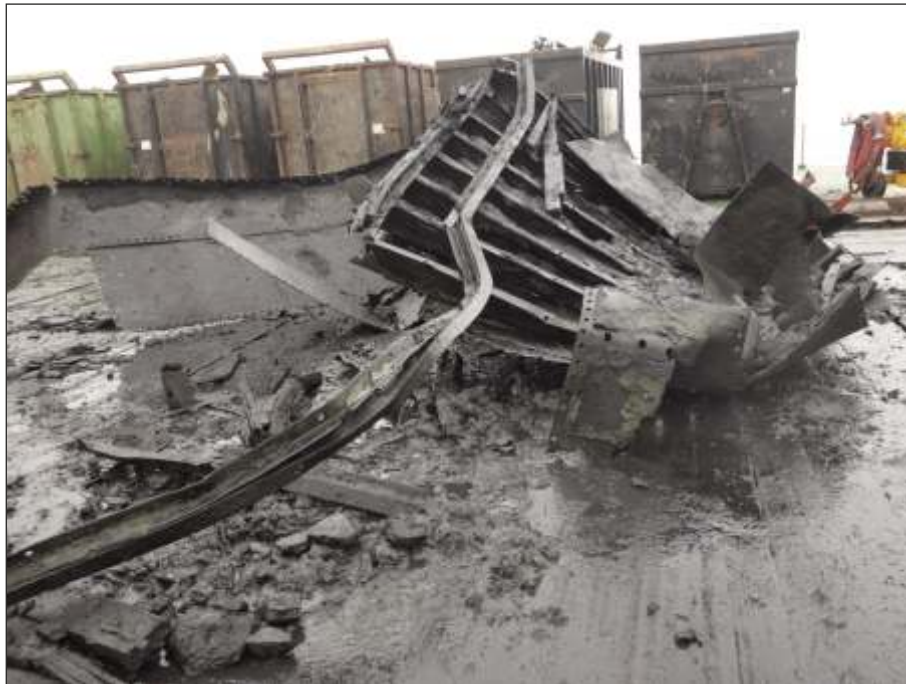
Plate 3: Section of hull with iron riveted plating, frames and stringers, **WA3152**

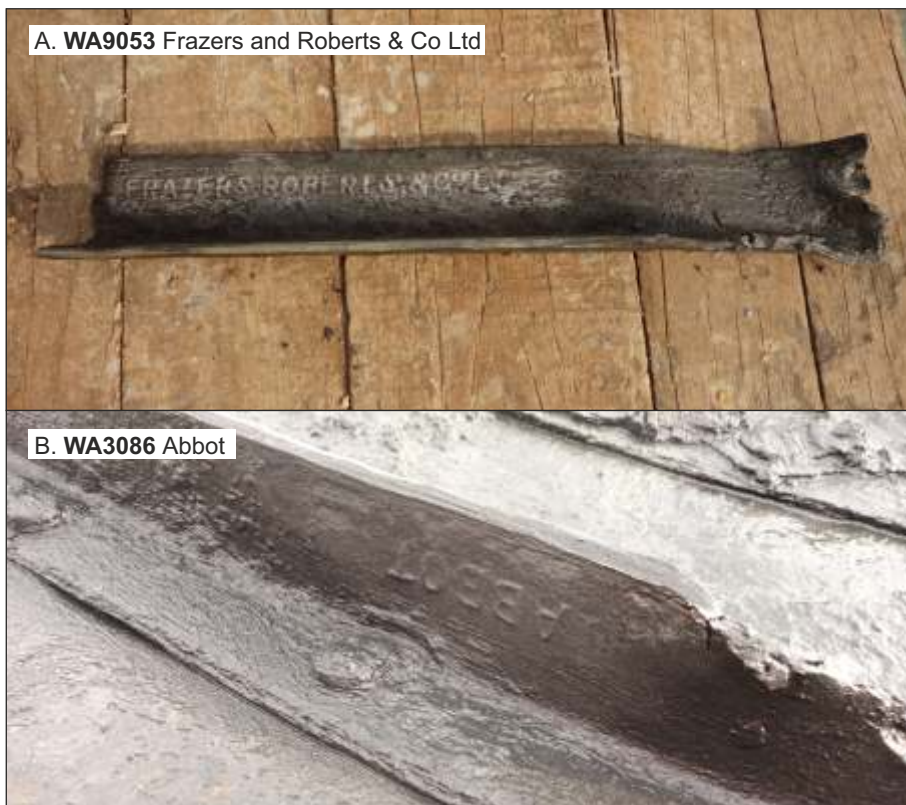
Plate 4: Manufacturer's marks on two iron floor frames

- 6.1.10 Iron manufacturer's marks found on two of the vessel's floors (**Plate 4A and 4B**) belong to two companies operating in the Gateshead area in the late 19<sup>th</sup> century; 'Frazers and Roberts' were based at Felling Shore and 'Abbot' at Gateshead Park. Both companies are present in the 'list of the mills and forges in the United Kingdom' and also the 'Mineral Statistic of the United Kingdom of Great Britain and Ireland for the year 1871'.

- 6.2.11 The iron manufacturer’s mark found on two frames indicates the banks of the river Tyne as the area where structural components of the hull were manufactured and possibly assembled. The mark ‘FRAZERS AND ROBERTS & Co LTD’ suggests 1866 as the *terminus post quem* for the construction of the vessel. There is the possibility that the floors with the markings were part of a repair made after the launch of the vessel, although this is unlikely and not supported by the available evidence.

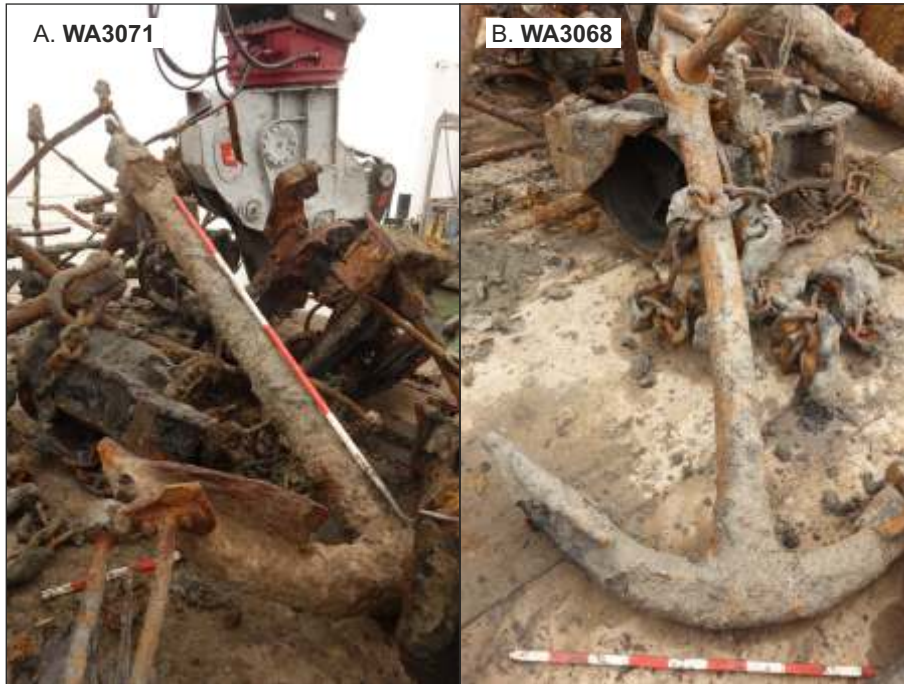
Plate 5: Admiralty anchors

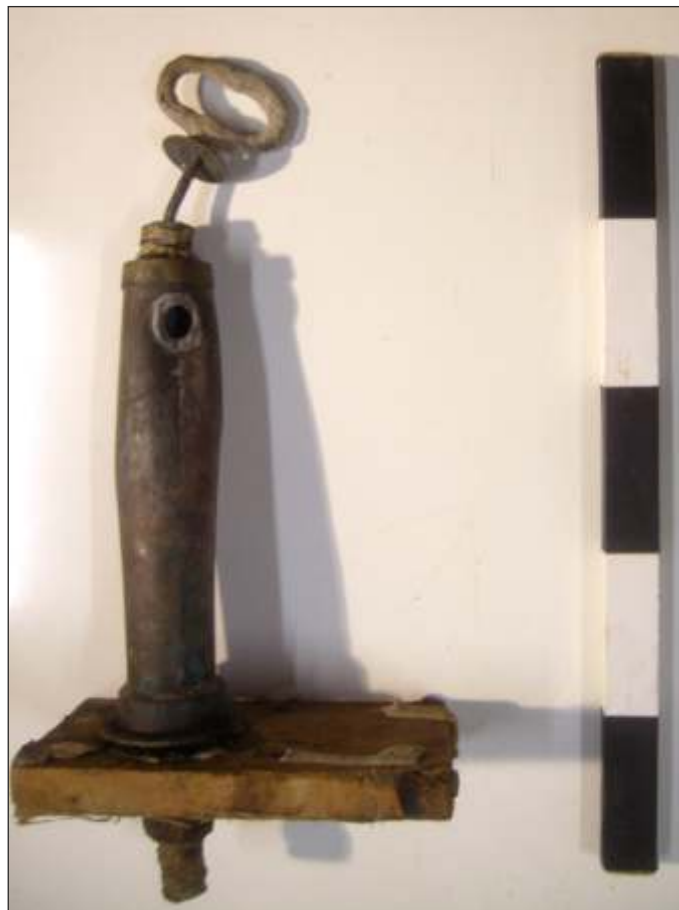
Plate 6: Bilge pump, WA9031

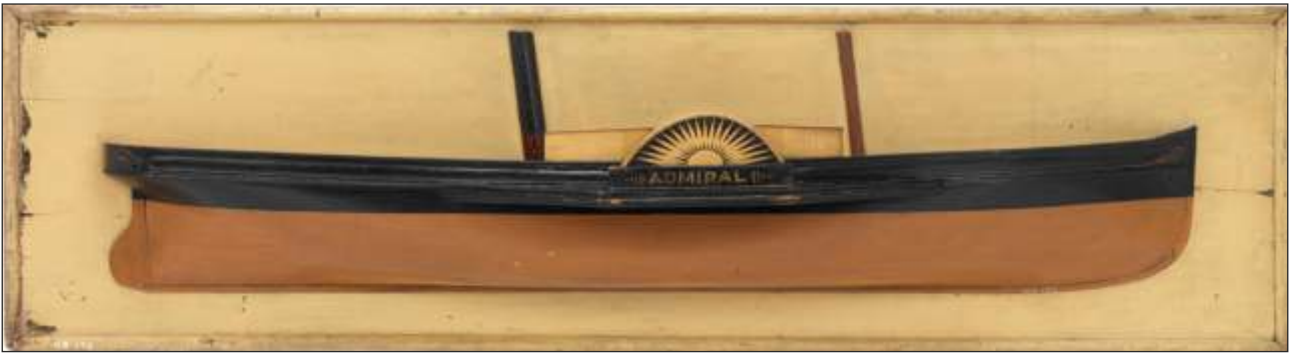
Plate 12: Wooden model of *Admiral*, c. 1869. Courtesy of National Maritime Museum, Greenwich

6.2.2 It is suggested that a possible identification of the wreck is the iron paddle tug *Admiral* that sank in 1872 (**Plate 12**), but further documentary research and fieldwork is recommended to confirm this.
