# London Gateway Clearance Programme: Wreck Site of 19th Century Paddle Steamer Sea Reach No. 1

Detailed Recording of the Maritime Material Stored at London Gateway

**Report Ref: 88631.04**

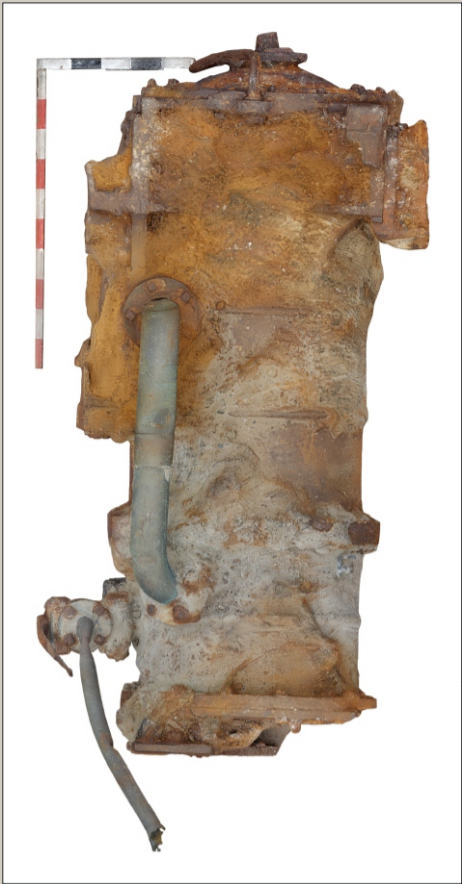
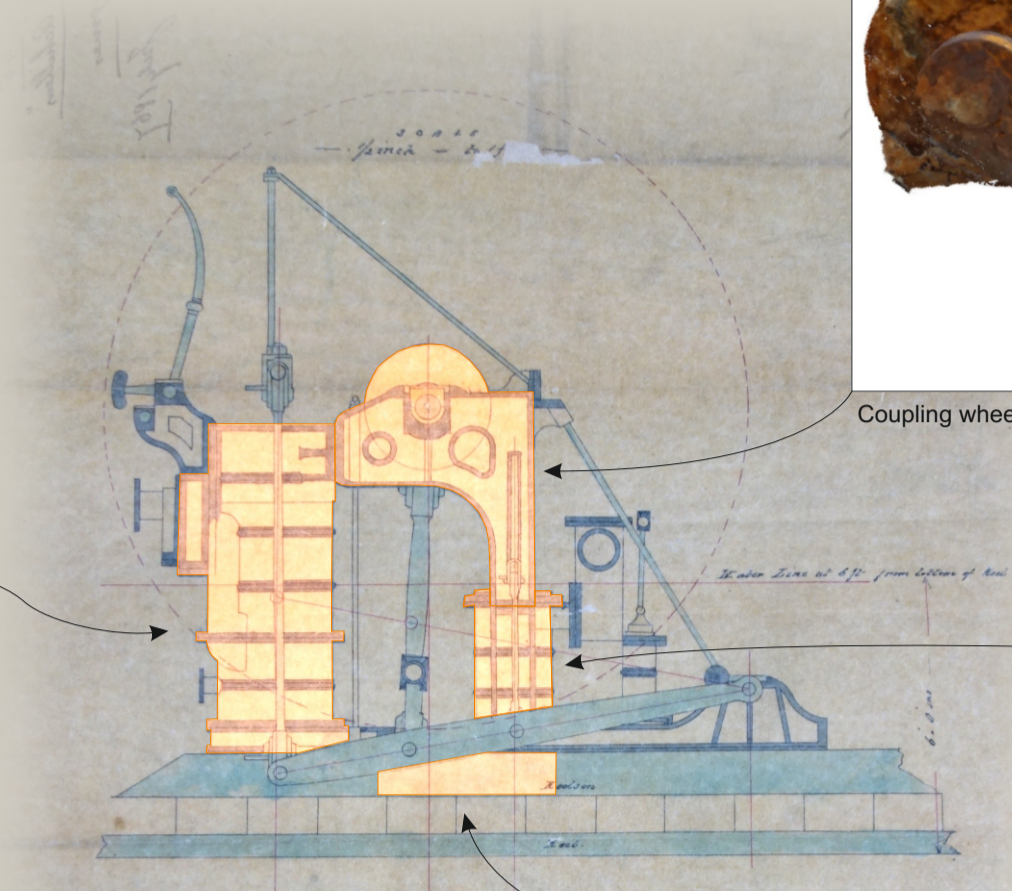
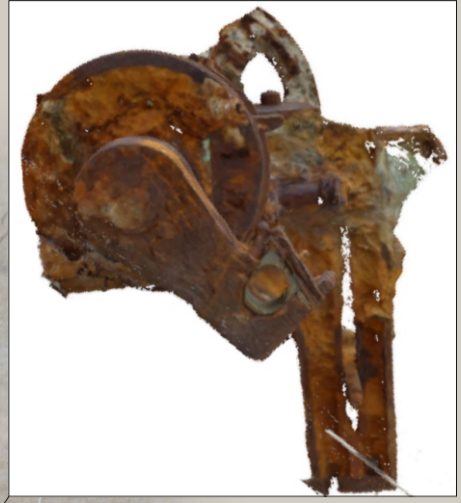
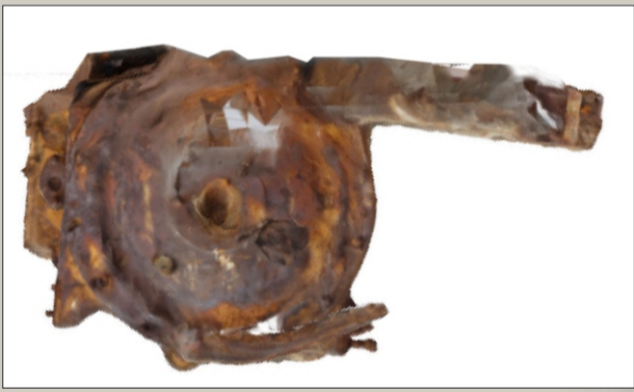
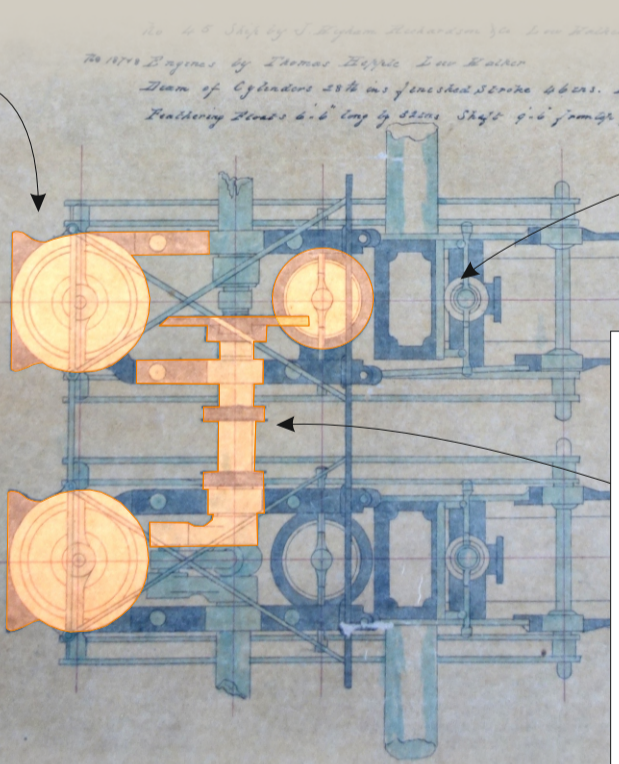
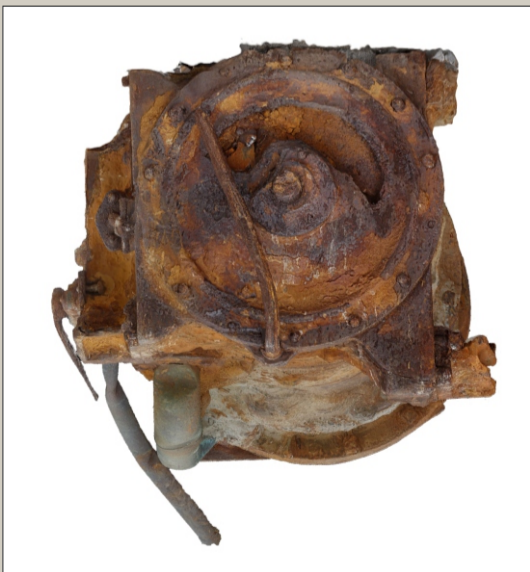
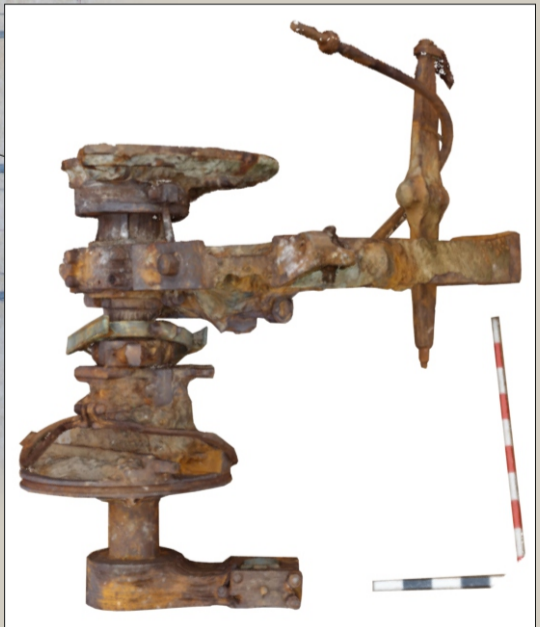
Cylinder 2

Coupling wheel with engine frame

Air pump

Bedplate

Cylinder 1

- 4.3.3 In the drawing of the engine from the Tyne and Wear archives (**fig 2**) there seems to be two eccentrics between the engines, which are also apparently in **WA3025**. However the other two discs needed for the main valves are not shown and unfortunately the drawing does not show details of the valve arrangements. Hence it appears that the engine in the drawing is incomplete and only partially corresponding to the recovered engine because it shows no method of driving the engines' main valve and this connection is required for any pair of disconnectable engines (Dickinson pers. Comm.).

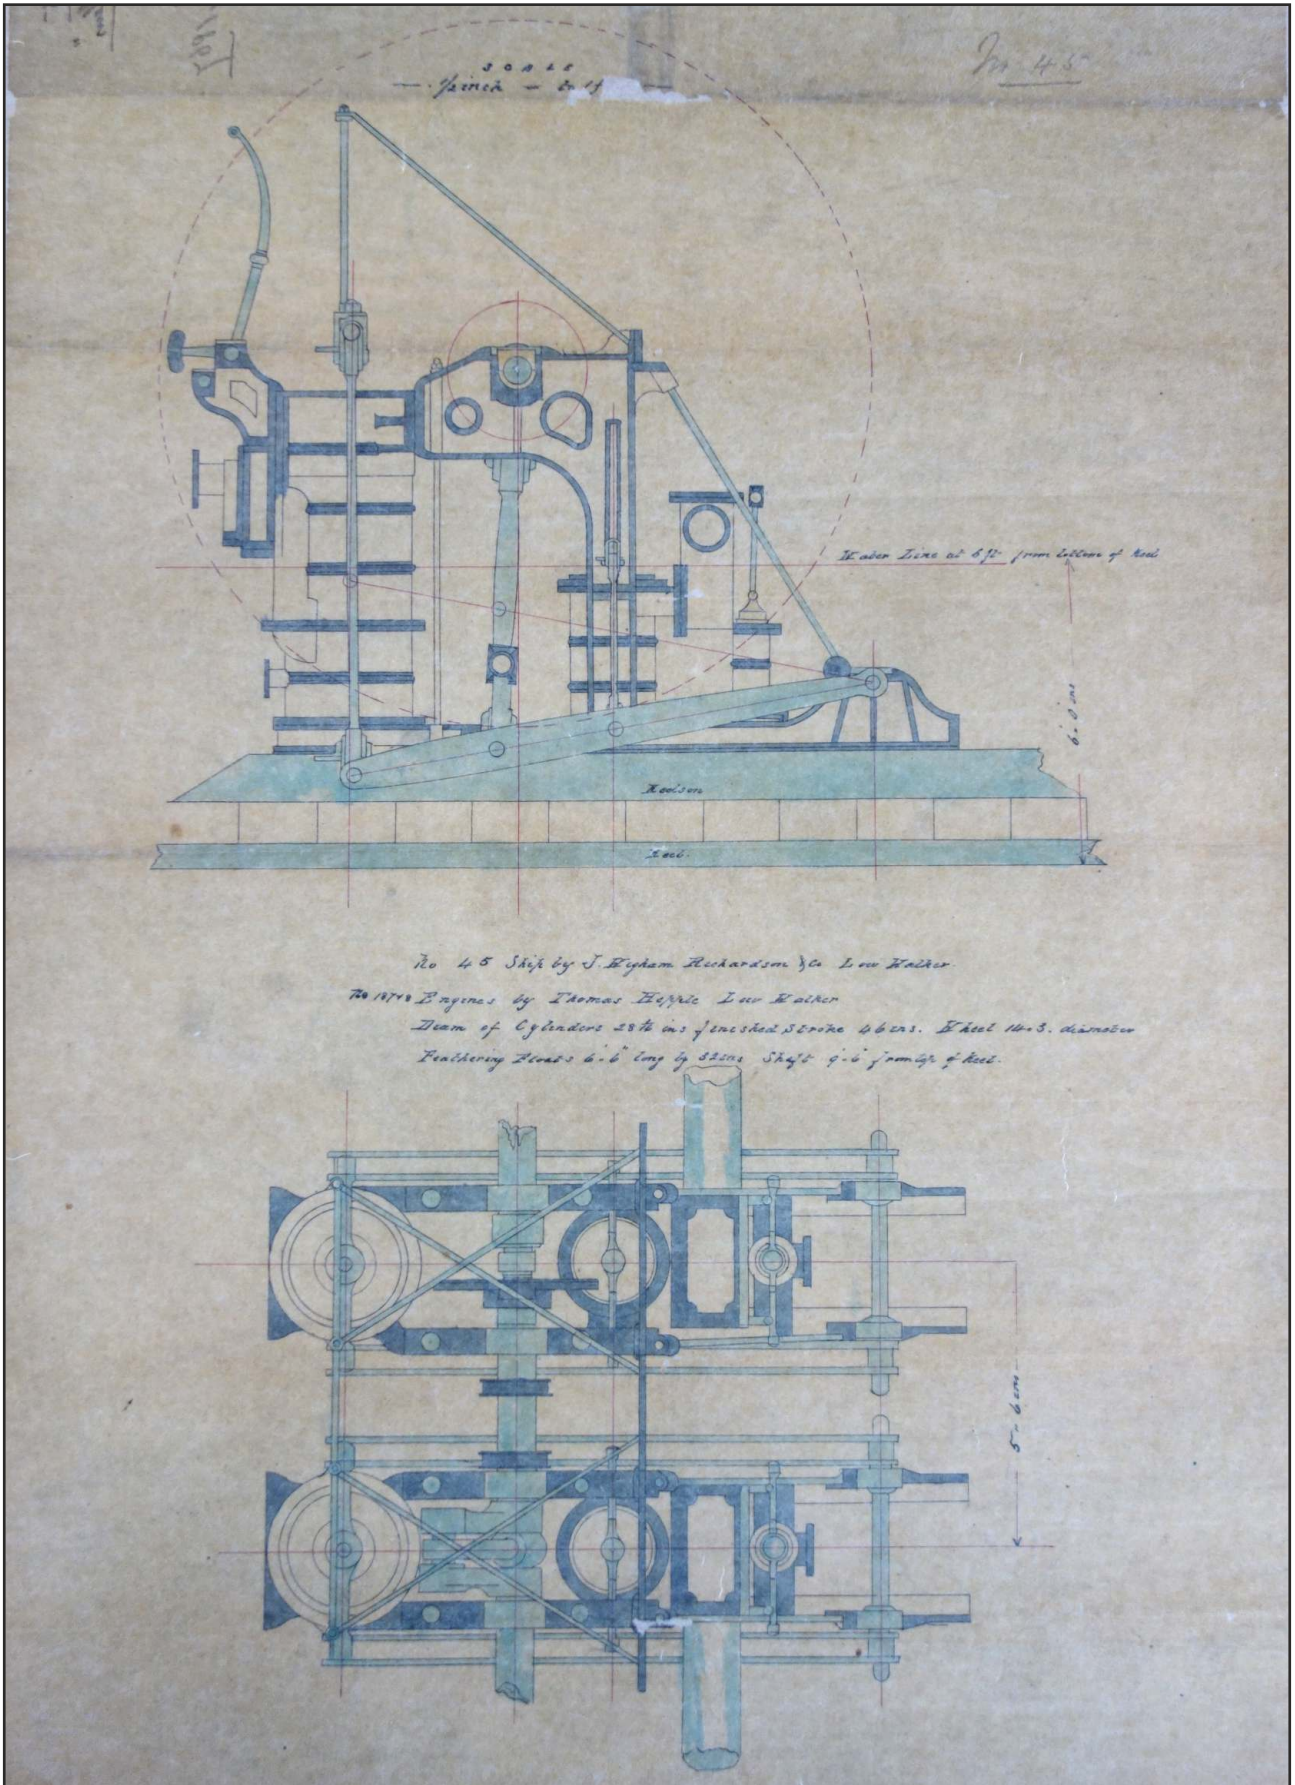
Figure 3

Plans of *Achilleus'* engines, built by Hepple in 1867

- 3.1.4 The images of engine plans for another paddle steamer constructed by Hepple in 1867, *Achilleus* that were taken from the Tyne and Wear Archives were used to compare with the recovered engine elements to aid identification of the different parts.

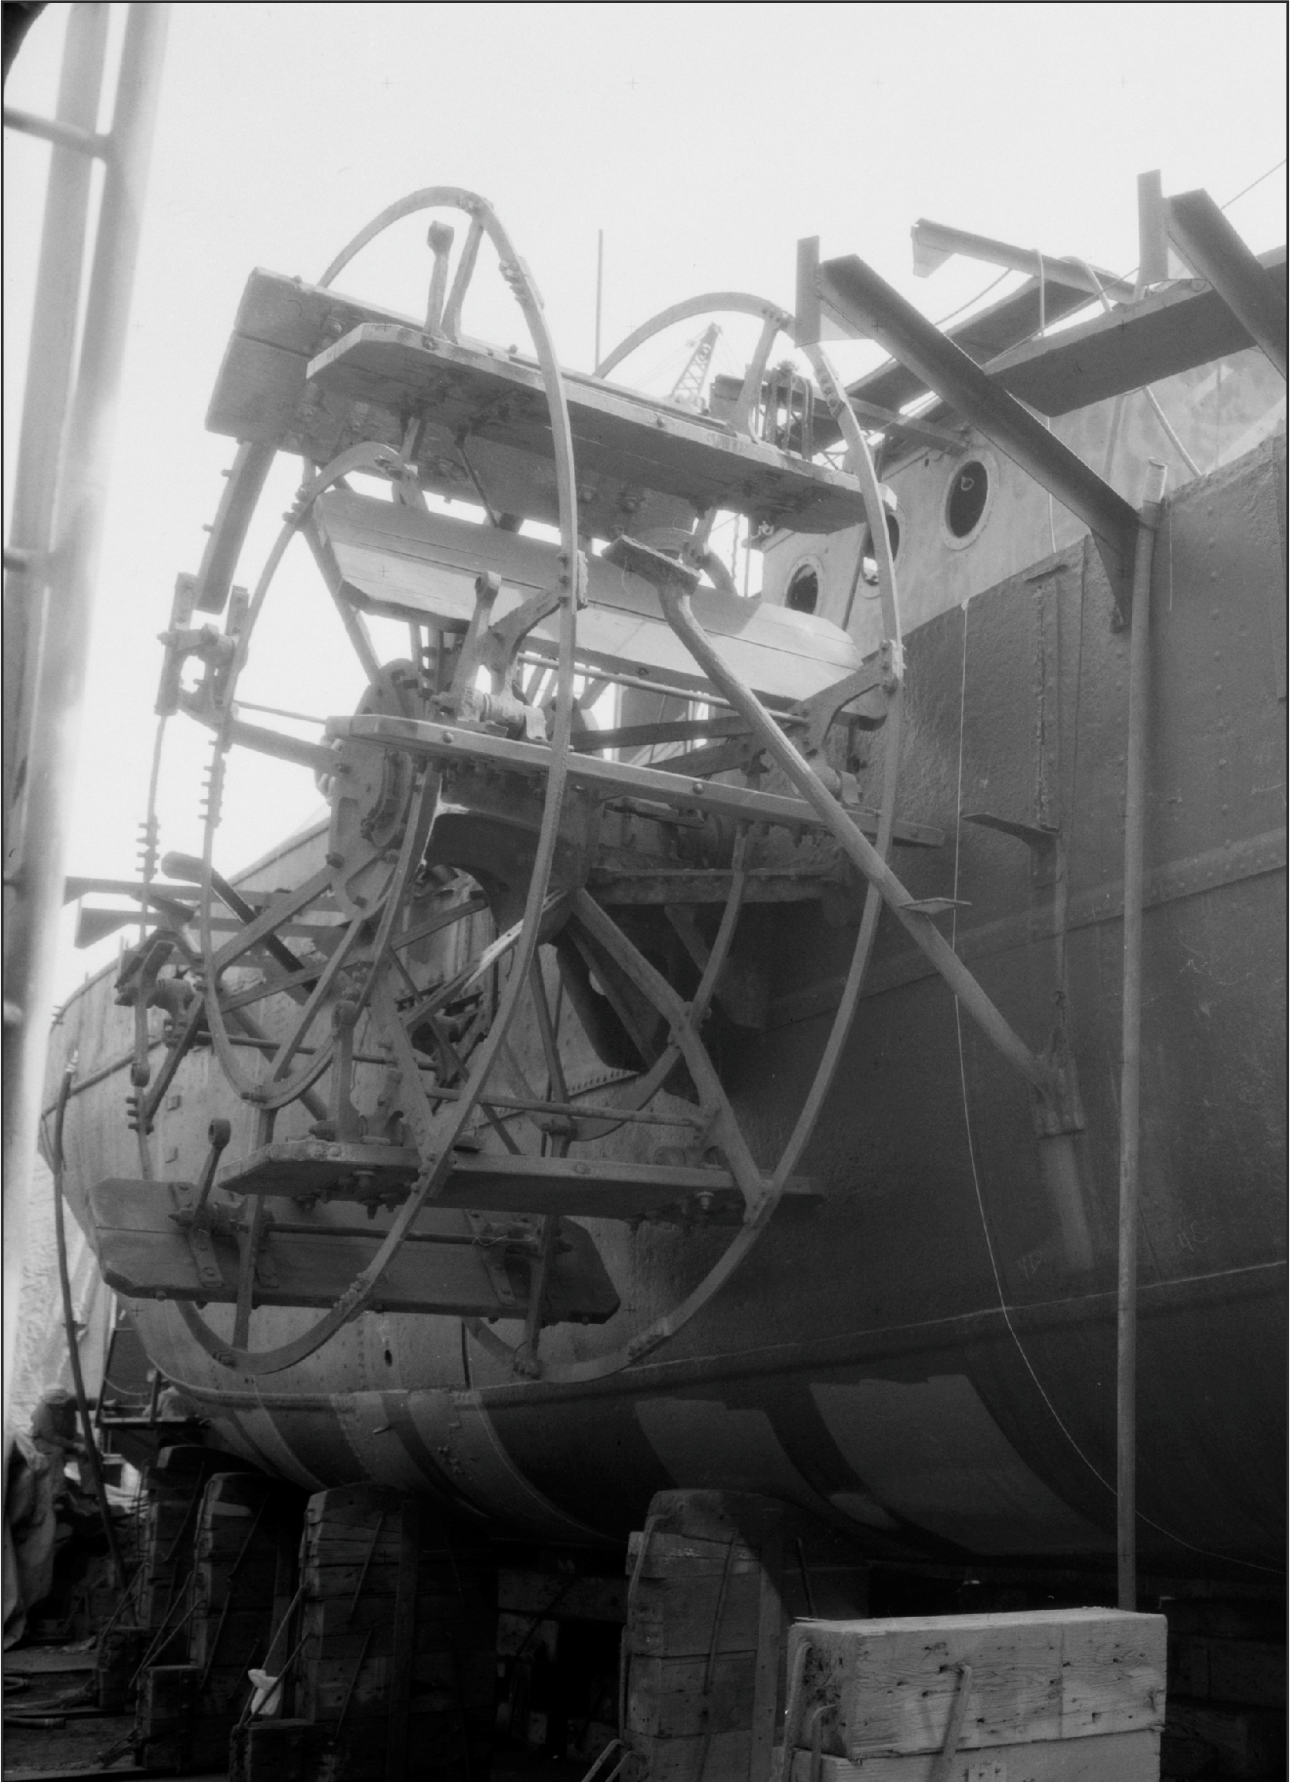
Figure 4

Photograph of Epbleton Hall tug port wheel

- 4.2.4 The arrangement of the paddle construction is similar to the one shown in the photograph of the starboard wheel of *Eppleton Hall* during renovation and maintenance (**Figure 2**) albeit of much lighter construction (pers. Comm. Dickinson).

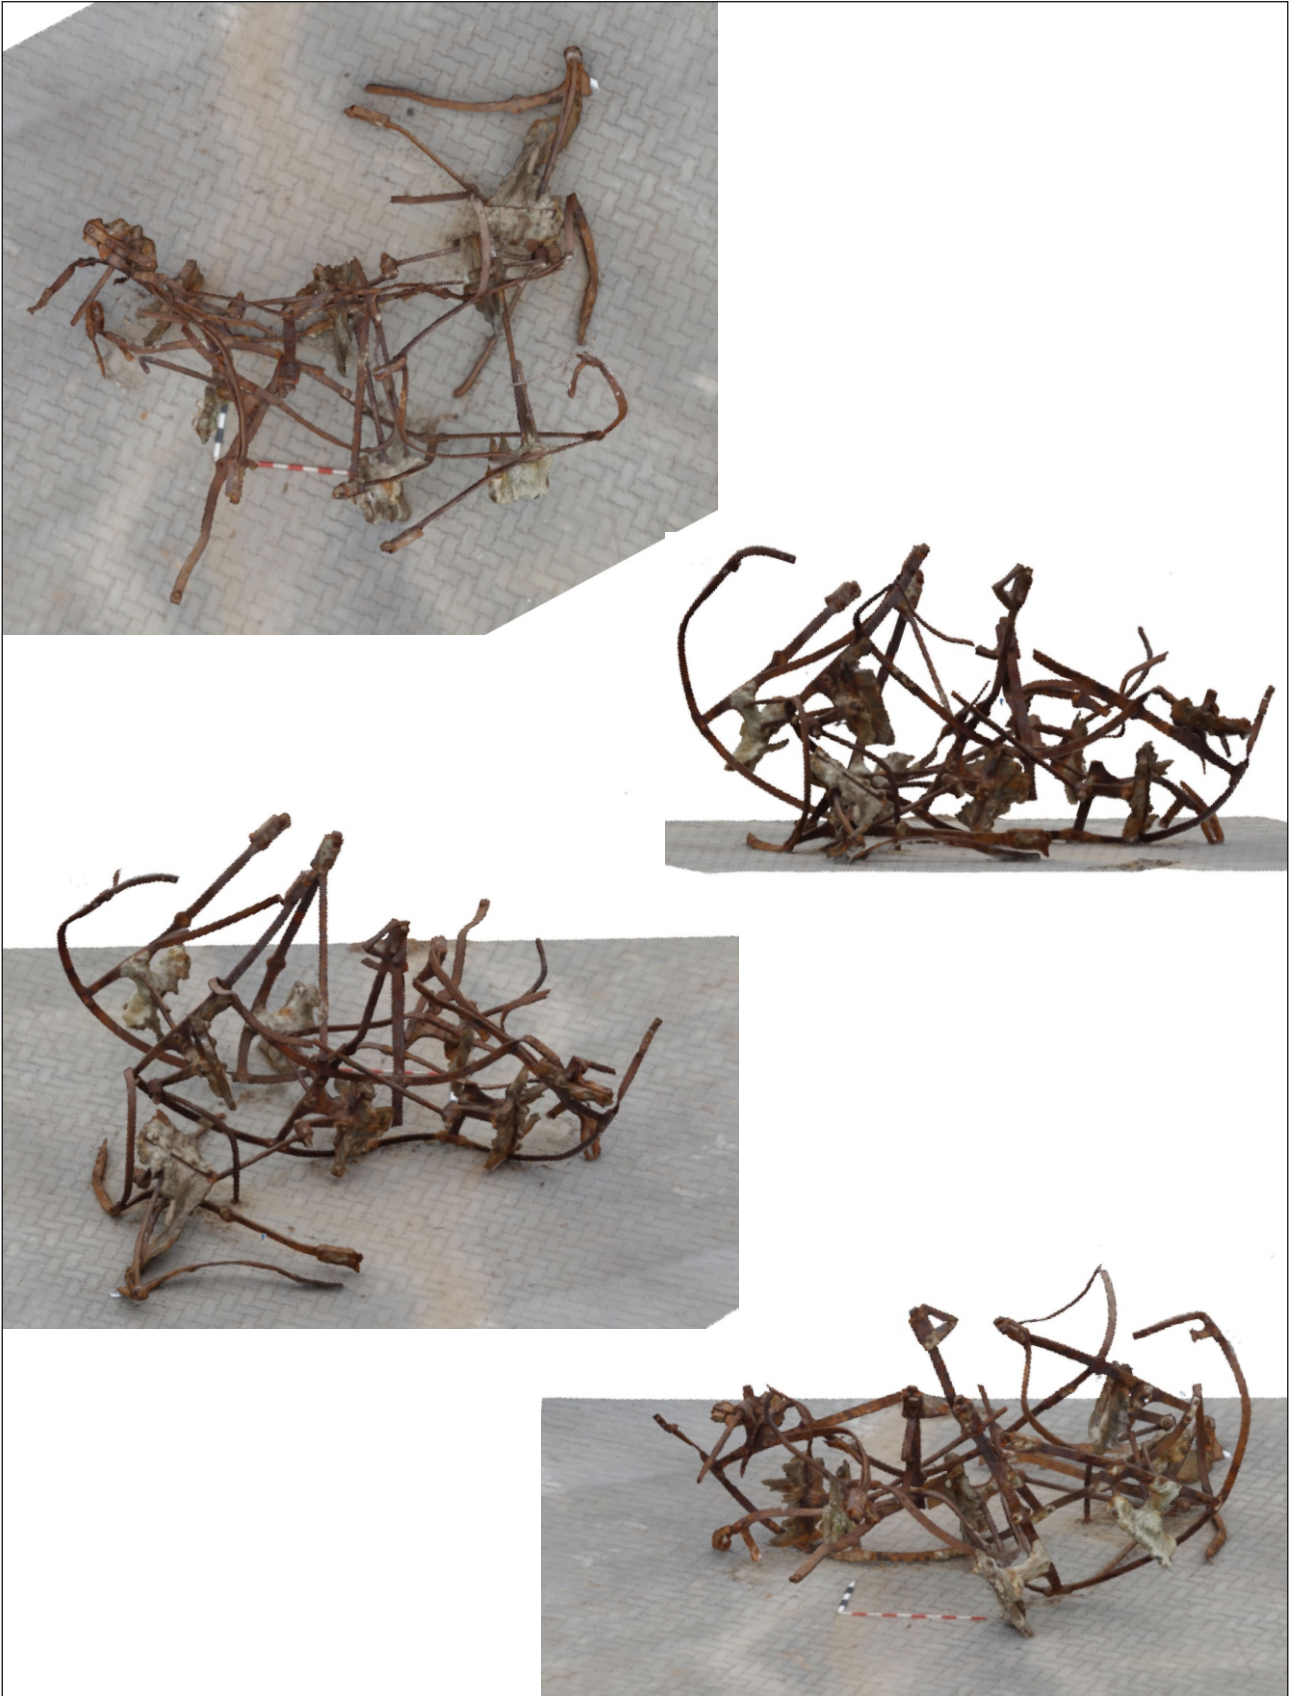
Plate 1: Paddle wheel

- 4.2.1 The paddle wheel (possible radius c. 1.920m, width 1.230m) is fitted with feathering gear. This feature allows the adjustment of the angle at which the paddles entered the water so that the paddles are aligned to be almost vertical and produce a more efficient thrust. The construction includes two large rings and two smaller ones and several radial smaller fixed spokes. At least one flat diagonal cross braces from the hub to spoke is visible within the entanglement and thin horizontal iron cross between corresponding spokes in the inner and the outer rings for rigidity. There are at least five floats in different but fragmented states still attached to their pivots. They all seem to be broadly the same size (1160 by 690mm). Each float is made from three wooden planks fixed together by two iron bands and fixed with four square headed bolts. On the other side a similar arrangement fits the brackets with a pin bearing to a corresponding pivot on a spoke. Feathering arms and brackets to support the floats are visible. Those of the *Reliant* were made of elm which seems to be the same wood species used in these floats. However no analysis has been carried out on the wood and the species of the wood used for the floats cannot be confirmed.

- 4.2.2 The paddle wheel is in a poor condition as result of the recovery by grab. Many key parts such as the feathering hub are missing and the rings are twisted as a consequence of the way it was recovered. A single and separated float was recorded and shows similar characteristics to those still attached to the wheel.

- 4.2.3 George Dickinson suggested that the feathering arrangement was not articulated by a separated hub as in *Reliant* but by an eccentric located on the shaft that rotated the wheel. This arrangement is suggested by the presence of a disc-like feature (eccentric<sup>1</sup>) in a mass of metal in the middle of the long shaft (**WA3012**). Unfortunately the shank has been lost during recovery but photographs taken at the time of the recovery shows the shaft having an eccentric and crank at one end and a disc that it is likely to be a bearing at the other extreme, and the possible eccentric for the feathering mechanism in the middle. The other eccentric, located near the crank arm, is also important as it is very likely to be the one for the starboard engine main valve.

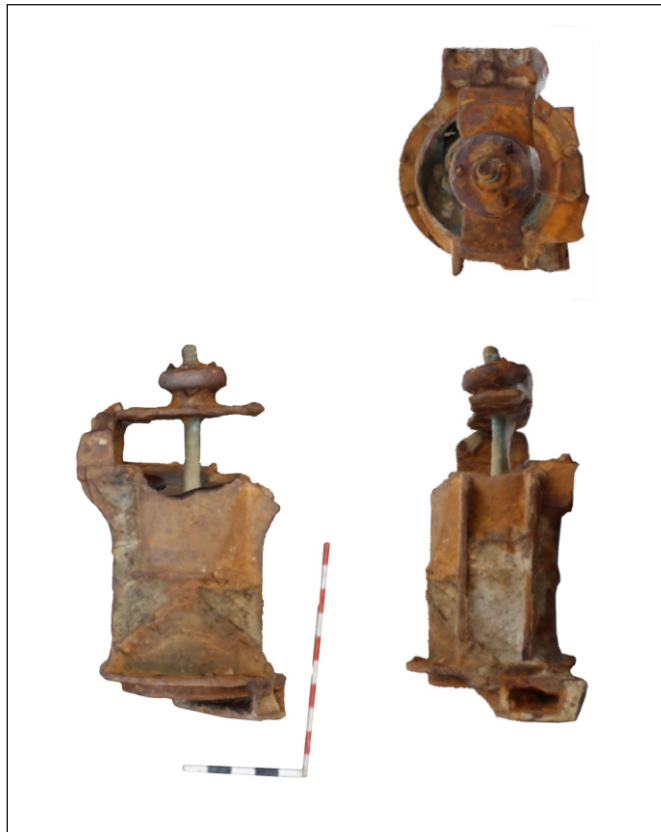
Plate 2: Air pump

- 4.3.1 **WA3047** is a pump, very possibly an air pump. As the lower end it is broken it was possible to measure the internal bore (460mm/ 18ins). The height is 940mm/37ins.

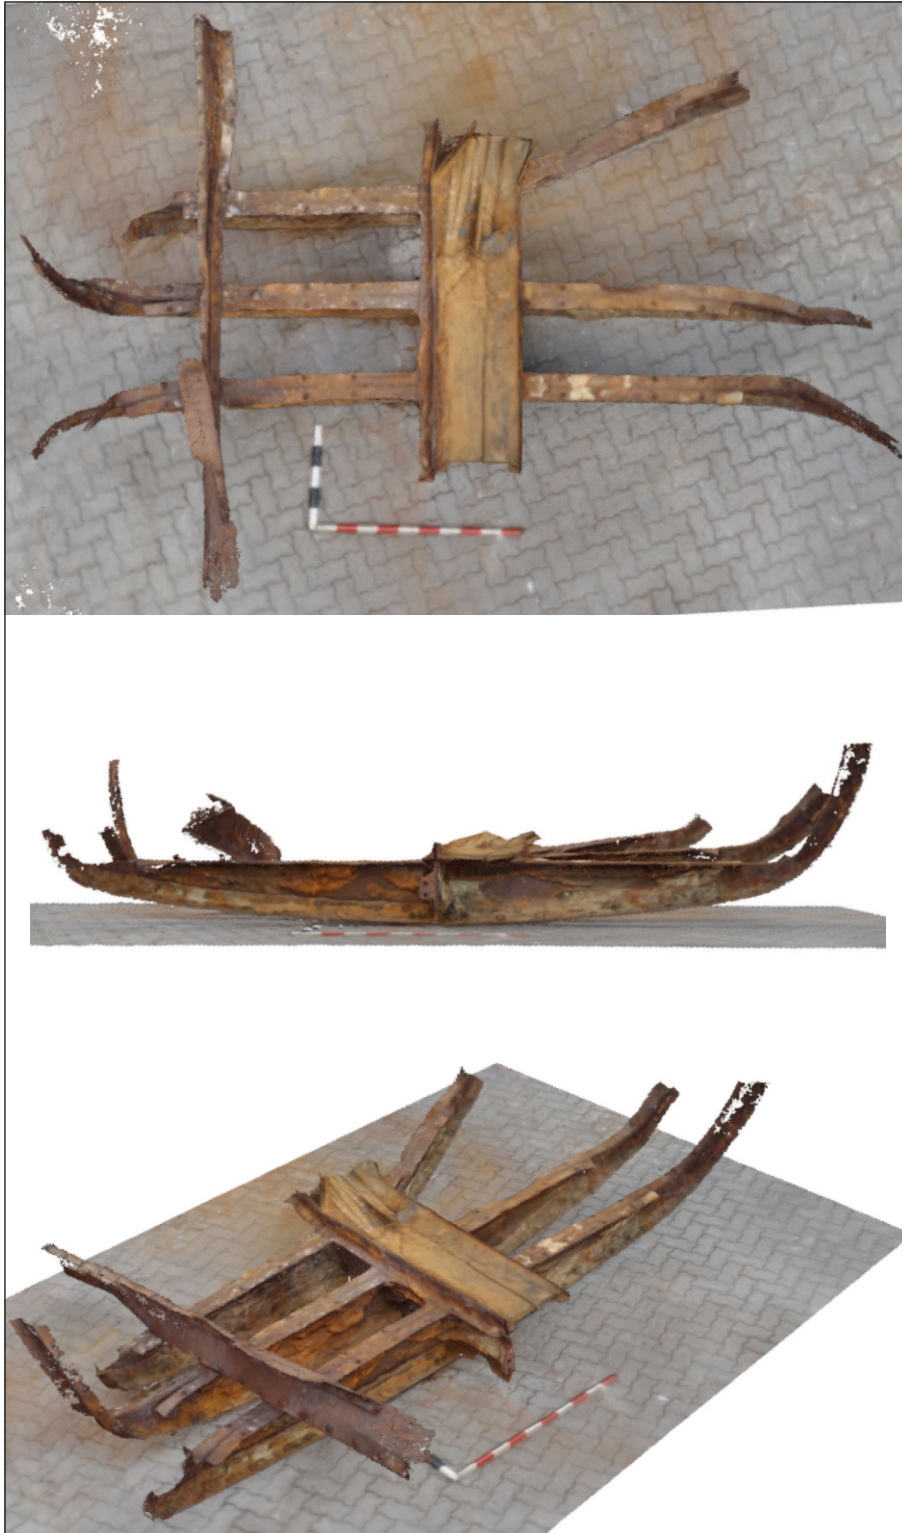
Plate 4: Hull section

4.4.2 **WA3080** is a hull section (approximately 3 by 4.25 by 1m) and consists of three iron floors and four longitudinal elements assembled by rivets. The rivets are mostly pan headed rivets and the section of the hull is a single skin type of construction (Corlett 1990). Two planks (total width 420mm length 1.5m) of the original wooden ceiling are still in place retained on top of the floor by two longitudinal angles of unequal flanges (Stokoe 1996). The spacing between the floors is a maximum of 550mm and plate riveting was 150mm. Only single or chain riveting is present. The floors are solid riveted plate floors with no apparent manholes and two reverse frame (L bars) on the top and two bottom frames. The hull seems to be externally flush and the longitudinal strength is provided by several longitudinal bars between the floors. These are reinforced by the use of side girders. On the side of the section a bilge or side keelson formed by a longitudinal bar (single plate keelson) is connected to the floors with an angle bar. A plate with squared holes is riveted with an angle frame to the upper part of the side keelson. The maximum moulded dimension of the floors at the centre line was 330mm and sided dimensions were c. 140mm with each floor doubled meaning that two frames of c. 70mm were placed alongside each other. Another similar longitudinal angle is opposite on the portside of the midline suggesting more planking on that side. Drain hole spacing was c. 170mm. The maximum beam was 3.70m although difficult to measure due to the condition of the section. Traces of bitumen or another bituminous sealing substance is present over up to the bilge covering frames and rivets. Unfortunately no plating was found attached to the frames. The condition of the structure is poor and suffered from several impacts during the recovery.

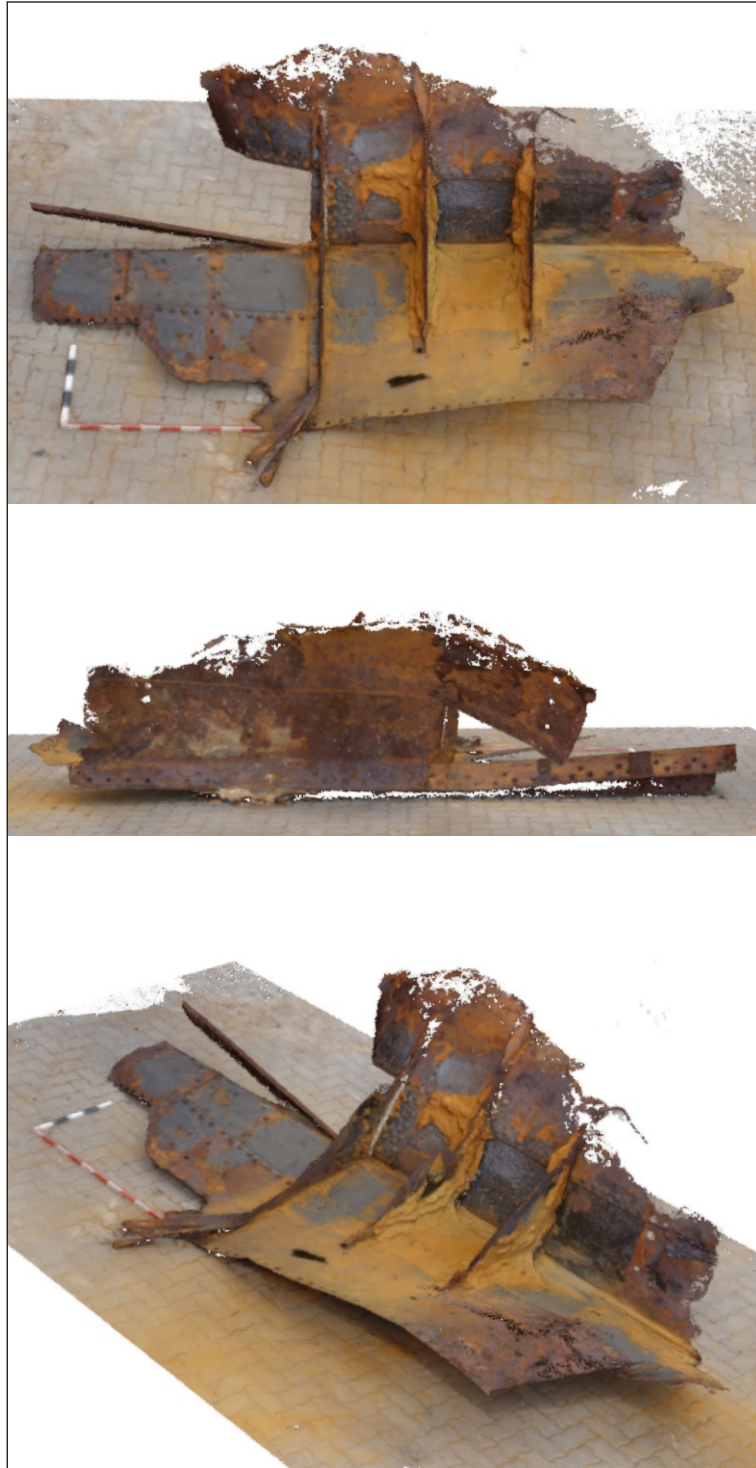
Plate 5: Keel section

4.4.3 **WA3216** is another and smaller (c. 3.4 by 2.4 by 0.7m) section of hull. It retains the keel bar, four plates in different states of preservation, and three floors (spacing 503mm). The arrangement of rivets on the garboard strake indicates that three floors are missing. The section is assembled with closely spaced pan head rivets and a layer of bitumen covers rivets, floors and plates at the level of the bilge. Circular bilge holes are visible and one still retains the wooden peg used as a plug. A butt strap with chain riveting runs on the garboard strake. The floors are made by solid V shaped beams attached to the plating with single angle frames riveted with a single line of rivets (rivet spacing 160mm - 140mm but closer as the strakes overlap). The plates (700mm) are in clinker fashion and fastened together by a single line of close spaced rivets (c. 65mm). This section of the hull does not retain any longitudinal elements apart from the keel. The keel (4m by 136mm) is made of a thick iron beam (25mm) attached to the turn of the two garboard strakes with rivets in a zig zag pattern. From the V shape of the frames it is very likely this section comes from one of the ends of the ship, possibly the bow. The section is very worn and the iron was brittle at the time of the survey.

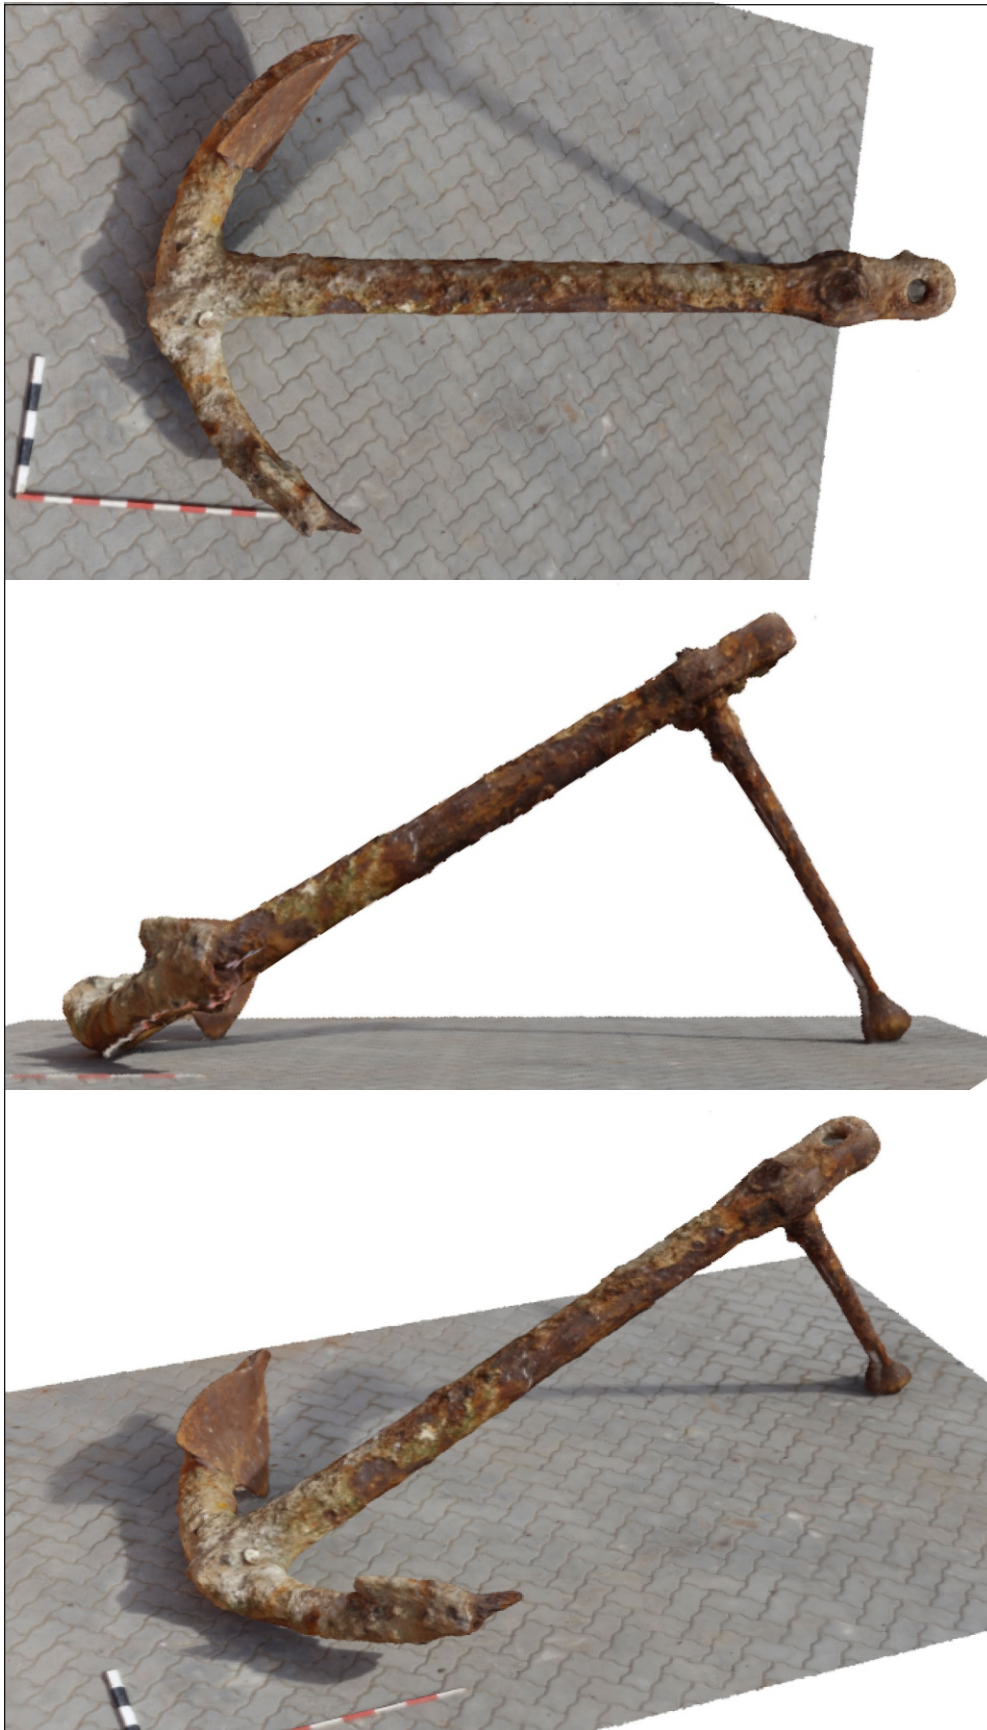
Plate 7: Anchor

4.5.1 Two admiralty pattern anchors were recovered during clearance works (**WA3068** and **WA3071**). The larger (**WA3068**) has one arm of the iron stock broken whilst the other arm is complete and still retains the ball. On the section of the broken arm of the stock hole for the retaining pin can be seen. The stock's eye diameter is c. 120mm and the remaining arm of the stock is c. 1.8m long. The shank is c. 3.2m long with diameter at the top measuring 150mm. The length of the fluke is 650mm (including bill) by a maximum width of 480mm. The distance between the bills is c. 1.75m.

- 4.5.2 The smaller one (**WA3071**) still retains the shackle and chain with studded links. The stock is complete with the retaining pin in place but an arm is bent. The shank length is c. 2.2m and diameter is 112mm. The length of the fluke is 420mm (including bill) by a maximum width of 330mm. The distance between the bills c. 1.3m.
- 4.5.3 **WA3145** is a wooden windlass. The overall length is 2.1m. The wooden barrel measures c. 1.6m and is octagonal in shape (side 120mm). Four of the iron whelps are still attached to one end of the wooden barrel. It is likely that there were eight whelps originally placed onto opposite faces of the barrel and divided in two groups of four at the two ends. At the centre an empty space (c. 140mm) suggests the location of the pawl rim.

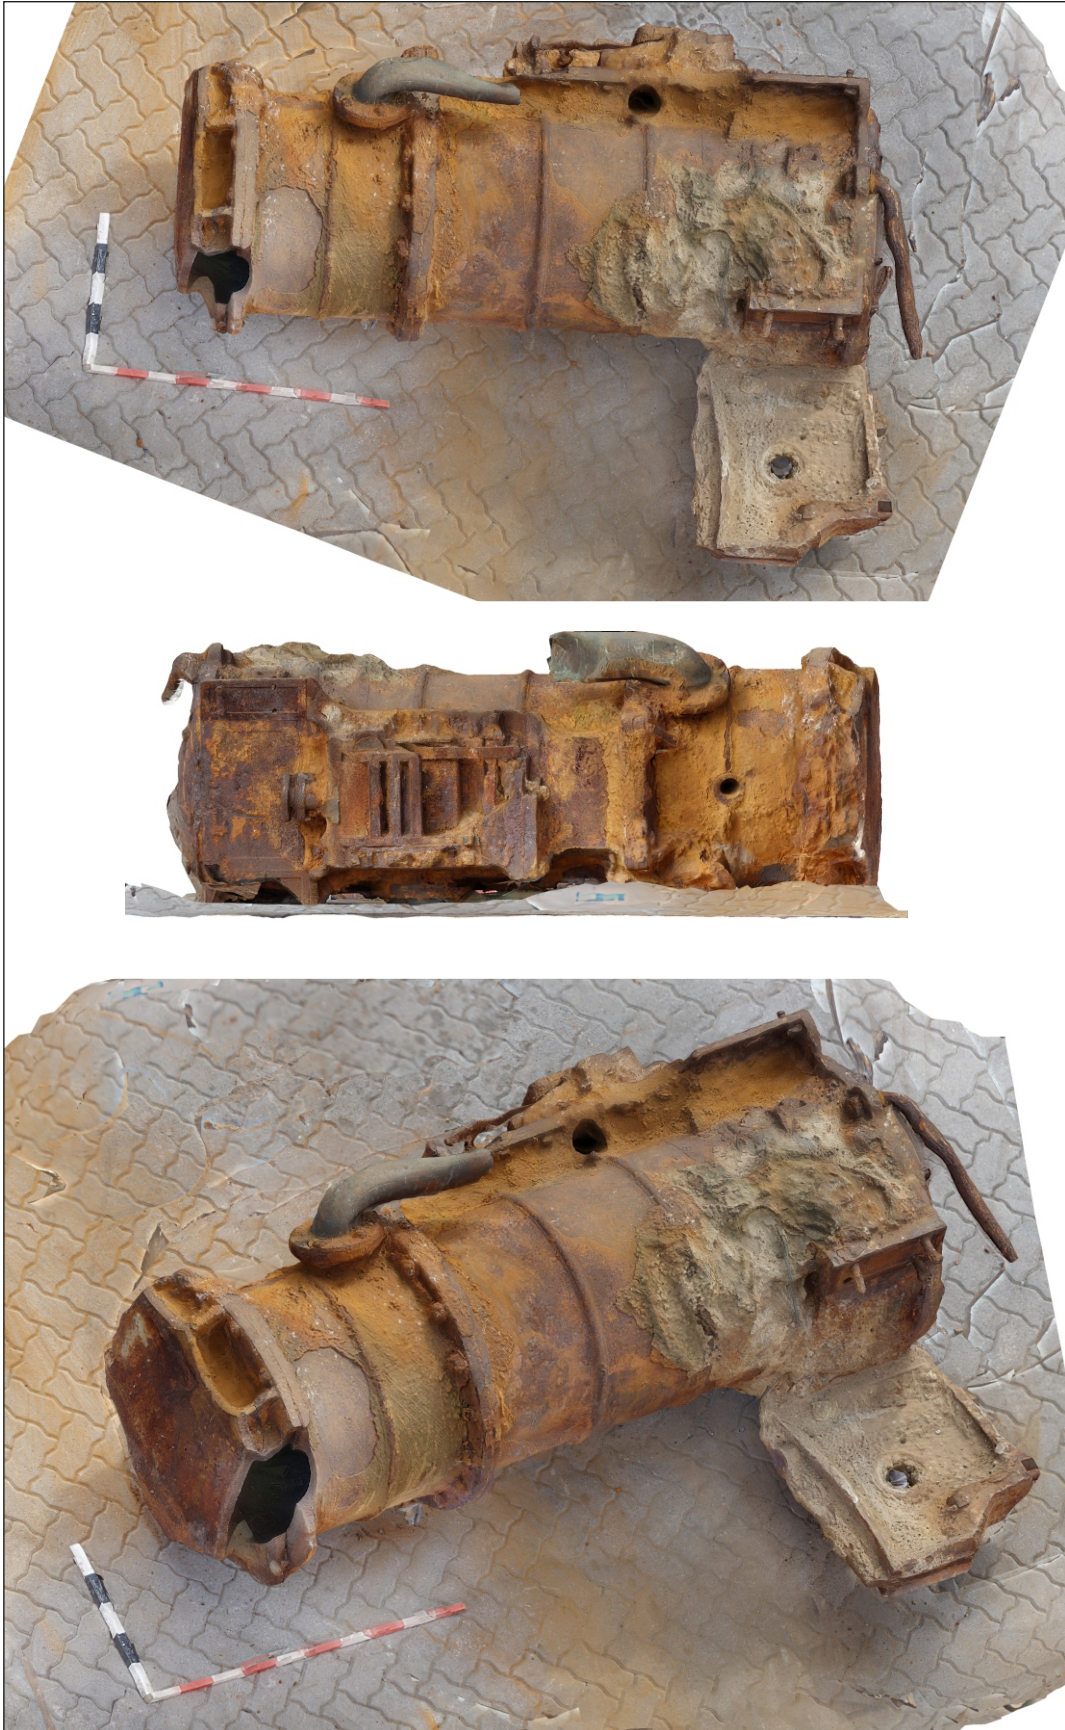
Plate 8: Cylinder 1

- 4.3.2 Both the single cylinders of the two engines were recorded (c. 2090mm by 850mm by 860mm). The cylinders have a condenser close-coupled below it (diameter of the bore 650mm/25.5ins) and bolted with large square headed bolts. Only one of the cylinders still retains the grid on which the expansion valve is mounted although the valve is not present. Behind it the main slide valve is visible. The flat faces to which the upper valve operating platform was bolted are also visible. The large copper pipes on each side conveyed the exhaust steam from the valve chest to the condenser. The pipes (two for each engine) are in different states of preservation: one of the pipes of **WA3044** is truncated and the other missing whilst the pipes of **WA3046** are still complete and have only suffered light damage. From the shape of the condensers and the absence of tubes in them they are likely to be jet condensers. The function of the jet condenser is to spray sea, canal or river water into the exhaust steam to condense it. Flow control valves are present on the two condensers.

- 4.3.3 On the cylinders there seems to have been an expansion valve mounted on the grid as a remaining part is visible outside the main slide valve. It has been observed (G. Dickinson pers. Comm.) that this valves would require its own separate eccentrics to work, therefore the total of eccentrics needed to run the pair of engines was four: two for the main valves and two for the expansion valves. These valves would be coupled to the discs of the eccentrics via gabs and the whole arrangement balanced with weights. However, the arrangement of the links that drove the expansion valve is at the moment not clear. The drawing of side lever engine published in *British Steam Tugs* (Thomas 1991: 199) shows the expansion valve as being driven via a Gooch type link, whereas *Reliant* is described as having completely different arrangement (Dickinson 2007). In fact the location of the eccentrics seems to have similar order to the one of *Reliant* where *"the expansion valve eccentrics are between the engines (and only usable when the engines were coupled and going ahead), and the main valve slip-eccentrics are outboard"* (G. Dickinson pers. Comm.).
