London Gateway Port Clearance Programme:
Wreck Site 343/26 5046 Northwest of Sea Reach 1, Thames Estuary

Balustrade Timber WA1168

Timber Survey

Ref: 88632
July 2017

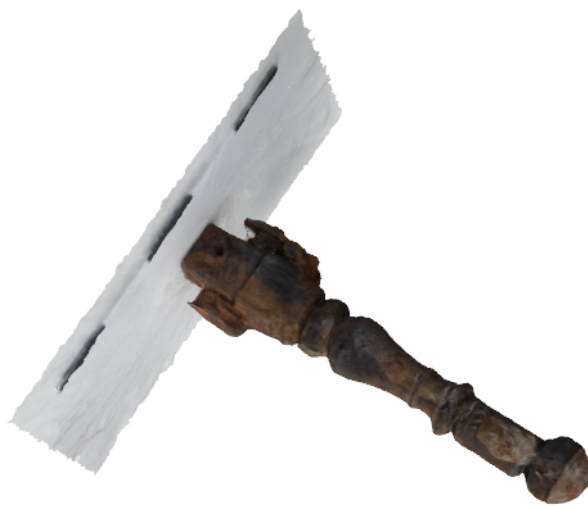
3.1.3 **Figure 3** contains an interactive 3D model of the timber (Adobe Reader 9 or higher required). The model has been down-sampled from a much higher resolution model in order to reduce the file size of this pdf. The model can be accessed by right clicking on the image and selecting 'Views'. Clicking on the model in either mode will allow you to rotate (left click and drag), zoom (mouse wheel) and pan (CTRL and drag).
