Wilton Autos,
West Street
Wilton
Wiltshire

Archaeological Watching Brief Report

Report 60516.03

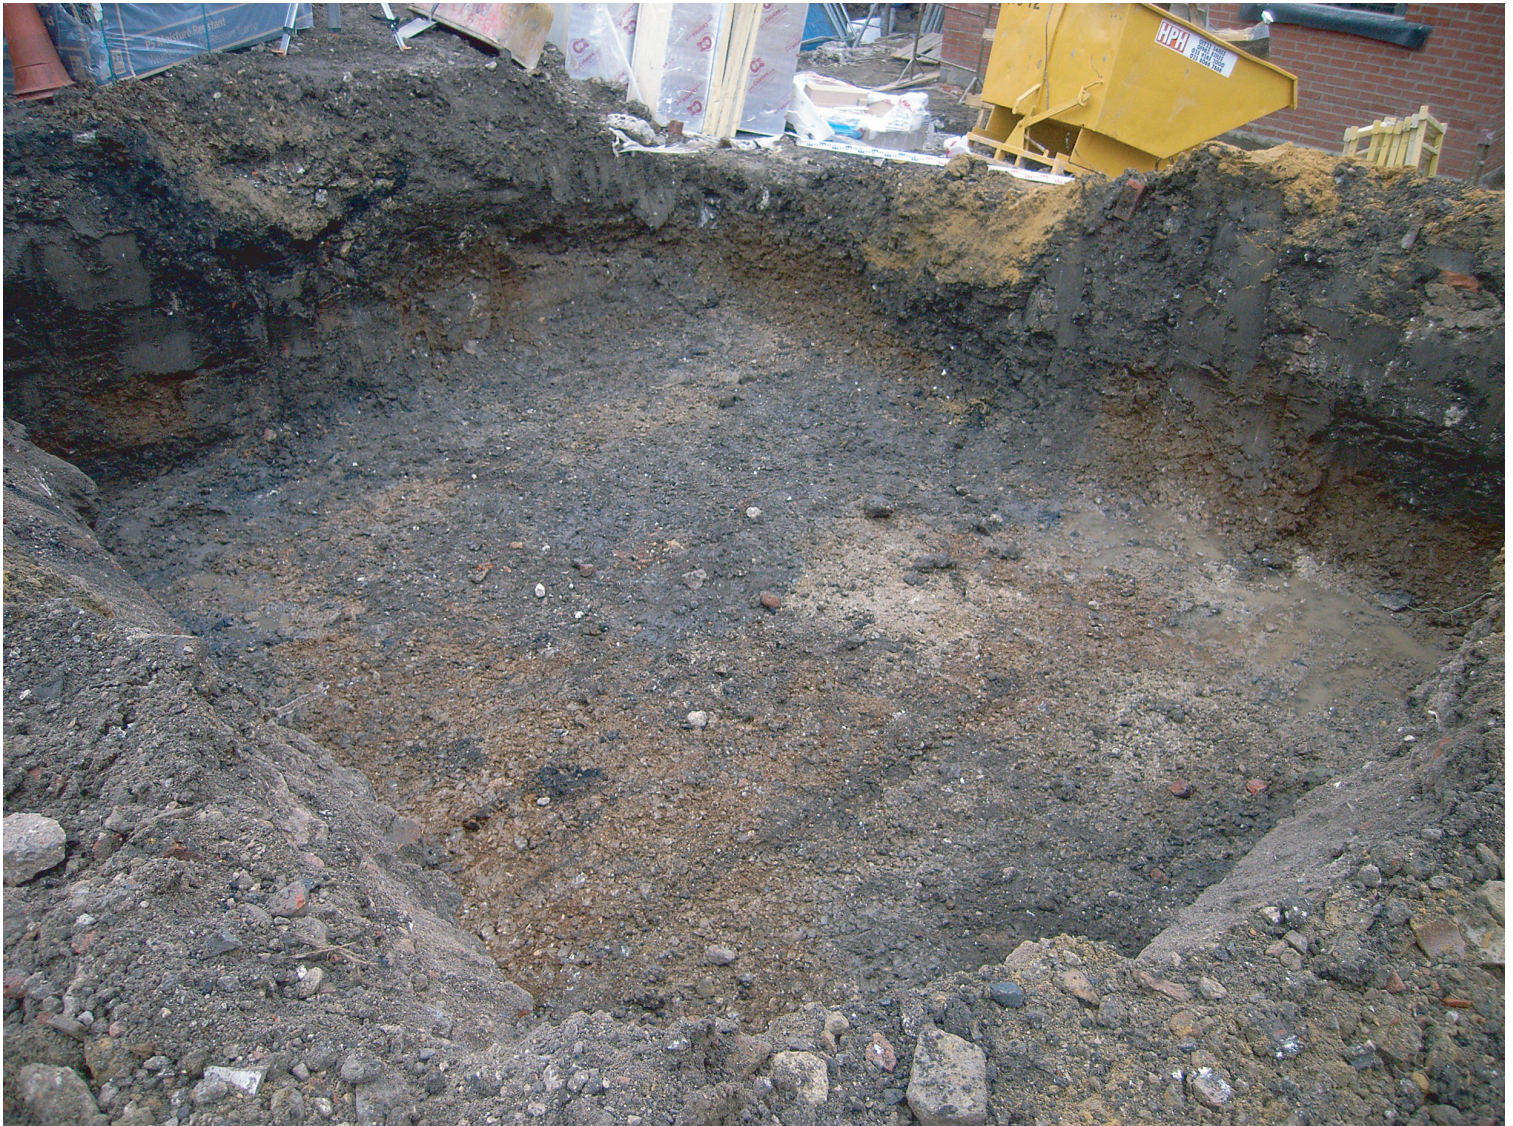
Cover: Working photograph of the Site
Figure 1: Location plan showing watching brief area and post-medieval features

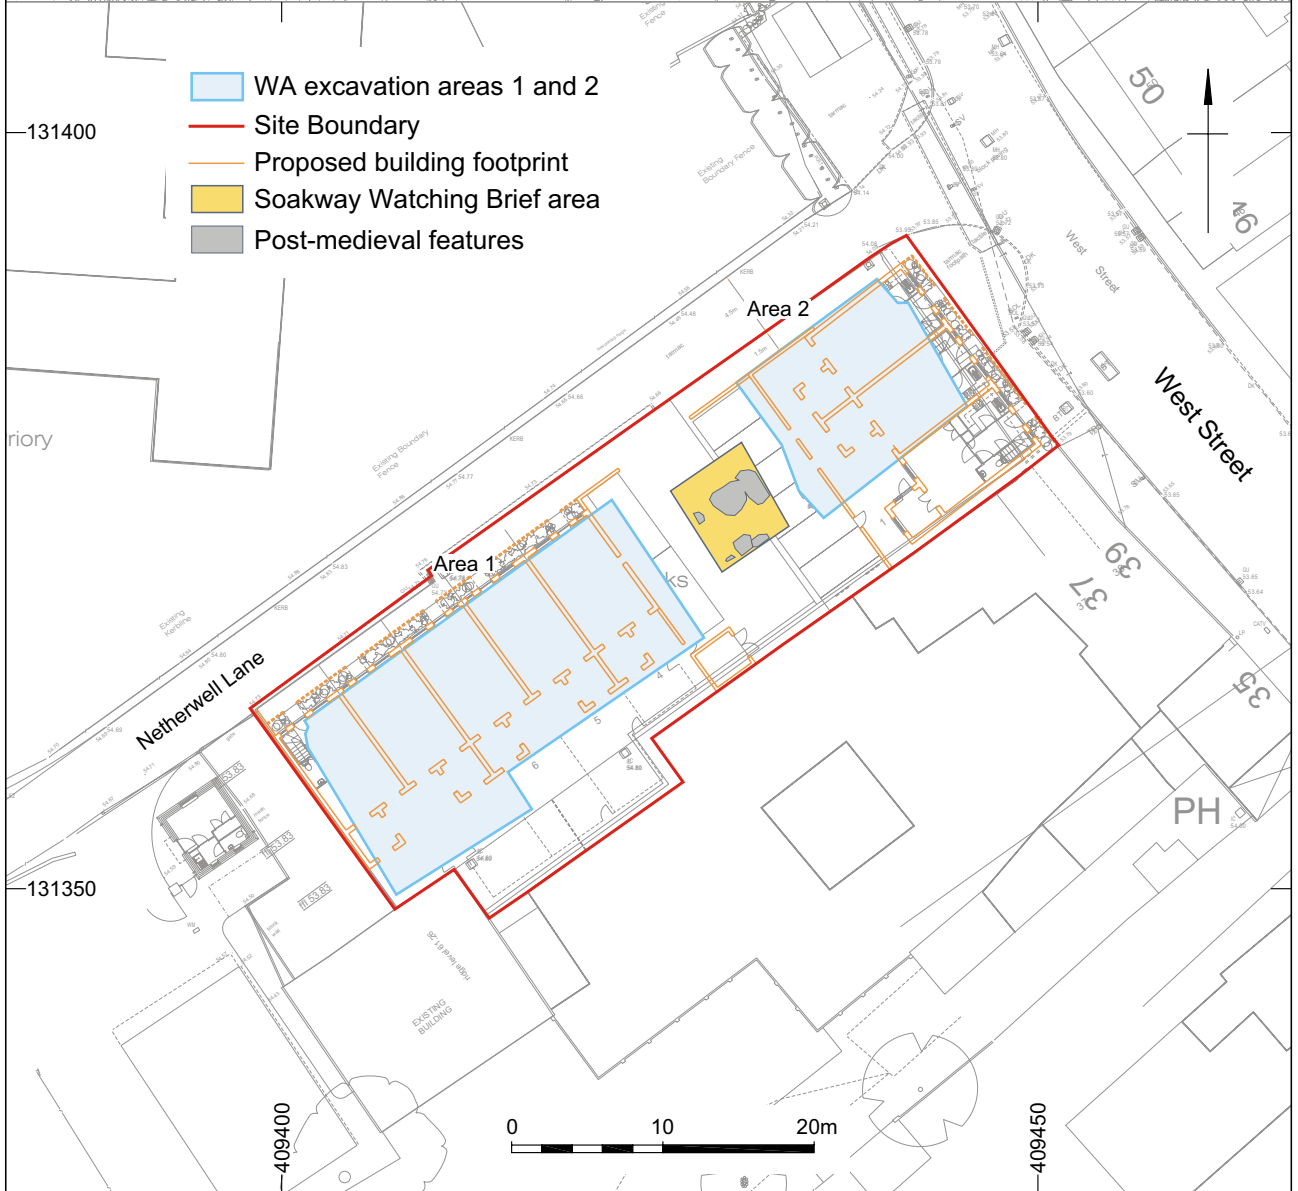
Figure 1

- 4.1.2 The area of penetrative groundworks for the soakaway was located between previous excavation areas 1 and 2 (**Figure 1**). The ground in this zone was known to be very disturbed and unstable to at least a depth of 2.00m.

Location Plan showing Watching Brief area and post-medieval features
