Moorhouses Farm, Bransdale Road, Rudland, Fadmoor, North Yorkshire

Archaeological Watching Brief Report

AOC Project No: 52051

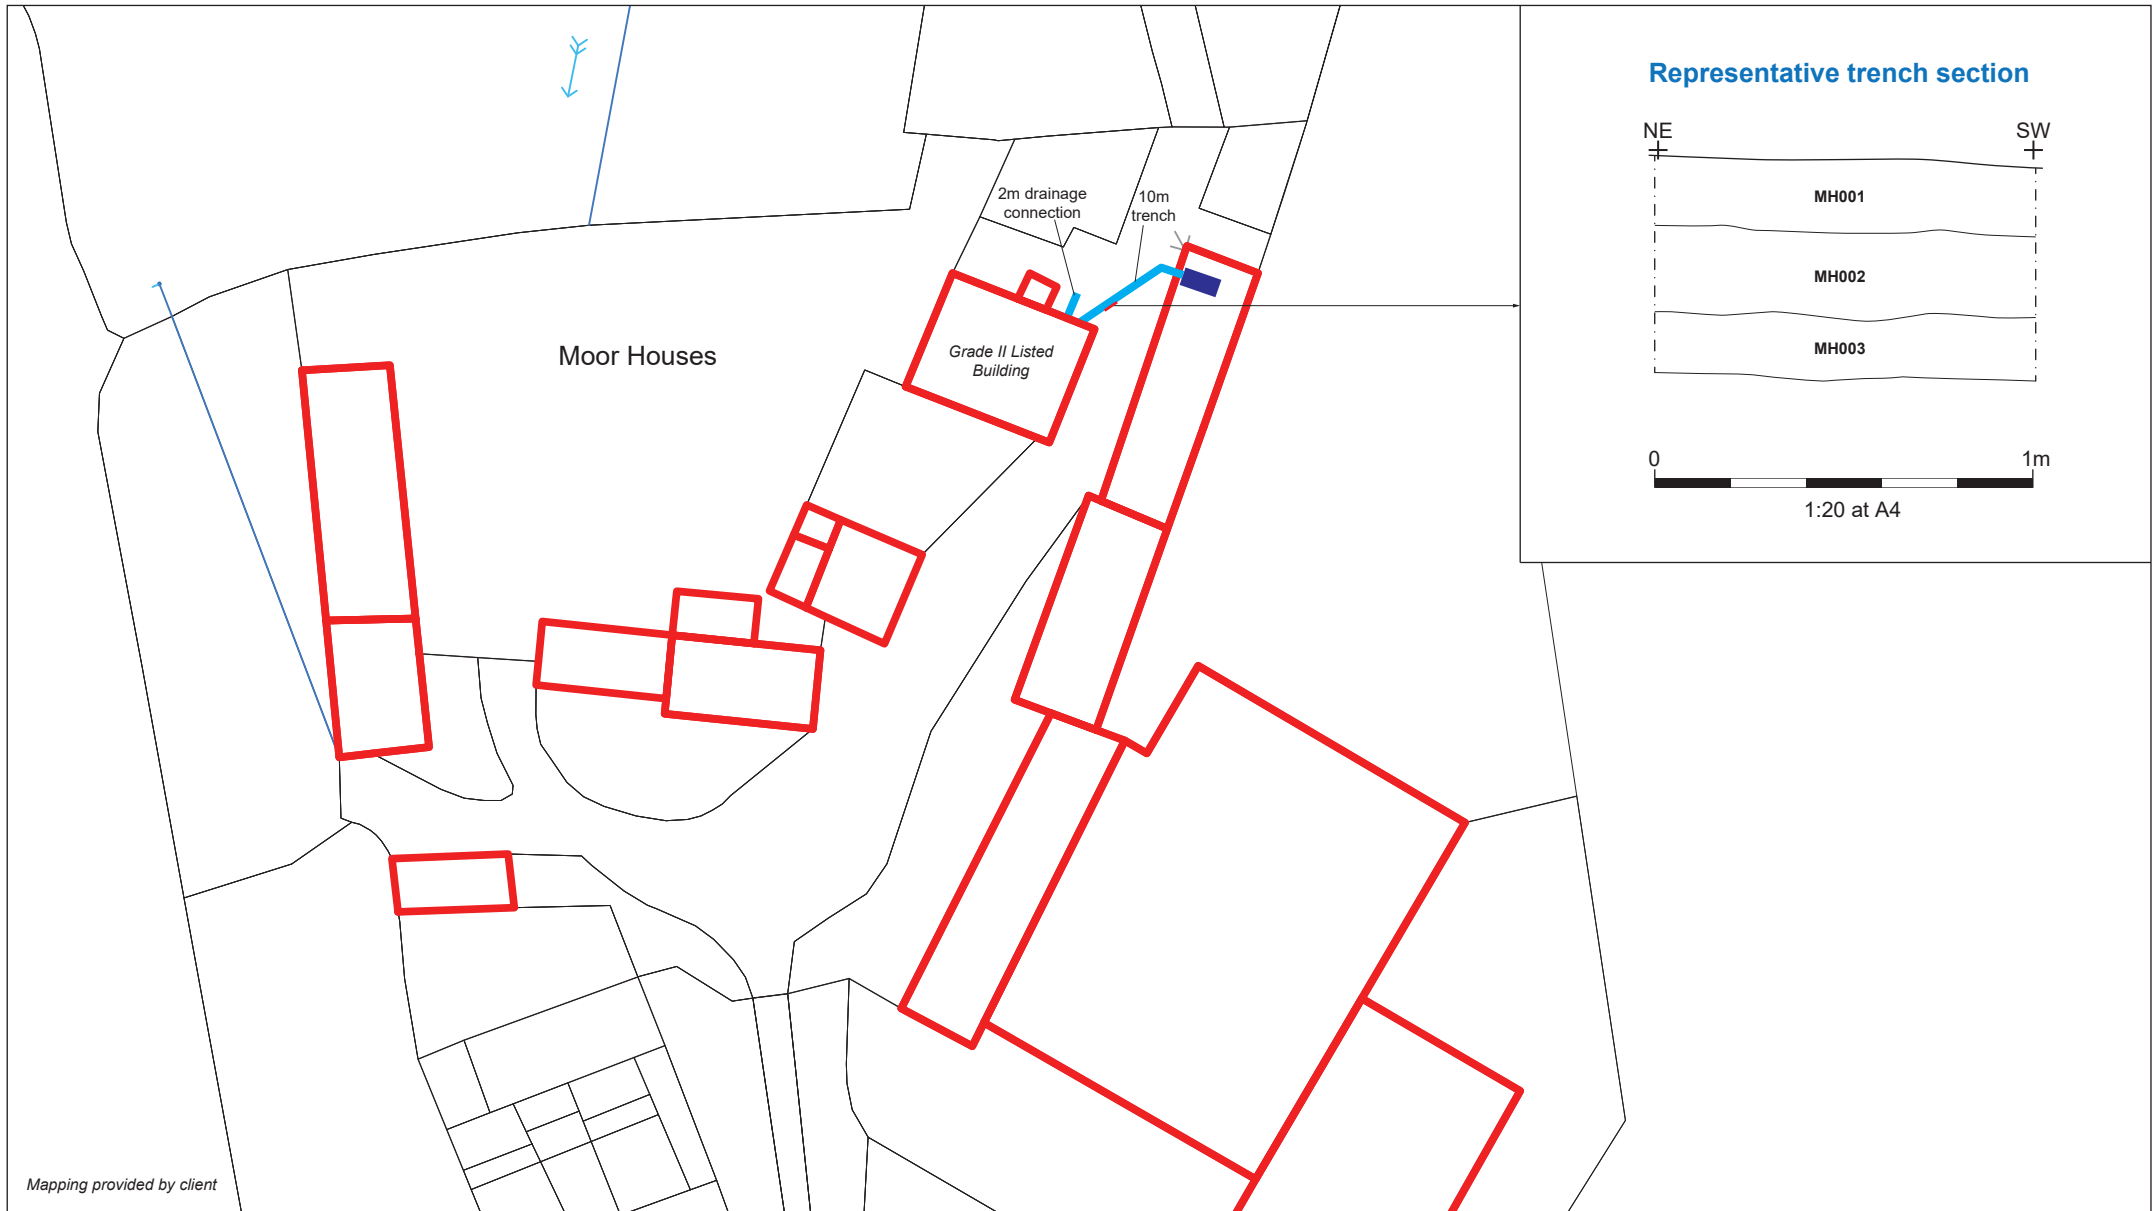
Figure
2

Site Plan and Section

Service trench location

New oil tank

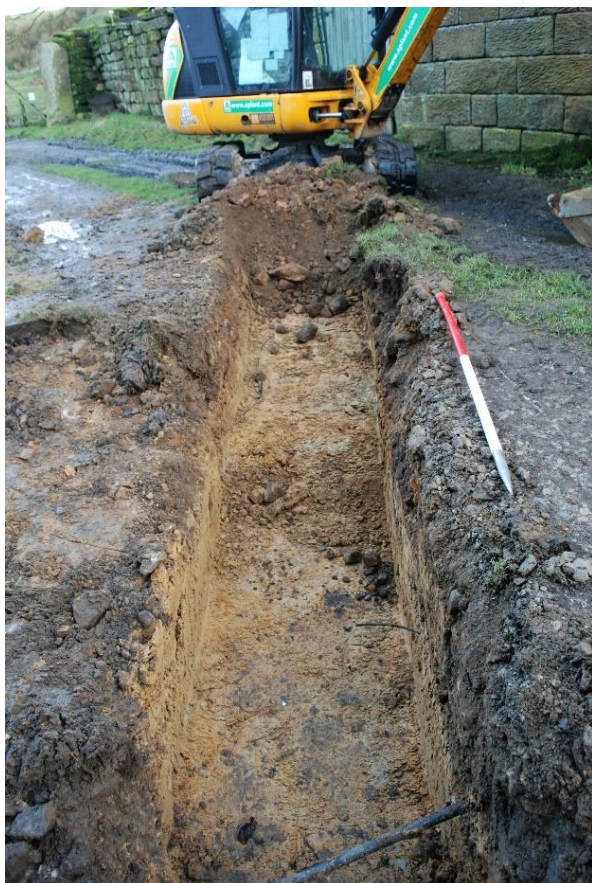
- 7.1 The service trench ran on a north-east to south-west alignment for a distance of 8.8m from the north eastern corner of the farmhouse (a Grade II Listed Building) to an adjacent barn (Plates 1 and 2). The trench measured 0.60m wide and 0.65m deep. Three deposits were recorded within the service trench. The lowest comprised clean pale brown silty clay which contained small stones and occasional larger stones; this is interpreted as natural subsoil (MH003; 0.25m+ deep). This deposit was sealed by a 0.25m deep mixed brown silty clay which contained stones (MH002). This appeared to represent made ground for a farm track which overlay the deposit (Plate 2). The upper deposit comprised a 0.22m deep mixed stone and gravel layer (MH001) which formed a trackway between the farmhouse and the barn.

Plate 1: Overall shot of service trench. Facing north-east.

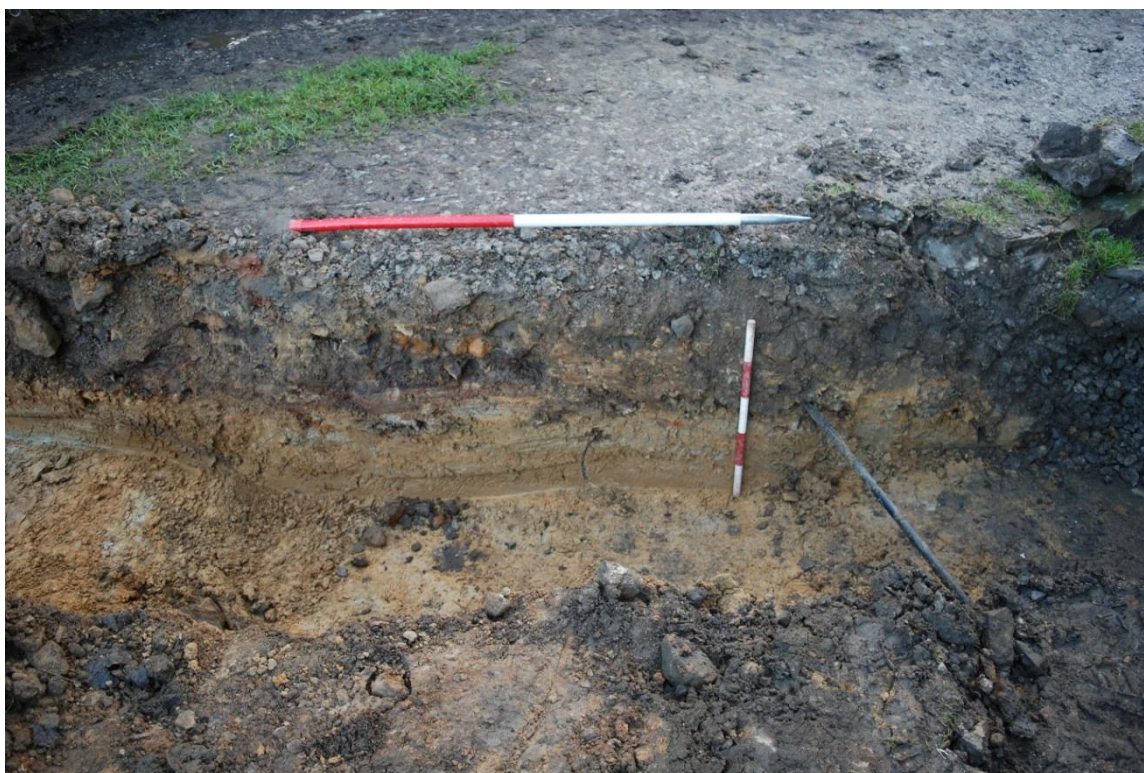
Plate 2: Section of service trench showing deposits (MH001-MH003). Facing south-east.

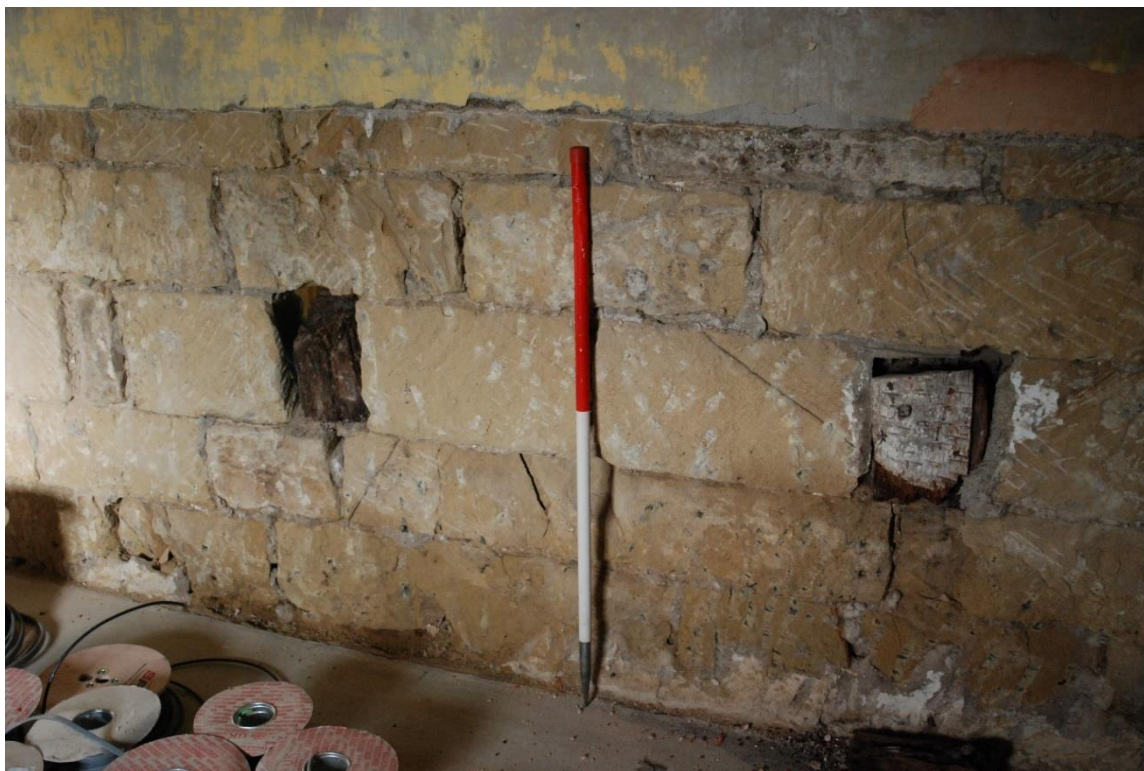
- 7.3 Within the Farmhouse, the wall between the kitchen and ground floor living room was inspected after the removal of plaster. Two wooden blocks were observed which filled rectangular holes in the masonry wall; the holes extended the full width of the wall between the two rooms (Plate 3). The timber blocks were not fixed and could be easily removed, possibly to allow warmth from the kitchen into the living room at a time prior to the plastering of the walls. Both blocks measured 0.30m by 0.18m and are most likely re-used timbers that were cut to fit the gaps in the wall.

Plate 3: Detail of timber blocks (MH04 and MH05) within the wall between kitchen and living room. Facing north-east.
