The Nailsea Glassworks,

Nailsea, North Somerset

A Summary of the known
Archaeological Interventions
1975 - 2004

Nailsea Glassworks Study 2004 - Part 2

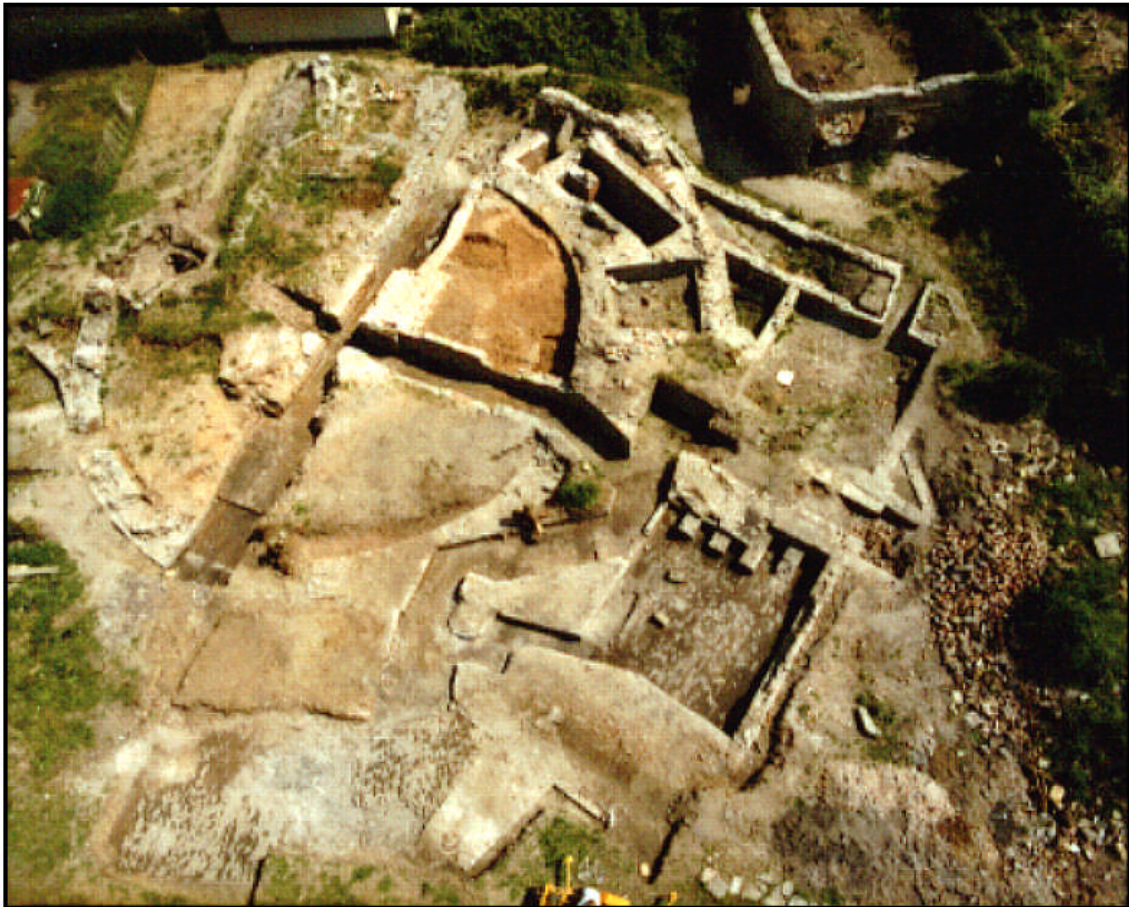
The cover photograph, © Cloud 9 High Level Photography, is an overhead view, looking approximately north-east, of the New House Cone base as excavated, and dates from 1987/1988. It is reproduced by courtesy of Mr M Thurstan, "Denmans", 5, West Street, South Petherton, Somerset, TA13 5DQ, the owner of Cloud 9 High Level Photography

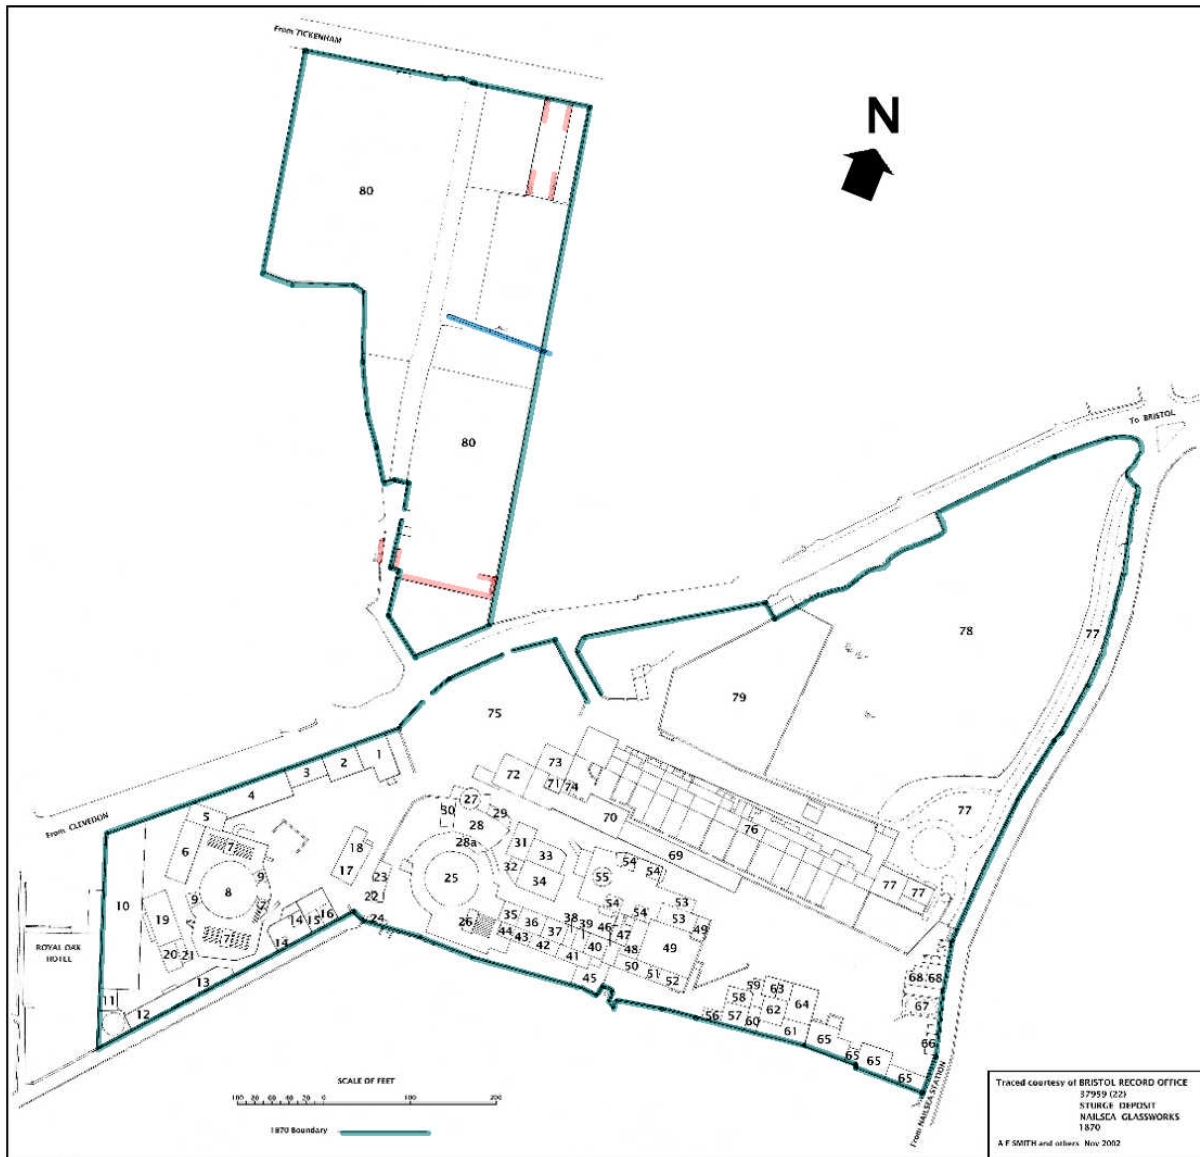
Figure 2.2: 1870 Plan of the Nailsea Glassworks Holding [BRO Sturge Deposit 57959 (22)]

The numbering, titling, etc on the 1870 plan (Figure 2.2, below) have all been enhanced, as the original is approximately 1.25 m square, and it was evident that hand transcription would not reproduce well. In the text building numbers referring to the 1870 plan are enclosed thus: - { }. It is not entirely clear when the cones became named, rather than numbered, but because it is the names of the cones that seem now to be in common usage they have been used here throughout. In any case, from the plan evidence, the numbering of the cones changed with time.

No explanation has been given for the name given to the Lilly Cone (1870 plan ref. {55}), when the other two remaining cones are numbered at that time. Some writers call it the “Lily” Cone. As it appears to have been the smallest cone it is suggested that “Lilly” was possibly a corruption of “Little”. Nor has an explanation been found for the names “French Kilns” or “Belgian Lears”. It is not known whether they are generic terms, referring to a certain design, or whether they were imported from their respective countries. [However, an unattributed note found in the SMR records (some long time after the foregoing was written) states that a French Kiln was for flattening cylinder glass, and a Belgian Lear, or lehr, was for annealing, the glass travelling through it on bogies from hot to cool.]¹

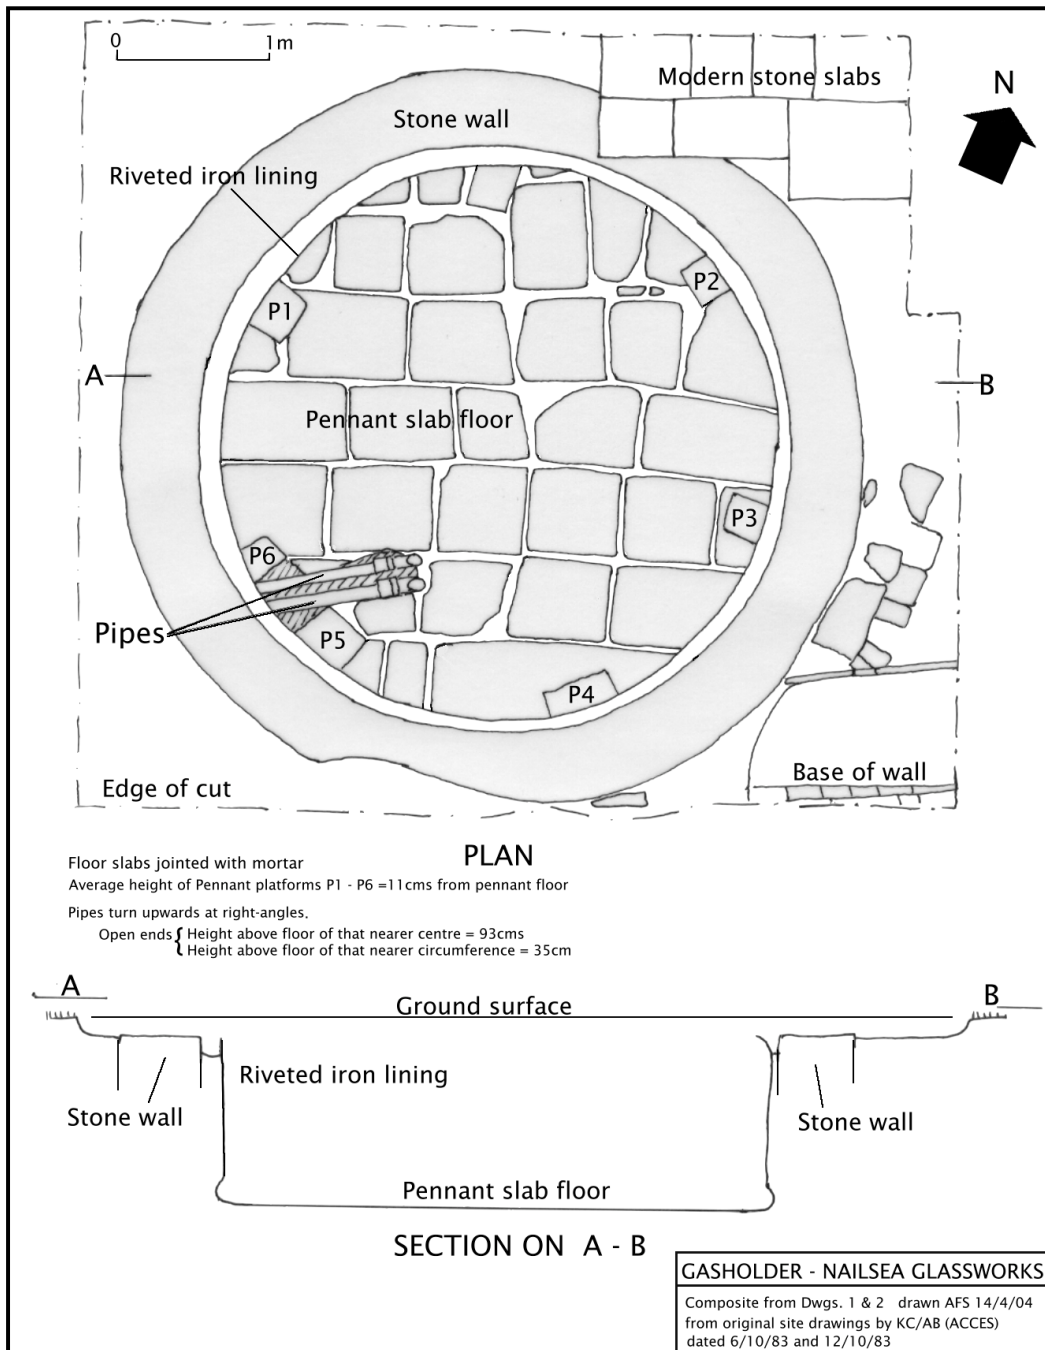
Figure 2.3: Composite plan and section of the gasholder

It does not seem that the retort building {11} itself was excavated. Nowhere has there been any mention of gas pipes having been found during any of the excavations. Either they were salvaged during demolition or scavenged subsequently, or the gas was maybe being piped direct to the French Kilns in the adjacent building {10}, which still survives on the western edge of the study area.]

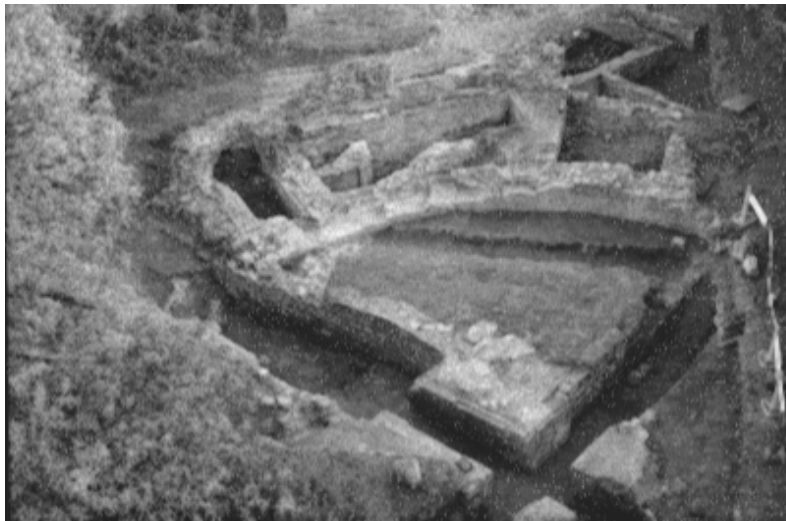
Figure 2.5: 1985 "The four main airways.... were revealed."

From the correspondence (NS SMR, Folder F) it appears that some work was done in **1985**, activity having been delayed for a year waiting for demolition of the bungalow, but work at No 37, High Street had recently restarted (R D Iles to J Hobbs, 17th May '85). Agreement was being sought from Mr J Hobbs for permission to excavate in No. 39 High Street, but this had not been secured by 30th August 1985. The temporary planning permission for No. 37 was therefore to be extended. An entry in *Avon Archaeology*, Iles and White, 1985, p.55, records, "Following demolition of a building (in 1984) over the centre of the New House Cone, excavations were resumed by T Downey for Avon Industrial Buildings Trust [AIBT]. The four main airways to the base of the furnace were revealed." This was after "most of the season was taken up with the removal of the concrete raft on which a recently demolished bungalow had been built." (Figure 2.5.)

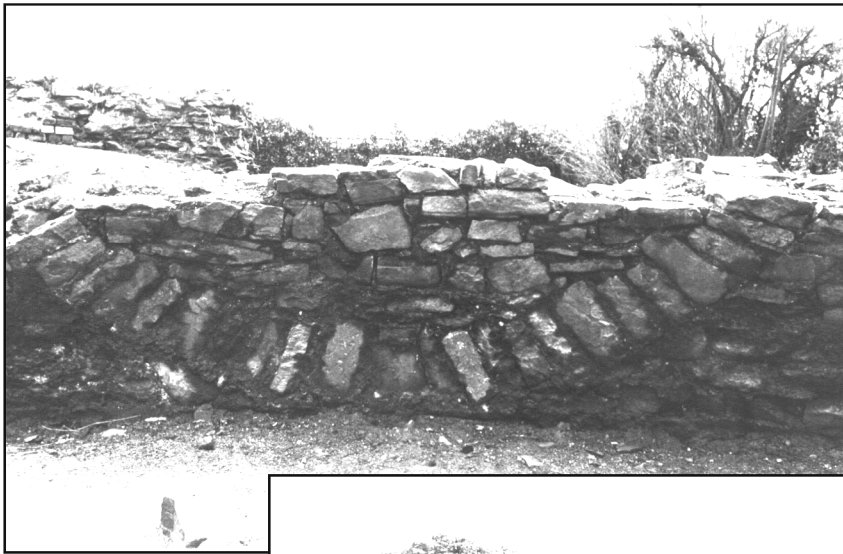
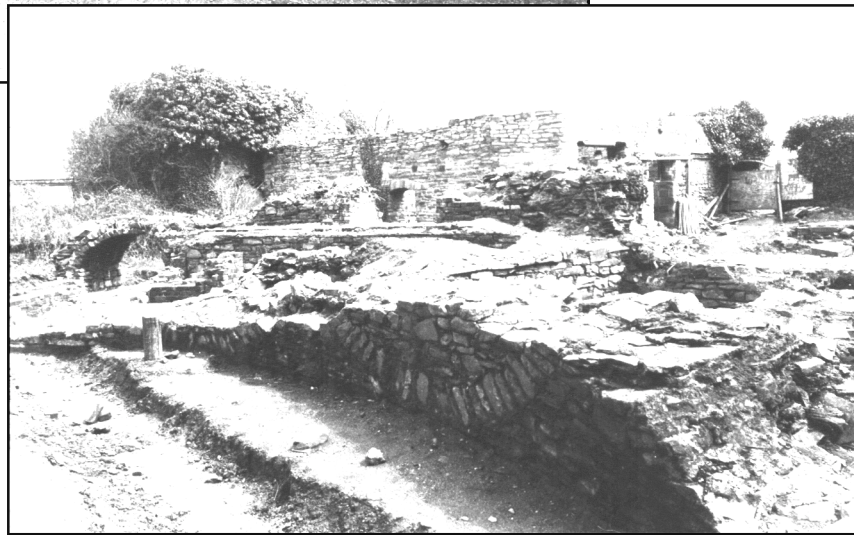
Left:
Relieving Arch B
(Interior)

Buildings 14 and
15
In background

Figure 2.6: Detail and general view of relieving arches A and B.

In the NS SMR (Folder B) there are copies of two plans, both dated 17-3-87, drawn by B Bentham showing details of the cone foundations and of the remaining three inverted relieving arches. Two, identified as B and C were diametrically opposite, and the centre-lines of A and B which are adjacent to each other (See Figure 2.6) are separated by 23.3°. Taking grid north as 0°, centred on the centre of the cone, and moving in a clockwise direction, the centrelines of the relieving arches A, B and C lie at 108.5°, 131.8° and 312.0° respectively.

It would appear, therefore, that if there were archways all round the cone then sixteen is a likely number. The relieving arches were to spread the downward thrust from the main arch piers to the whole foundation, which appears to have been entirely of stone. The superstructure was built in brick. (See Figure 2.8 below.) [The photographer has used the classic “framing” technique of taking the picture through an arch - at first glance it might be thought that the “cone” was in fact a dome.]

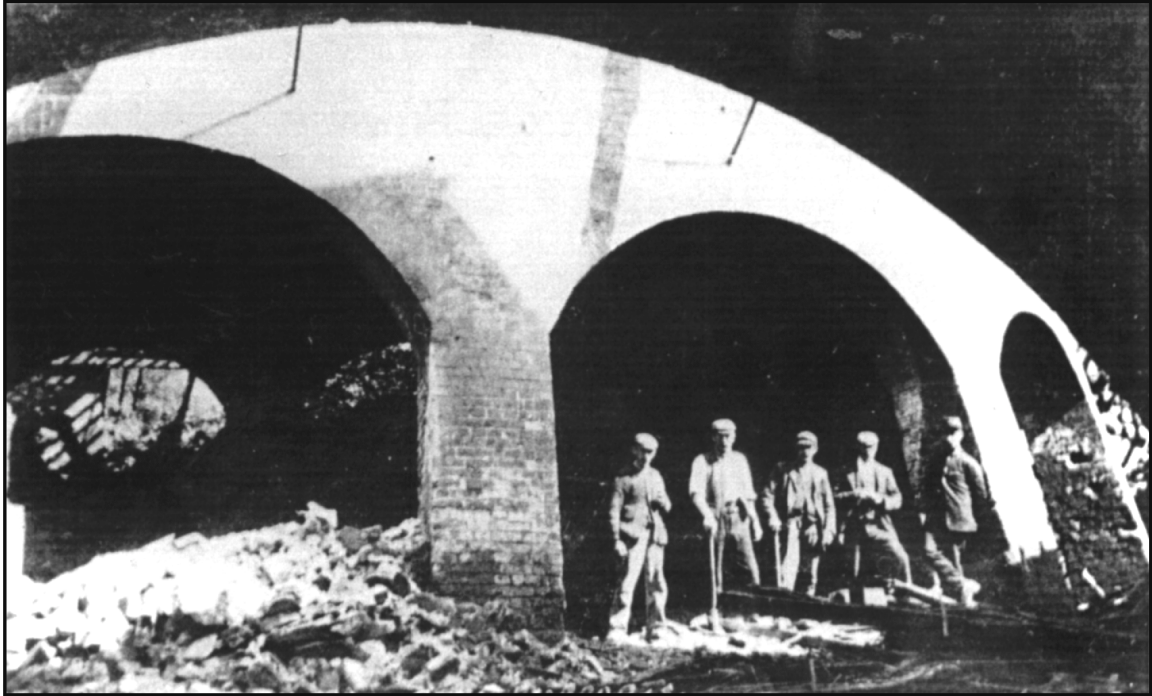
Figure 2.8: The Nailsea Glassworks Cone Supports, revealed during demolition in 1905 (NDLHS)

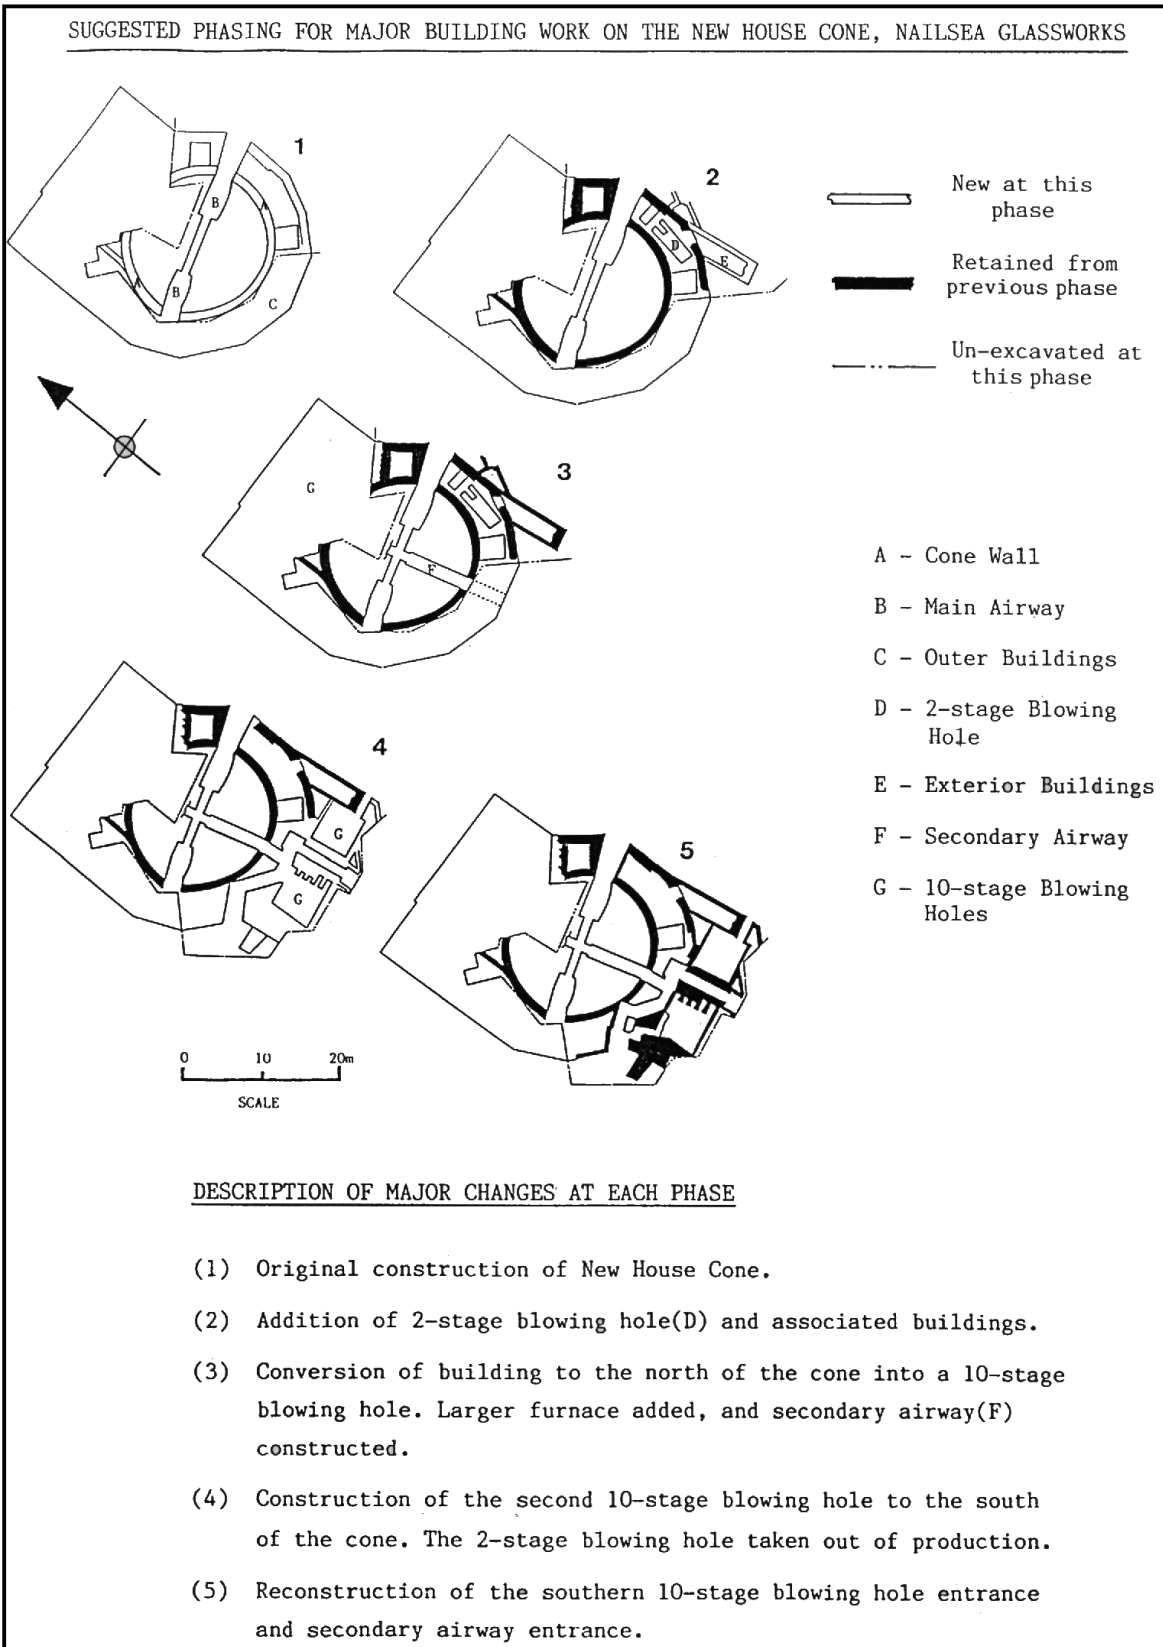
Figure 2.10: 1987 Suggested Phasing Plan (probably by B Bentham)

[See comments above on the assumed phasing in this diagram – the analysis appears to have followed textual evidence, rather than that from the archaeology, at least in part.]

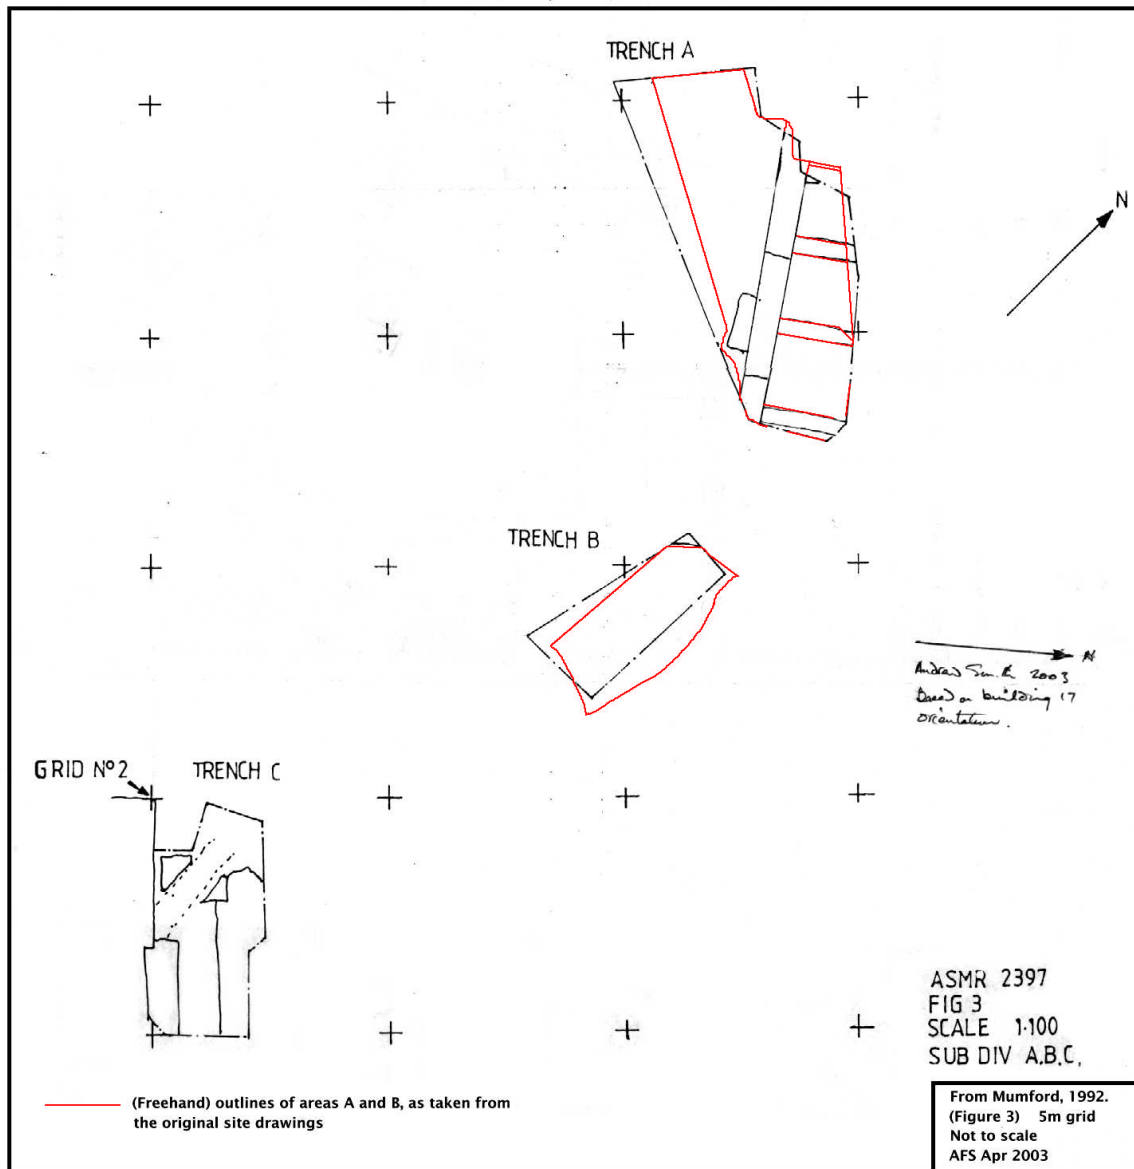
Figure 2.16: 1992, Figure 3 from Mumford, showing areas A, B & C, amended

1870 plan. This puts area C approximately in the right position, east west, abutting the southern boundary of the site. If area A is moved approximately 2m “south”, then the external wall revealed in area A becomes the south-, rather than west-, facing wall of building {17} – see Figure 2.30, below. [None of this is of any immediate help as all these points have disappeared in the course of the present development, but it does tie the results reasonably well in to the national grid, from the point of view of any future researcher.]

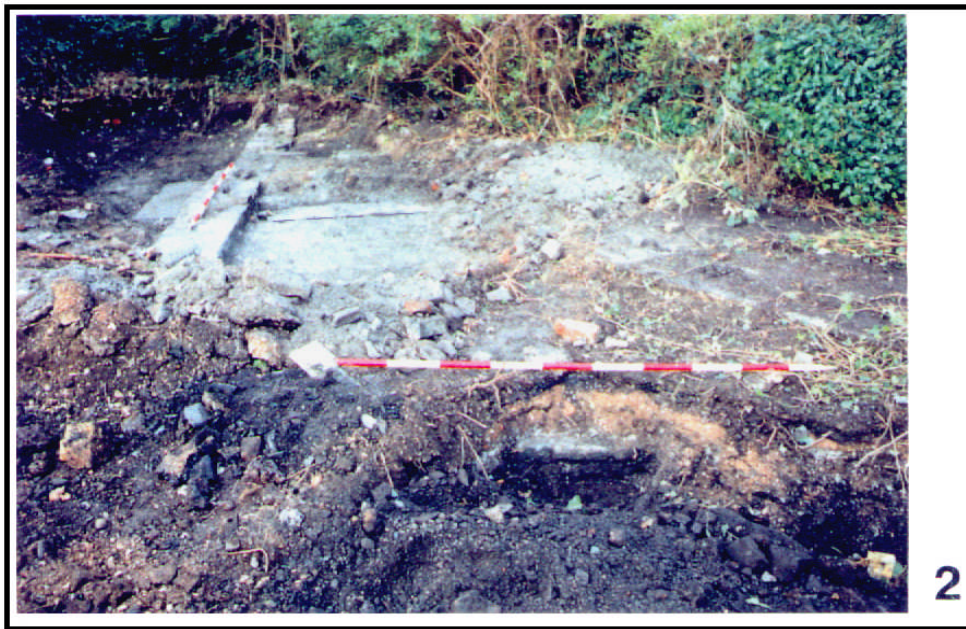
Figure 2.17: 1992, Photograph 2 (Mumford), showing relationship between areas A & B

correct relationship to {17}, but the fit is reasonably close. Photograph 2 of area B in the report (see Figure 2.17 below), shows this short section of wall; it appears to be about 2m north of the line of the external east-west wall in area A. This would then almost certainly make it part of (or adjacent to - see below) building {17}, the “Old office” on the 1870 schedule. Area A can be seen in the background (upper left). The step to the (blocked) doorway can be seen to the left of that wall, and the line of the sleeper wall (3290) may be seen on the opposite side of the wall from the step. Alternatively, the tithe maps show a long wall running down through the works with {17} butting it on the western side, so this very short section of wall could be this wall which does not seem to appear on any other map or plan. A deeper cut in this area led to the conclusion that this structure at least had been built over a large pit or quarry that had been filled with compacted waste from the kilns sometime before building was started.

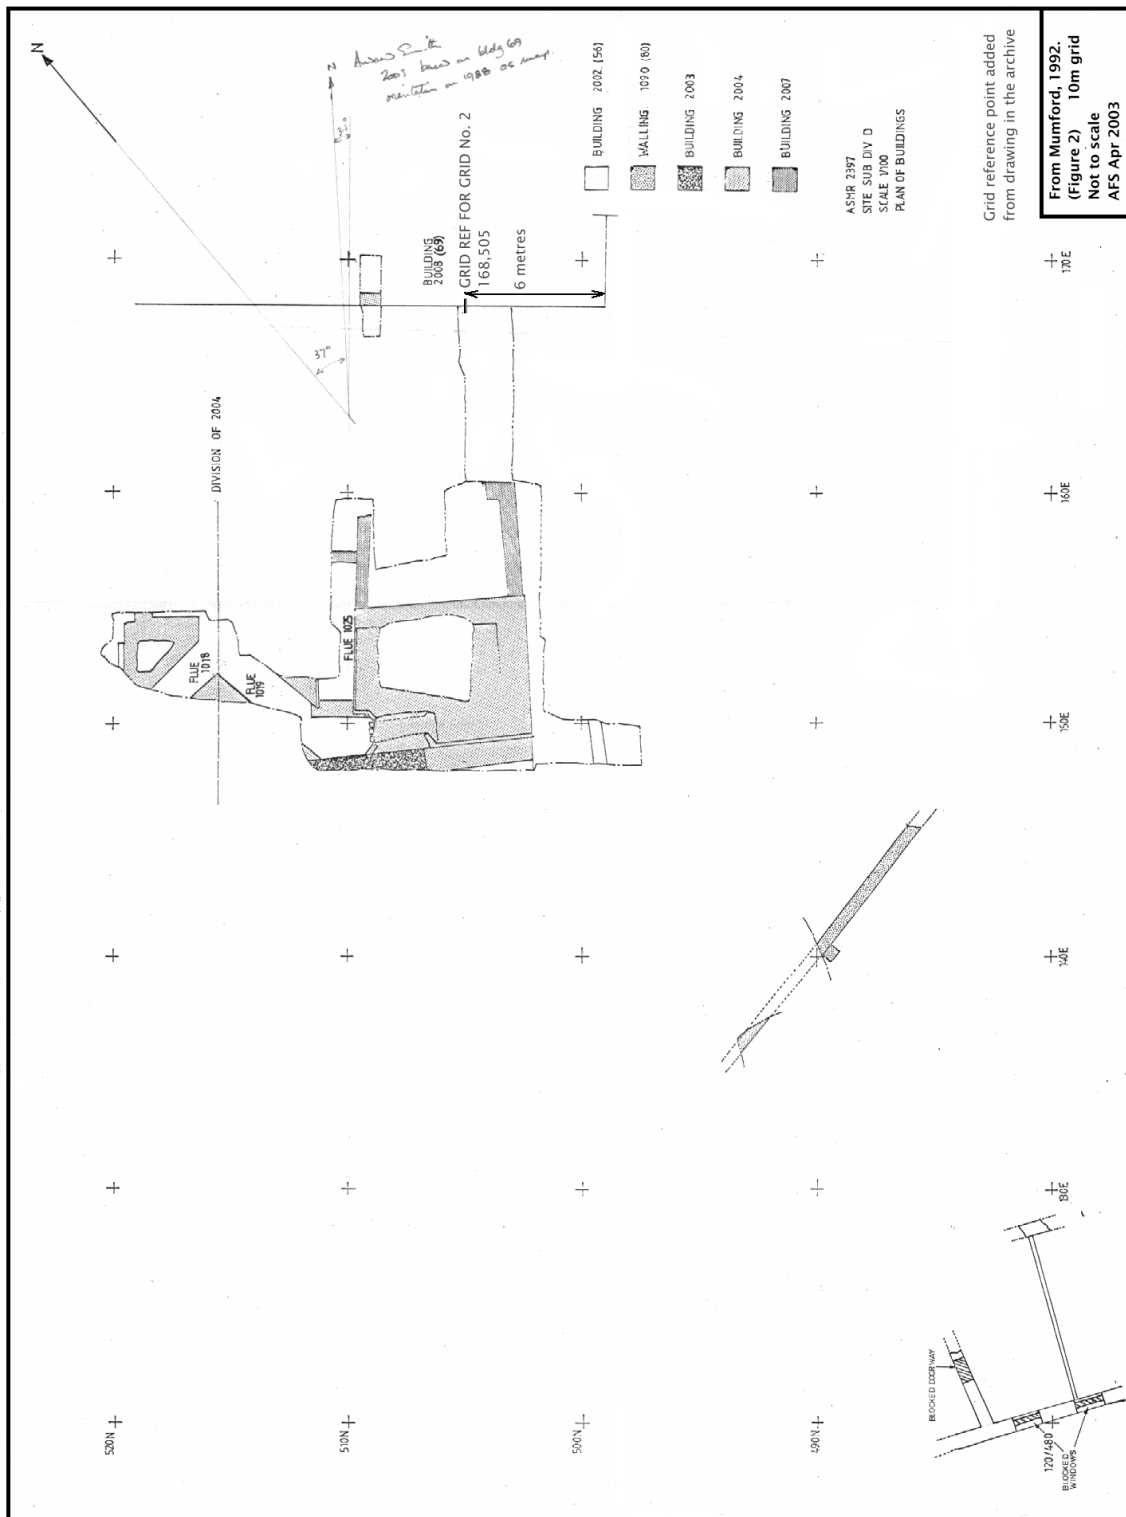
Figure 2.18: 1992, Figure 2 from Mumford, showing area D

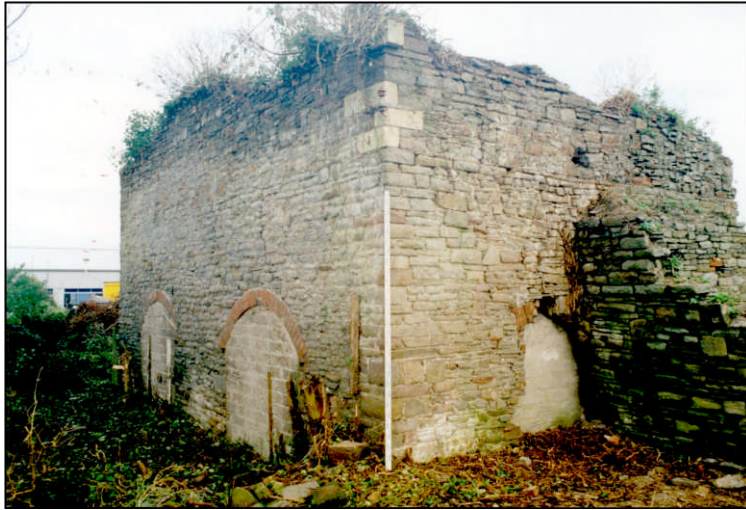
Figure 2.28: Exterior of pot arch building {15}/{16}, from west.

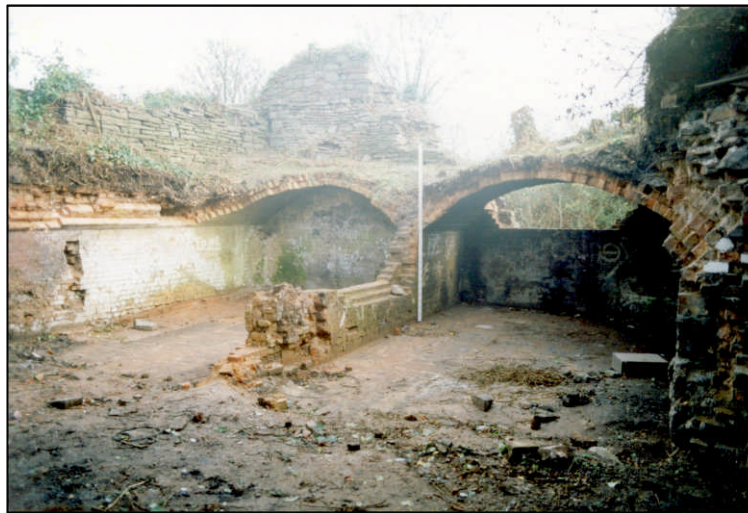
Figure 2.29: Remains of pot arches {15}/{16} - interior view looking east.

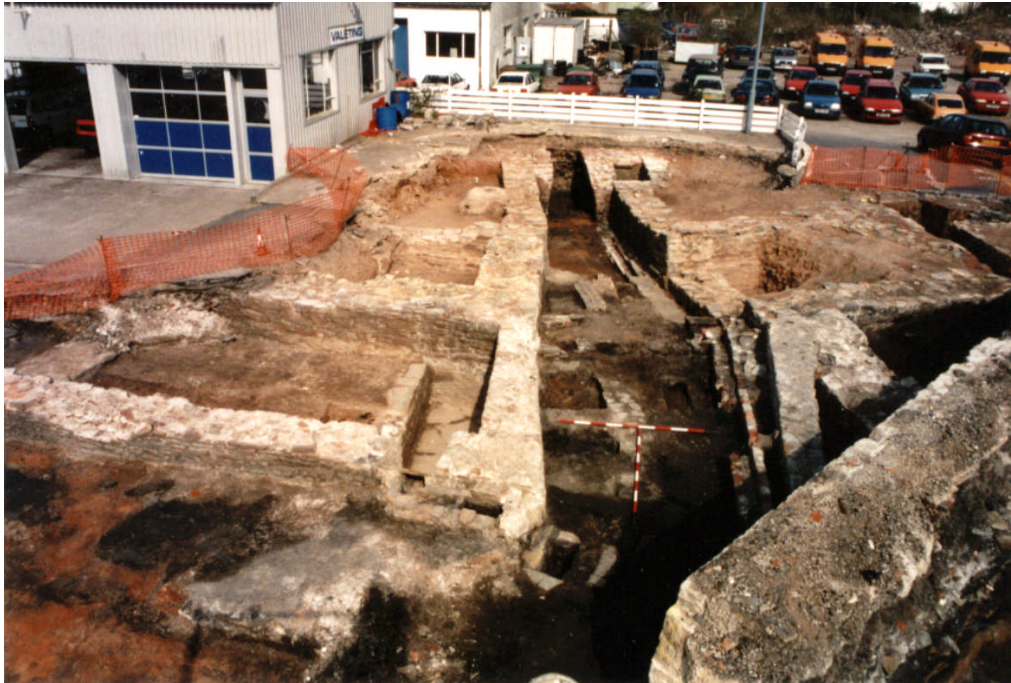
Figure 2.33: General view of 1995 excavation: Old House Cone area.

The 1995 report contains a detailed diagram (Figure 7) of the suggested phasing of construction which is reproduced as Figure 2.32 below, with additions. The following general view (Figure 2.33 below) corresponds with most of this diagram.

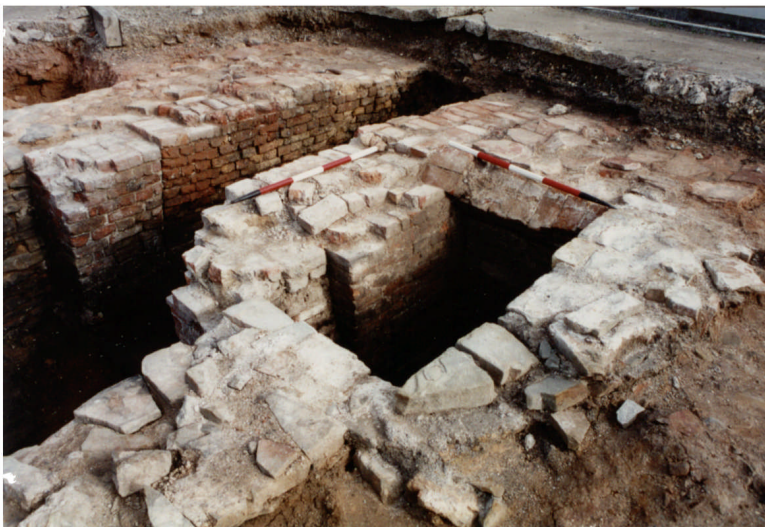
Figure 2.34: Possible furnace feeder chamber (1995 Report - Photograph 10 Context 363).

Context 363, the white rectangle surrounded by blue at the inner end of the main airway in Figure 2.32, is a “deep square chamber ... originally capped by a brick arch...”.

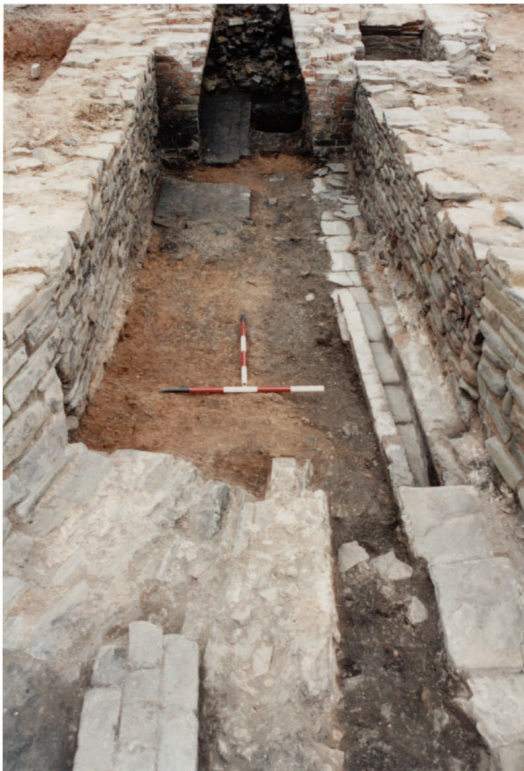
Figure 2.35: Main Airway looking NE

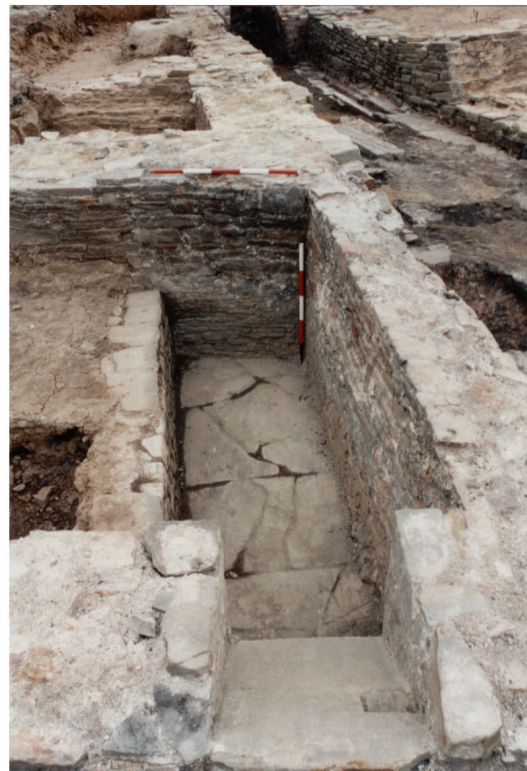
Figure 2.36: Stone lined “tank “

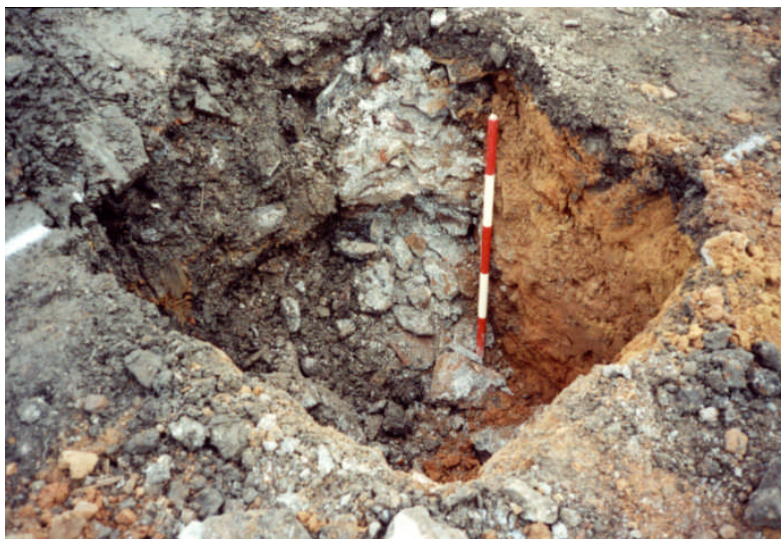
Figure 2.43: Foundation Pit No 50 from ESE.

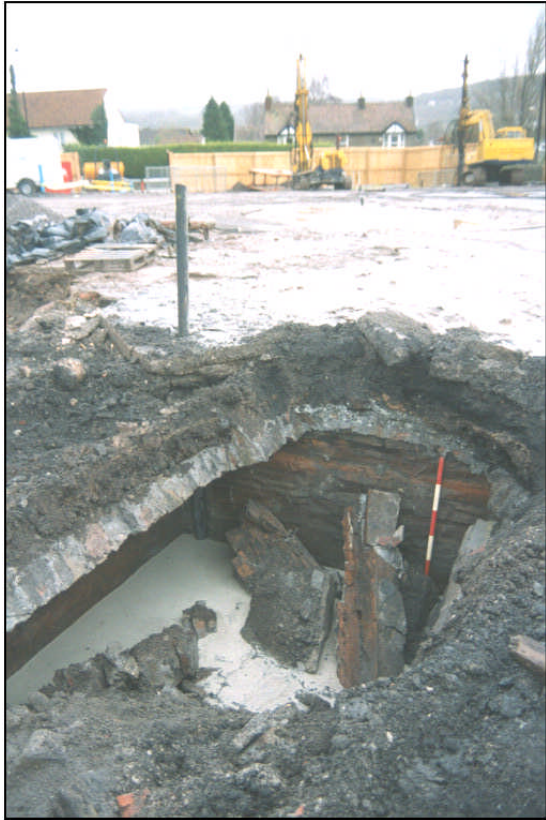
Figure 2.46: Northern chamber.

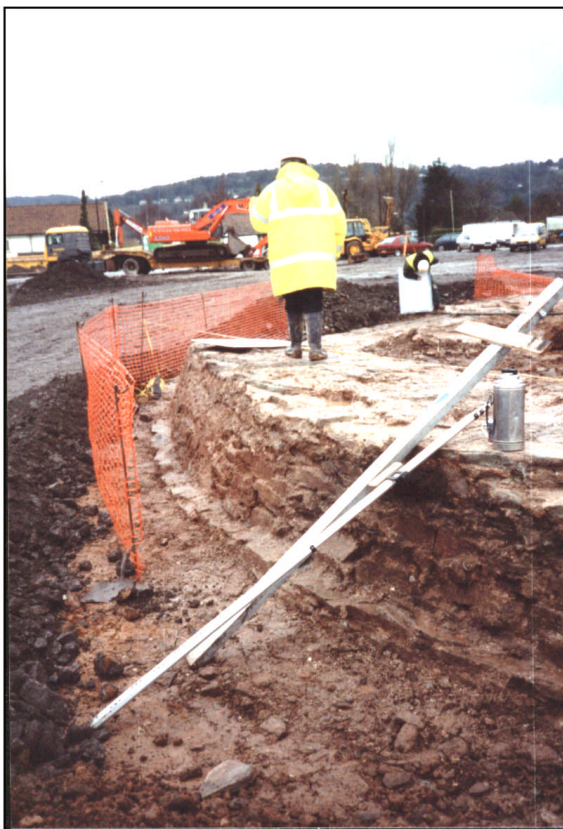
Figure 2.48: New House Cone, showing foundation extension - western sector

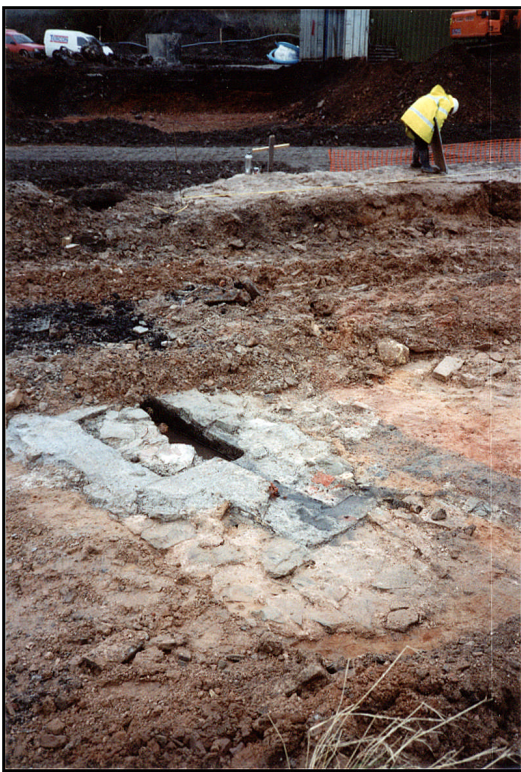
Figure 2.50: Old House Cone South furnace box?

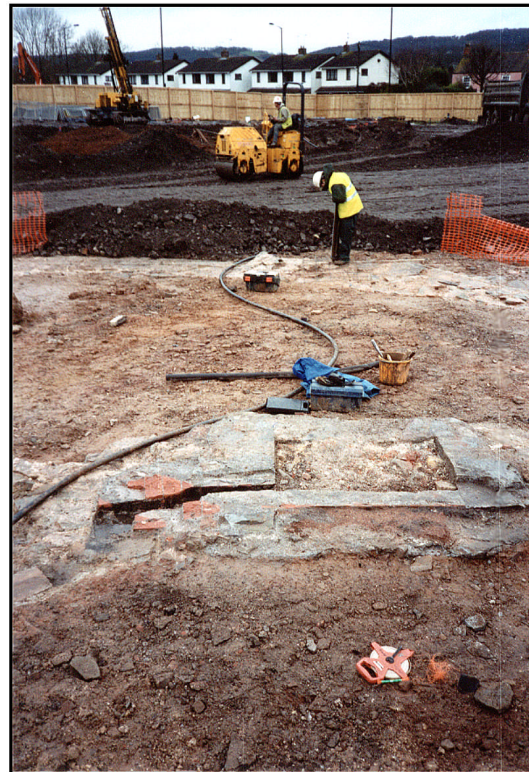
Figure 2.51: Old House Cone North furnace box?

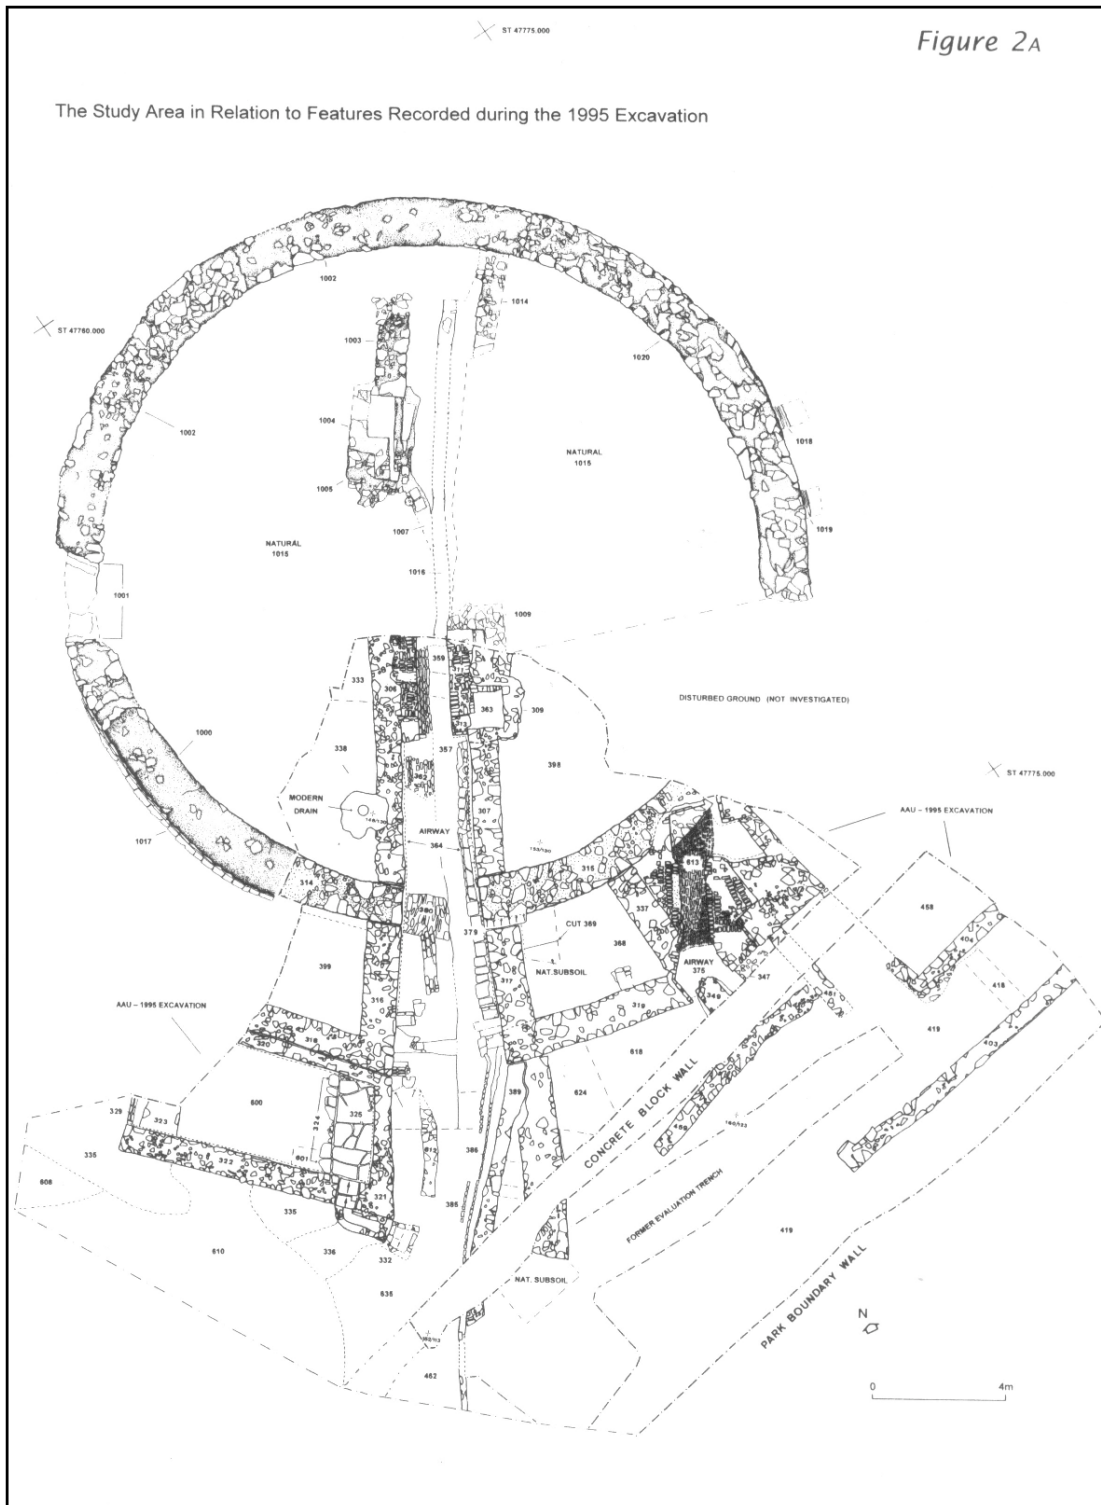
Figure 2.52: Old House Cone composite 1995 + 2002 - Figure 2A from 2002 report
