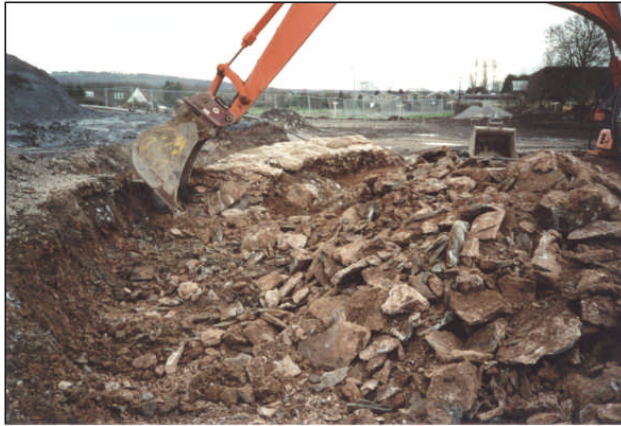
Figure 2.53: Old House Cone - Final destruction, 2002

As the recording was being completed, so there was encroachment on the site, and the final destruction of the Old House Cone was photographed before the archaeologists had left site (Figure 2.53.)
