**TULIP MEWS  
HEDDON-ON-THE-WALL  
NORTHUMBERLAND**

**AUGUST 2020**

**DATE ISSUED:** August 2020  
**JOB NUMBER:** CL12097  
**SITE CODE:** HED/ B  
**OASIS REFERENCE:** wardella2-394155  
**SCHEDULED MONUMENT CONSENT NO:** S00213496001  
**REPORT VERSION NUMBER:** V0.2

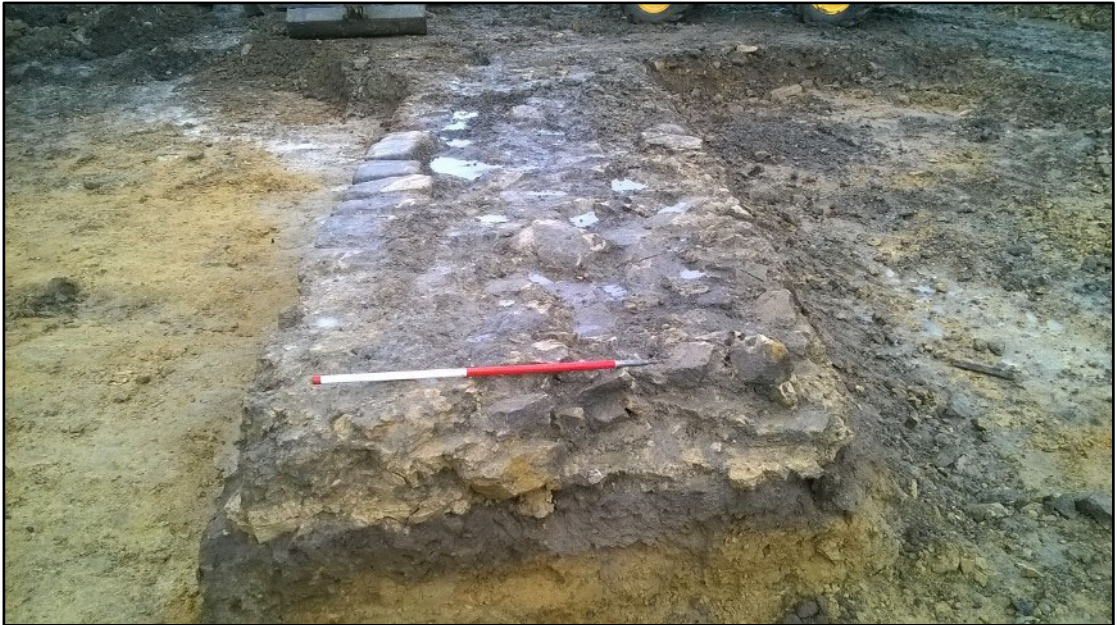
Plate 3; Foundations of Hadrian's Wall (109)

4.2.3 The core of the wall (**109**) (Plate 3) measured over 2.0m in width and was faced by fitted worked sandstone blocks (**114**) (Plate 4). These stones had an average width of 0.40m and height of 0.30m and were shaped to fit closely together with no bonding material observed. The facing stones overlay a series of sandstone slabs (**115**) forming a base for the wall (Plate 5). These slabs were mixed with a firm yellow clay and were directly above a soft dark brown sandy clay (**112**) buried soil. The buried soil measured 0.2m in depth on average and contained small amounts of rounded pebbles and occasional charcoal flecks. Two samples <1> and <2> were taken from the deposit.

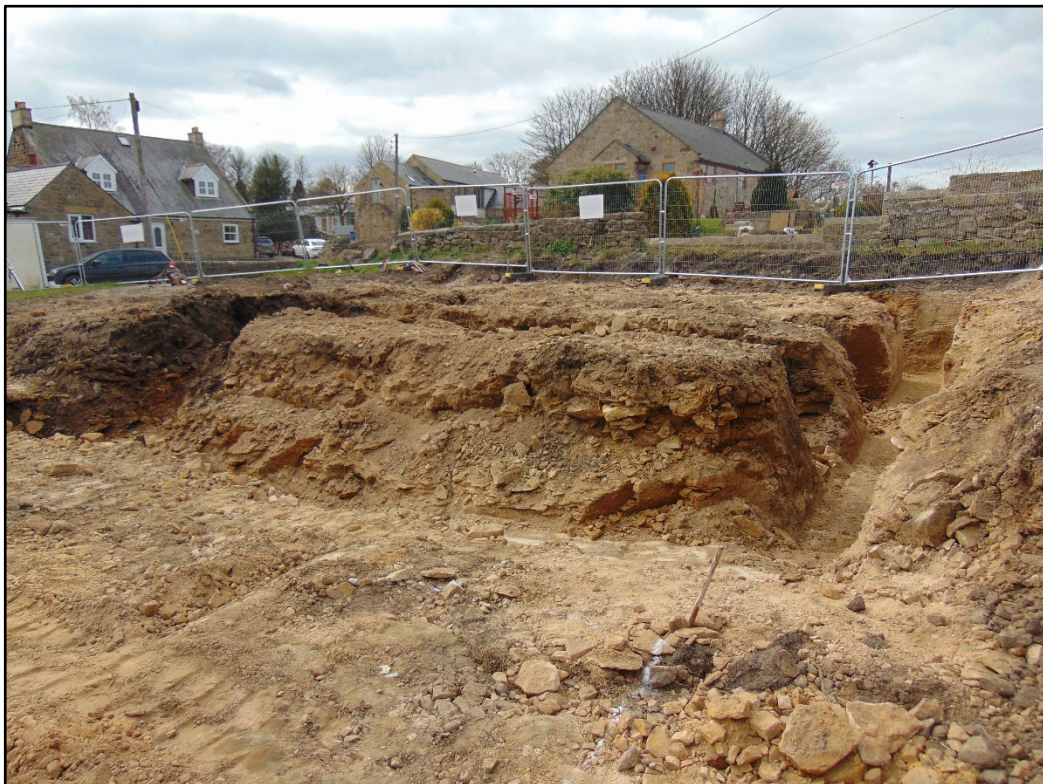
Plate 12; Foundations showing sandstone bedrock (108)

- 4.2.10 Additional site works monitored during the watching brief included the excavation of wall foundations (Plate 12), site landscaping and service trenches. A section of trenching for services was undertaken following a programme of evaluation within the Military Road to the north of the site (see Appendix 5). The service trench within this area measured 1.0m in width and reached a depth of approximately 1.2m. Excavations

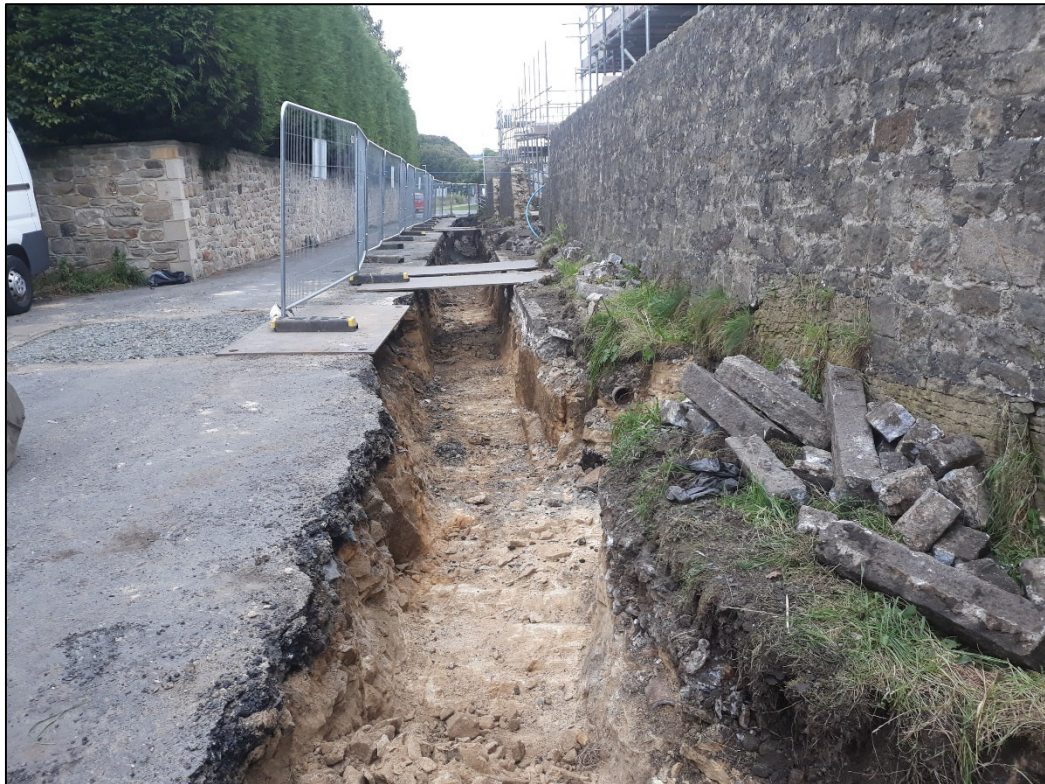
Plate 13; Western end of service trench within military road showing bedrock (1002)

revealed a yellow sandstone bedrock (**1002**) below hardcore (**1001**) and tarmac (**1000**) within the western and central sections of the service trench (Plate 13). The sandstone bedrock was replaced by a deposit of dark grey silty clay (**1004**) throughout the eastern section of the trench, which probably corresponds with deposit (**105**) observed within the easternmost trench of the evaluation. Although this change could suggest that the bedrock had been truncated at this point, no clear cut was observed within the confines of the excavation area.

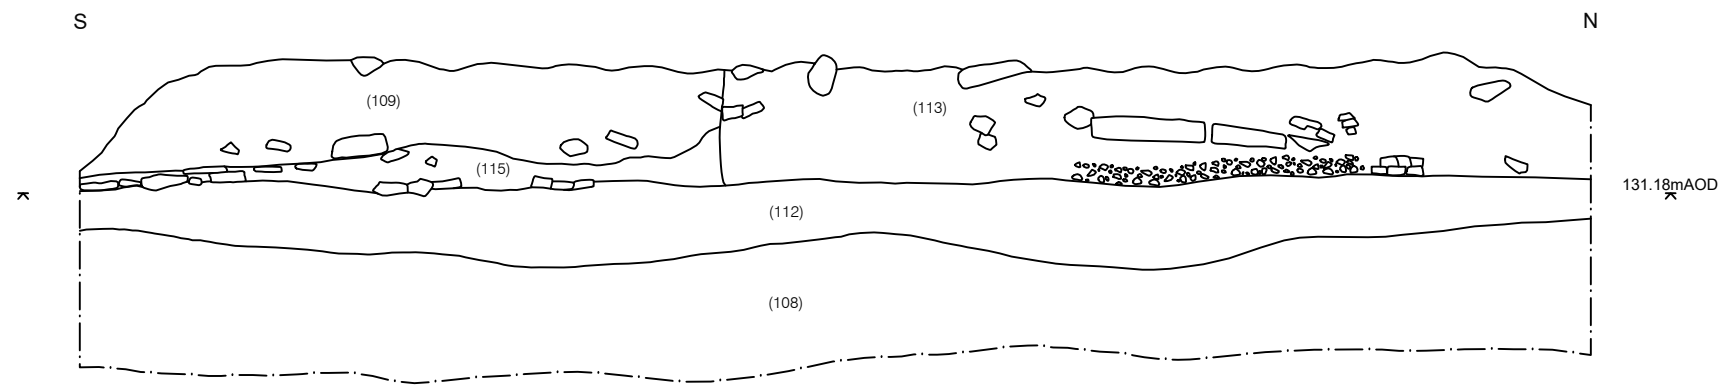
Section 1. East facing section across foundation of wall.

- 4.2.4 Several sections were excavated across the revealed length of Hadrian's Wall (Figure 5). These sections revealed that the remains of the wall measured 2.9m in width on average and survived to a maximum height of 0.45m. As the wall was removed it was confirmed that the core of the wall (**109**) was held together with clay whilst the facing stones were worked, providing a regular foundation course (**114**). As excavations continued within the eastern half of the site, no further remains of Hadrian's Wall survived, with ground reductions for the 20<sup>th</sup> century haulage yard possibly removing any subsequent remains.

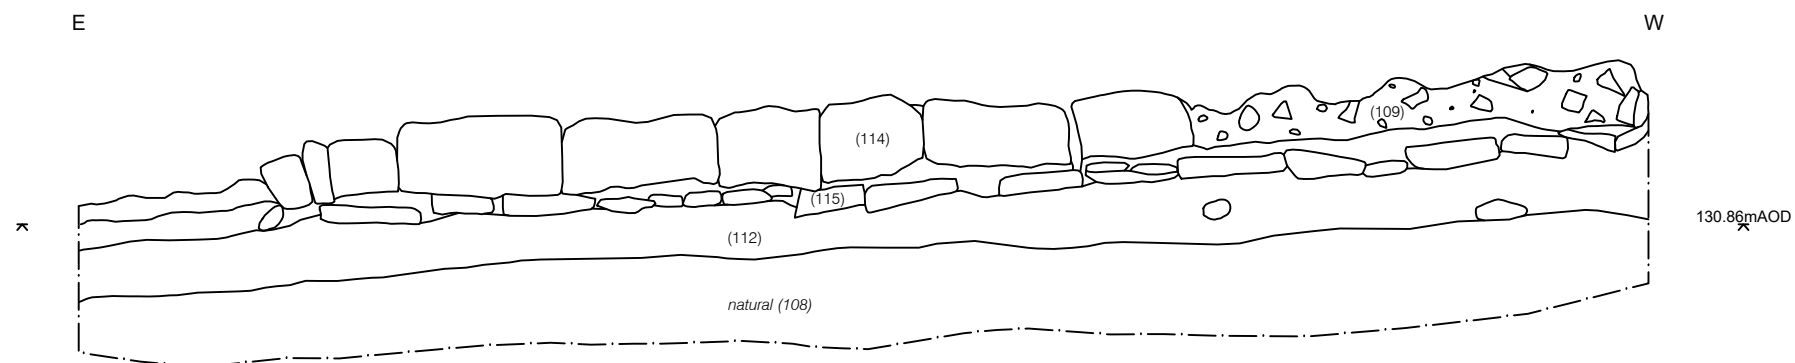
Section 4. North facing section of eastern part of the wall.

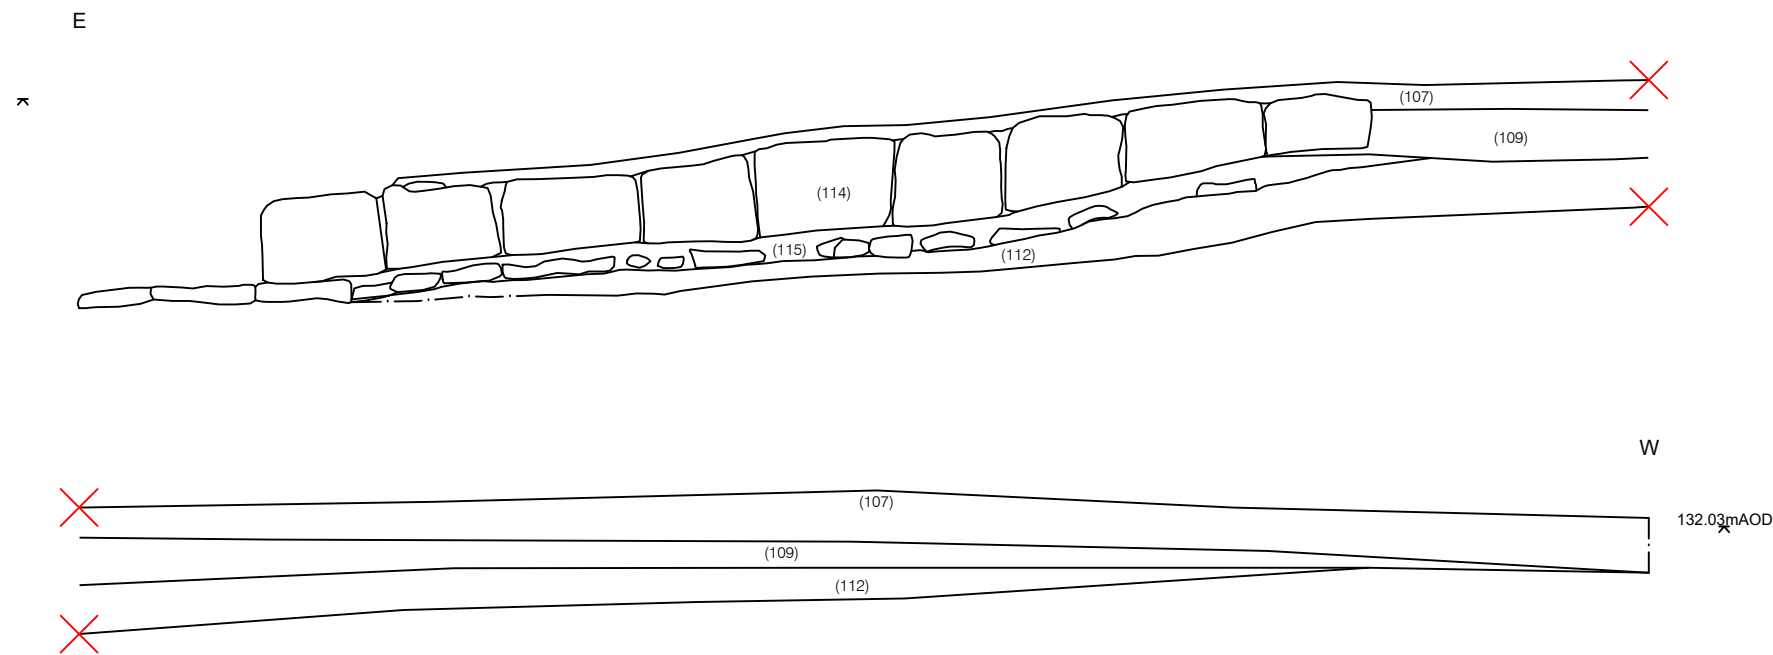
Section 6. North facing section of western part of the wall.

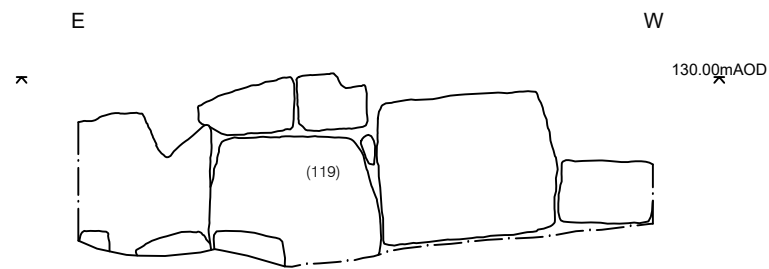
Section 12. North facing section across wall.

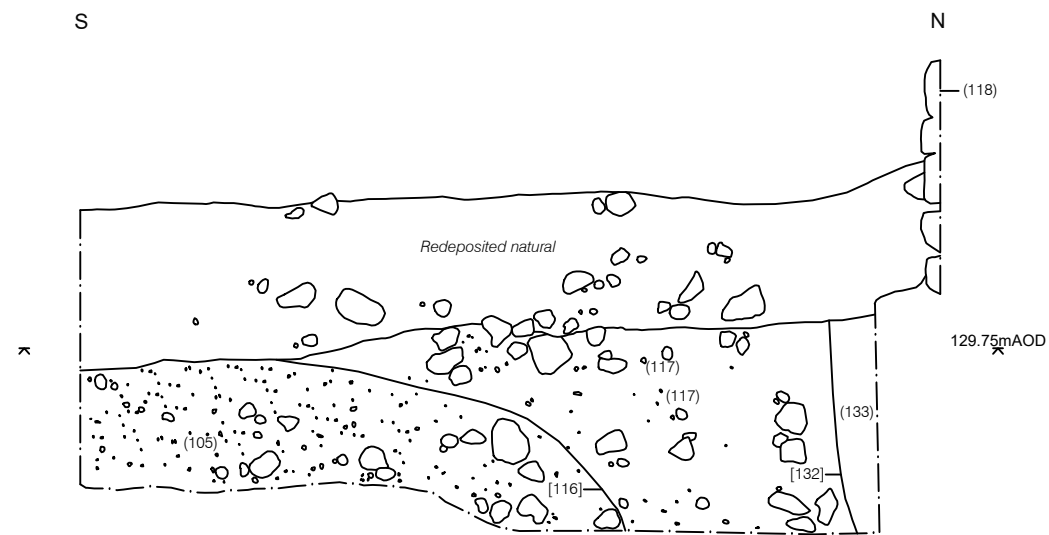
Section 13. East facing section across feature [116] and construction cut [132].

- 4.2.5 Ground reduction work within the north-eastern extent of the site revealed a feature probably representing the remains of the Wall ditch to the north of Hadrian's Wall (Figures 3 & 6). The ditch [**116**] was aligned north-northwest to south-southeast (Plate 6), although only its southern edge was revealed within the site boundary. The observed section of the ditch measured over 10.5m in length and over 2m in width. The ditch was only excavated to a maximum depth of 0.7m due to safety concerns regarding the stability of an adjacent extant wall. The excavated section of the ditch revealed that it was cut through a natural deposit of mixed sandstone and clay (**105**) and retained a profile which ranged from gradually sloping to steep, becoming more pronounced towards the excavated limit of the feature. The ditch contained a single fill of dark grey silt with frequent sandstone inclusions (**117**) (Figure 7; Section 13, Plate 7). A single sample <6> was recovered from the fill, although high amounts of diesel contamination were noticeable. The fill (**117**) of the Wall ditch had been truncated by the foundation cut [**132**] for wall (**118**), which formed the northern extent of a former diesel store and the northern boundary of the site.

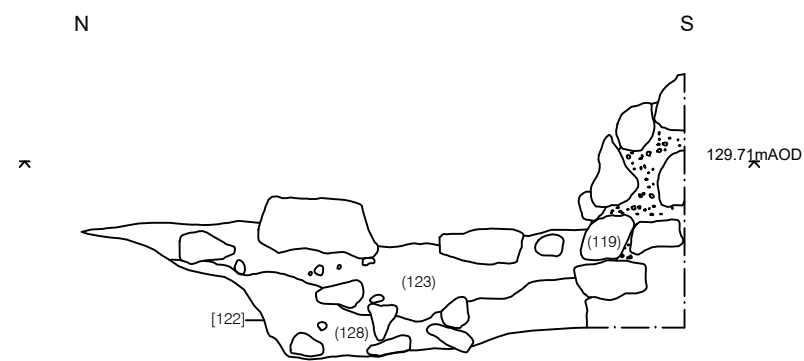
Section 14. West facing section across cut [122]

- 4.2.8 An east to west aligned flue adjoined the western edge of the kiln. The flue was formed by two sandstone block walls (120) and measured c.1.1m in length, 0.85m in width, leading to a circular fire pit (Figure 6). The fire pit [122] measured c.1.3m in diameter and contained two fills (Figure 7, Section 14). The primary fill consisted of loose mid grey silty clay (128) and contained several medium to large stones throughout. The fill had been heavily contaminated by diesel with rising water showing remnant diesel floating to the surface. A sample of the deposit was taken during the excavation <4>. The primary fill was sealed by a deposit of soft grey black silty clay (123), which included frequent stone inclusions and occasional charcoal flecks. Two samples <3> and <5> were recovered from the upper deposit during excavation, with one of the samples producing a fragment of medieval pottery and a complete annular bead.

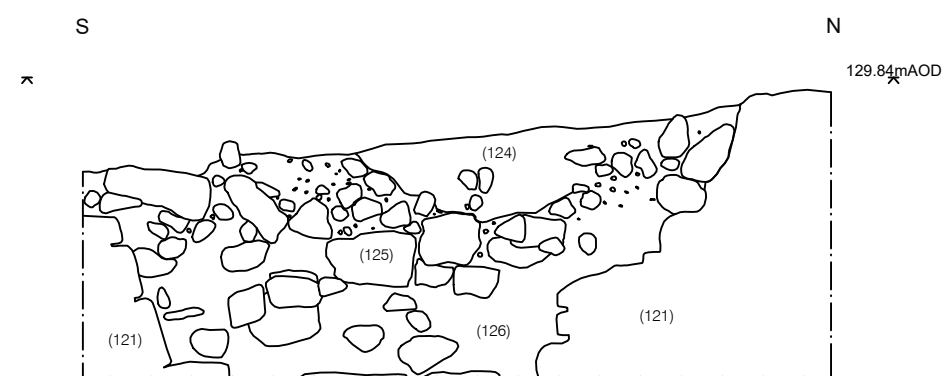
Section 19. East facing section across Kiln.

- 4.2.7 The kiln (121) contained a total of three fills (Figure 7, Section 19). The primary fill of the kiln comprised a soft dark grey silt (126) with frequent charcoal inclusions, which possibly relates to the use of the feature. A sample <7> was taken from this deposit. The primary fill was sealed by a rubble deposit of loose silty clay and irregular sandstone blocks (125) (Plate 9). Fragments of medieval pottery and animal bone were recovered from deposit (125), which may represent the partial collapse of the structure. The rubble deposit was sealed by an upper deposit of dark greyish brown silty clay (124).

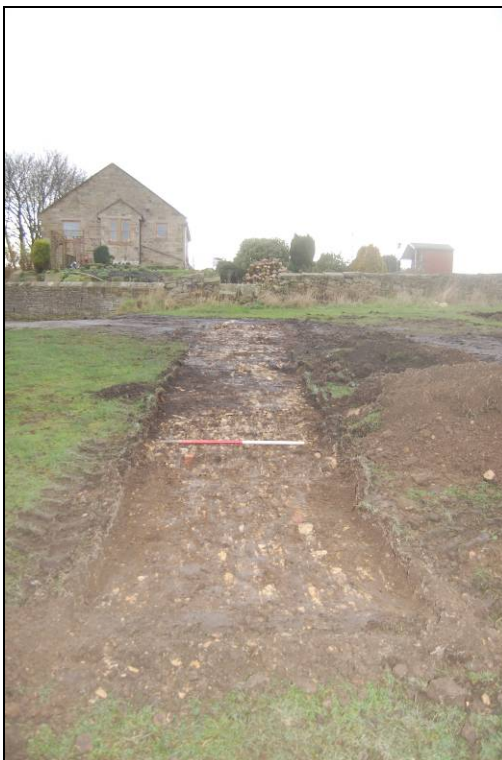
*Plate 2: Trench 3, facing west-northwest*

- 4.2.3 **Trench 3:** Trench 3 was located centrally within the western half of Area A, approximately 7m south of Trench 2 and situated between the proposed routes of Hadrian's Wall and the vallum. The east-southeast to west-northwest aligned trench measured 10m in length, 1.6m in width and was excavated to a maximum depth of 0.2m, revealing solid sandstone bedrock **(101)** below c.0.1m of dark brown clayey silt topsoil **(100)** (Plate 2).

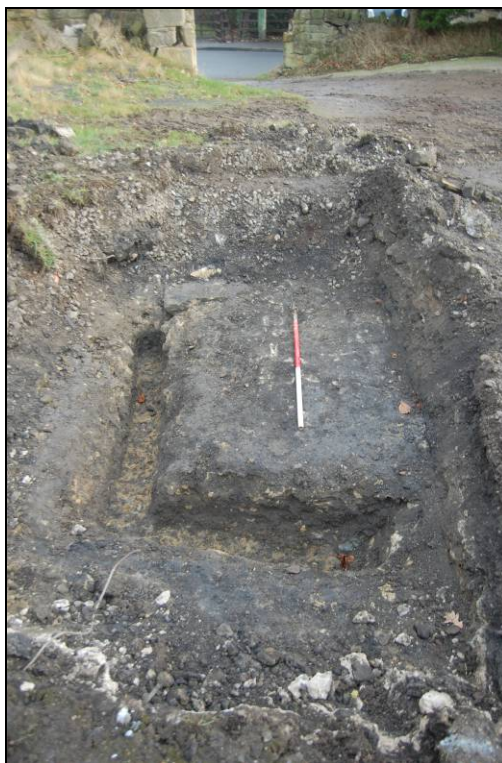
*Plate 3: Trench 5, facing east-southeast*

4.2.6 **Trench 5:** Trench 5 was located towards the northeast corner of Area A, approximately 12m east of Trench 4 and on the proposed line of Hadrian's Wall. The trench measured 3m<sup>2</sup> and was excavated to a maximum depth of 0.9m, revealing the natural drift geology (**201**) which was comprised of firm yellow clay. The natural clay was sealed by a 0.15m deposit of dark grey redeposited clay (**104**), which included modern waste and had probably been used to level out the area. This was further sealed by 0.2m deposit of solid fragments of yellow sandstone (**103**), many of which appeared to have been worked including a large faced block. It is likely that this deposit of fragmented stone was used to further level out the area following the demolition of a building which is present in the same location on the First, Second and Third Edition OS Maps. The fragmented sandstone deposit was below a c.0.35m deposit of ash and modern waste (**102**), and c.0.2m of hardstanding (**100**) (Plate 3).

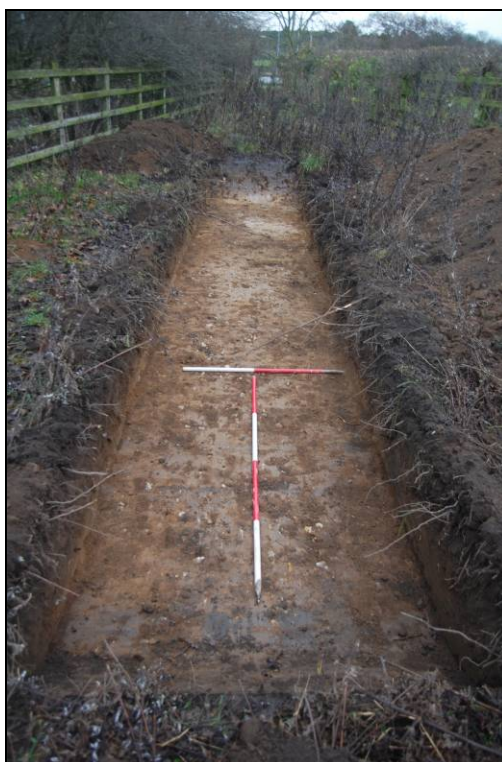
*Plate 4: Trench 7, facing east-southeast*

4.3.2 **Trench 7:** Trench 7 was located within the eastern half of Area B, approximately 17m east of Trench 6 and approximately 25m north of the proposed line of Hadrian's Wall. The west-northwest to east-southeast aligned trench measured 10m in length, 1.6m in width and was excavated to a maximum depth of 0.7m, revealing the natural drift geology (**201**), which was sealed by c.0.25m of mid-brown clayey silt subsoil (**202**) and c.0.15m of dark brown clayey silt topsoil (**200**) (Plate 4).
