**Queen Elizabeth Class Capital Dredge Project
Her Majesty's Naval Base Portsmouth**

**Archaeological Monitoring and Mitigation:
Written Scheme of Investigation**

Wessex Archaeology
Portway House
Old Sarum Park
Salisbury
Wiltshire
SP4 6EB

October 2015

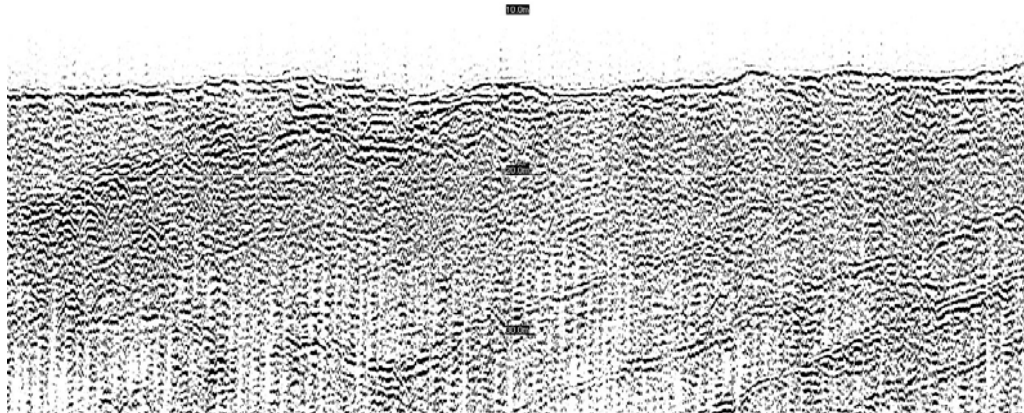
<p>MA Number: MA 14003 Position Start: 462367 100253 Position End: 462404 100043 Description: Start of channel edge is not clearly defined, potentially at 14.23m below OD – End of channel edge at 14.23m below OD –Maximum depth unclear.</p>
	<p>MA Number: MA 14004 Position Start: 462438 100061 Position End: 462463 99995 Description: Start of channel edge 14.23m below OD – End of channel edge at seabed – Maximum depth of channel 14.23m below OD</p>

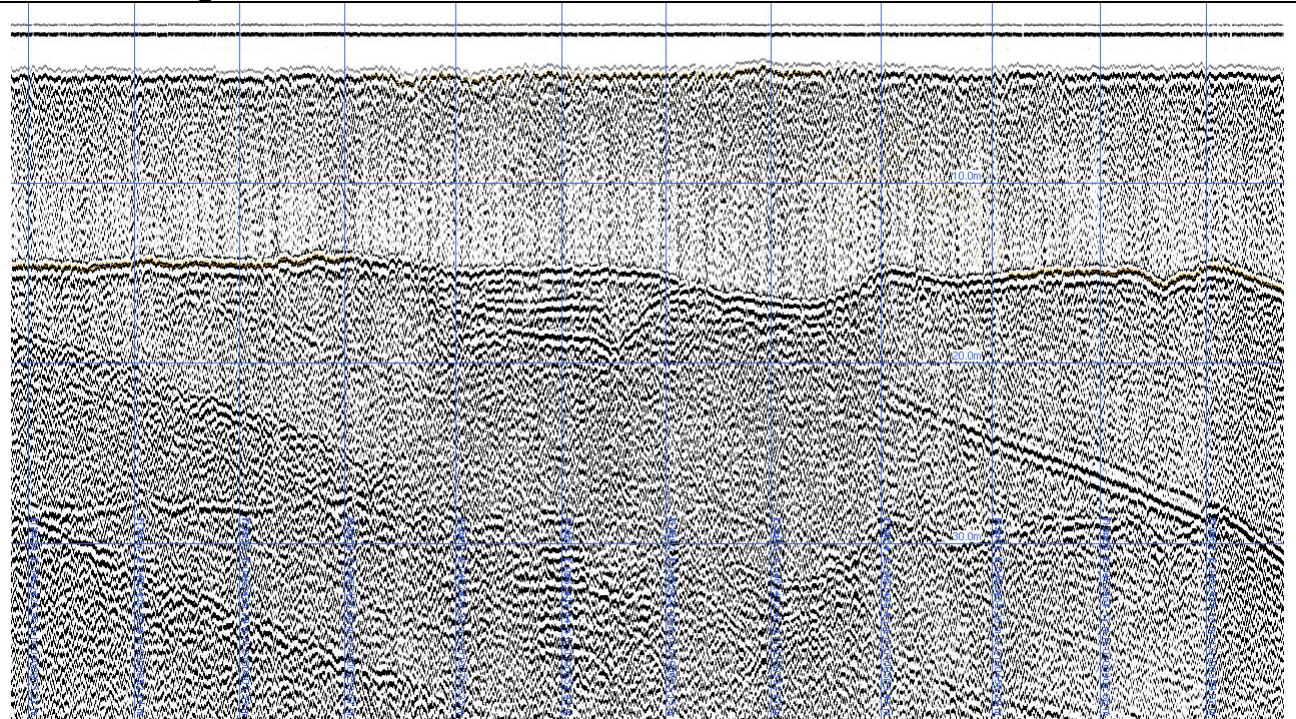
<p>MA Number: MA 14005 Position Start: 462421 101325 Position End: Description: Edge of channel starts 12.73m below OD</p>

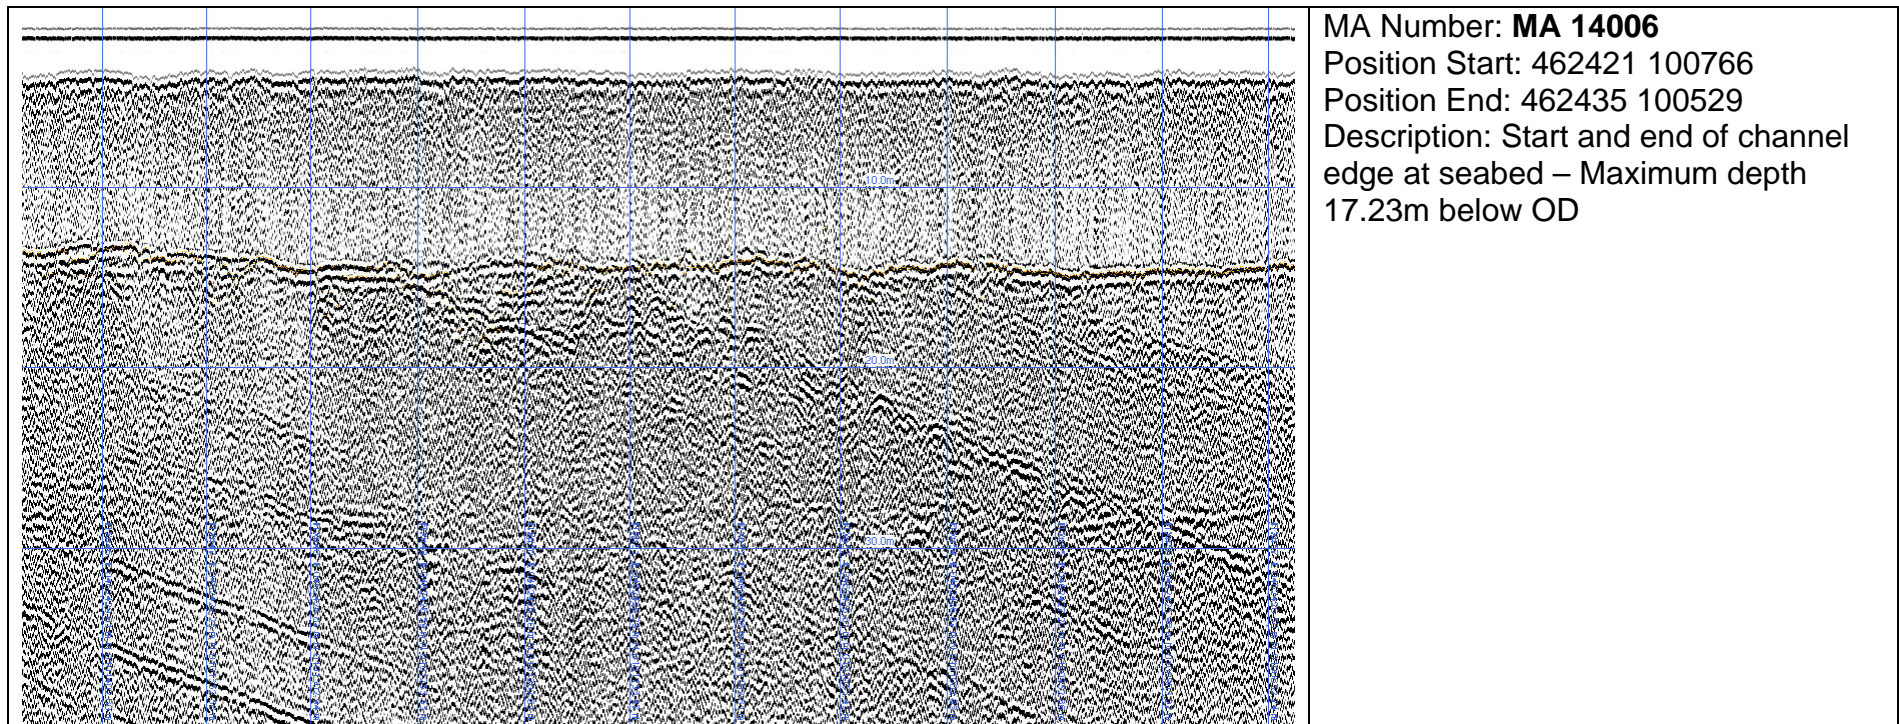
Seismic Image	Anomaly Information
	<p>MA Number: MA 14007 Position Start: 462463 99995 Position End: Description: Edge of channel at seabed sloping down to a maximum depth 17.23m below OD</p>

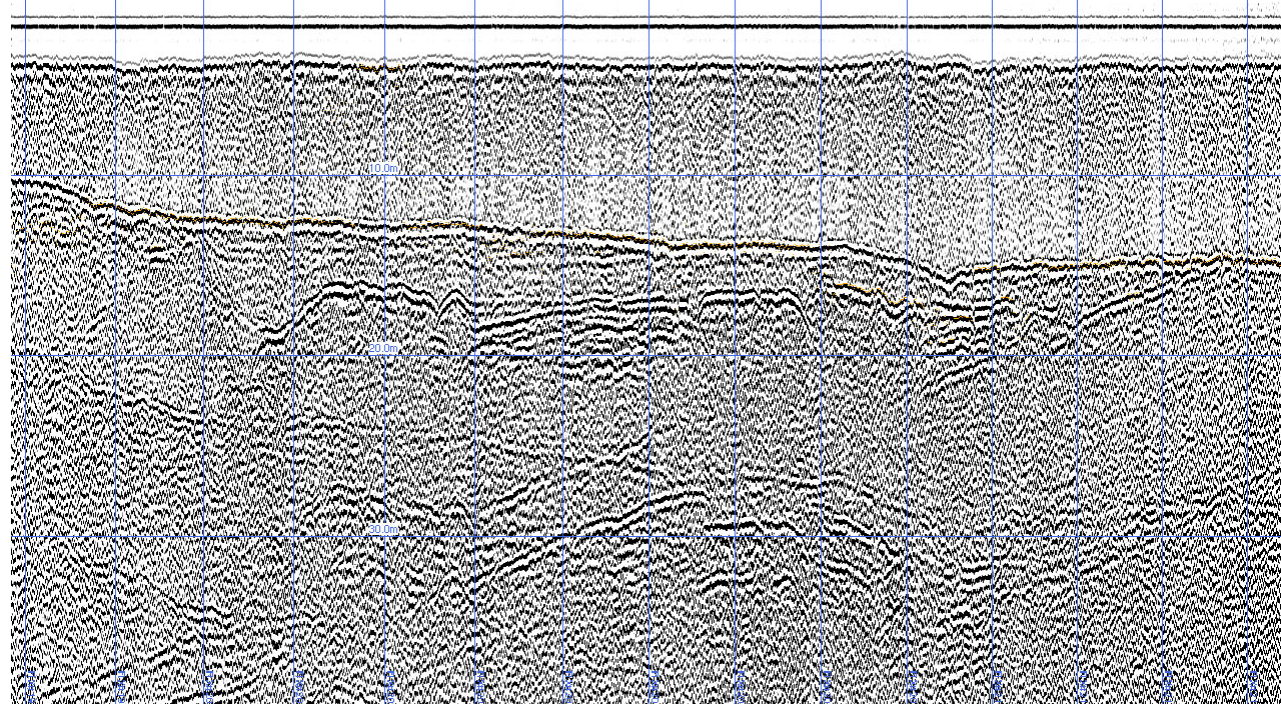
<p>The seismic image displays a series of horizontal lines representing geological layers. A prominent feature is a channel edge at the seabed, which slopes downwards from left to right, reaching a maximum depth of 18.23m below OD. The image is overlaid with a grid of blue lines.</p>	<p>MA Number: MA 14008 Position Start: 462702 99373 Position End: Description: Edge of channel at seabed – Maximum depth 18.23m below OD</p>

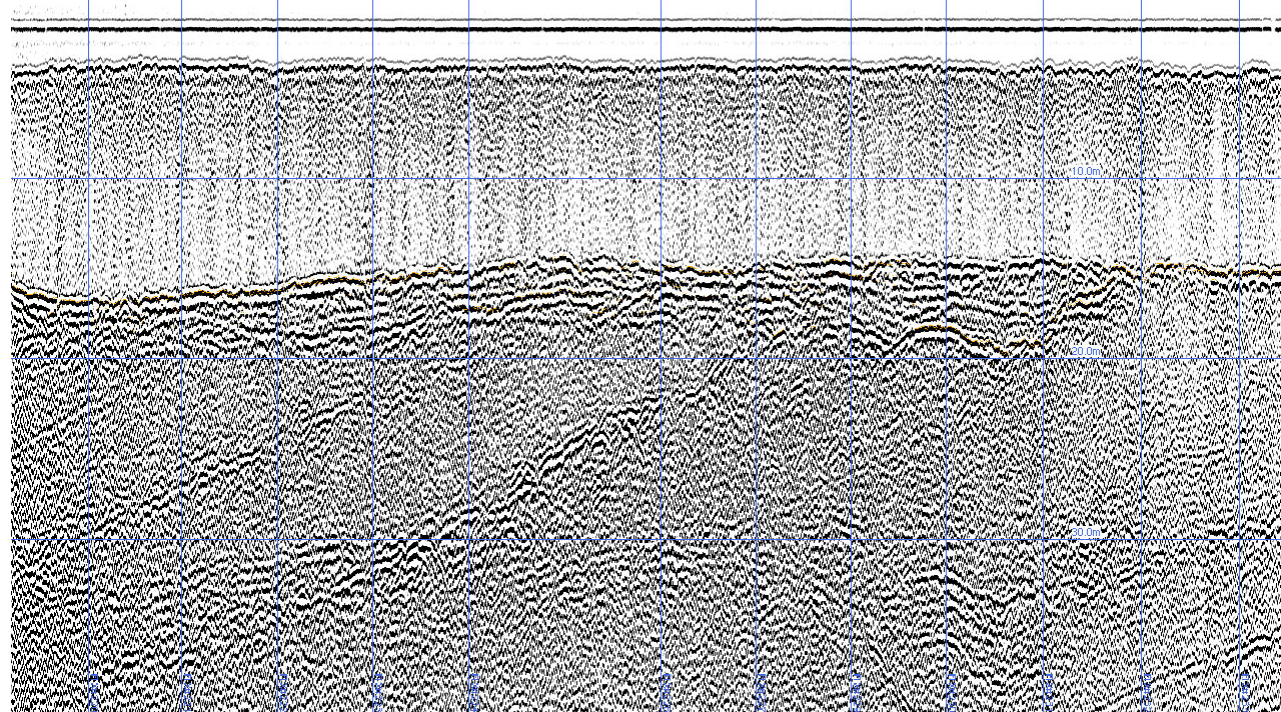
<p>MA Number: MA 14010 Position Start: 462799 99655 Position End: 462760 99791 Description: Edge of channel not well defined approximately 12.73m below OD – Maximum depth of channel 15.23m below OD</p>

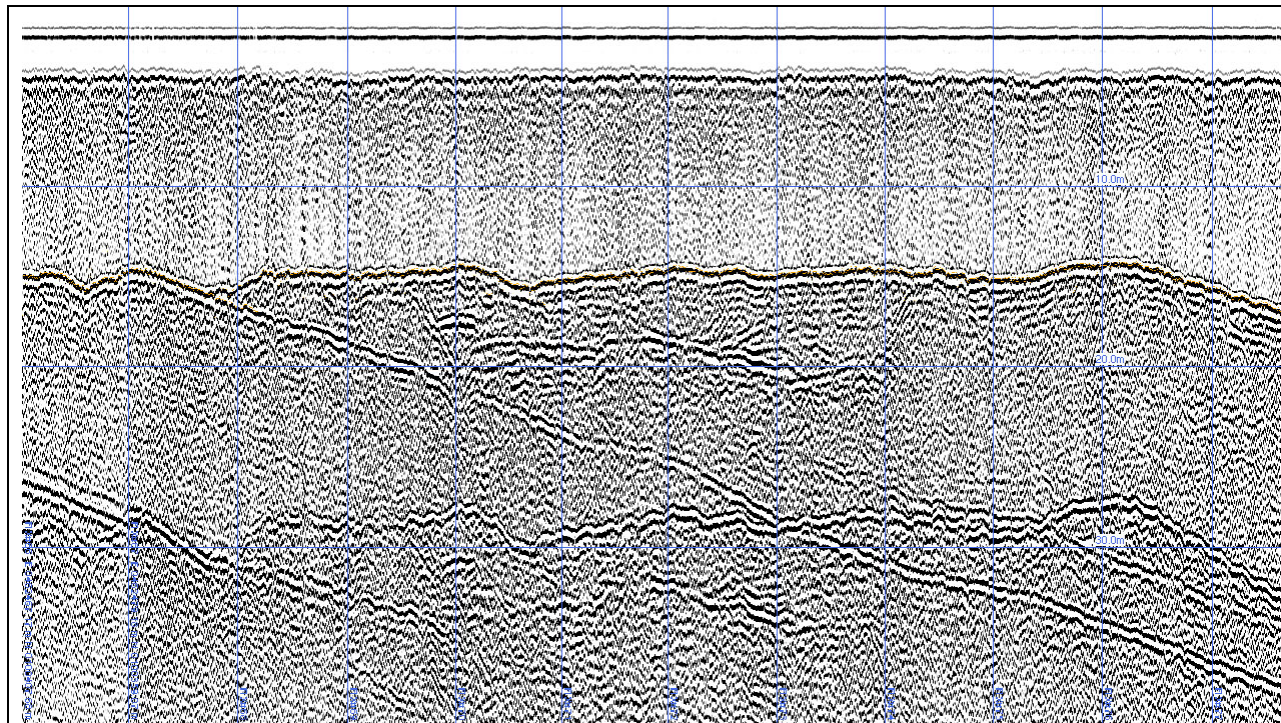
MA Number: **MA 14012**
Position Start: 462576 101009
Position End: 462566 101252
Description: Edge of channel at seabed sloping steeply - Maximum depth of channel 19.23m below OD. This area comprises of a reflective surface which could be bedrock which has not been completely eroded and outcrops at the seabed.

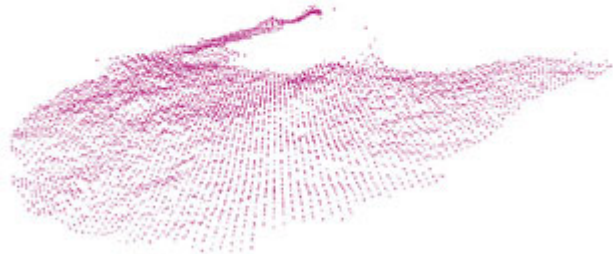
<p>MA Ltd No: MA13000 Grading: Low Position: 462040 101321 Size of anomaly: L 3.2m W 1.9m H 0.3m Target description: Elongated raised feature with an area sloping upward Magnetic strength: Associated References: Grouping: MA18037</p>

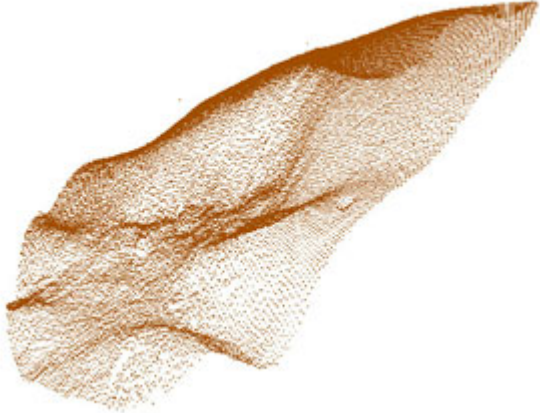
<p>MA Ltd No: MA13002 Grading: High Position: 462495 101550 Size of anomaly: L18.8m W3.3m H Target description: Raised elliptically shaped feature Magnetic strength: 27nT Associated References:</p>

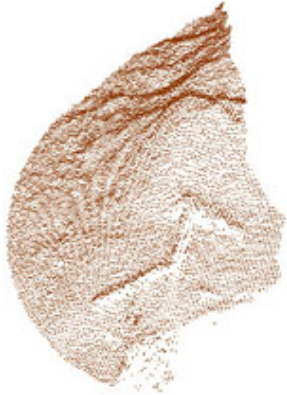
<p>MA Ltd No: MA13019 Grading: High Position: 462398 99969 Size of anomaly: L11m W H1.6m Target description: Unidentified anomaly. Large raised object with a Y shaped raised feature in the vicinity of a crescent buried feature. Magnetic strength: Associated References: Grouping: MA18037</p>

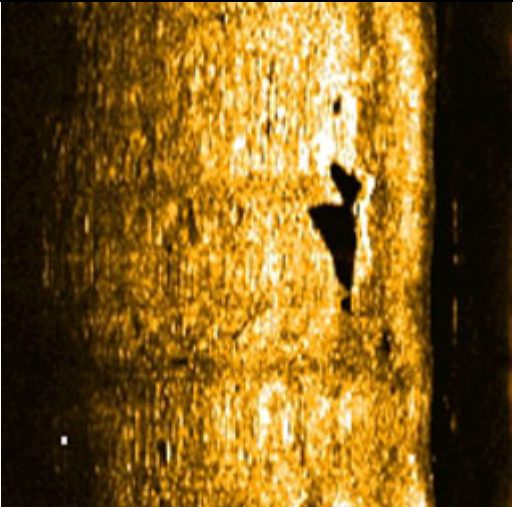
<p>MA Ltd No: MA13020 Grading: High Position: 462421 100002 Size of anomaly: L11.2m W H0.6m Target description: Raised feature. Unidentified anomaly. Magnetic strength: Associated References:</p>

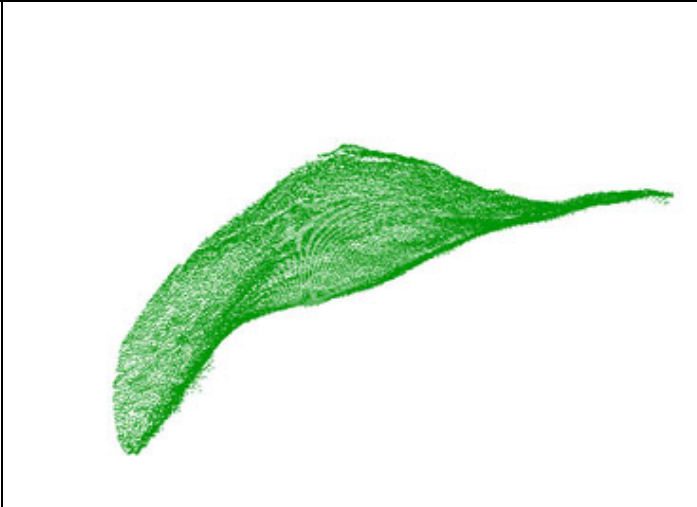
<p>MA Ltd No: MA13024 Grading: Low Position: 462624 99507 Size of anomaly: L6.8m W0.9m H Target description: Linear sinuous feature lying low on the seabed, probable chain. Magnetic strength: Associated References: Grouping: MA18032</p>

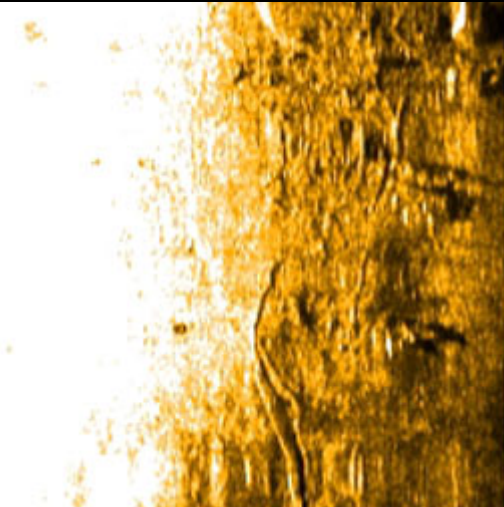
<p>MA Ltd No: MA13031 Grading: High Position: 462412 100055 Size of anomaly: L18.7m W H Target description: Linear feature. Identifiable anthropogenic object. Magnetic strength: 134nT Associated References:</p>

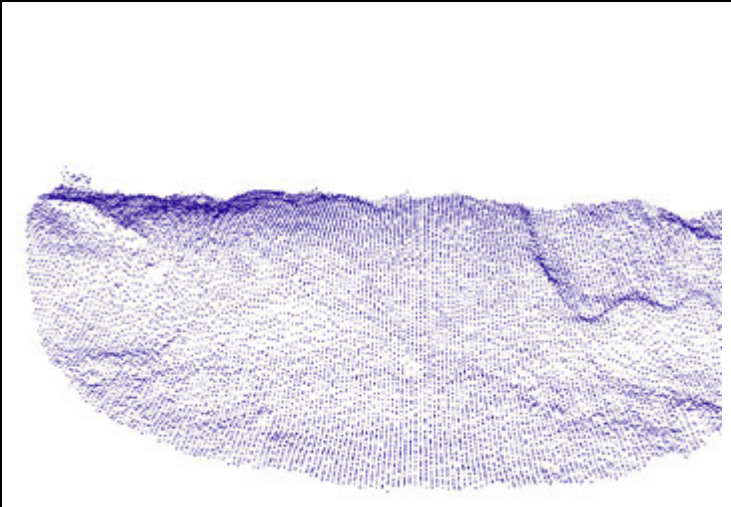
<p>MA Ltd No: MA13042 Grading: Medium Position: 462712 101229 Size of anomaly: L5.3m W1.7m H Target description: Debris comprising of linear feature Magnetic strength: Associated References:</p>

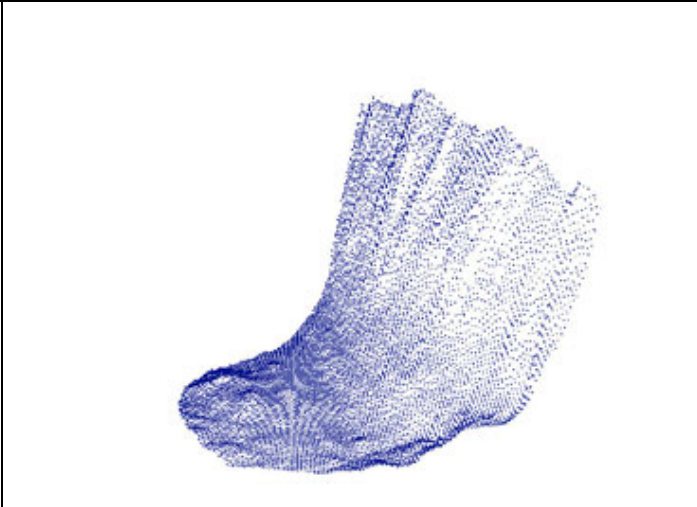
<p>MA Ltd No: MA13048 Grading: Low Position: 462730 100278 Size of anomaly: L19.1m W H Target description: Buried linear feature. Identifiable anthropogenic object. Magnetic strength: Associated References:</p>

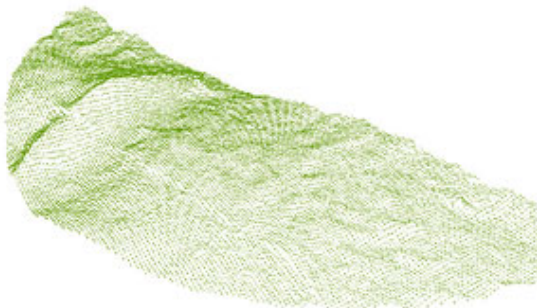
<p>MA Ltd No: MA13057 Grading: High Position: 462802 99929 Size of anomaly: L13.1m W2.5m H Target description: Debris field. Identifiable anthropogenic objects. Magnetic strength: Associated References:</p>

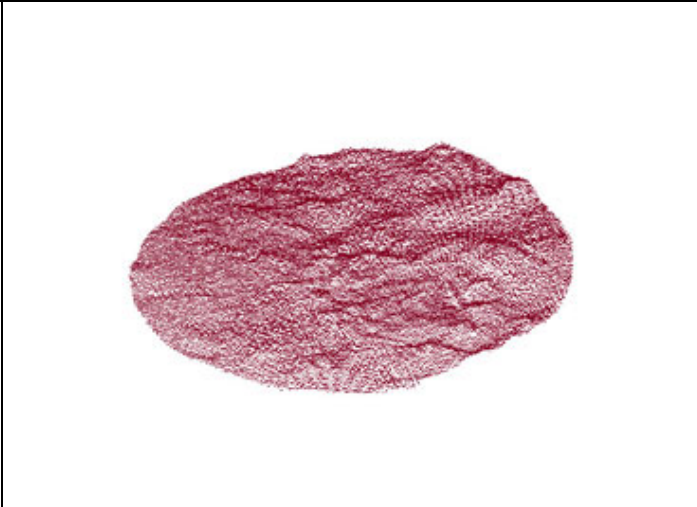
<p>MA Ltd No: MA13067 Grading: Low Position: 462606 100561 Size of anomaly: L17.4m W3m H Target description: Buried feature. Unidentified anomaly. Magnetic strength: Associated References:</p>

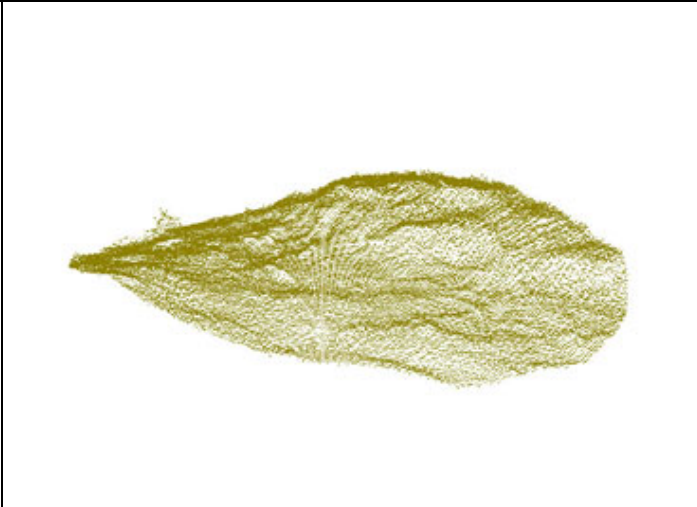
<p>MA Ltd No: MA13069 Grading: Medium Position: 462598 100621 Size of anomaly: L31.6m W H Target description: Debris field. Areas of seabed relief with slightly raised features. Magnetic strength: 187nT Associated References:</p>

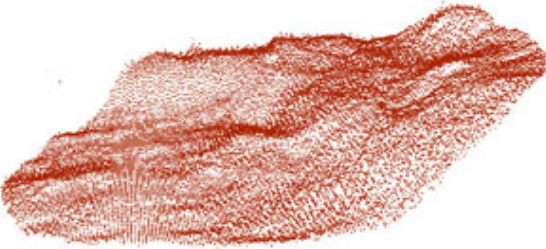
<p>MA Ltd No: MA13076 Grading: Medium Position: 462654 101252 Size of anomaly: L W H Target description: Debris field. Areas of seabed relief with slightly raised features. Magnetic strength: Associated References:</p>

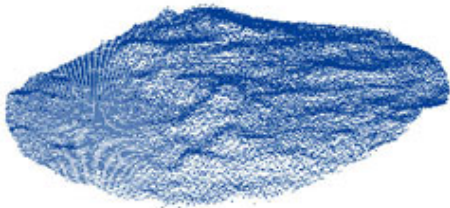
<p>MA Ltd No: MA13087 Grading: High Position: 462614 100604 Size of anomaly: L W H Target description: Debris field. Area of seabed relief with high raised features. Magnetic strength: Associated References:</p>

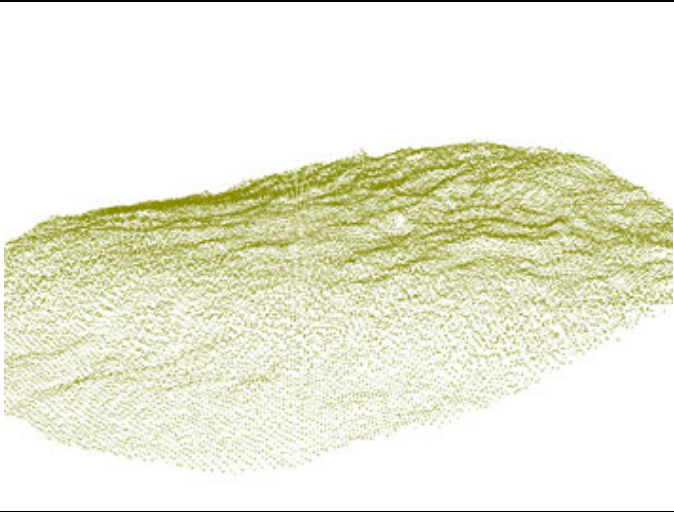
<p>MA Ltd No: MA13094 Grading: Medium Position: 462715 99950 Size of anomaly: L3.3m W H Target description: Potentially small area of debris or seabed relief. Magnetic strength: 55nT Associated References:</p>

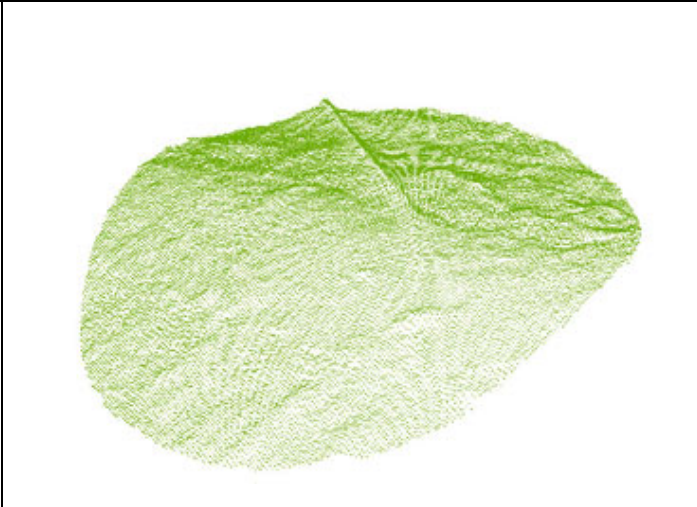
<p>MA Ltd No: MA13097 Grading: High Position: 462783 99825 Size of anomaly: L46.6 W H Target description: A distinctive linear feature that is partly buried. Magnetic strength: 15nT Associated References:</p>

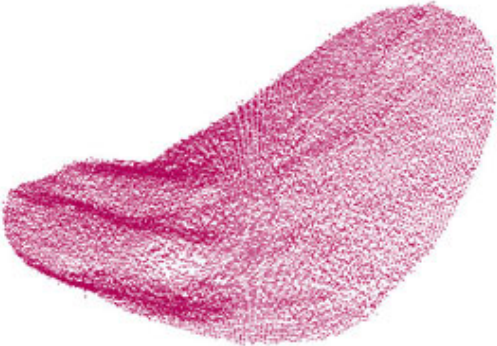
<p>MA Ltd No: MA13100 Grading: High Position: 462780 99422 Size of anomaly: L3m W H0.4m Target description: Series of raised features. Unidentified anomalies. Magnetic strength: Associated References:</p>

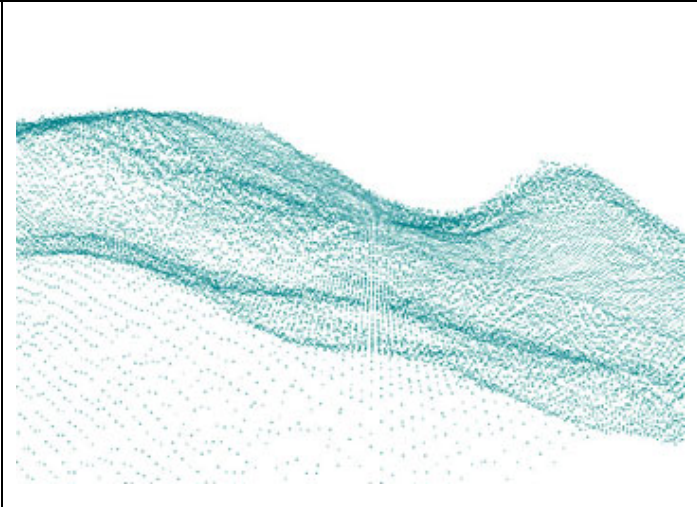
<p>MA Ltd No: MA13105 Grading: Medium Position: 462682 99791 Size of anomaly: L7.2m W H Target description: Depression with raised area of seabed. Magnetic strength: Associated References:</p>

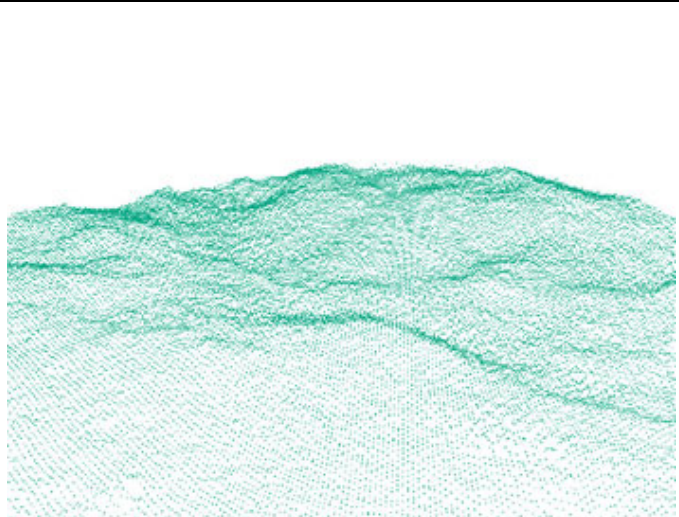
<p>MA Ltd No: MA13116 Grading: Medium Position: 462495 100722 Size of anomaly: L12.6m W H Target description: Unidentified anomaly. Depression with raised area of seabed. Magnetic strength: 303nT Associated References:</p>

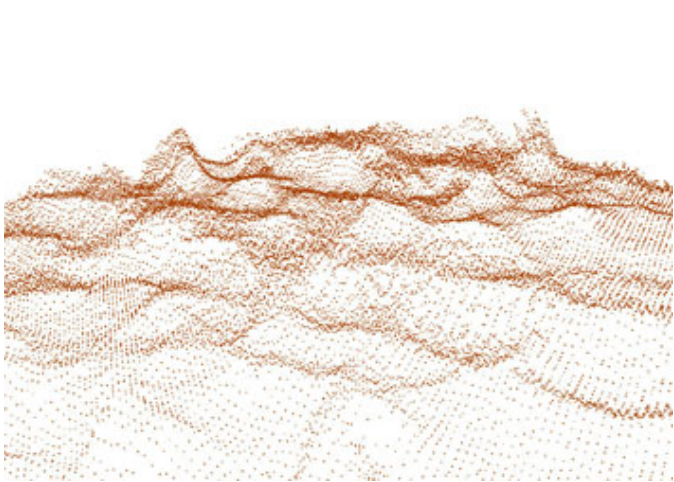
<p>MA Ltd No: MA131134 Grading: Medium Position: 462490 101114 Size of anomaly: L2.9m W2.3m H Target description: Raised feature. Area of varied seabed relief. Magnetic strength: 192nT Associated References:</p>

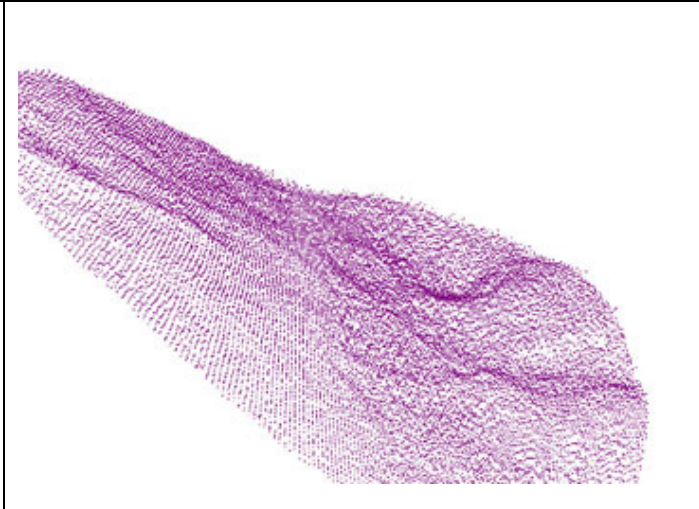
<p>MA Ltd No: MA13147 Grading: Medium Position: 462786 99427 Size of anomaly: L3.8m W2.3m H Target description: Depression with raised area of seabed. Magnetic strength: Associated References:</p>

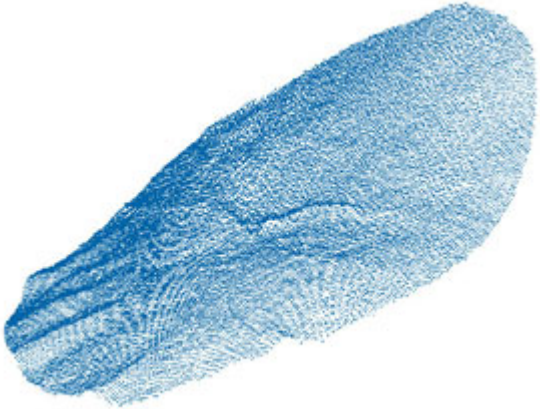
<p>MA Ltd No: MA13151 Grading: Medium Position: 462659 99506 Size of anomaly: L10.9m W3.4m H Target description: Triangular feature. Probably partially buried chain or rope. Magnetic strength: 11nT Associated References:</p>

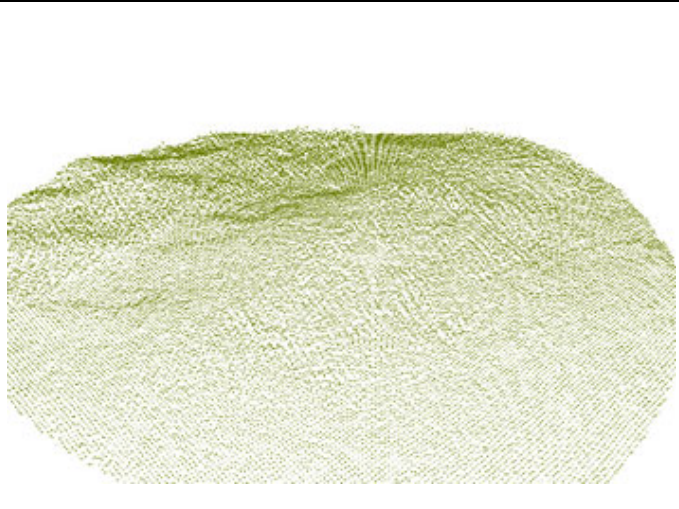
<p>MA Ltd No: MA13162 Grading: Medium Position: 462535 100180 Size of anomaly: L2.0m W1.4m H Target description: Circular feature. Depression area with some raised relief. Magnetic strength: 15nT Associated References:</p>

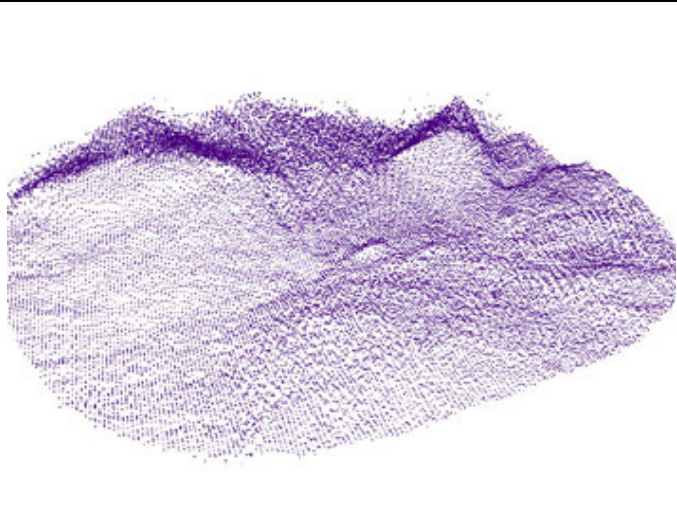
<p>MA Ltd No: MA13173 Grading: High Position: 462450 100183 Size of anomaly: L11.6m W H Target description: Debris field. Area of raised objects within varied seabed. Magnetic strength: Associated References:</p>

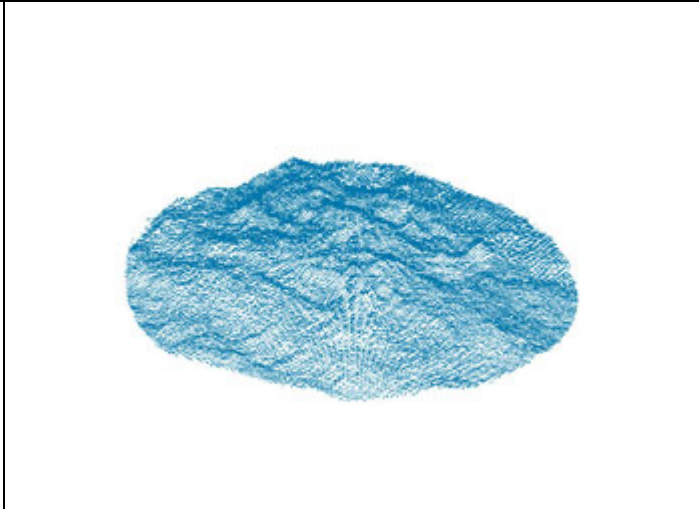
<p>MA Ltd No: MA13175 Grading: Medium Position: 462413 100748 Size of anomaly: L7.8m W2.1m H Target description: Vessel shaped feature. Raised buried feature. Magnetic strength: 13nT Associated References:</p>

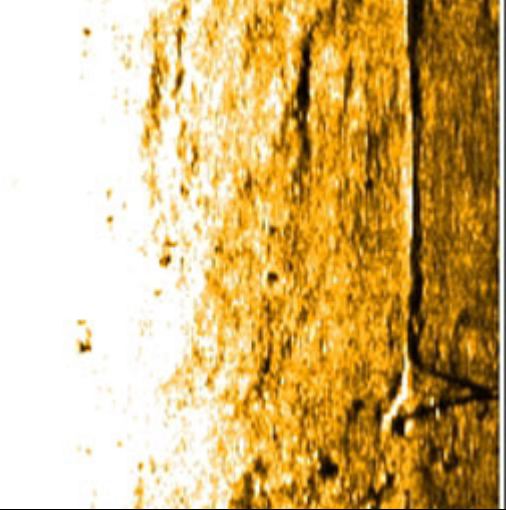
<p>MA Ltd No: MA13177 Grading: Medium Position: 462383 100937 Size of anomaly: L28.2 W H Target description: Raised triangular feature. Identifiable anthropogenic object. Magnetic strength: 62nT Associated References:</p>

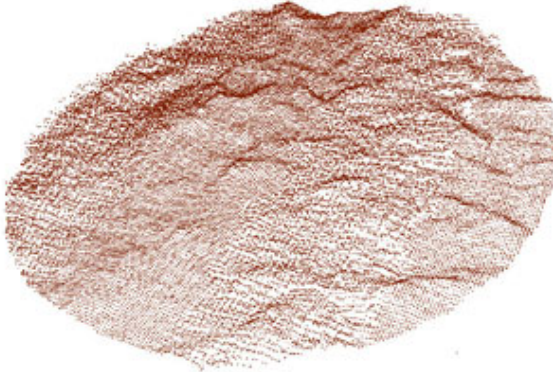
<p>MA Ltd No: MA13208 Grading: High Position: 462354 100831 Size of anomaly: L W H Target description: Debris field. Area of raised features. Magnetic strength: 31nT Associated References:</p>

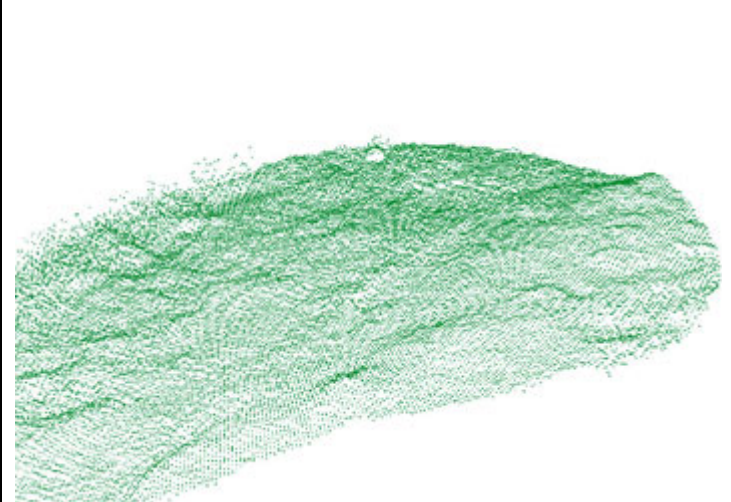
<p>MA Ltd No: MA13212 Grading: High Position: 462404 100665 Size of anomaly: L W H Target description: Debris field. Area of raised features. Magnetic strength: 100nT Associated References: Grouping: MA18021</p>

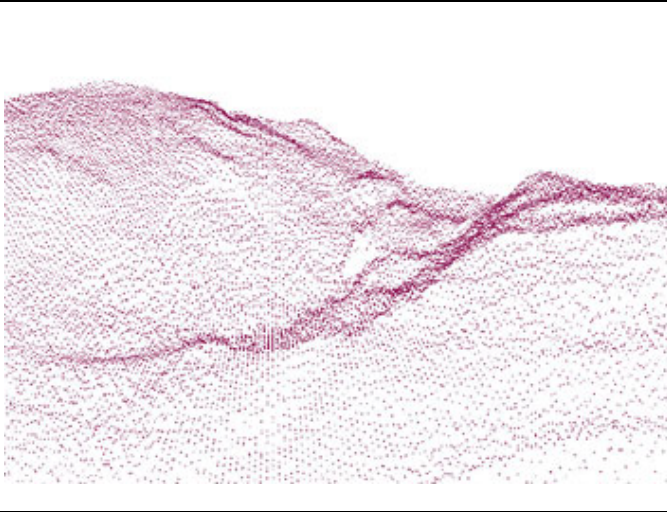
<p>MA Ltd No: MA13225 Grading: High Position: 462518 100155 Size of anomaly: L27.7m W12.4m H Target description: Debris field. Area of depressions and raised features. Magnetic strength: 16nT Associated References:</p>

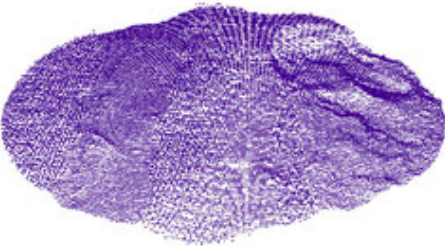
<p>MA Ltd No: MA13240 Grading: Medium Position: 462549 101357 Size of anomaly: L W H Target description: Debris field. Depressions and raised features. Magnetic strength: Associated References:</p>

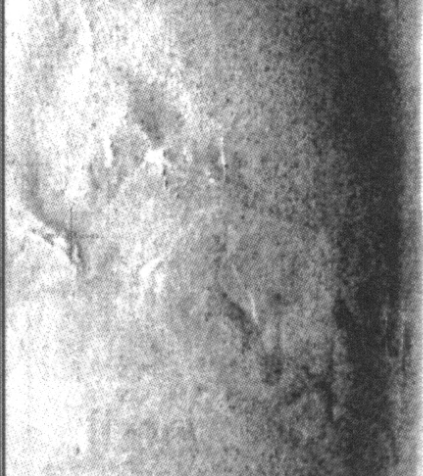
<p>MA Ltd No: MA13243 Grading: Low Position: 462800 99504 Size of anomaly: L11.23m W4.89m H Target description: Possible feature. Unidentified anomaly. Magnetic strength: 85nT Associated References:</p>

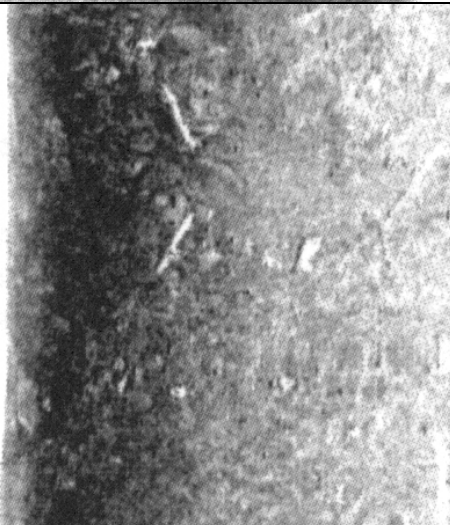
<p>MA Ltd No: MA13246 Grading: High Position: 462615 100534 Size of anomaly: L W H Target description: Debris field. Area of raised features and varied seabed relief. Magnetic strength: Associated References:</p>

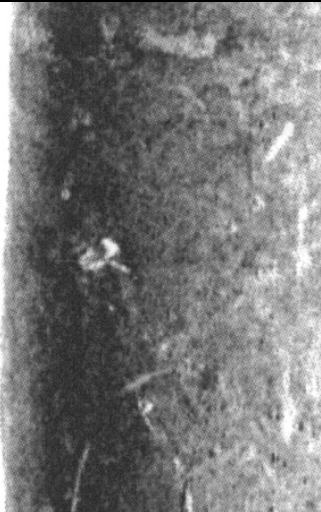
<p>MA Ltd No: MA13247 Grading: High Position: 462615 100534 Size of anomaly: L4.74m W2.42m H0.69m Target description: Debris field. Area of raised features and varied seabed relief. Magnetic strength: Associated References:</p>

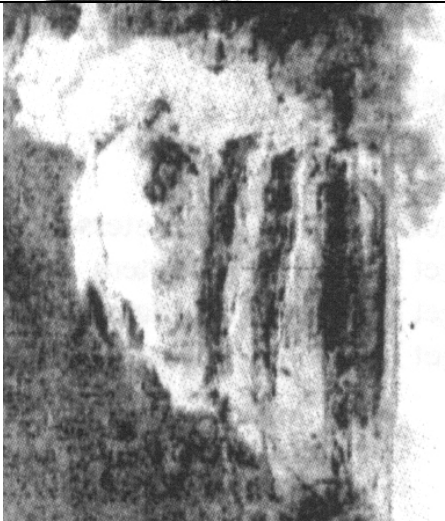
<p>MA Ltd No: MA13257 Grading: Low Position: 462407 100207 Size of anomaly: L W H Target description: Debris field. Identifiable anthropogenic objects. Magnetic strength: Associated References:</p>

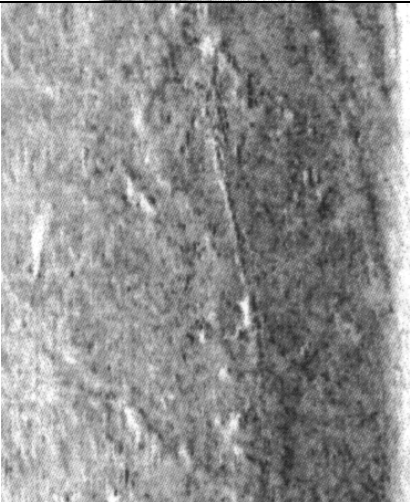
<p>MA Ltd No: MA13259 Grading: Low Position: 462654 100709 Size of anomaly: L25.27m W H Target description: chain Magnetic strength: Associated References</p>

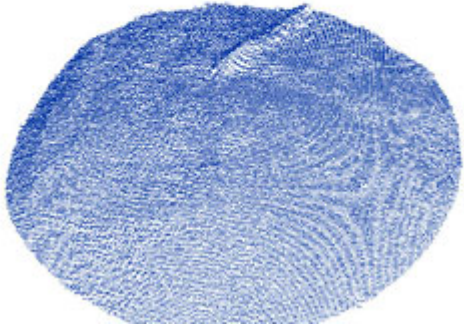
<p>MA Ltd No: MA13260 Grading: Medium Position: 462665 101046 Size of anomaly: L16.72m W H Target description: Debris field. A linear buried raised feature. Magnetic strength: 3nT Associated References:</p>

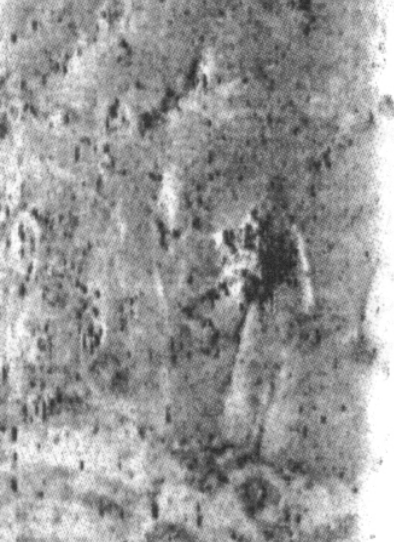
<p>MA Ltd No: MA13261 Grading: High Position: 462660 101271 Size of anomaly: L8.63m W5.22m H Target description: Debris field. Varied seabed relief with an apparent raised feature. Magnetic strength: 12nT Associated References:</p>

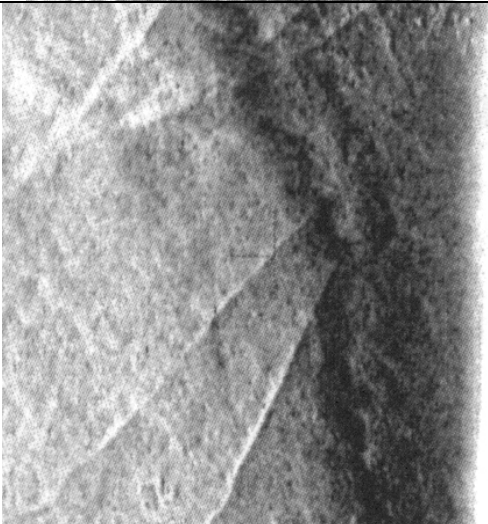
<p>MA Ltd No: MA13265 Grading: Low Position: 462868 99292 Size of anomaly: L W H Target description: Chains/ ropes Magnetic strength: 27nT Associated References: Grouping: MA 18033</p>

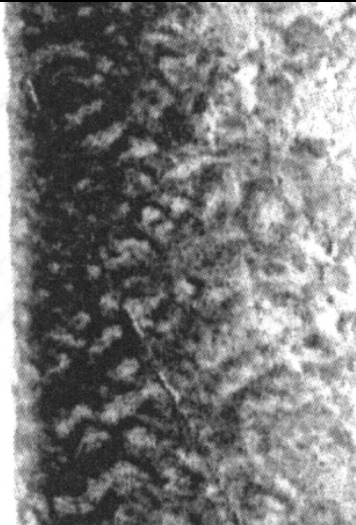
<p>MA Ltd No: MA13269 Grading: Low Position: 462312 100851 Size of anomaly: L W H Target description: Chain Magnetic strength: Associated References: Grouping: MA 18036</p>

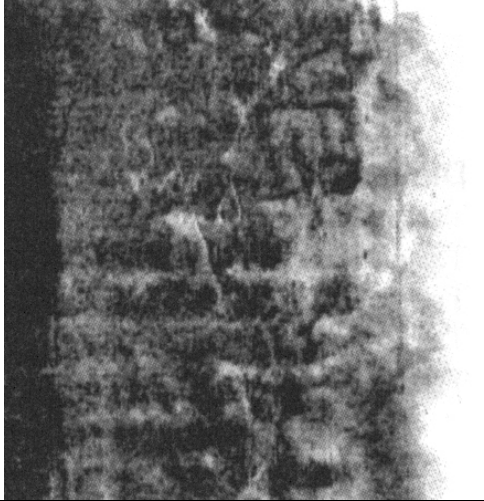
<p>MA Ltd No: MA13272 Grading: Low Position: 462393 100290 Size of anomaly: L W H Target description: Debris field Magnetic strength: Associated References:</p>

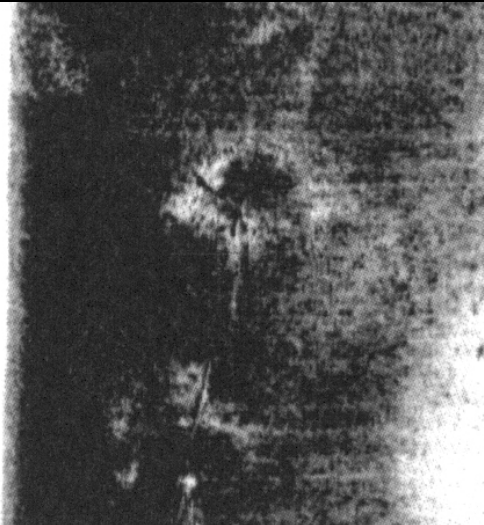
<p>MA Ltd No: MA13273 Grading: Low Position: 462220 100893 Size of anomaly: L W H Target description: Moorings Magnetic strength: 23nT Associated References: Grouping: MA 18035</p>

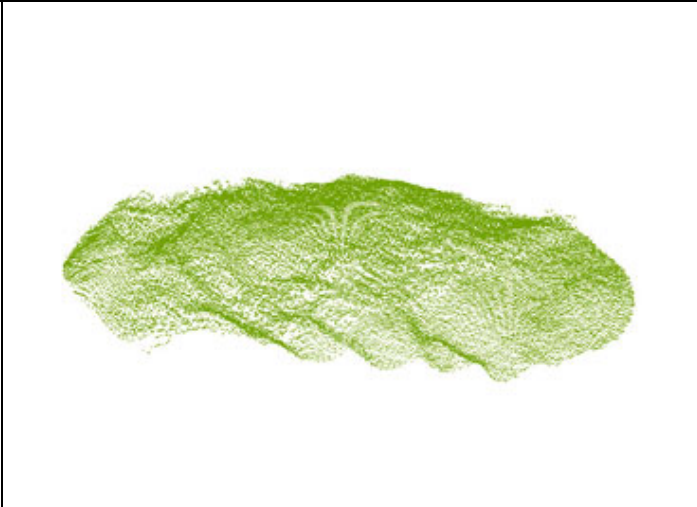
<p>MA Ltd No: MA13283 Grading: High Position: 462347 101455 Size of anomaly: L9.6m W2.3m H Target description: Raised feature with depressions and varied seabed. Magnetic strength: 90nT Associated References:</p>

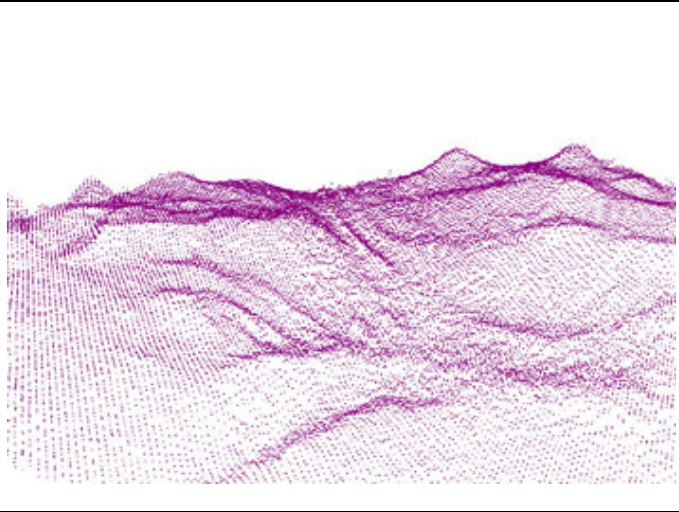
<p>MA Ltd No: MA13284 Grading: High Position: 462308 101335 Size of anomaly: L23.3m W H Target description: Raised linear feature. Magnetic strength: 2nT Associated References:</p>

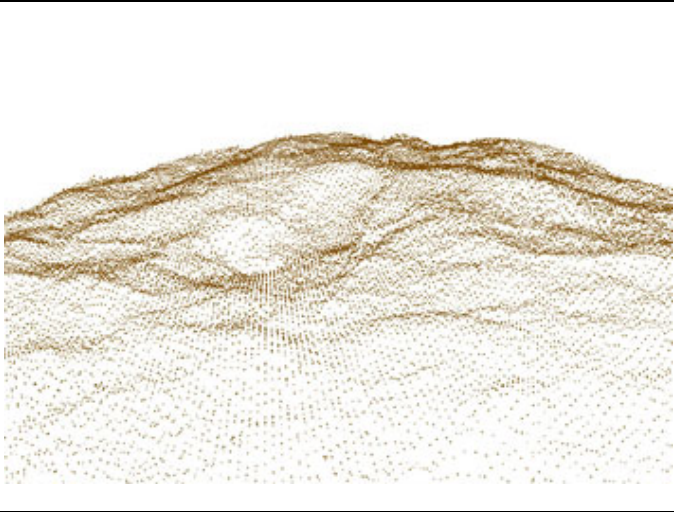
<p>MA Ltd No: MA13286 Grading: Medium Position: 462258 100978 Size of anomaly: L13.3m W8.0m H2.0m Target description: Depression and a raised feature. Magnetic strength: Associated References:</p>

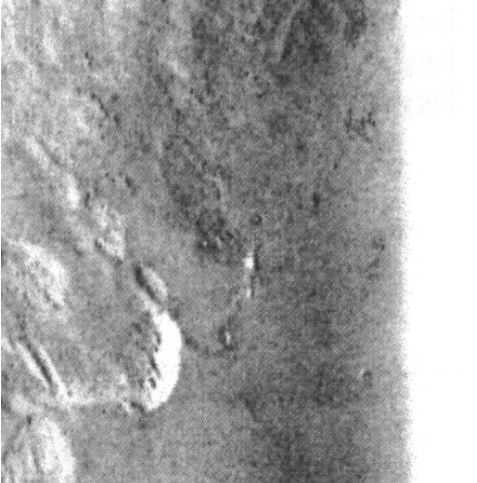
<p>MA Ltd No: MA13291 Grading: High Position: 462489 100238 Size of anomaly: L15.36m W H Target description: Debris field. Several raised features. Magnetic strength: Associated References:</p>

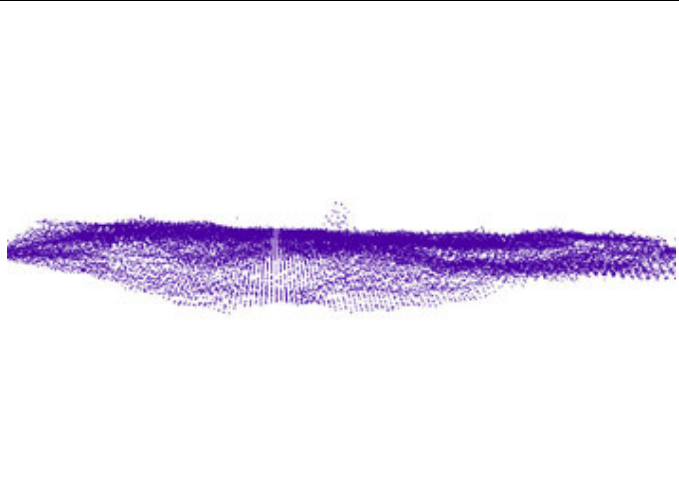
<p>MA Ltd No: MA13294 Grading: Medium Position: 462532 100598 Size of anomaly: L3.66m W1.38m H0.59m Target description: Distinct raised feature. Unidentified anomaly. Magnetic strength: Associated References:</p>

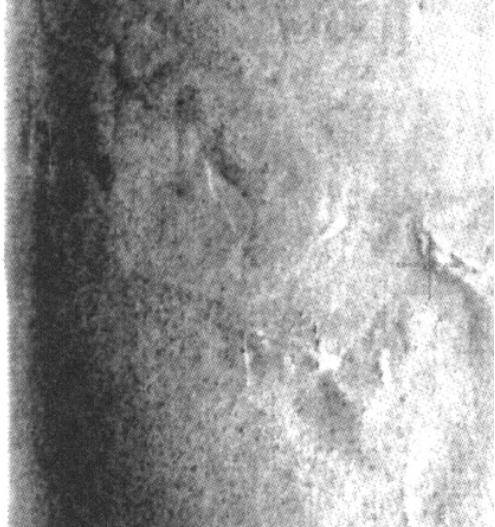
<p>MA Ltd No: MA13295 Grading: Medium Position: 462650 99883 Size of anomaly: L W H Target description: Debris field. Raised sinuous feature potentially chain. Magnetic strength: Associated References:</p>

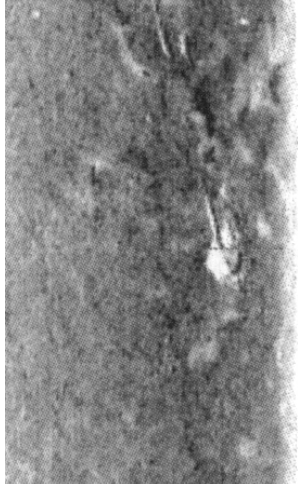
<p>MA Ltd No: MA13297 Grading: Low Position: 462564 100697 Size of anomaly: L W H Target description: Raised features. Identifiable anthropogenic objects. Magnetic strength: Associated References:</p>

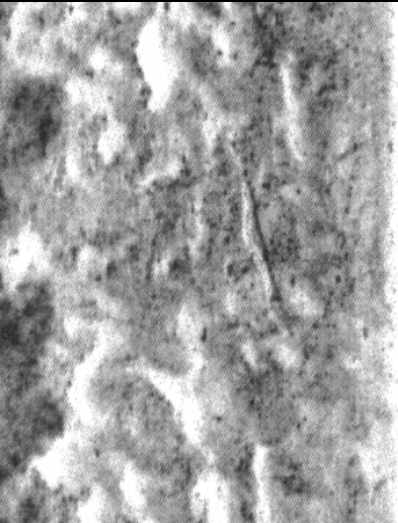
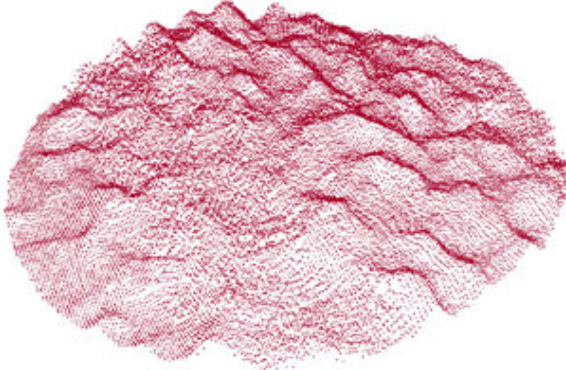
<p>MA Ltd No: MA13298 Grading: High Position: 462559 100986 Size of anomaly: L17.12m W1.48m H Target description: Raised sinuous linear feature, potentially chain. Magnetic strength: Associated References:</p>

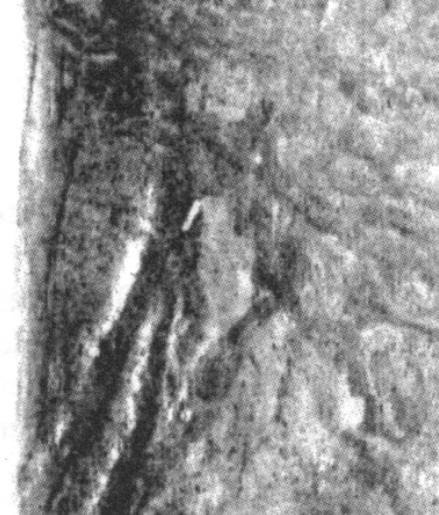
<p>MA Ltd No: MA13302 Grading: Low Position: 462638 100470 Size of anomaly: L30.38m W3.45m H0.59m Target description: Deep scars, geological. Magnetic strength: Associated References: Grouping: MA18024</p>

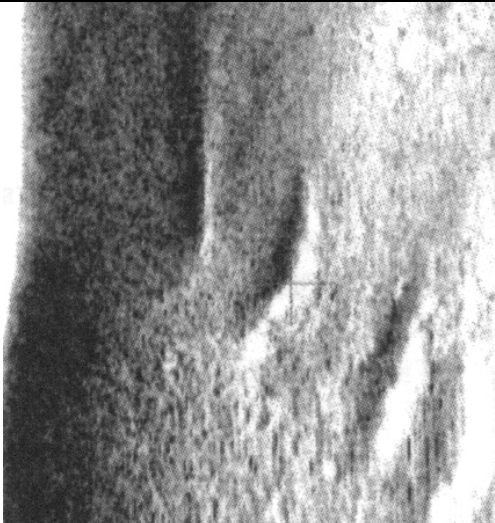
<p>MA Ltd No: MA13304 Grading: Low Position: 462655 99534 Size of anomaly: L16.99m W3.16m H0.43m Target description: Several raised features. Unidentified anomalies. Magnetic strength: Associated References:</p>

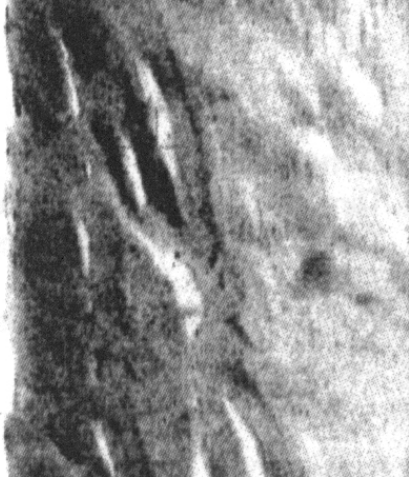
<p>MA Ltd No: MA13305 Grading: Low Position: 462398 101462 Size of anomaly: L W H Target description: Varied relief. Unidentified anomaly. Magnetic strength: 28nT Associated References:</p>

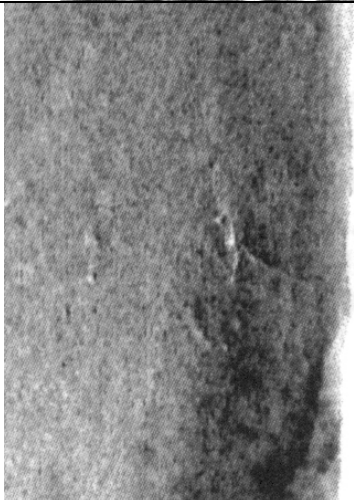
<p>MA Ltd No: MA13306 Grading: Low Position: 462629 99886 Size of anomaly: L5.09m W4.21m H Target description: Mooring Magnetic strength: 13nT Associated References:</p>

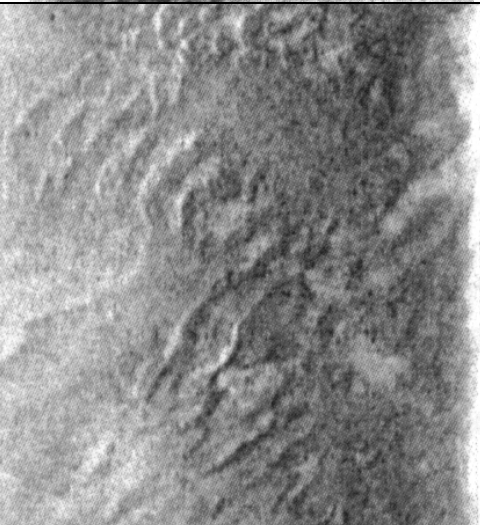
<p>MA Ltd No: MA13308 Grading: Low Position: 462601 99539 Size of anomaly: L W H Target description: Rippled seabed, geological Magnetic strength: Associated References:</p>
