**Queen Elizabeth Class Capital Dredge Project
Her Majesty's Naval Base Portsmouth**

**Archaeological Monitoring and Mitigation:
Written Scheme of Investigation**

Wessex Archaeology
Portway House
Old Sarum Park
Salisbury
Wiltshire
SP4 6EB

October 2015

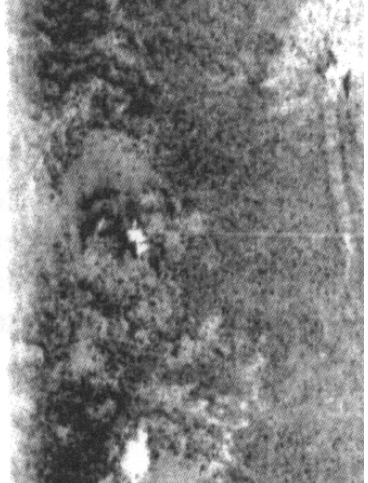
<p>MA Ltd No: MA13309 Grading: Low Position: 462312 100605 Size of anomaly: L3.97m W1.96m H0.39m Target description: Raised feature. Unidentified anomaly. Magnetic strength: 68nT Associated References:</p>

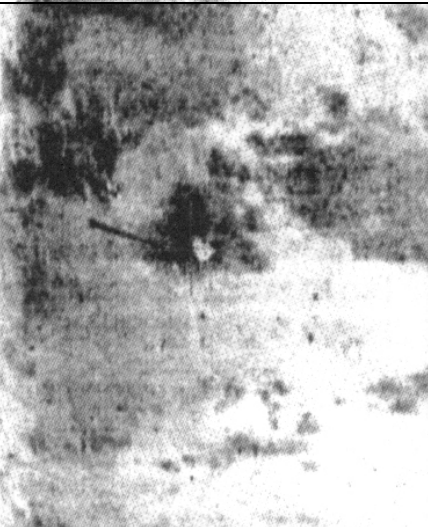
<p>MA Ltd No: MA13312 Grading: Low Position: 462064 101278 Size of anomaly: L W H Target description: Mooring Magnetic strength: 40nT Associated References:</p>

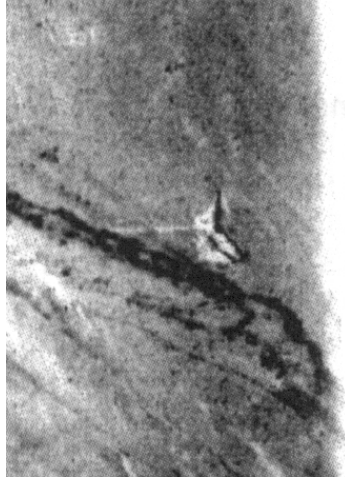
<p>MA Ltd No: MA13313 Grading: Medium Position: 462345 101475 Size of anomaly: L7.38m W2.45m H Target description: Debris field. Raised features with seabed scarring. Magnetic strength: Associated References:</p>

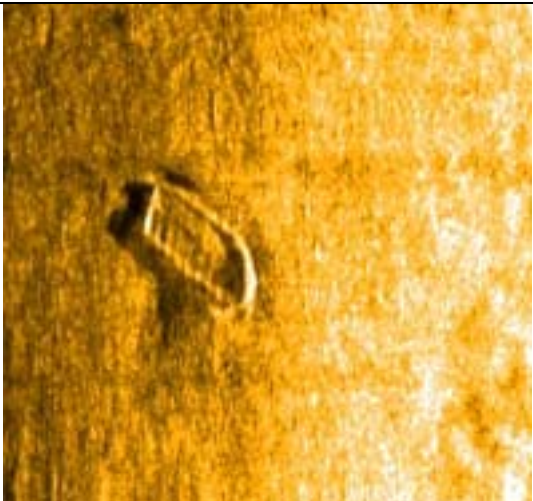
<p>MA Ltd No: MA13314 Grading: High Position: 462439 100239 Size of anomaly: L6.68m W3.88m H0.60m Target description: Wreck Magnetic strength: Associated References:</p>

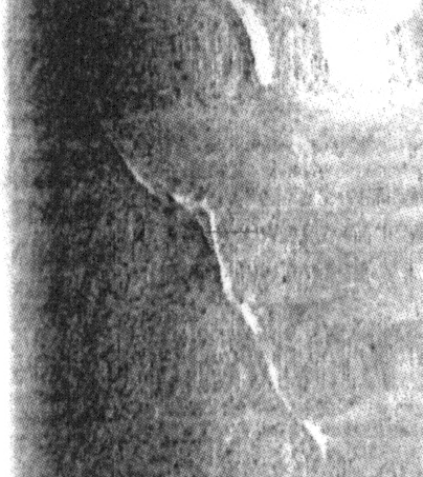
<p>MA Ltd No: MA13315 Grading: Low Position: 462673 99491 Size of anomaly: L W H Target description: Chains/ rope Magnetic strength: Associated References: Grouping: MA18022</p>

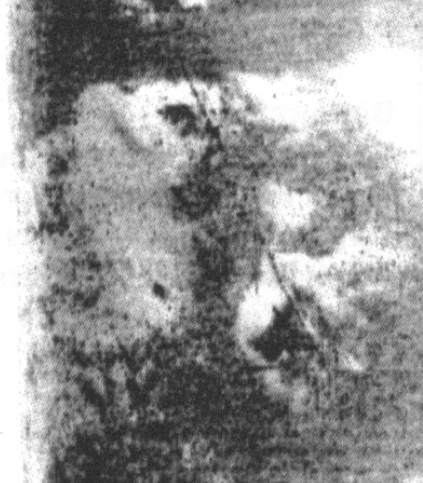
<p>MA Ltd No: MA13319 Grading: Low Position: 462147 101105 Size of anomaly: L W H Target description: Chain Magnetic strength: Associated References:</p>
