## THE OLD HALL OF LINCOLN'S INN.

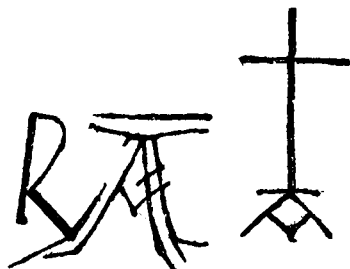
LINCOLN'S INN HALL; MASON'S MARK.  
EAST ORIEL.

Photograph No. 1 shows the interior of the east oriel; No. 2 an enlargement of the vaulting of the east oriel; No. 3, the interior of the west oriel; and No. 4 the lower portion of windows in the west oriel. A tracing by Mr. Sidney Toy of a photograph of the mason's mark which appears on the north flank of the east oriel is here given.
