# ARCHAEOLOGICAL FINDS IN THE CITY OF LONDON 1967-70

BY PETER MARSDEN

*Guildhall Museum*

## SITE I. BLACKFRIARS EMBANKMENT SCHEME, 1969-70

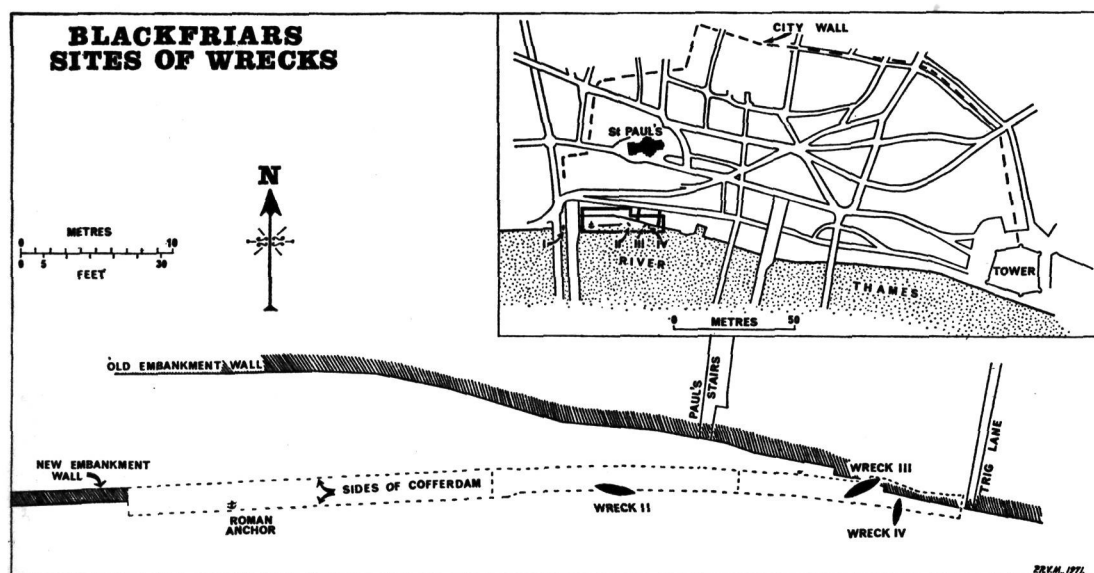
Fig. 2

Site of wrecks in the Thames east of Blackfriars. The concentration of sixteenth-century knives and daggers was between wrecks II and III.

The wreck lay roughly east-west in the bed of the Thames several feet below the river bed, and was surrounded by black muddy gravel. Its bottom lay about 3 metres below Ordnance Datum, and its position east of Blackfriars Bridge is shown on Fig. 2.

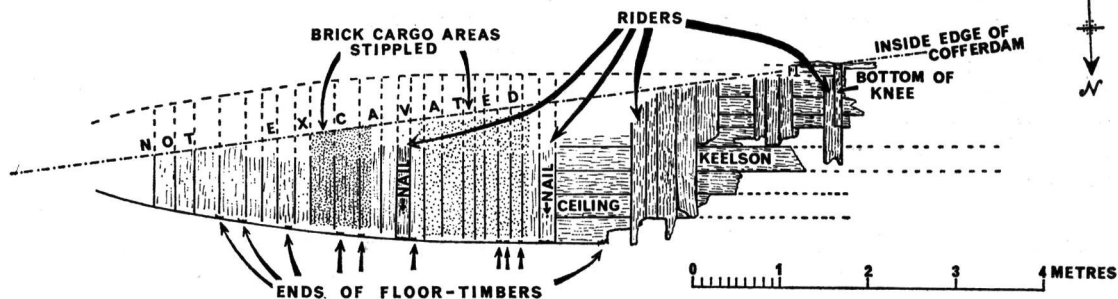
Fig. 3

Plan of the seventeenth-century Blackfriars wreck II.

A considerable part of the west end of the boat had been destroyed before the vessel was recognised, and part of one side lay outside the coffer-dam and may not have been disturbed by the excavations (Plate 1). The east end of the boat was sharp, and if the missing west end had also been sharp the boat may have been about 14 metres long. It was clinker

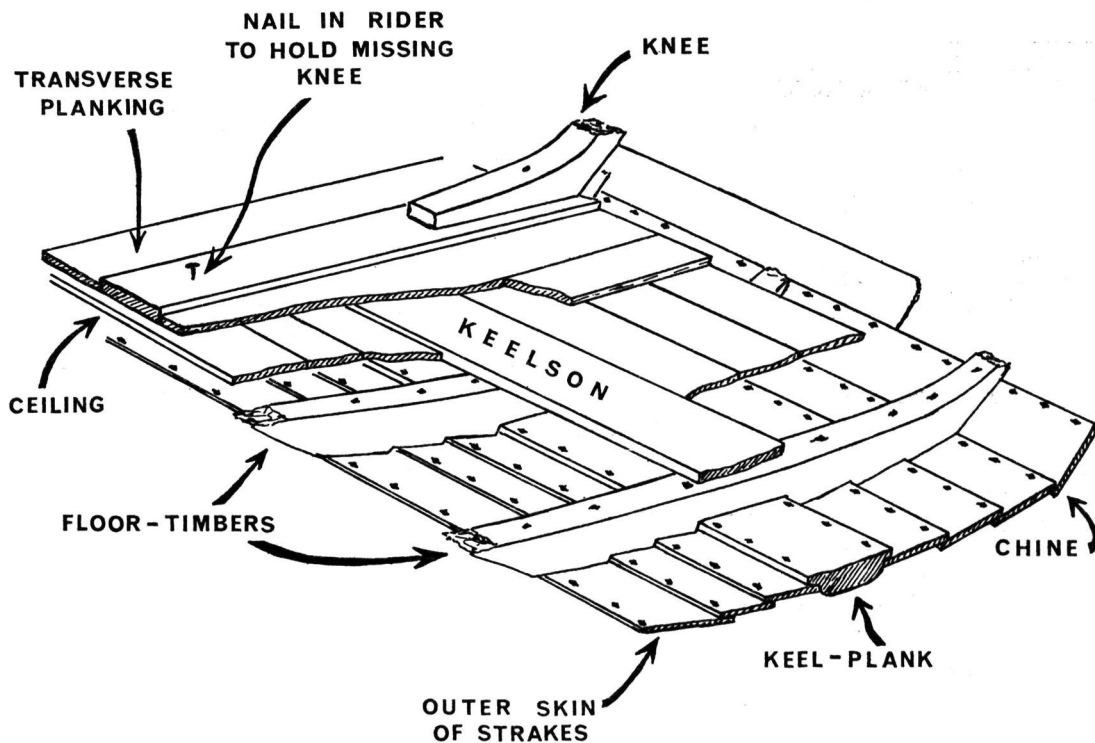
Fig. 4

Drawing to illustrate the construction of wreck II.

built, flat-bottomed, and each side met the flat bottom to form a chine (Fig. 4). The sides had been almost completely destroyed, so it is impossible to judge the beam of the vessel. The maximum distance between the chines, however, was just over 2 metres.

The keel-plank was of elm (*Ulmus* sp.), 17 cms. wide and 5 cms. thick. It was therefore little more than an extra thick plank. This keel-plank was only studied in its fragmented

state and not *in situ*. The garboard strakes fitted into rabbets on each side of the keel-plank and were held in place by iron rivets spaced about 9 cms. apart. The joint was caulked with an unidentifiable plant-like material.

The floor-timbers were small, between 4 and 7 cms. wide and roughly 5 cms. deep, and were notched on their undersides to accommodate the keel-plank and the overlapping strakes. Because the construction of this part of the boat was not examined *in situ* it is difficult to judge the spacing of the floor-timbers. However, a portion of the keel bore the impression of two floor-timbers 49.5 cms. apart on its upper surface. One of the floor-timbers clearly overlay a rivet holding the garboard strake to the keel, showing that the outer skin of strakes had been built first and that the ribs had been added after. This was the usual method of constructing clinker-built vessels. The floor-timbers have long rivets at the steps in the undersides where the overlap of the strakes must have occurred. The rivets used in this boat are all of the same form but of varying lengths; each comprises an iron nail with a flat head and square shank which is driven through the wood from outside the boat and the point is bent or clenched down over a small diamond-shaped iron rove (Fig. 5, no. 15). The roves had been cut from a strip of iron, as two were found still partly joined together, and each was punched into a domed shape.

A keelson, about 25 cms. wide, ran along the centre of the vessel on top of the floor-timbers, and was held by ordinary iron nails with flat heads and square shanks. On either side there was an inner skin or ceiling of planks, a sample of which has been identified as Pine (probably *Pinus silvestris*). These were laid longitudinally, and on top of them were a large number of transverse planks and riders (Fig. 4, plate 2). The purpose of the transverse planks was evidently to save the bottom of the boat from damage when loading and unloading a cargo of bricks. The riders, however, were thicker than the transverse planks and their primary purpose was evidently to support the lower ends of the side frames. None of the side frames had survived except on the south side where a knee, which may have been the lower end of a side frame, had been attached to the top of a rider by a large iron nail. On the north side of the boat the ends of several riders had similar large nails projecting out of them with the head of each several centimetres above the top of each rider, and clearly these had once held other knees. The spacing of the riders was not very regular but it would seem that 1.70 metres was a rough average measurement. On the south side of the boat the first side strake above the chine was fastened to the knee, but on the north side of the boat this strake was missing. It is interesting that the knee was not directly fastened to the top of the floor-timber, as this would seem to have been a much stronger construction.

The outer skin planking was of Oak (*Quercus robur* type) and 1.5 cms. thick. Although only fragments of the outer skin planking could be studied it is clear that each strake comprised an unknown number of planks which were joined end-wise with a simple overlap scarf of about 15 cms. The outer end of the scarf was secured by an iron rivet centrally placed in the strake, and by a number of small iron nails. The seam was caulked with a felt-like material. The overlapping strakes were held together by iron rivets spaced at intervals of about 7 cms. A small area of the outside of the outer skin of the east end of the boat was recorded *in situ* and was found to be sheathed probably with oak planks about 5 mm. thick. This was fastened by many small iron nails with square shanks, spoon-shaped pointed ends and with curious waisted flat nail heads (see Fig. 5, no. 16).

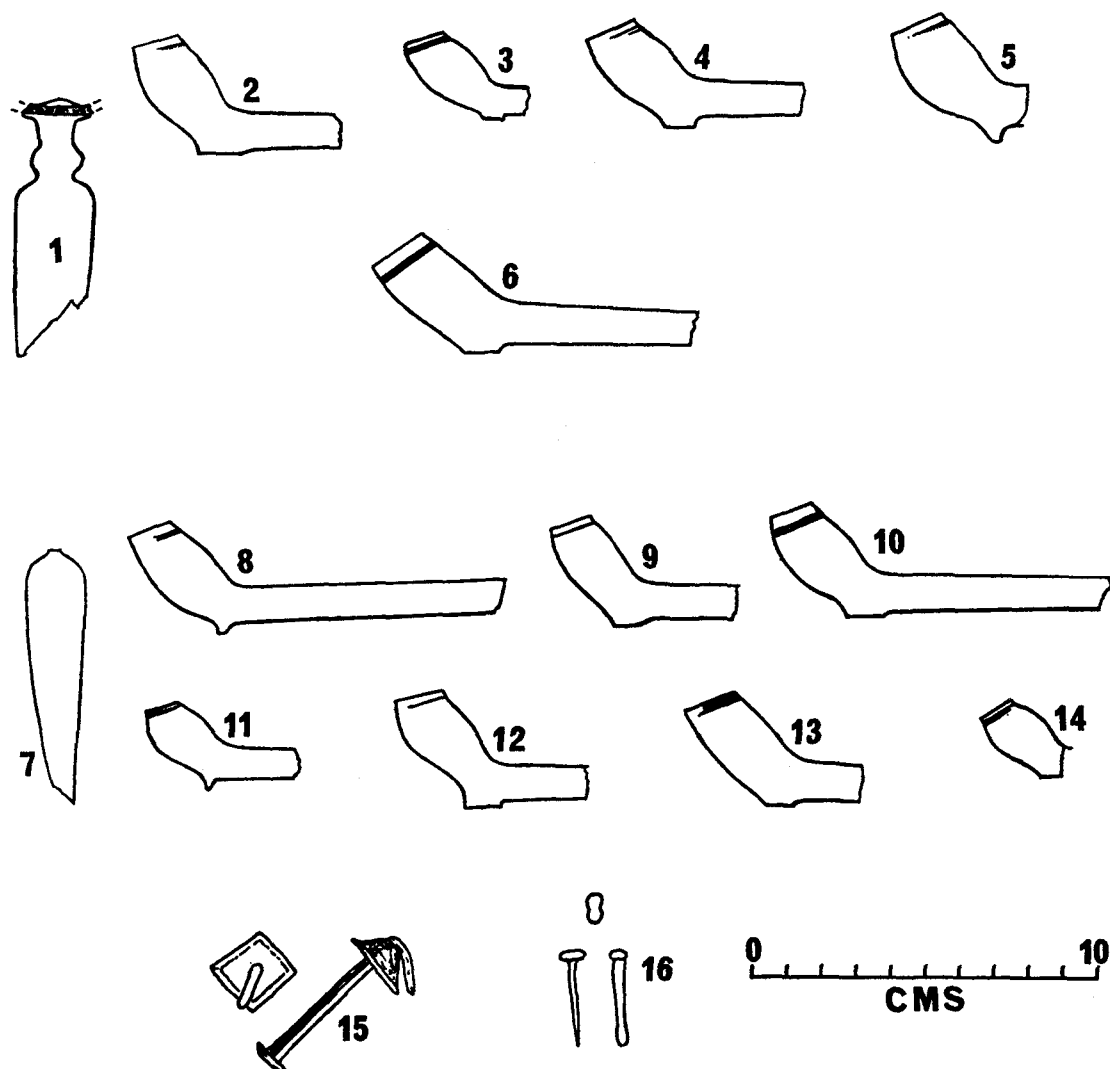
Fig. 5  
Dating evidence for wreck II. Nos. 1-6 from on the bottom of the boat;  
Nos. 7-14 from immediately beneath the boat.

Evidence to date the loss of the boat was recovered from both inside the boat and from the silty gravel beneath the boat. The significant dateable material from inside the boat on the bottom boards comprised a number of clay pipes (Fig. 5, nos. 2-6) of the period 1650-70. Other finds from inside the boat include part of a wine glass stem (Fig. 5, no. 1), sixteen brass pins with twisted wire heads, three small brass pin cases, iron nails, several small lumps of coal (at the east end), and two fragments of brown coarse ware pottery.

From immediately beneath the boat were recovered 25 clay pipe bowls all of the period 1650-70 (Fig. 5, nos. 8-14). Other finds include a broken wine glass stem (Fig. 5, no. 7), parts of a Bellarmine jug with the bottom of a bearded face and a rose medallion, a fragment of black glazed ware, small fragments of buff ware with the pale greenish-yellow glaze which is typical of the 17th century, and several small fragments of brown glazed red coarse ware.

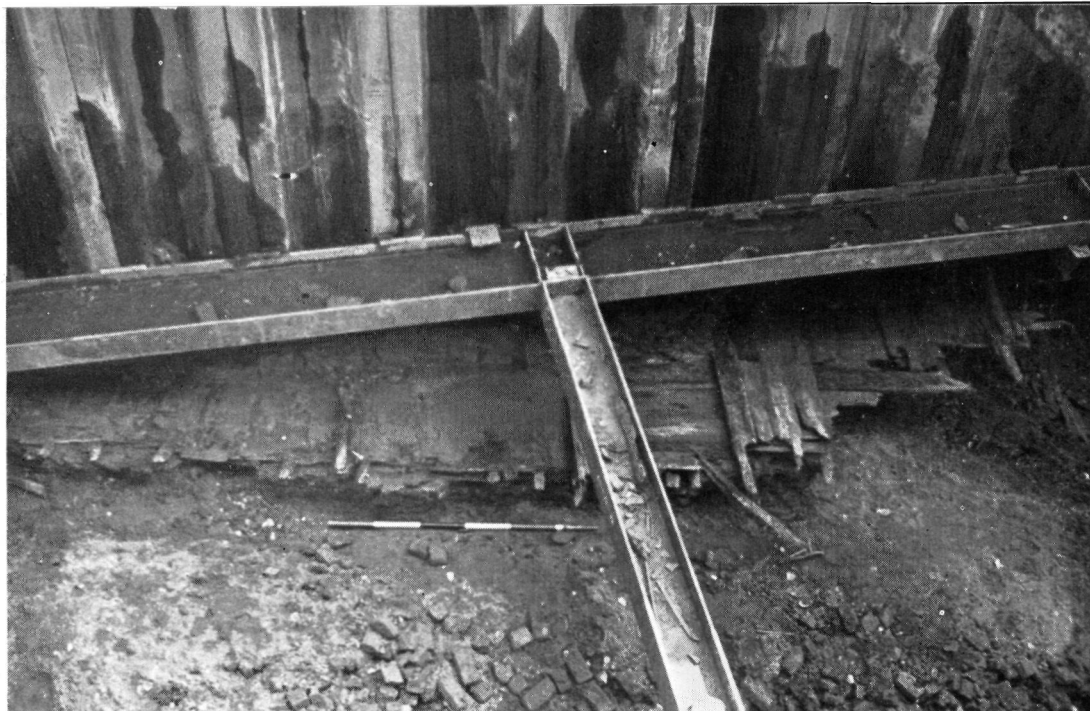
PLATE 1. View from above of the bottom of the seventeenth-century Blackfriars wreck II, after the cargo had been cleared. Scale of feet.

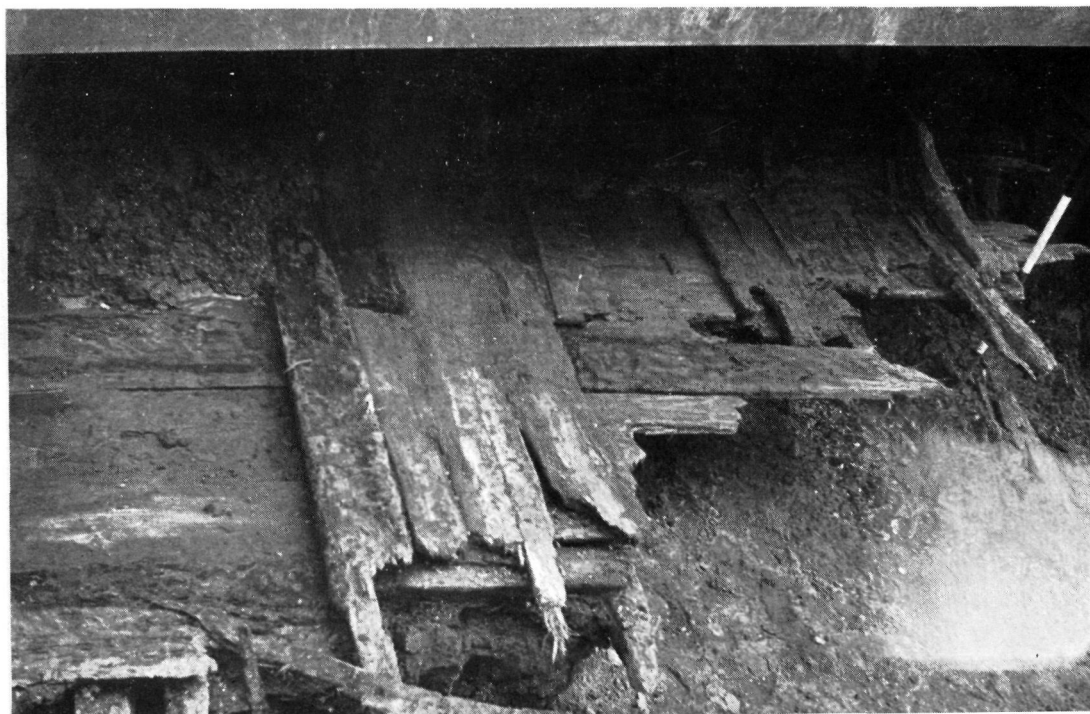
PLATE 2. The longitudinal and transverse planking in the bottom of wreck II, over the floor-timbers.

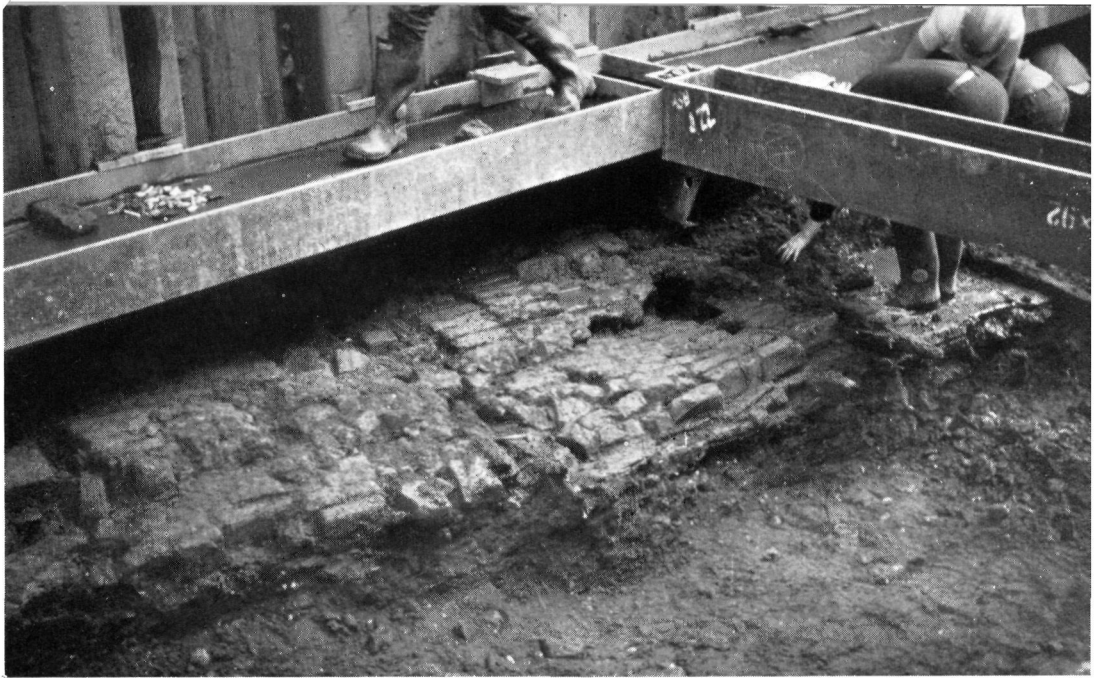
PLATE 3. The brick cargo of wreck II *in situ*.

This flat-bottomed boat was carrying a cargo of red bricks and was evidently a barge. These were carefully laid on top of the transverse planks in two areas, three bricks deep (Plate 3). Each brick was a featureless rectangular block  $22\frac{1}{2}$  cm. long,  $10\frac{1}{2}$  cm. wide, and  $5\frac{1}{2}$  cm. deep. None of the bricks had ever been mortared together so it is likely that they were being brought new from brickworks somewhere to London for building purposes.

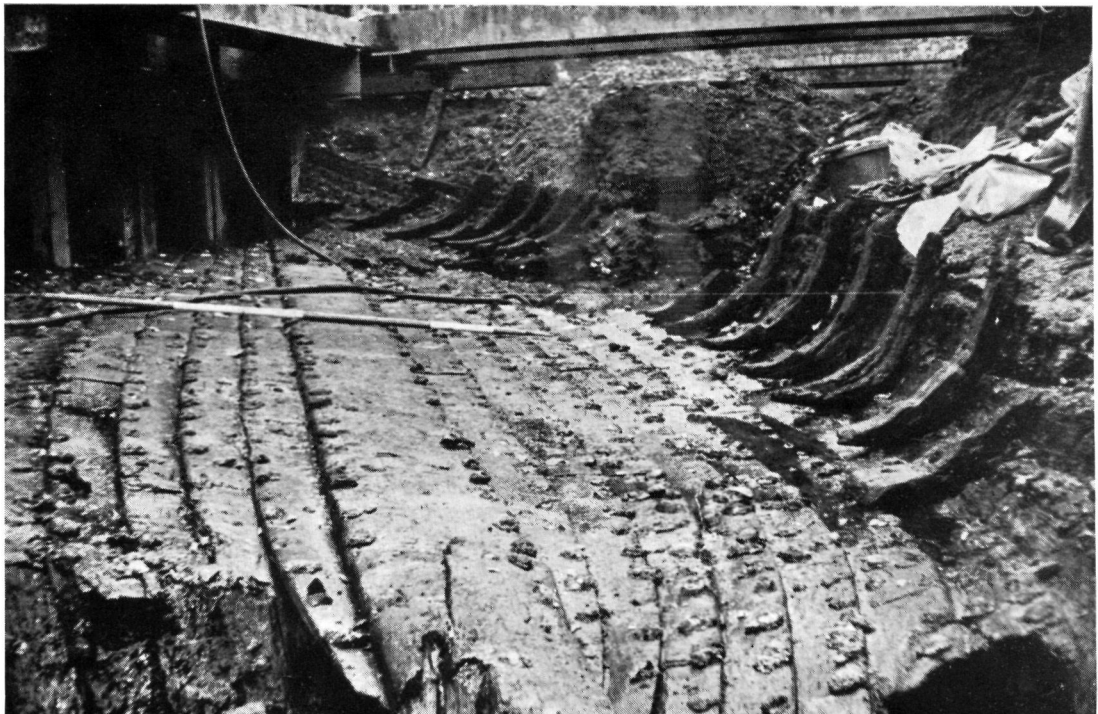
PLATE 4. View of the fifteenth-century wreck III looking aft. The floor-timbers, mast step and the stringer have all been removed. The sternposts can just be seen in the far distance. Scale of half metres.

A considerable amount of the boat had survived showing that it was originally about 16 metres long, and about 3 metres wide (Plate 4). It had a flat bottom and both ends of the craft were pointed. Its overlapping planks, riveted together, showed that it was clinker built (Fig. 6). Unfortunately the bow had been destroyed during the contractor's excavations prior to the discovery of the wreck, but the junction of the stempost and the keel had

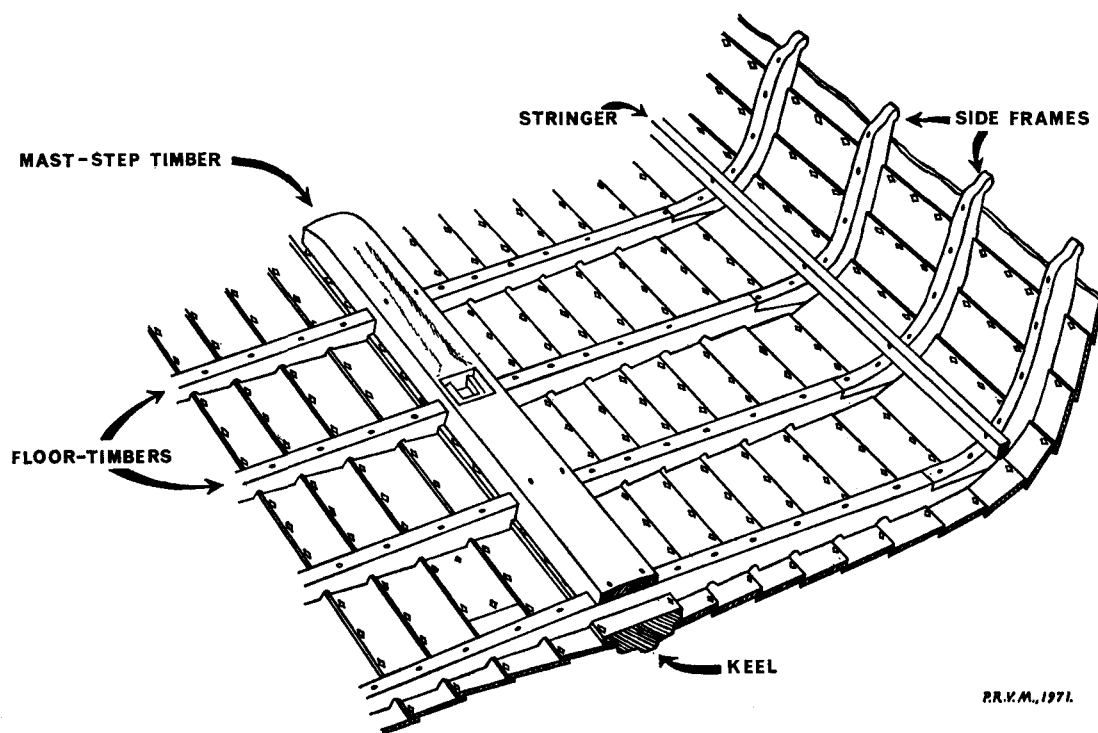
Fig. 6  
Drawing to illustrate the construction of the fifteenth-century Blackfriars wreck III looking aft.

survived. The stern, however, was very well preserved (Plate 5), and the sternpost stood to a height of several feet. Inside, the boat was strengthened by many floor-timbers and side frames, and a stringer fastened to the top of the ribs gave some longitudinal strength. The main longitudinal timber, however, was the keel which, although quite wide, was only a few inches thick, and was really nothing more than a rather thick plank.

The ribs were fastened to the planks by wooden pegs (trenails) at the ends of which had been inserted wooden wedges. On top of the ribs roughly amidships was a longitudinal timber containing a mast-step, showing that the boat was propelled by sail.

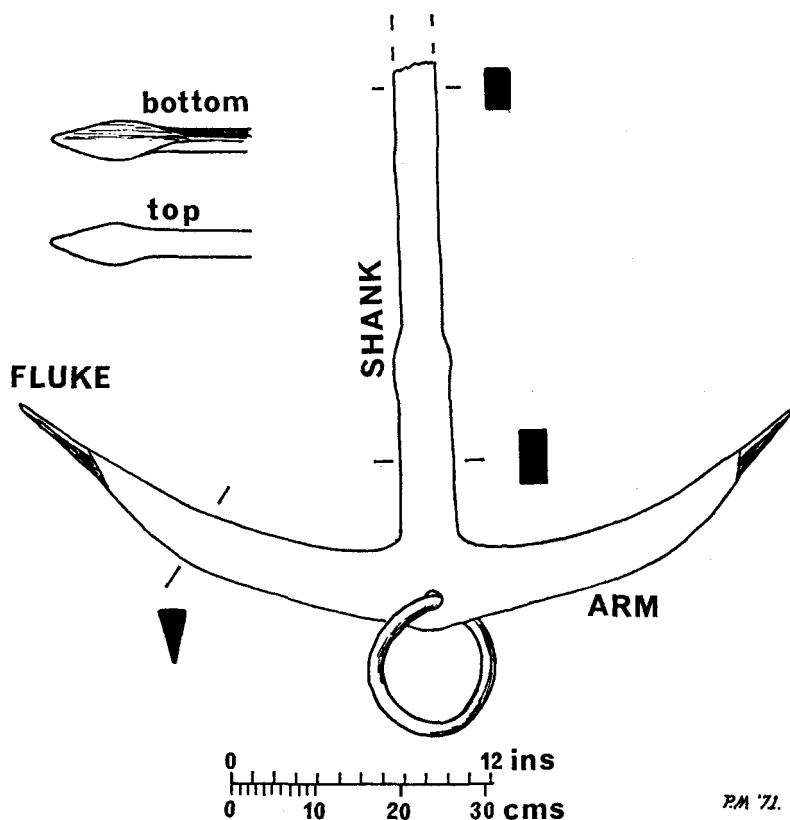
Fig. 7  
Iron anchor from the Thames at Blackfriars, probably Roman.

any dating evidence (Fig. 7). From its depth, form, and condition, however, it is clear that the anchor is not of recent date, and is most likely to be Romano-British.

The form of the anchor itself is a useful clue to its date, although it must be remembered that very little is known about the development of the anchor in Northern Europe until recent times. The shank is broken and only the lower half survives. The shank is rectangular in form with a curious swelling close to the crown. The arms are triangular in section, and the crown is pierced for an iron ring. The flukes are pointed and have a flattened triangular cross section.

A feature of the London anchor which may be significant is the curious swelling on two sides of the lower part of the shank. To my knowledge this has only been found on an iron anchor of Roman date from Pompeii; and a similar feature is indicated on a cast taken of a natural concretion-mould of a corroded Roman anchor from the sea bed off the south coast of France, now preserved in the Boreli Museum at Marseilles.

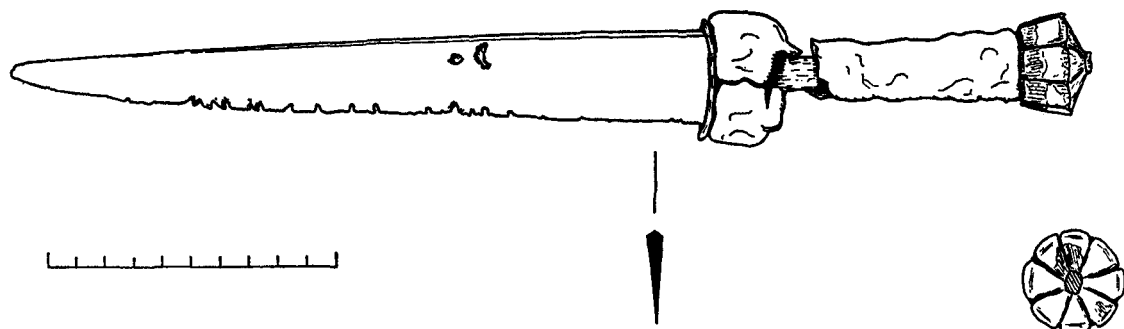
Fig. 8  
Kidney dagger from the Thames at Blackfriars. Scale of centimetres.  
(Drawn by J. Clark).

It comprises 25 daggers, seven of which are of the kidney type, and two of the rondel type. An additional kidney dagger in private hands is illustrated here (Fig. 8). It has a damaged wooden handle at the end of which is an iron terminal with a brass wash. The iron blade has been irreparably damaged in antiquity by being chopped on the cutting edge. There are also four quillon daggers, and a fine main-gauche with a decorated blade.

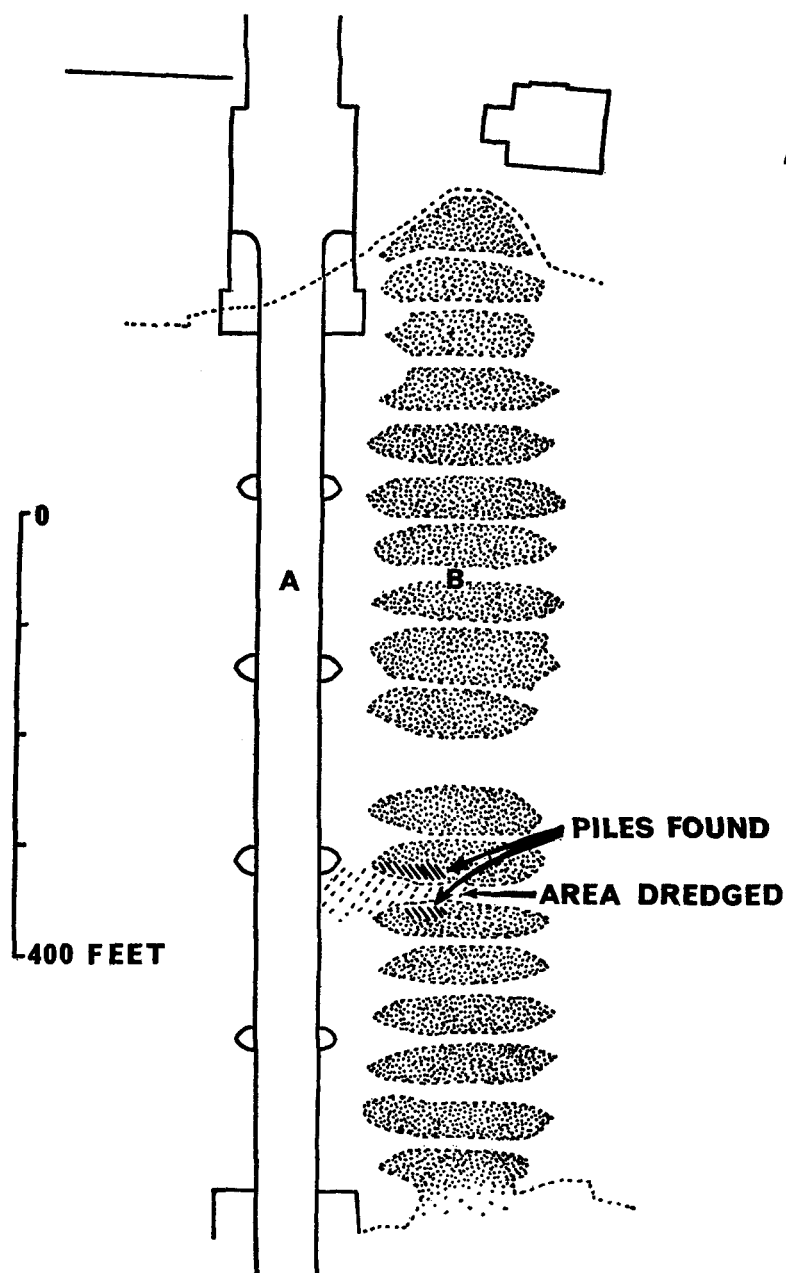
Fig. 9  
Plan of London Bridge region to show area of dredging in 1967. "A" is the nineteenth-century bridge, now being re-built; and the stippled areas marked "B" are the foundations, or starlings, of the medieval London Bridge.

Between 8th and 13th November, 1967, the Port of London Authority dredged a channel east of the 19th-century London Bridge, opposite the second arch from the Southwark side, and across the site of the medieval bridge (Fig. 9). The dredger used a grab to excavate generally to a depth of 5 feet into the river bed, and the debris was dumped into a dumb-barge lying alongside. Members of the City of London Archaeological Society were on board, and after each grab of black muddy gravel had been dumped into the barge, they quickly raked through the material looking for objects.

As the dredger dug it brought up many large facing blocks from the old bridge, and even two portions of the 18th-century balustrade, very waterworn. It also pulled up many timber piles from the foundations of two of the starlings of the bridge. They belonged to two types—the “old” piles roughly cut from individual tree-trunks and roughly 45–60 cms. in diameter. The lower end was always pointed and many piles had this end fitted with an iron point or shoe. The grab had chopped off the tops of most of these piles, but it seems that their average length was in the region of 4.5 metres, but one especially long pile was 7 metres long. The soft spongy and stained colour of this wood indicated that they were of considerable antiquity, whereas the more recent piles, which were square in section, were hard and only superficially discoloured. These were also fitted with iron points. From amongst the piles the grab also brought up great quantities of chalk and ragstone rubble.
