THE EXCAVATION OF A ROMAN PALACE SITE IN LONDON, 1961-1972

BY PETER MARSDEN

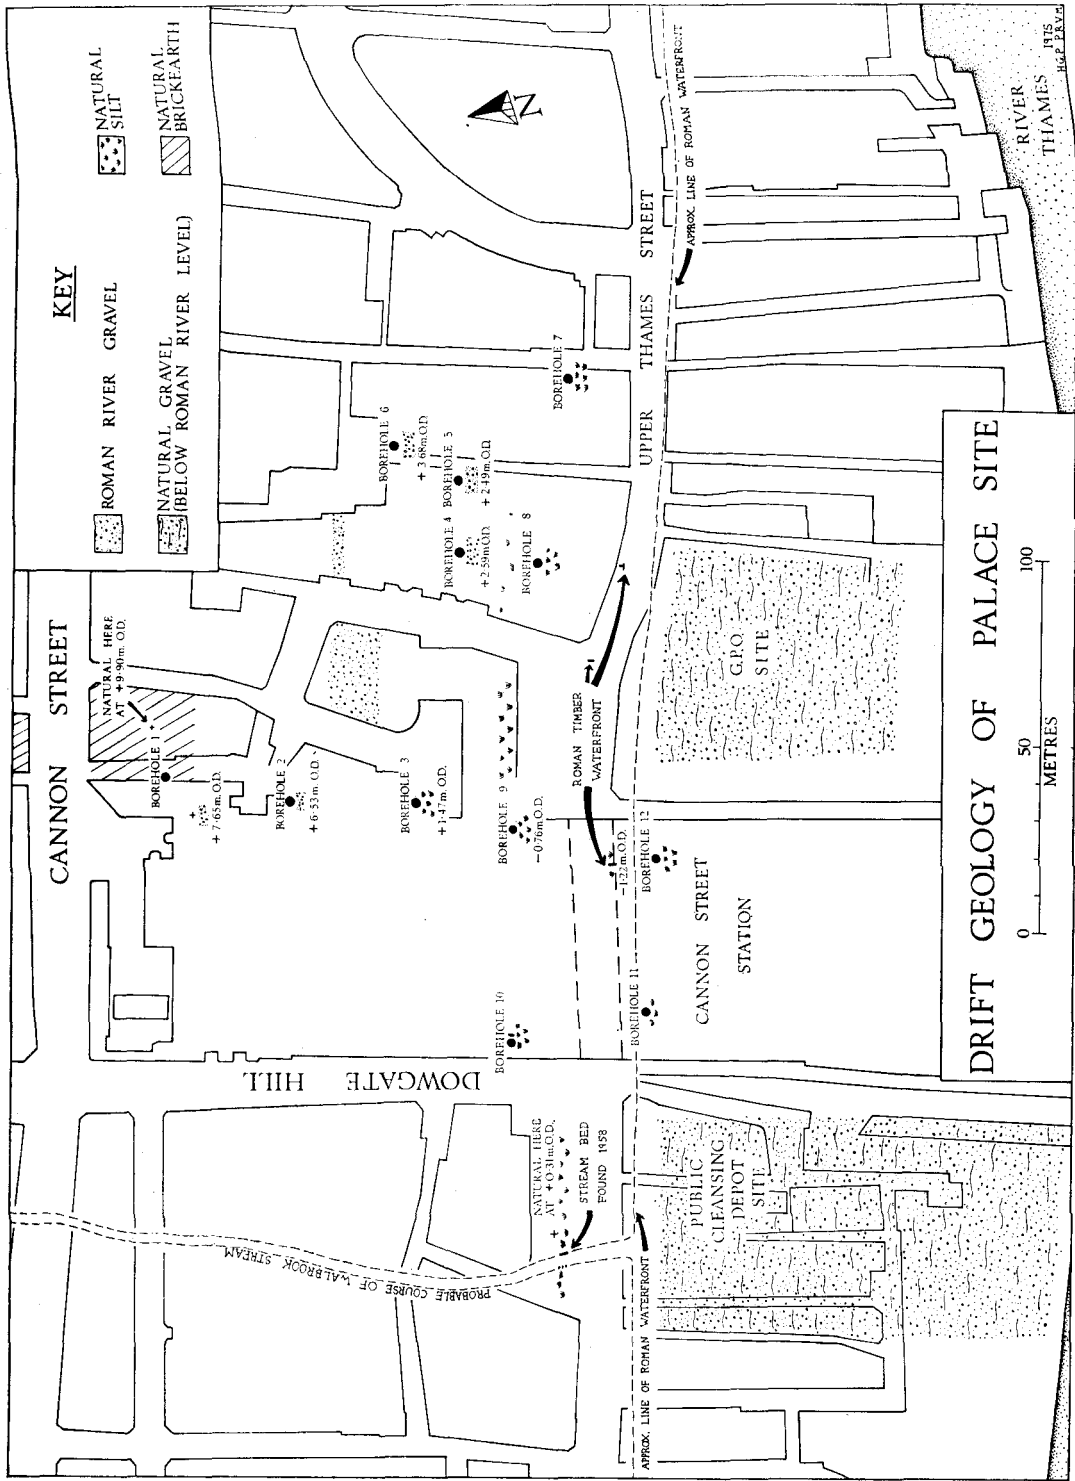
Fig. 2 Roman Palace. The recorded geology of the site

At the top of the hillside the natural subsoil was a yellowish-brown brickearth and was revealed in 1960–61 by Professor W. F. Grimes on the site of the Church of St. Swithin, London Stone, in Cannon Street,¹² and also on the site of 143–149 Cannon Street (personal observation). Excavations further south on the upper edge of the hillside slope, on the site of the Dyers Arms public house, and beneath Bush Lane House,¹³ showed that the natural subsoil lay at 9.90 m above O.D., and that the brickearth was somewhat sandy, being a transitional form between the underlying gravel and the brickearth. The actual junction between the brickearth and the gravel was not observed since it had been destroyed by the Roman and modern terracing. The actual junction line was probably at the north end of the great hall, Room 42, of the palace.

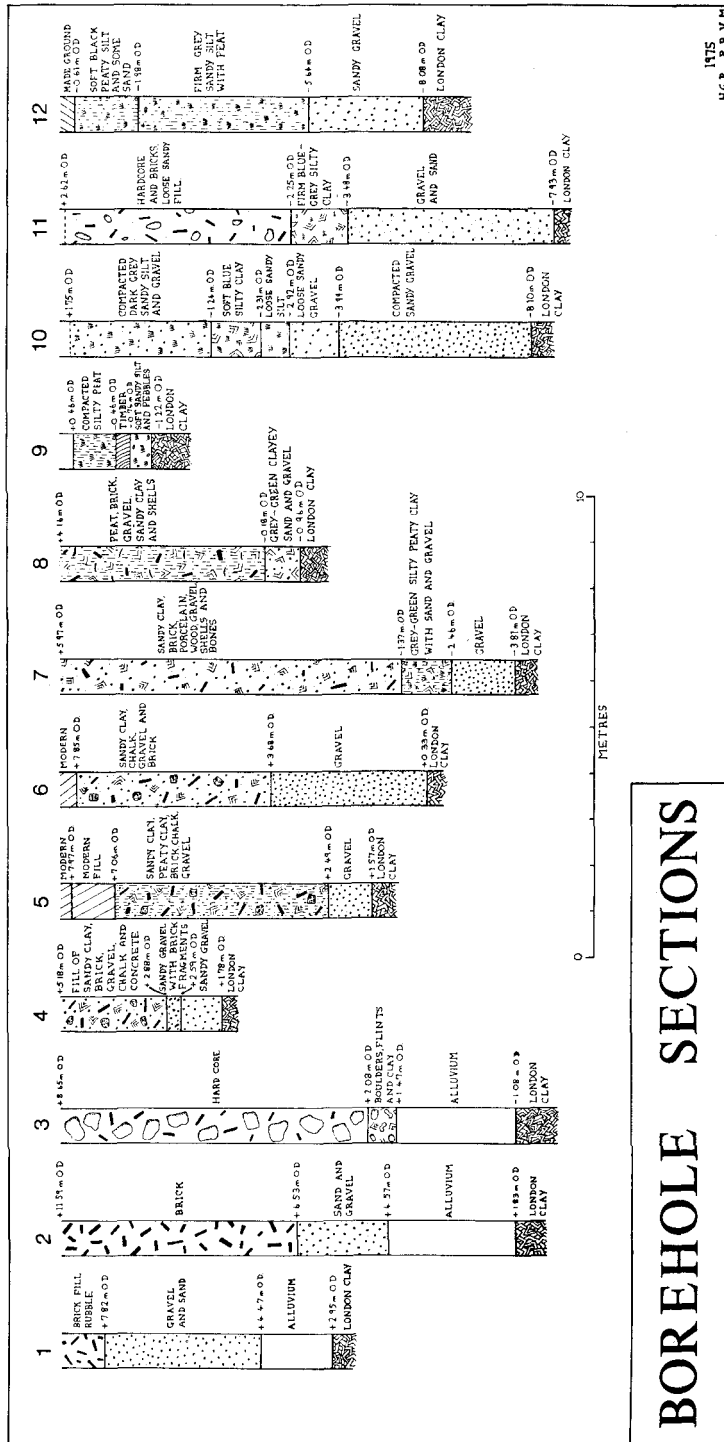
Fig. 3 Roman Palace. Borehole sections recorded during commercial site investigations

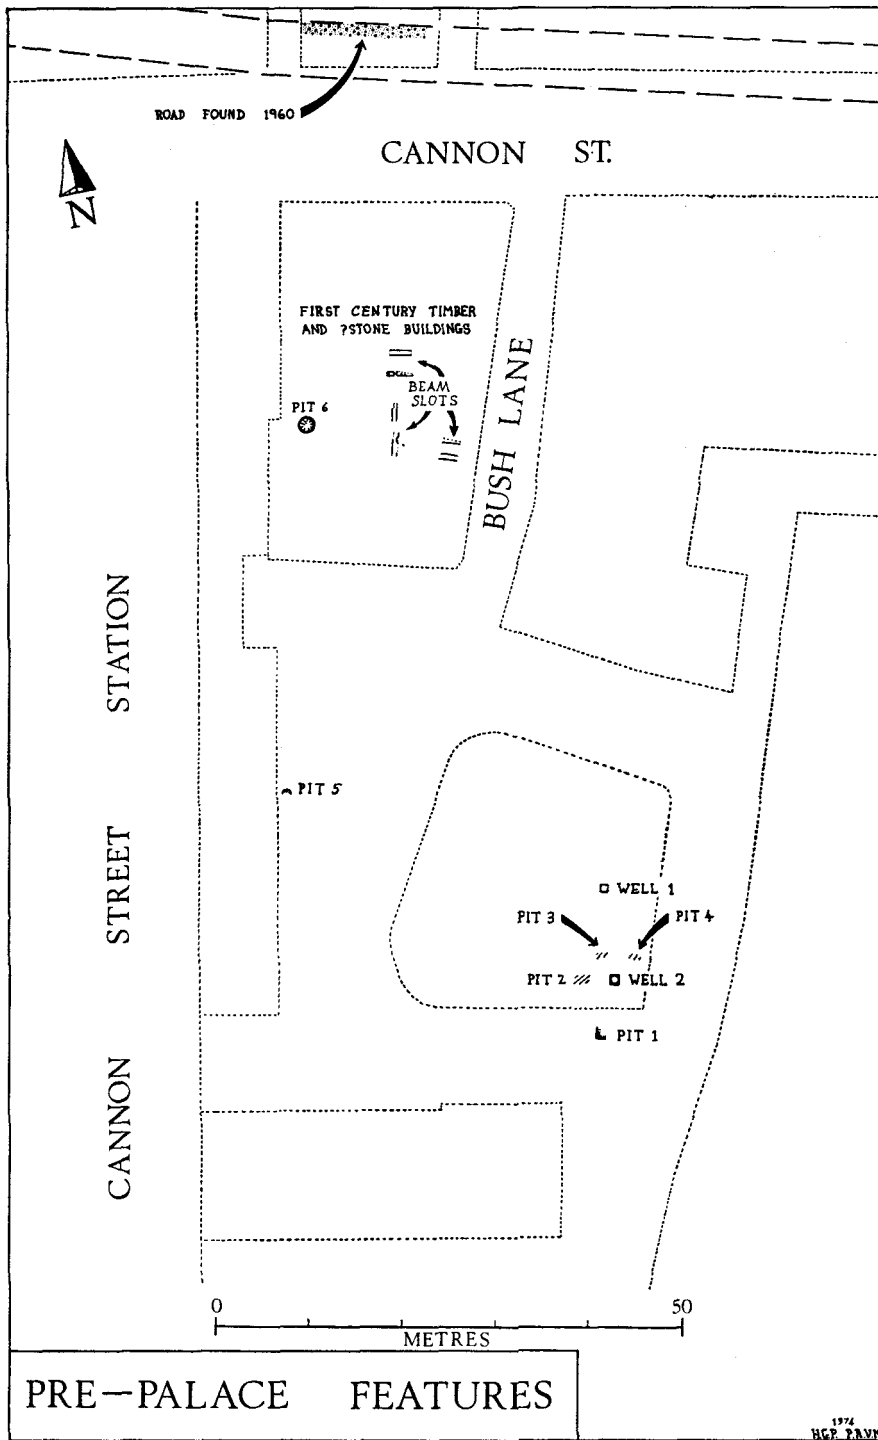
Fig. 4 Roman Palace. Pre-palace features of the first century A.D. The early date of the Roman road under Cannon Street is not established

Evidence of occupation prior to the palace construction has been found on various parts of the site (Fig. 4), and these are described under their separate areas (Fig. 1).

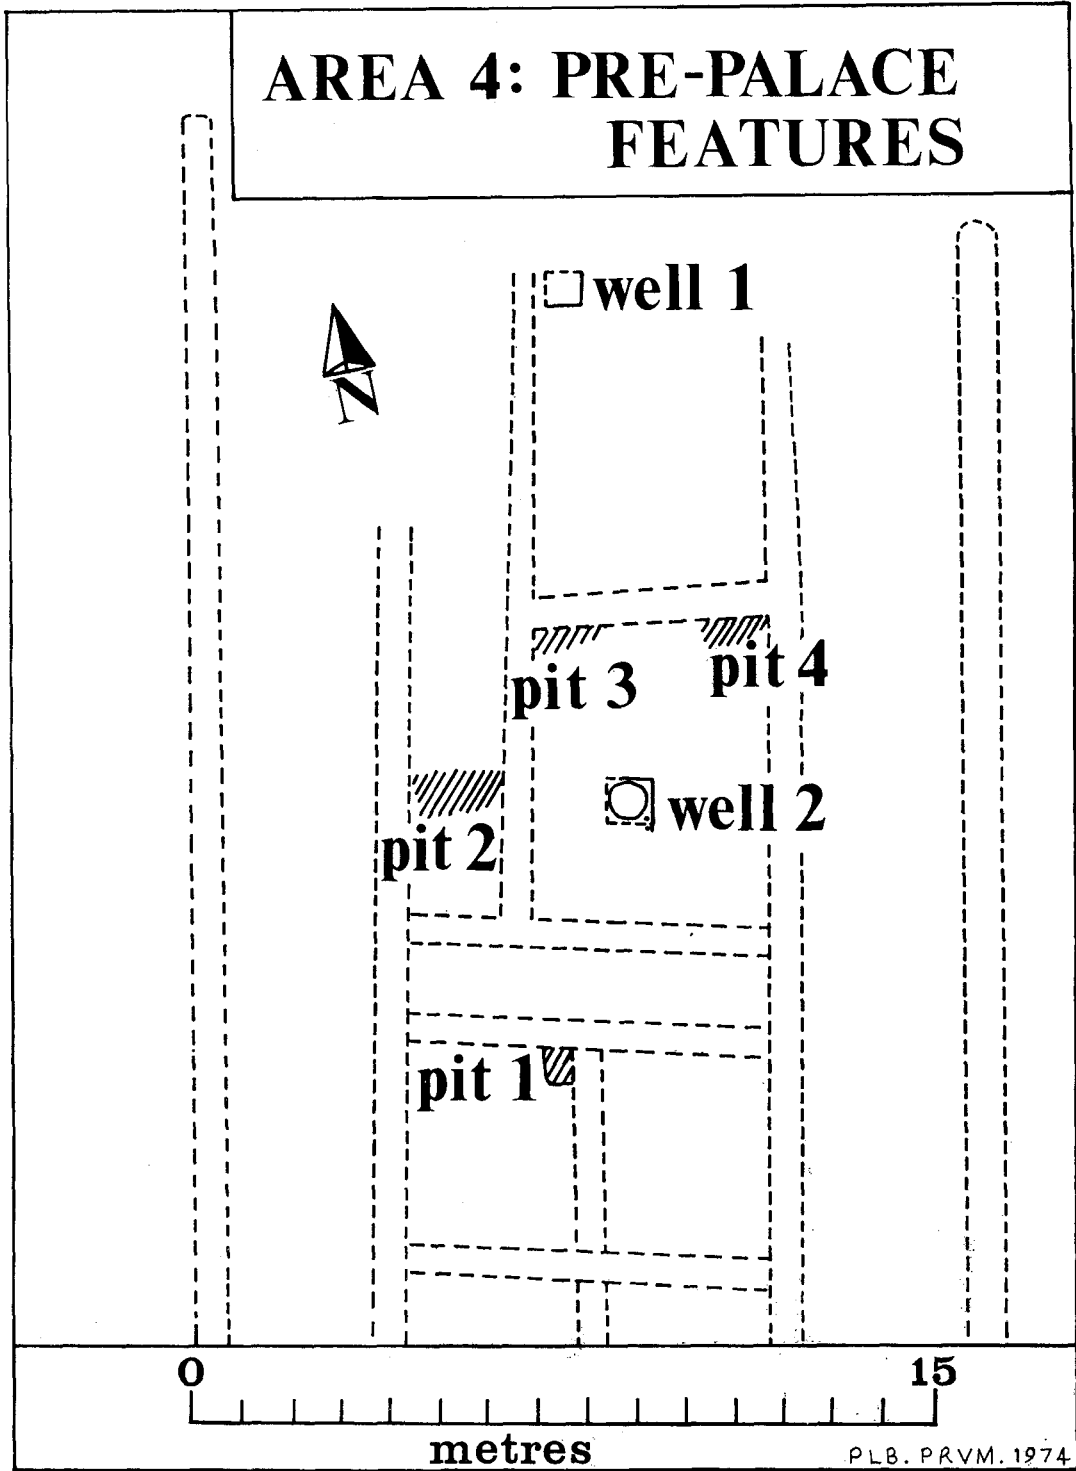
Fig. 5 Roman Palace. Pits and wells recorded in Area 4. Well 2 and Pit 1 contained evidence of Flavian gold refining

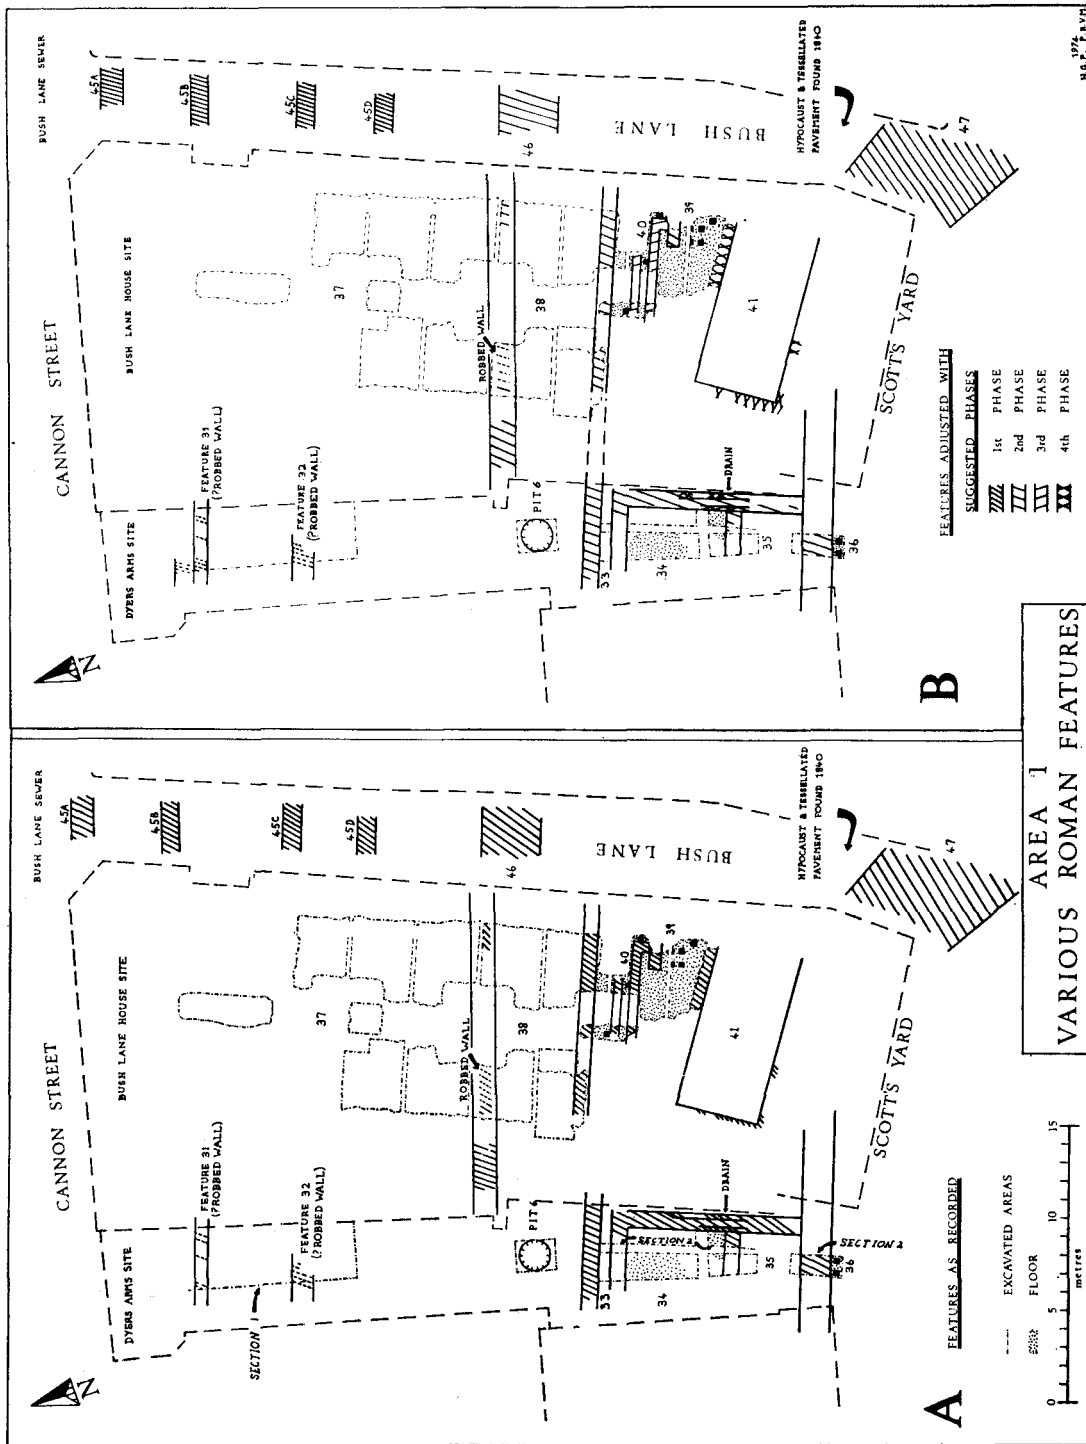
Fig. 6 Roman Palace. Roman masonry structures of all phases in A, as recorded, and in B, as adjusted to bring the Dyers Arms and Bush Lane House sites into line

The final Roman phase was not dated by any archaeological evidence but merely from the style of construction. It was, in fact, a sunken room (Fig. 6, Room 41), aligned obliquely to the earlier Roman structures, which had been cut through the hypocaust floor of Phase B, and through the overlying rubble. The walls were built of ragstone, flint, occasional Roman brick fragments, and a little chalk, set in a hard pale concrete and, in spite of the presence of the chalk (which is rarely found in Roman buildings), it had all the appearance of being of Roman date. The sunken interior faces of the room were rendered in white plaster, possibly painted white originally. No trace of any hypocaust was found, and the entire contents of the room, including the original floor, had been dug away in the nineteenth century and backfilled before Bush Lane House was built at the end of the nineteenth century.

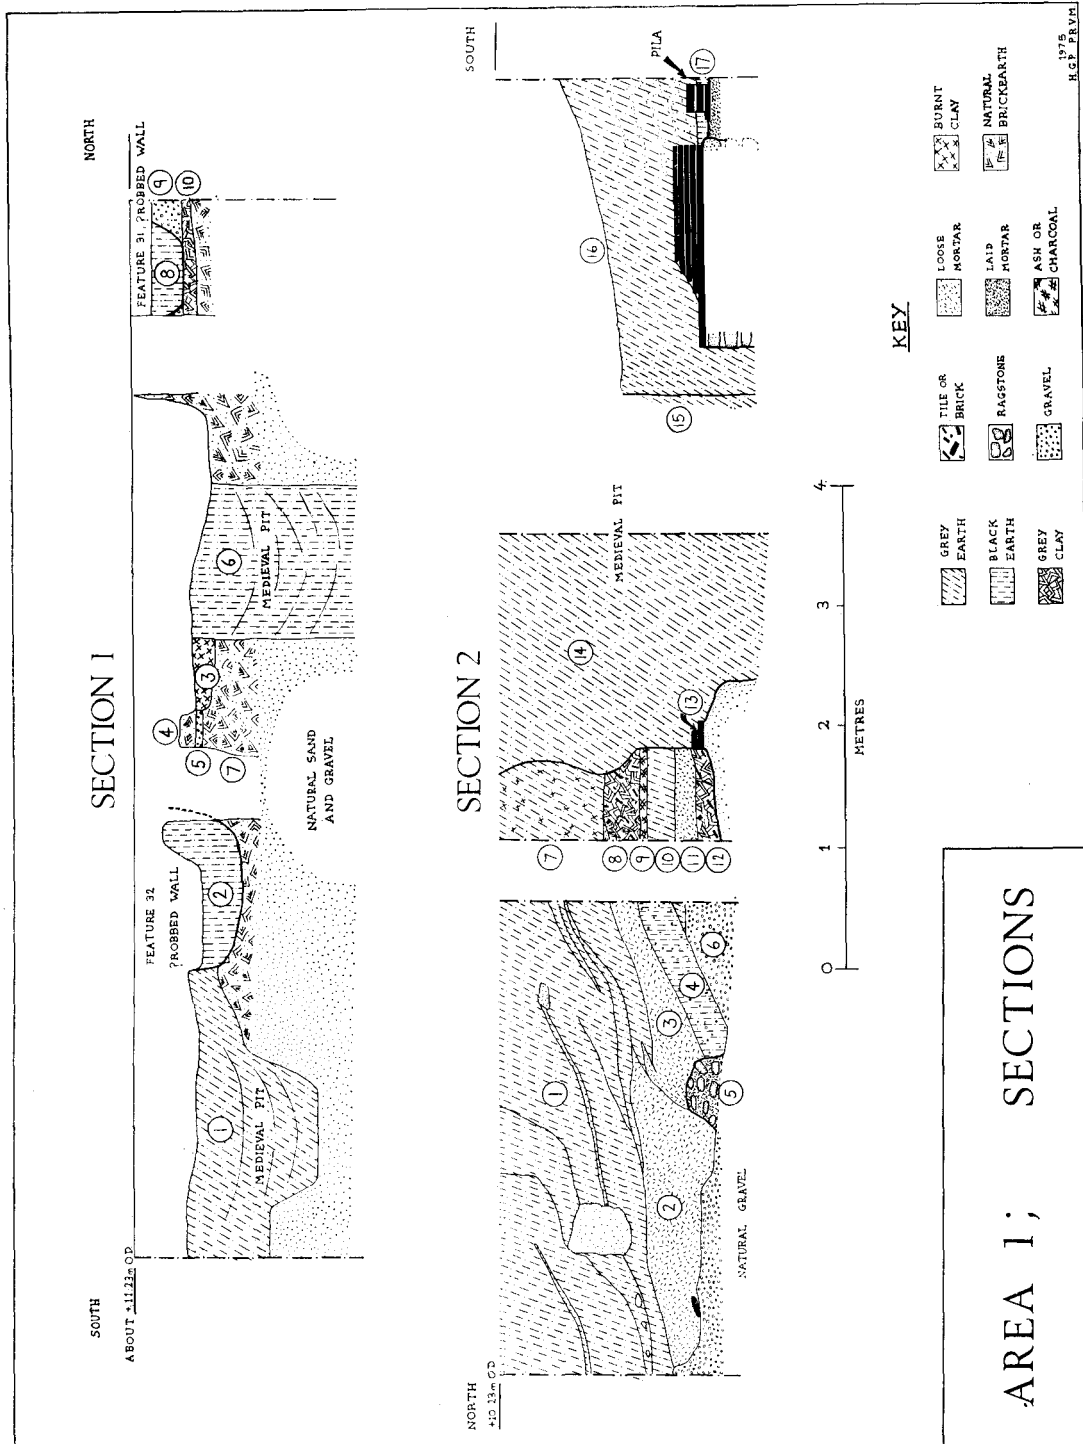
Fig. 7 Roman Palace. Sections 1 and 2 on the Dyers Arms site

Some possible indication of the interior of Rooms 34 and 35 was included in the contents of the early medieval pits dug into Rooms 34 and 35 (Fig. 7, Section 2). There appear to have been two separate pits (Layers 1–4, 6–12 and 14); that dug into Room 34 being the earlier. In this pit the deposits included Roman tiles, both of the *imbrex* and *tegula* types, as well as fragments of box flue tiles—these generally having traces of the buff-coloured mortar in which they had been set. Also a small number of pieces of pink-painted wall

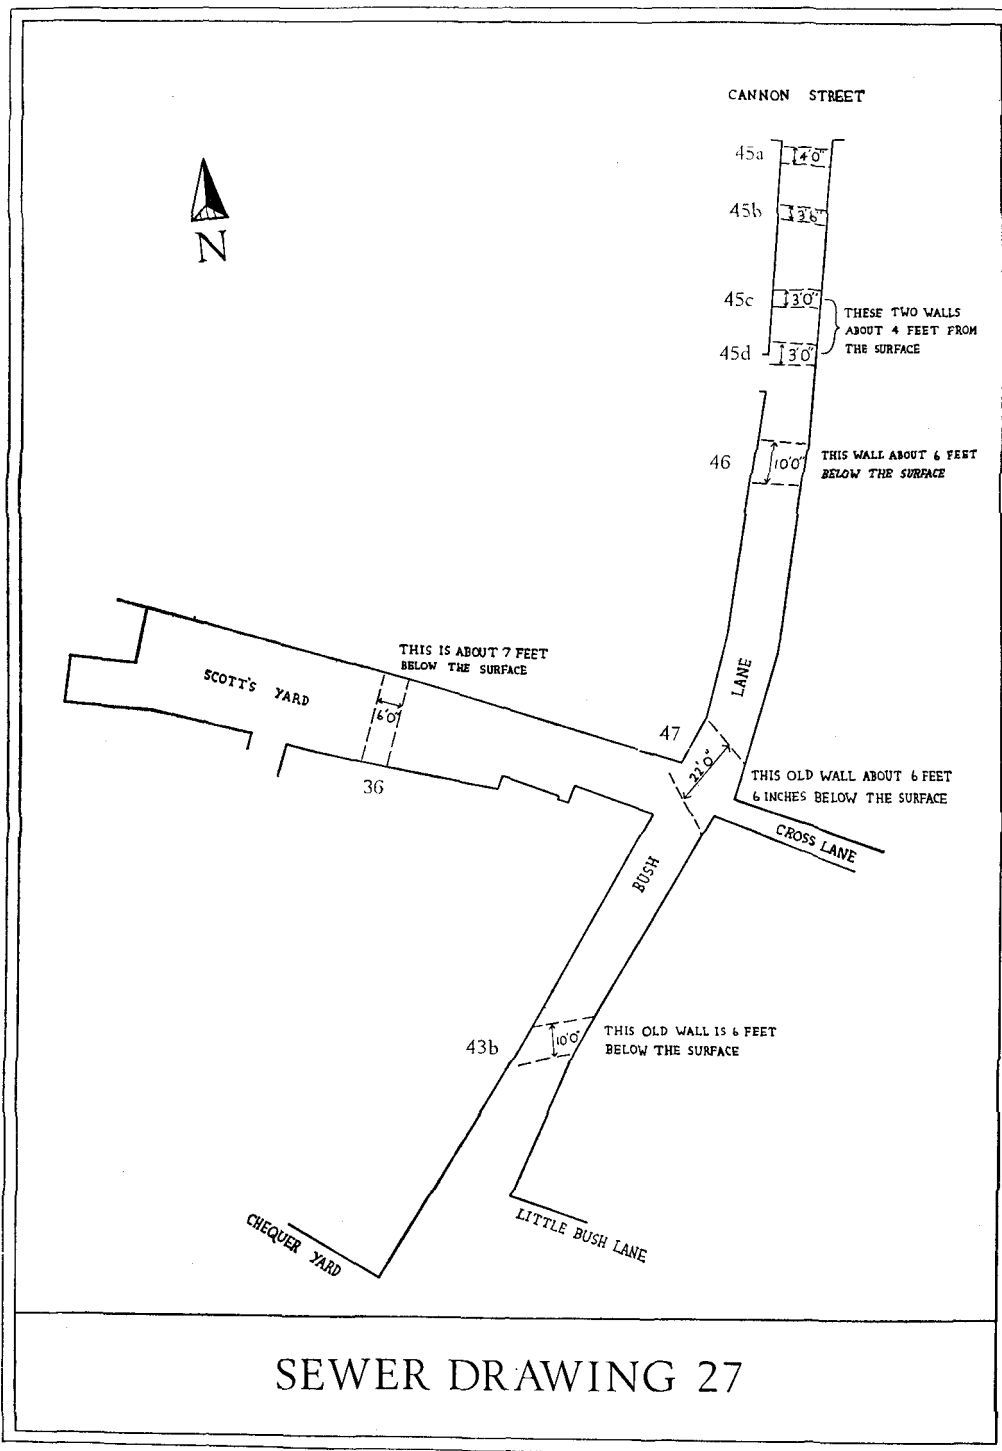
Fig. 8 Roman Palace. Roman walls recorded on Sewer Drawing 27, c. 1840, re-drawn for publication. The feature references used in this report have been added to the plan

The position of the Roman walls found in Bush Lane about 1840 were sketched in pencil on Sewer Plan 27 (Fig. 8), and related to the buildings then extant, but none of which existed when the post-war archaeological excavations were carried out. Thus, although the sewer position and, therefore, the sewer trench in which the walls were found is known, it is not possible to establish the exact position north or south of the Roman walls.

This "great wall" is recorded on Sewer Drawing 27 (Fig. 8), which states that it was 22 ft (6.7 m) wide. Sewer Drawing 43 (Fig. 9) gives us an additional record which states that the "old stone wall" lay at a depth of 6 ft 3 in (1.91 m) and that it was 5 ft (1.52 m) thick, this latter figure being implied by the note indicating that the base of the wall lay below 6 ft 3 in (1.91 m) of made ground and 5 ft (1.52 m) of old stone wall—a total depth of 11 ft 3 in (3.45 m) below Bush Lane, whereas the base of the new Bush Lane sewer lay at a depth of 13 ft 3 in (4.04 m), two feet (0.61 m) below the bottom of the masonry.

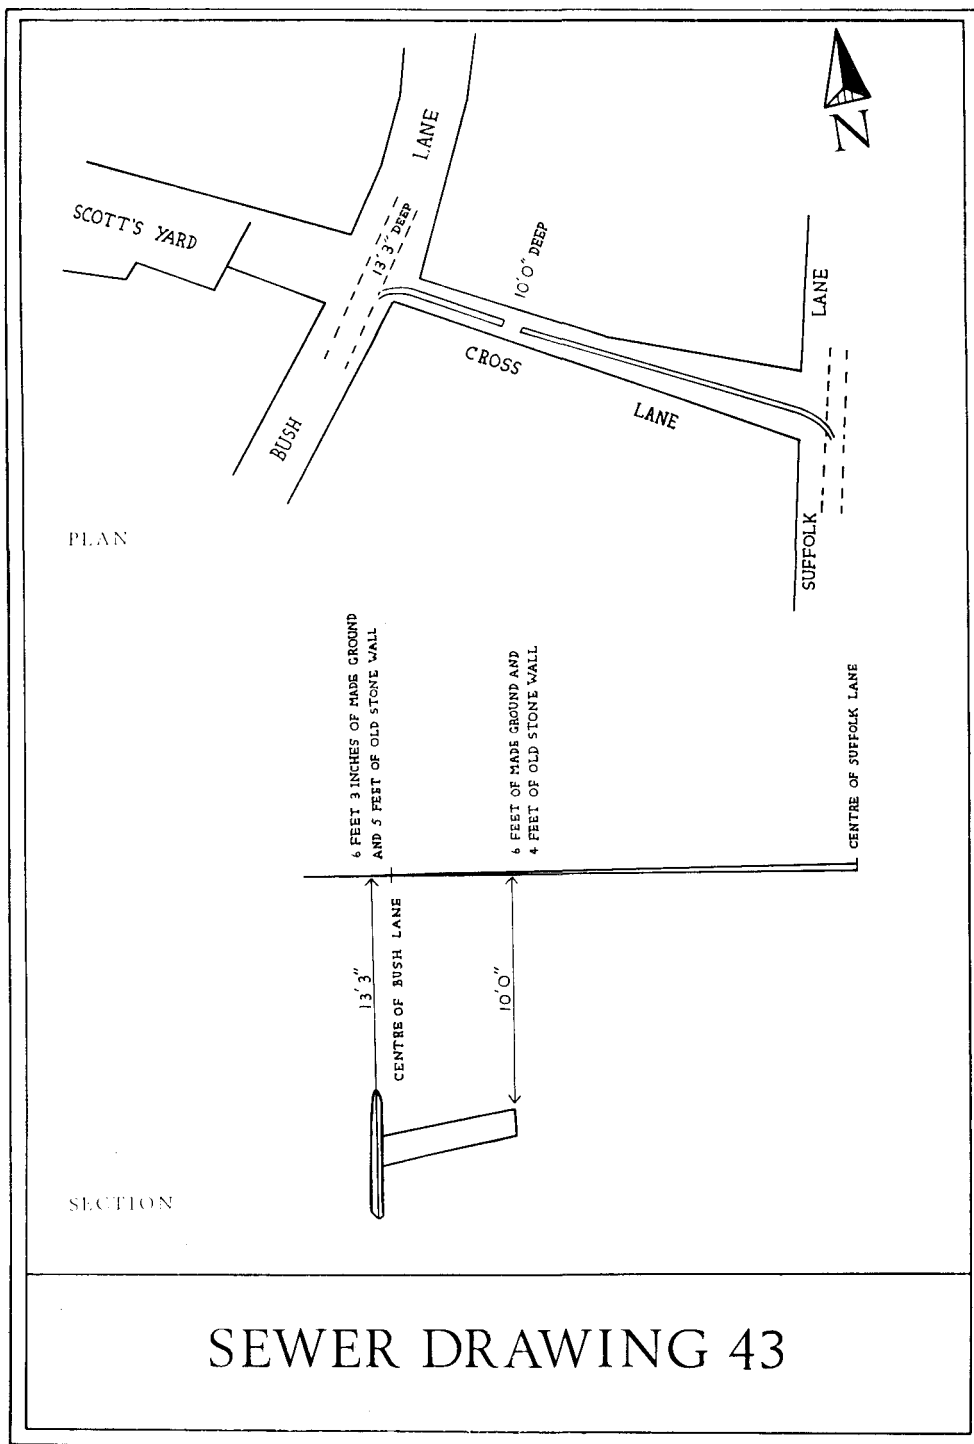
Fig. 9 Roman Palace. Roman walls recorded on Sewer Drawing 43, c. 1840, re-drawn for publication. See Fig. 10 for their location in the Roman Palace

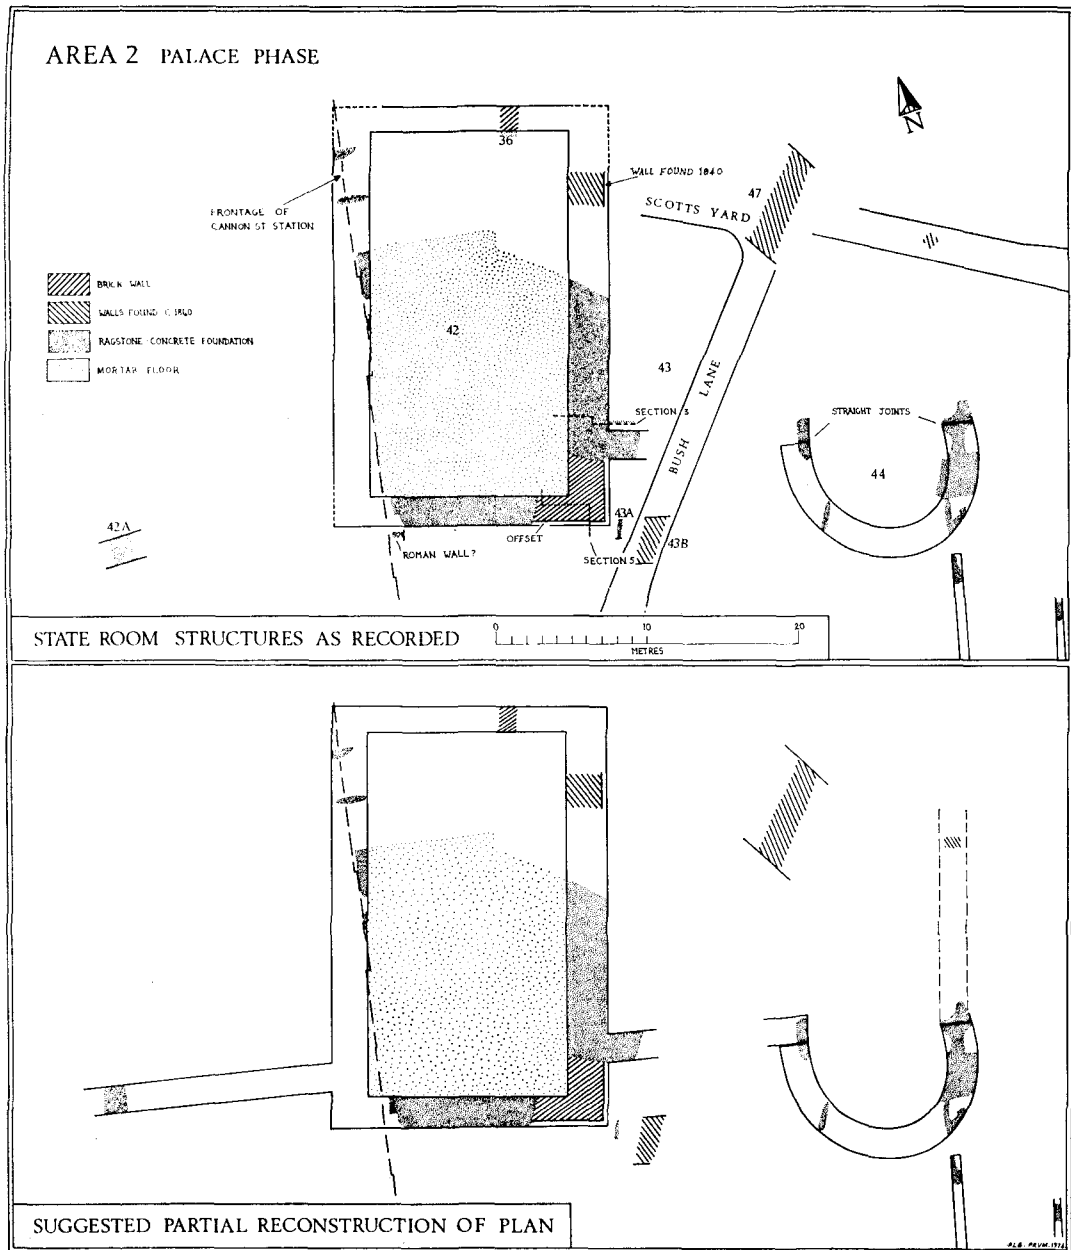
Fig. 10 Roman Palace. Area 2. Plan of the "state rooms" of the palace as recorded (upper) and as partly reconstructed (lower). The large rooms overlooked the ornamental garden-court (Area 3) to the south

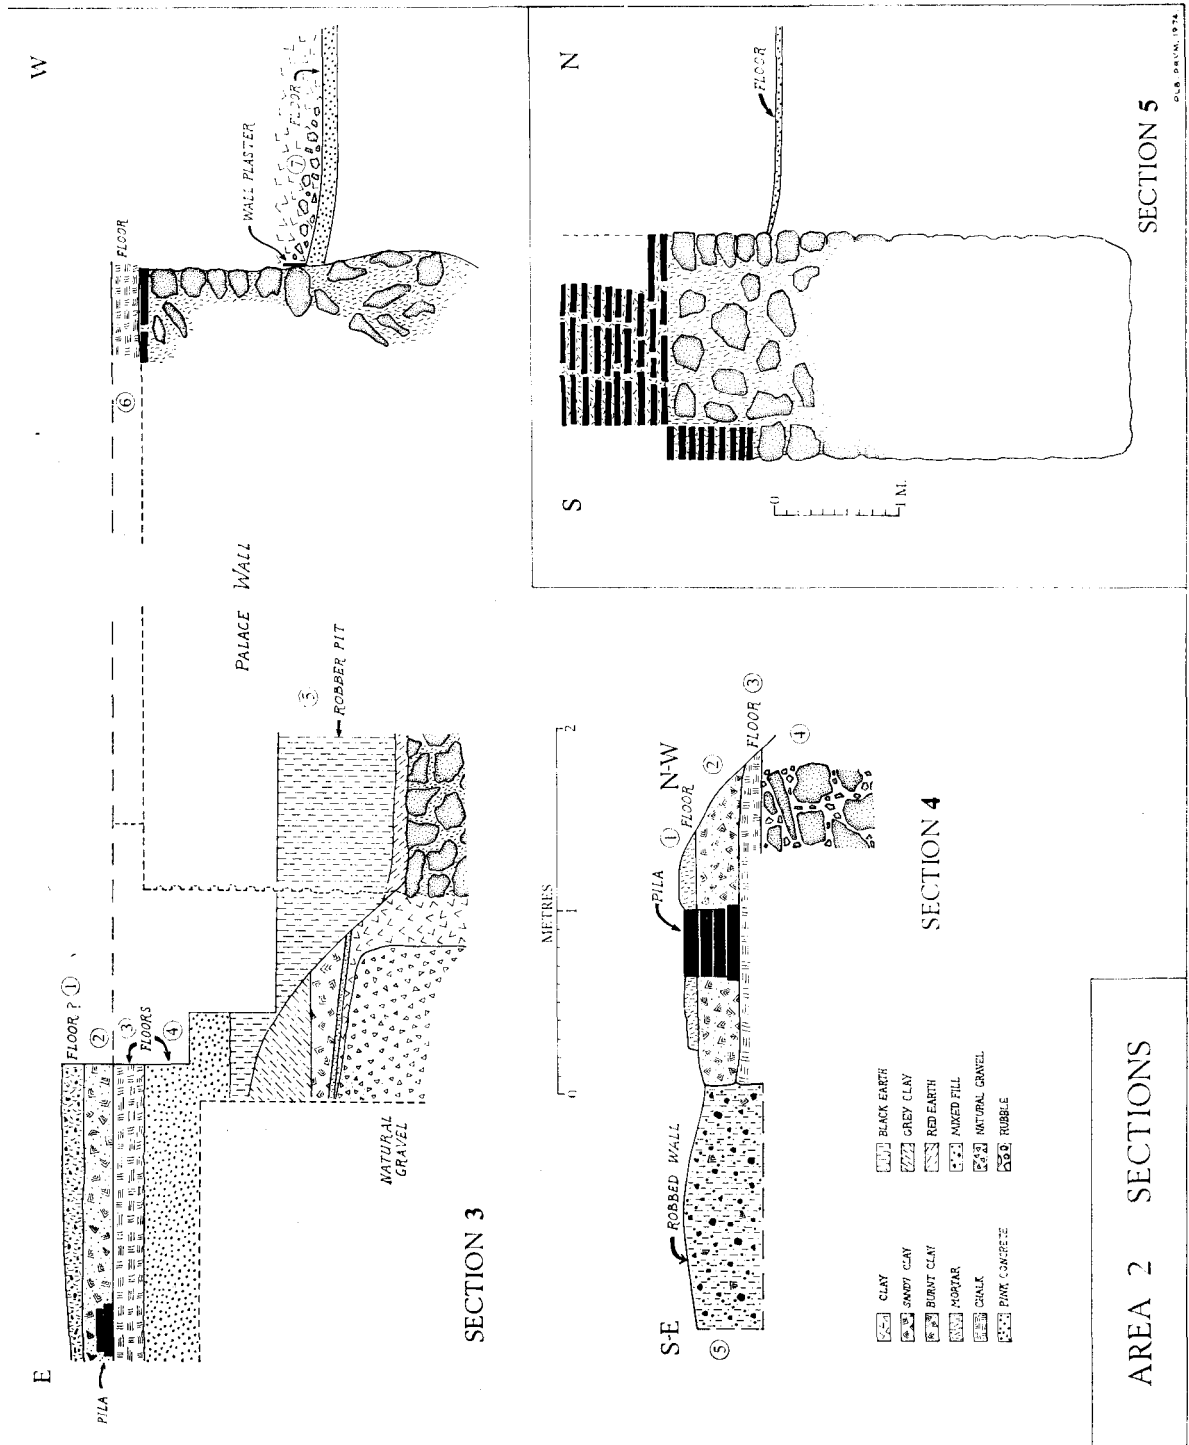
Fig. II Roman Palace. Area 2. Sections showing both the palace (Sections 3, 5) and post-palace (Sections 3, 4) Roman buildings.

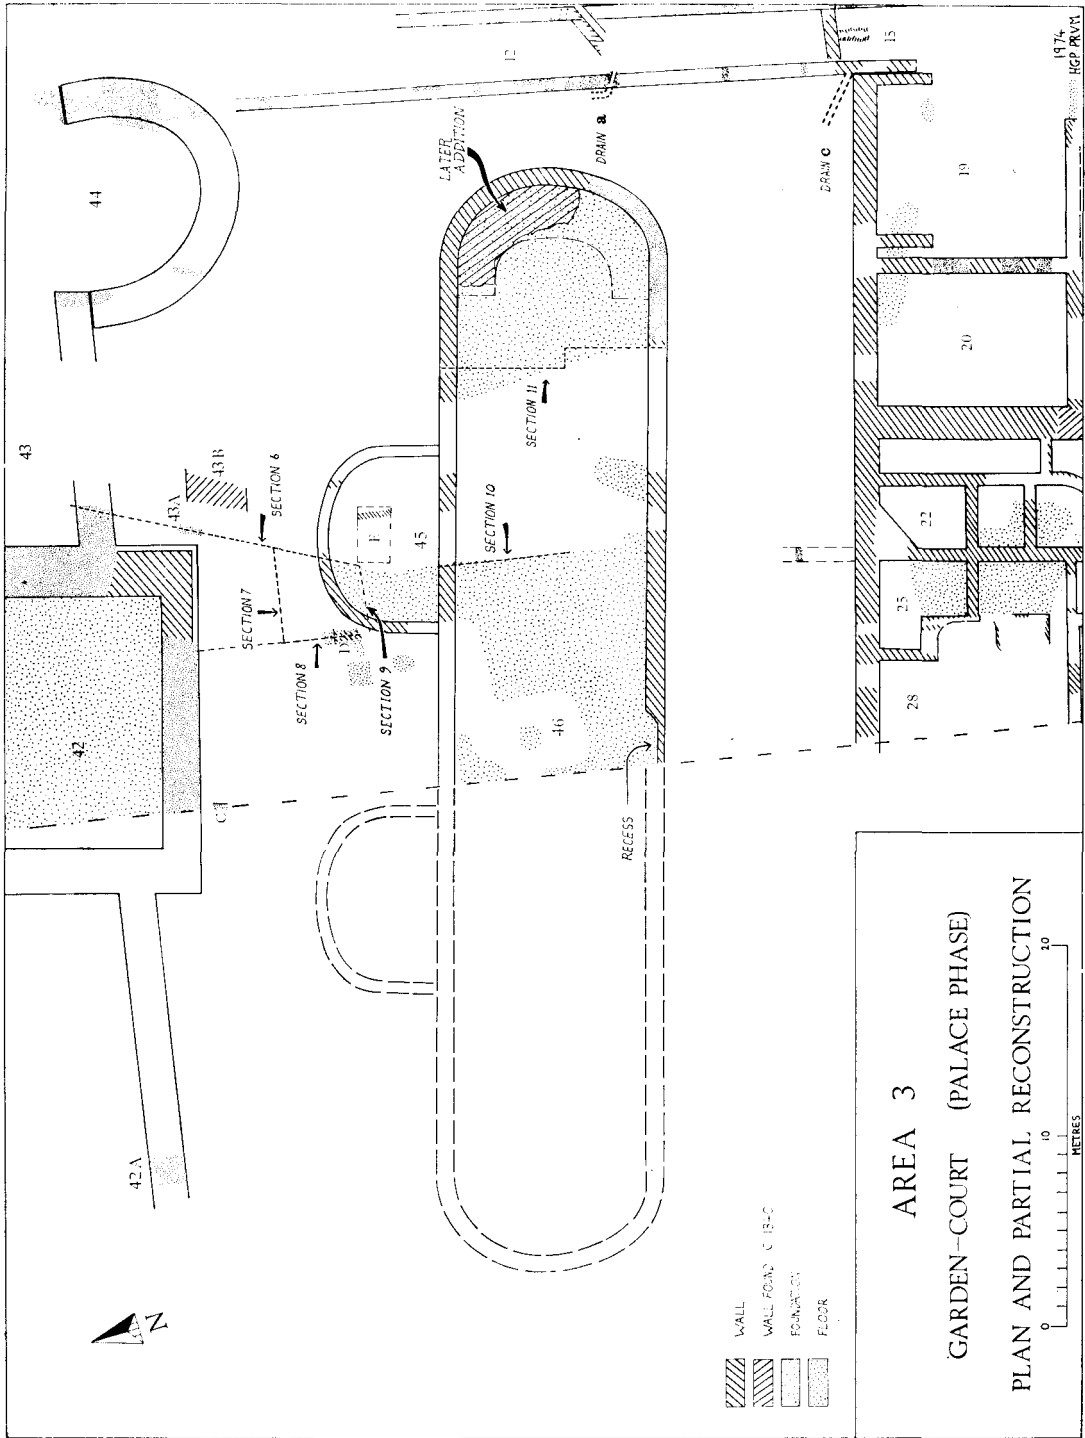
Fig. 12 Roman Palace. Area 3. Partially reconstructed plan of the garden-court of the palace

It was clear in 1960–61 that the combination of massive Roman structures and a concentration of official Roman stamped tiles indicated the former existence of a very important building or group of buildings in this part of the City, and that every effort should be made to define the nature of the building(s). The investigations began in 1961 on the site of Elizabeth House where a small archaeological sondage revealed a hypocaust overlying earlier Roman structures. It was not until Elizabeth House was built in 1961, however, that the first positive evidence was found of what is now interpreted as a Roman palace. Here the great hall (Room 42, Fig. 10) of the state rooms of the palace was revealed and recorded during the building operations and, later, part of the great pool (Feature 46, Fig. 12) was recorded. Observations and records were generally made by the author, but with valuable assistance from Gordon Davies who recorded the small apsidal pool (Feature 45, Fig. 12).

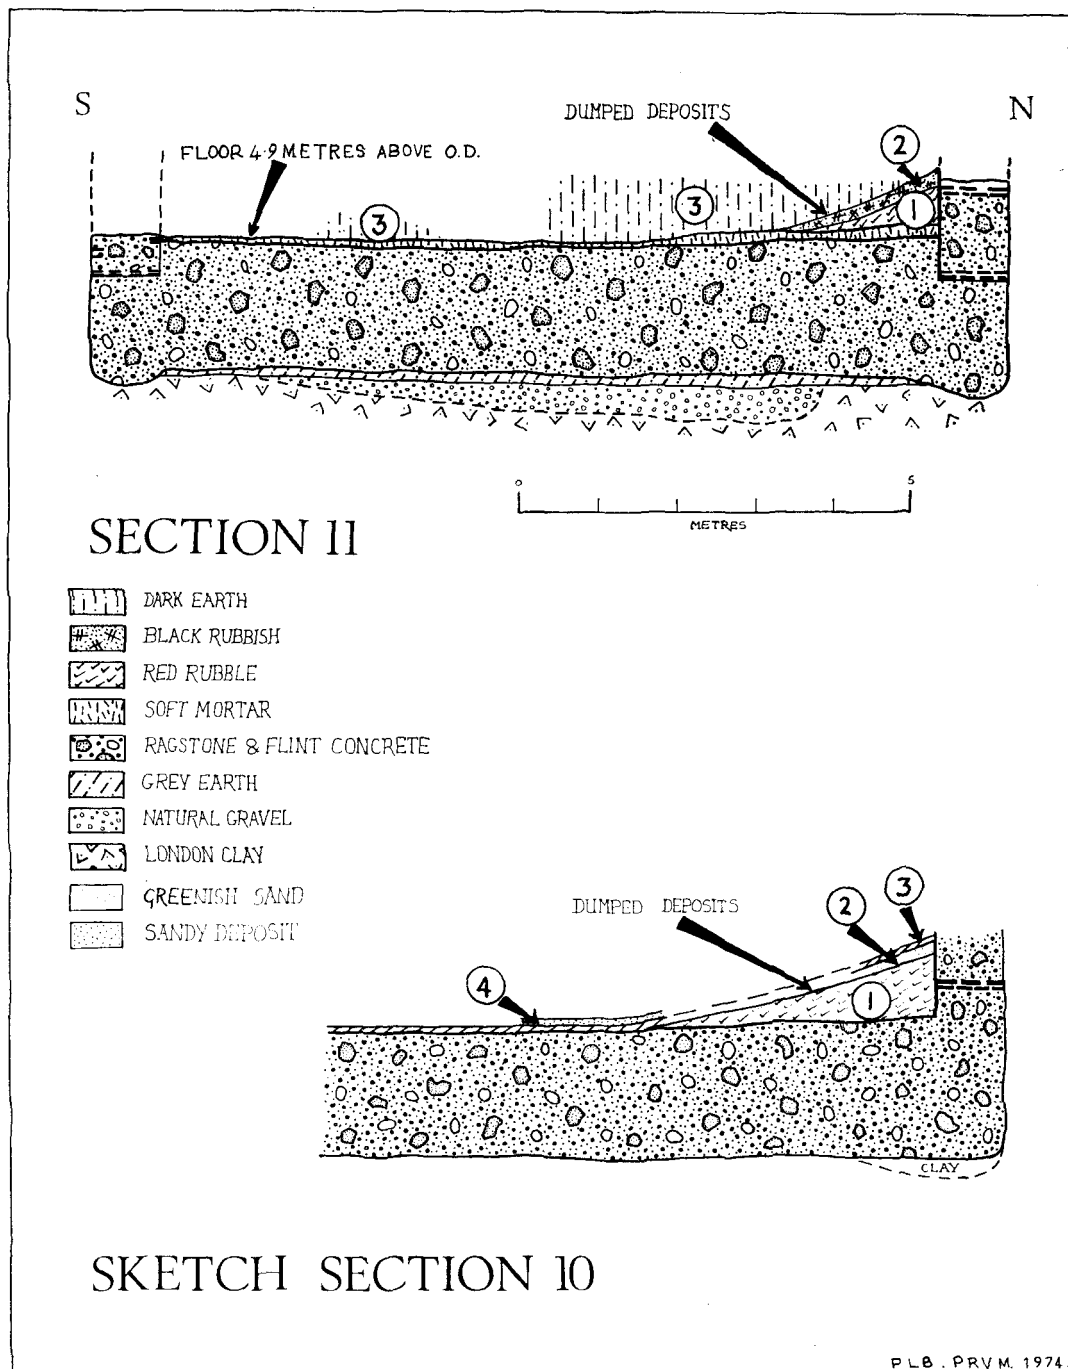
Fig. 13 Roman Palace. Area 3. Sections 10 and 11 across the great pool (Feature 46) showing the dumped deposits against the north wall

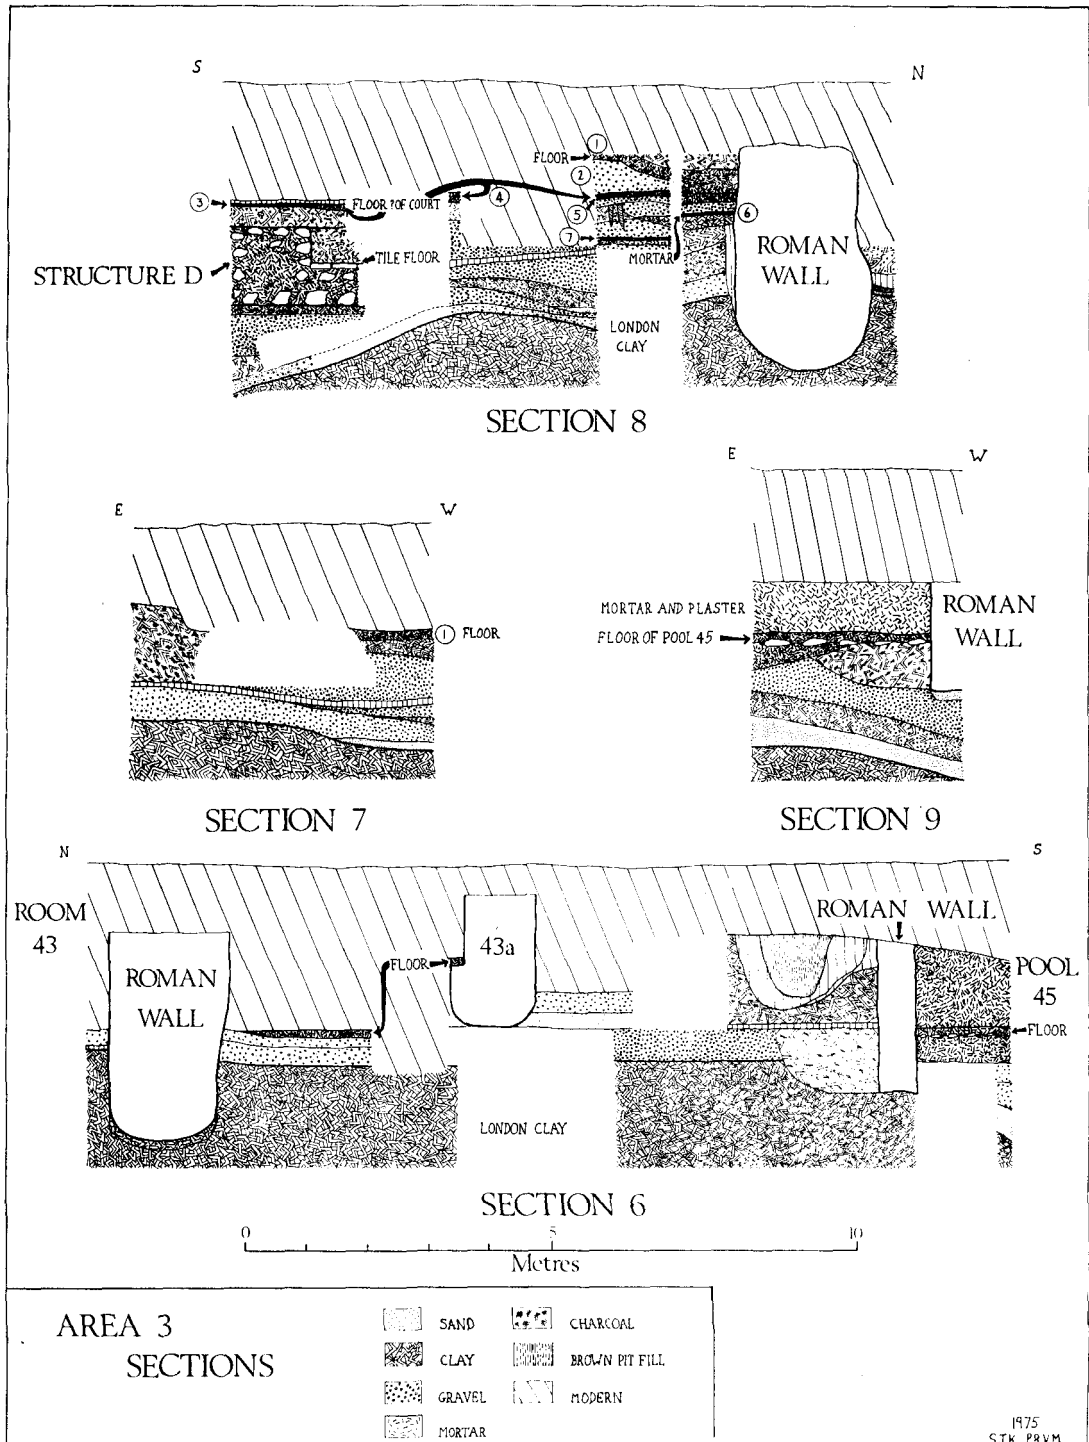
Fig. 14 Roman Palace. Area 3. Sections 6, 7, 8, 9 in the garden-court area

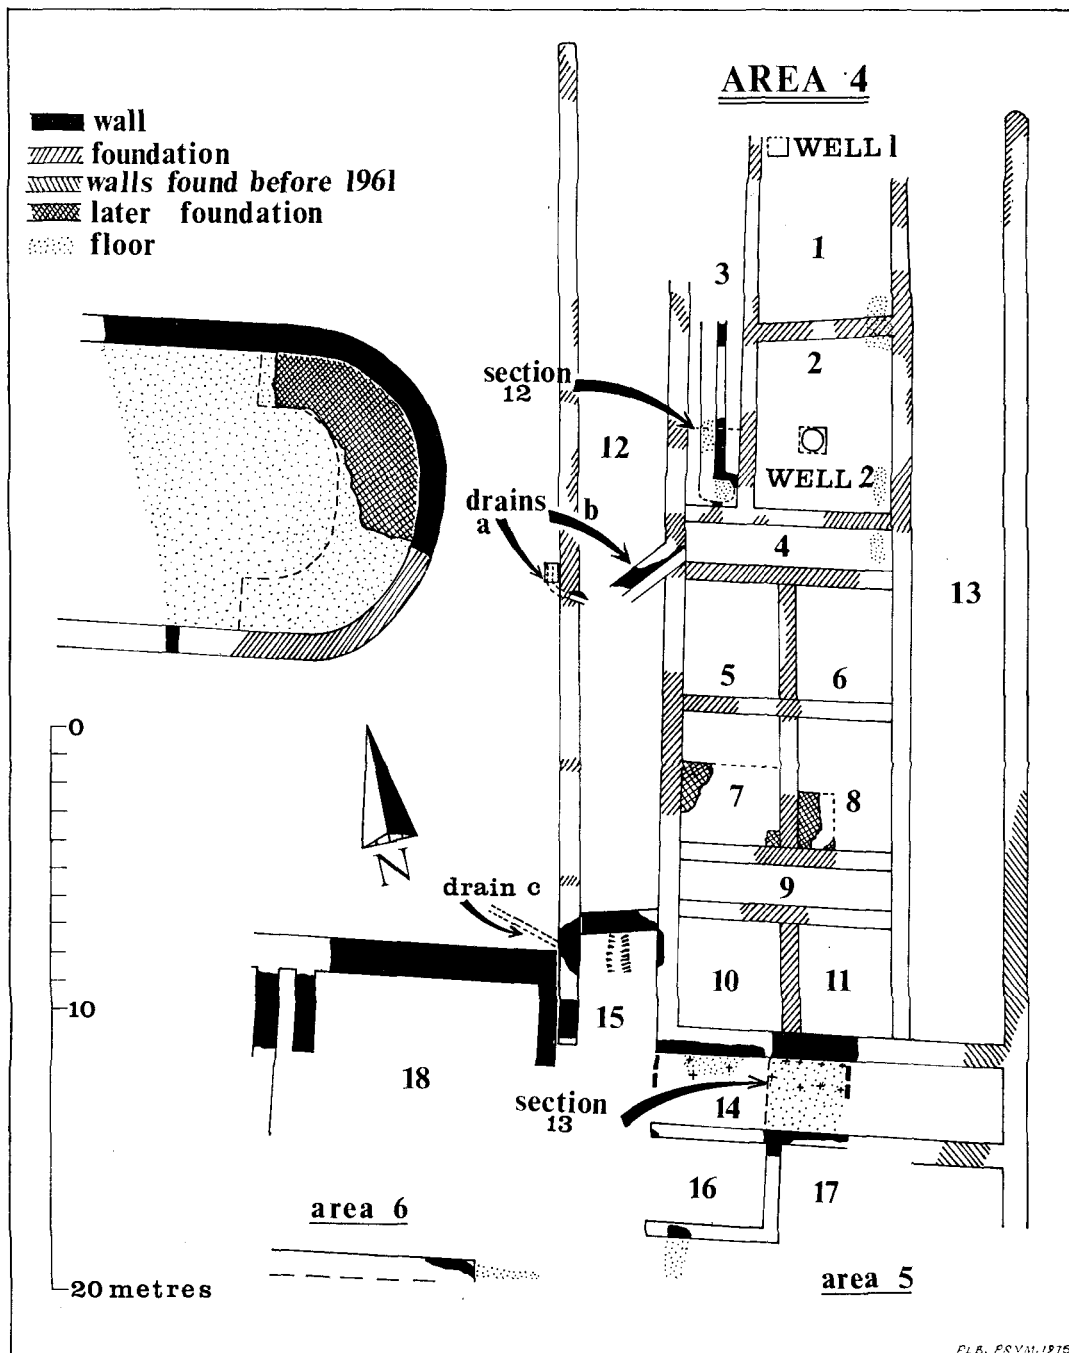
Fig. 15 Roman Palace. Areas 4 and 5. Structures of all Roman phases showing their relationships to each other

Two drains (a and b, Fig. 15) were found which originally flowed through the side walls of the corridor, evidently downwards towards a central drain, which was not excavated, but which can be inferred to have run north-south down the middle of the corridor beneath the floor to issue out through the retaining wall at the lower terrace level in Room 15, where it was discovered. Drain "b" crossed the west wall of the Passage 4, and sloped down towards the middle of the corridor where it had been destroyed by a medieval pit. Only the lower part of the drain had survived but clearly it was originally of substantial size as it measured 0.53 m wide internally. Its sides were constructed of broken roof tiles set in pinkish mortar so that their flanges formed the inside face of the drain, while the bottom of the drain was formed of pinkish mortar—the whole construction being very similar to the probable hypocaust flue in Room 3. Only a very short length of
