THE EXCAVATION OF A ROMAN PALACE SITE IN LONDON, 1961-1972

BY PETER MARSDEN

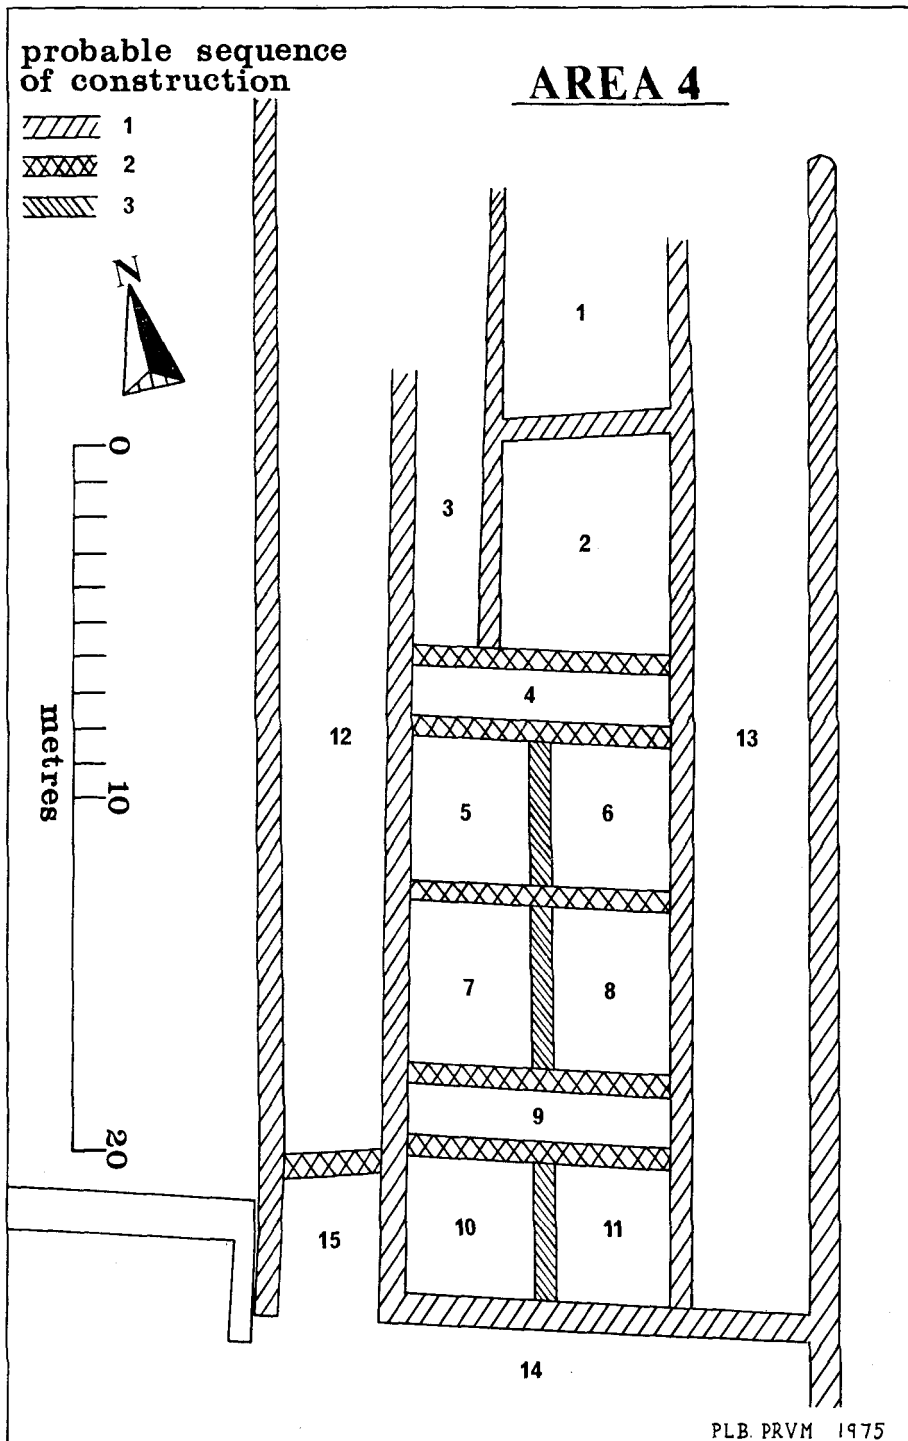
Fig. 16 Roman Palace. Area 4: the probable sequence of construction of the east wing of the palace, based on the evidence of the straight joints between the foundations

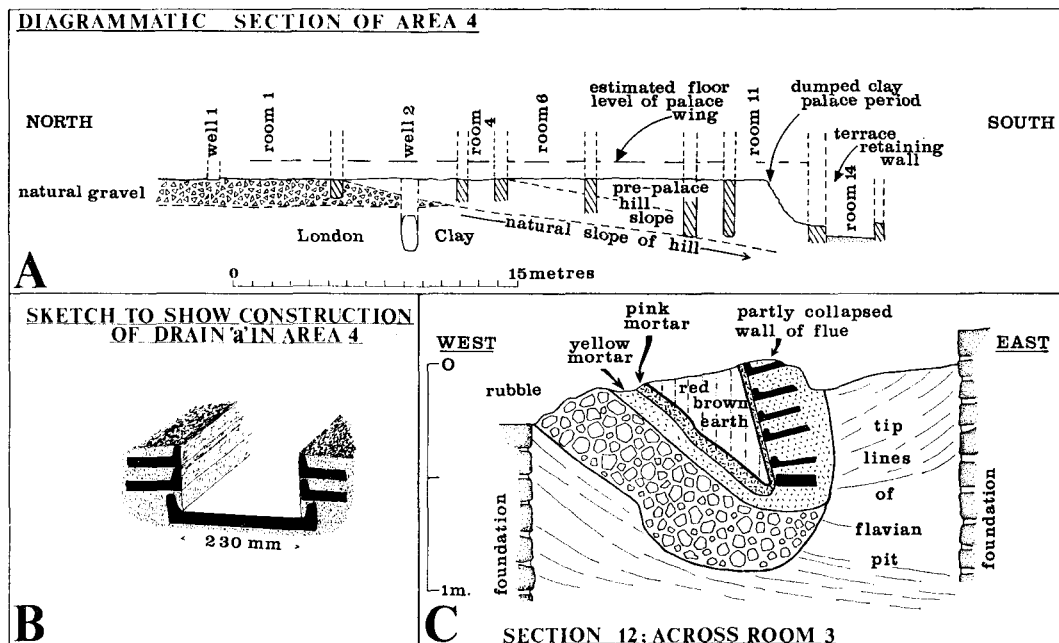
Fig. 17 Roman Palace. Area 4: (A) Diagrammatic north-south section along the east wing of the palace; (B) sketch to show construction of drain "a"; (C) Section 12, across a probable flue in Room 3, distorted by subsidence into an earlier pit

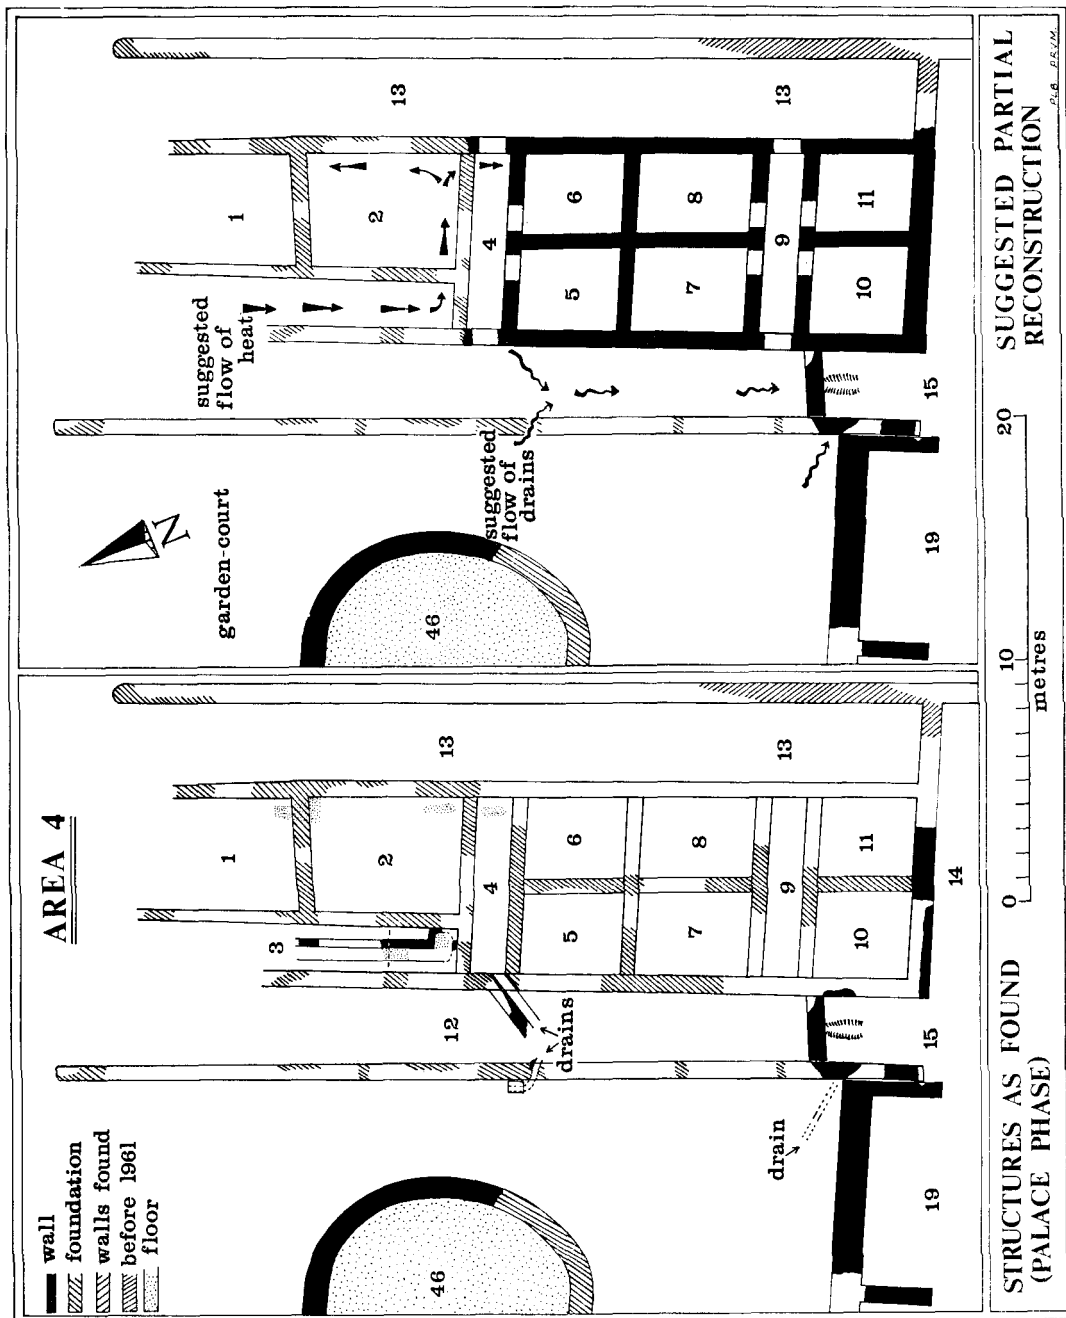
Fig. 18 Roman Palace. Area 4. Plan of palace phase structures as found (left), and a suggested partial reconstruction of the wing (right)

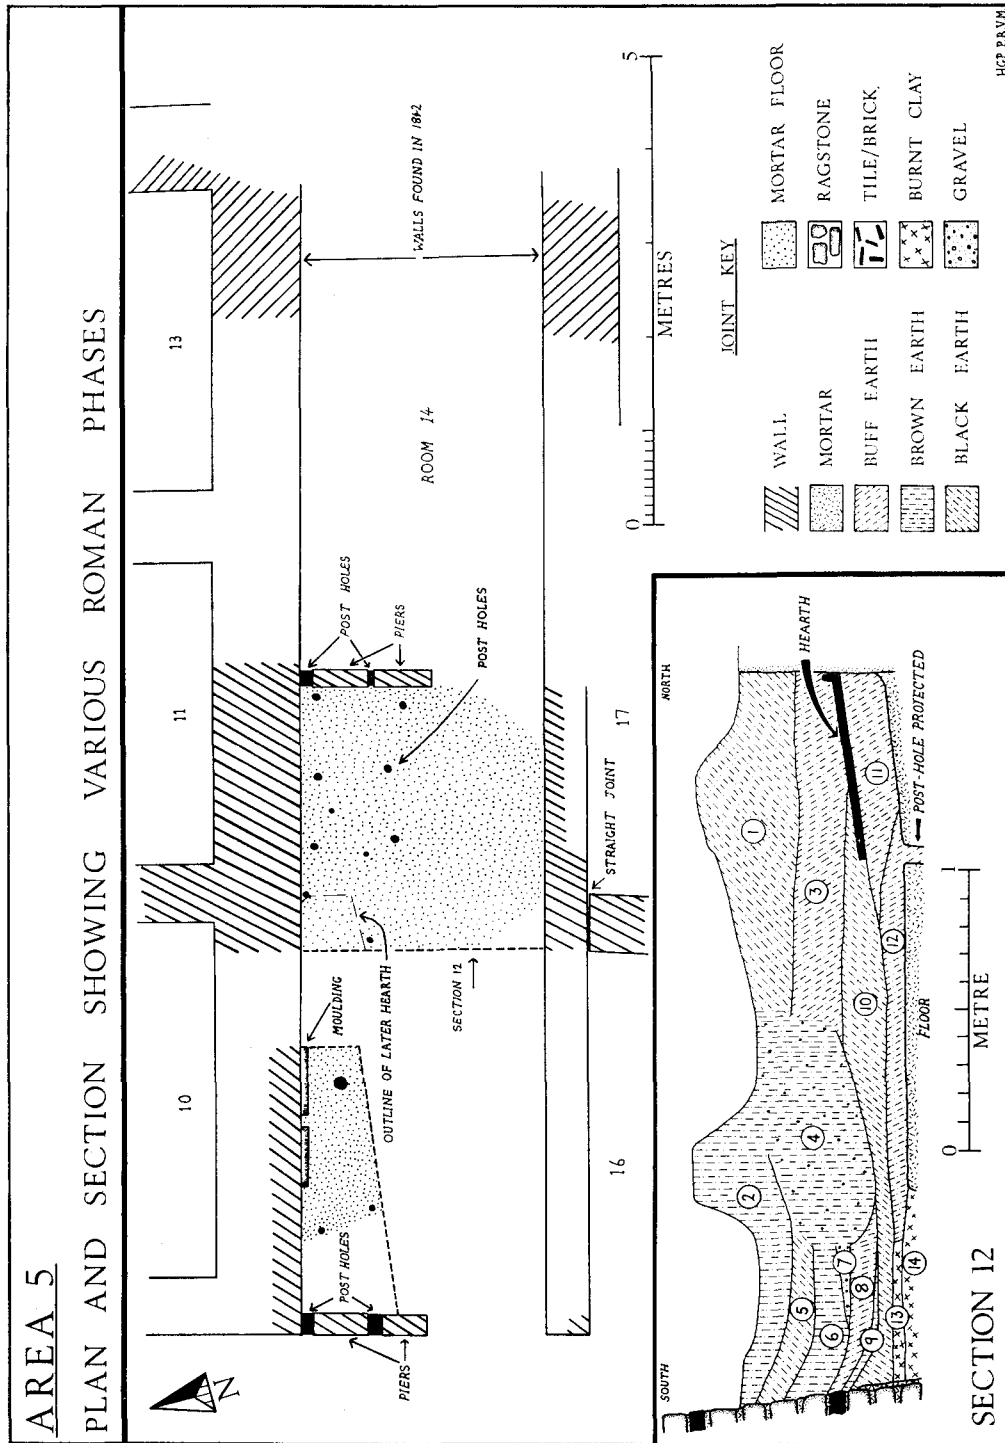
Fig. 19 Roman Palace. Area 5. Plan of room 14, and Section 12 across the room

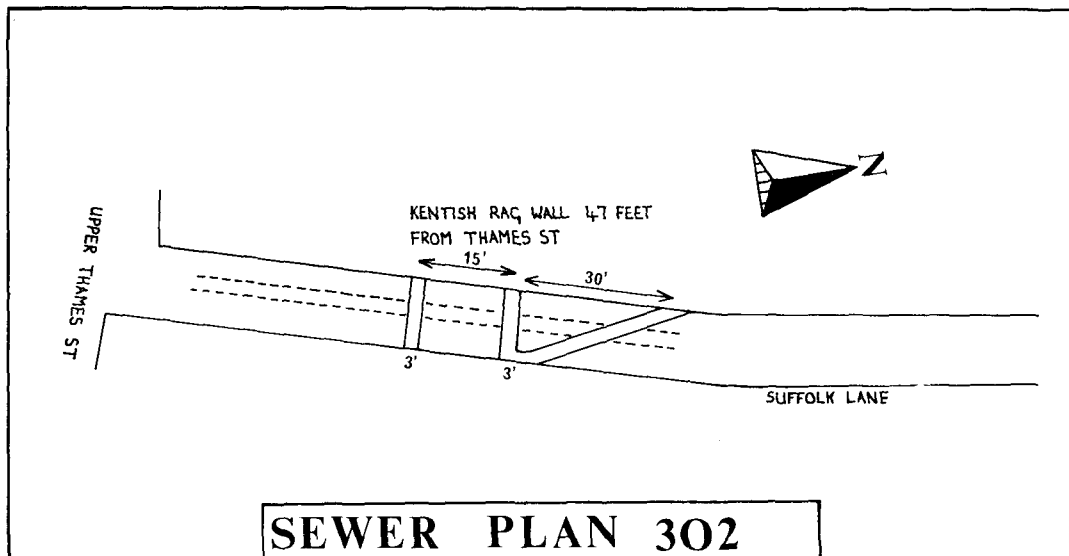
Fig. 20 Roman Palace. Roman walls as recorded on Sewer Drawing 302, c. 1840, re-drawn for publication

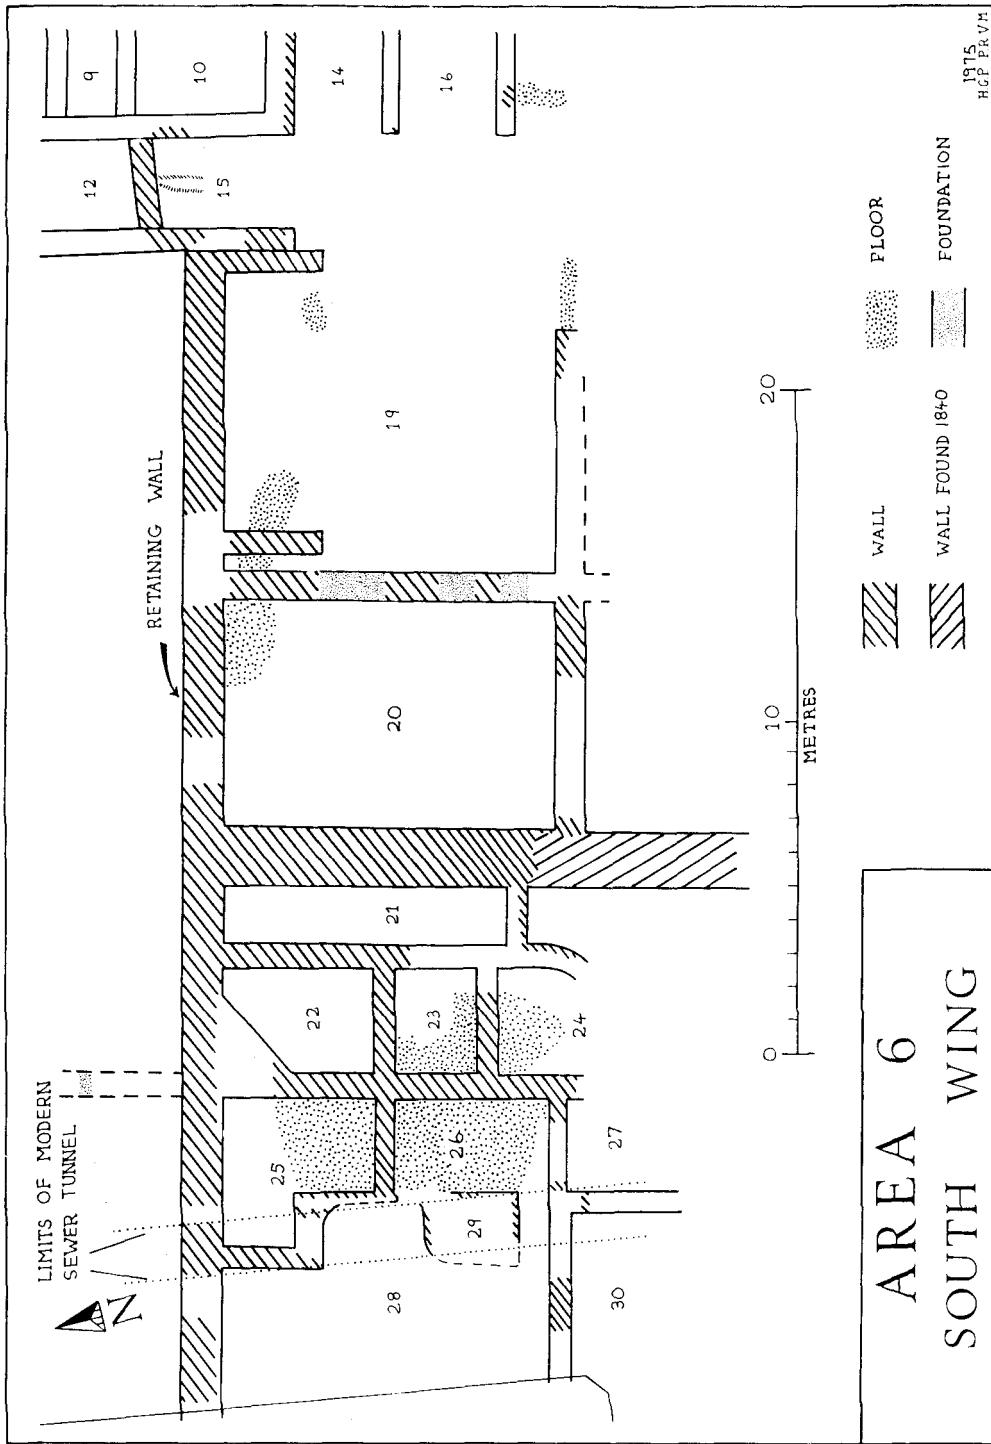
Fig. 21 Roman Palace. Area 6. Plan of the south wing of the palace

A substantial retaining wall (Fig. 21), 1.14 m thick and built of ragstone set in yellow-brown cement and containing double courses of bonding tiles, separated the upper terrace of the garden-court at about 6.4 m above O.D., from the south wing terrace in Area 6 at about 3 m above O.D. Only the lower 1.83 m of the wall had survived, however, and it was found to be lying on a foundation of timber piles between 1.52 m and 3.35 m in length, and about 0.15 m square, the lower ends of which were pointed, driven into the underlying soft grey silt and clay.

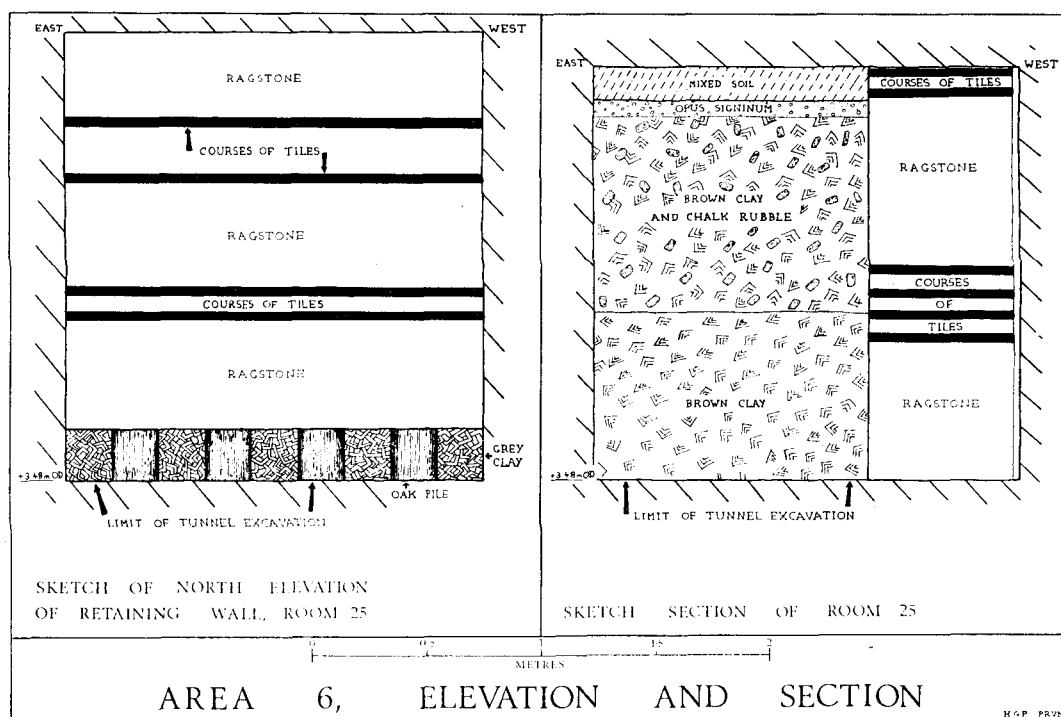
Fig. 22 Roman Palace. Area 6. North face of the retaining wall (1), and a sketch section across wall (3) in the sewer tunnel (see Fig. 23)

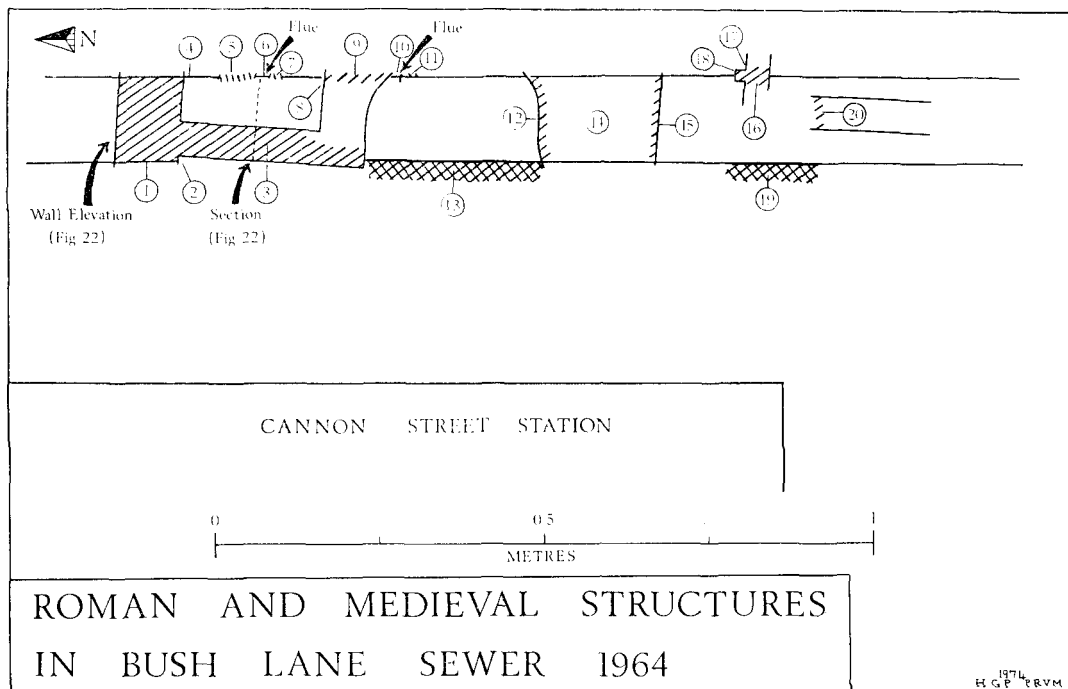
Fig. 23 Roman Palace. Area 6. Detail of Roman and medieval structures found in the Bush Lane sewer (see Fig. 21). The numbered features are:

18. *Pila* of five superimposed tiles.
19. Medieval foundation of chalk set in brown mortar.
20. Roman wall of ragstone and buff mortar.

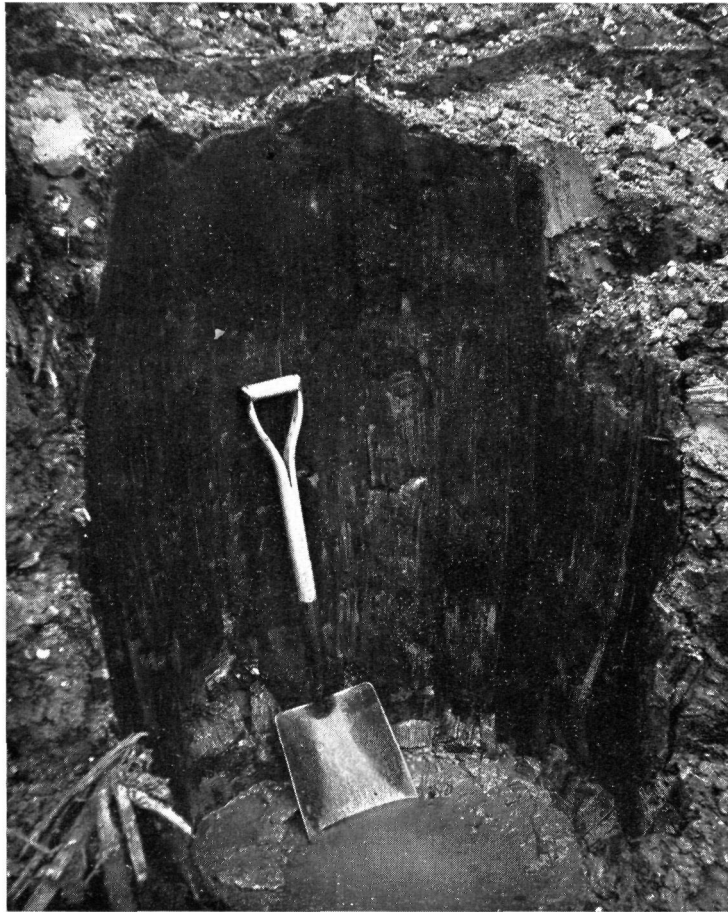
Plate 1 Roman Palace. Flavian barrel forming the bottom of Well 2.

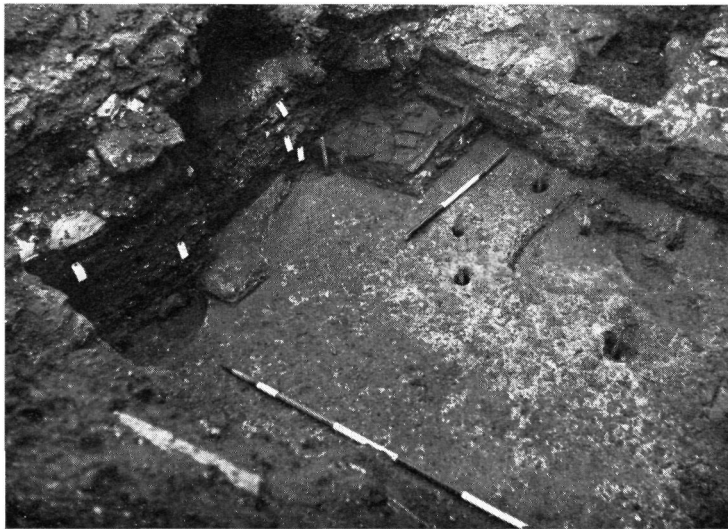
Plate 2 Roman Palace. Room 14 and late Roman hearth. Scale of feet; view to north.

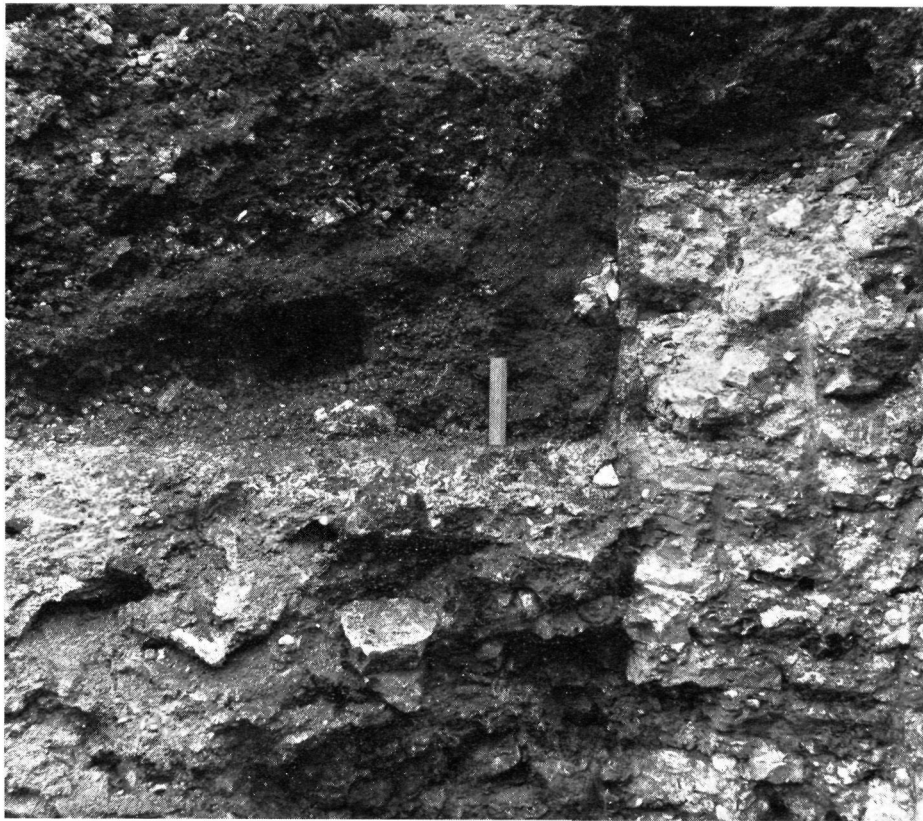
Plate 3 Roman Palace. Junction of north wall and bottom of great pool (Feature 46).
Scale of 6 inches

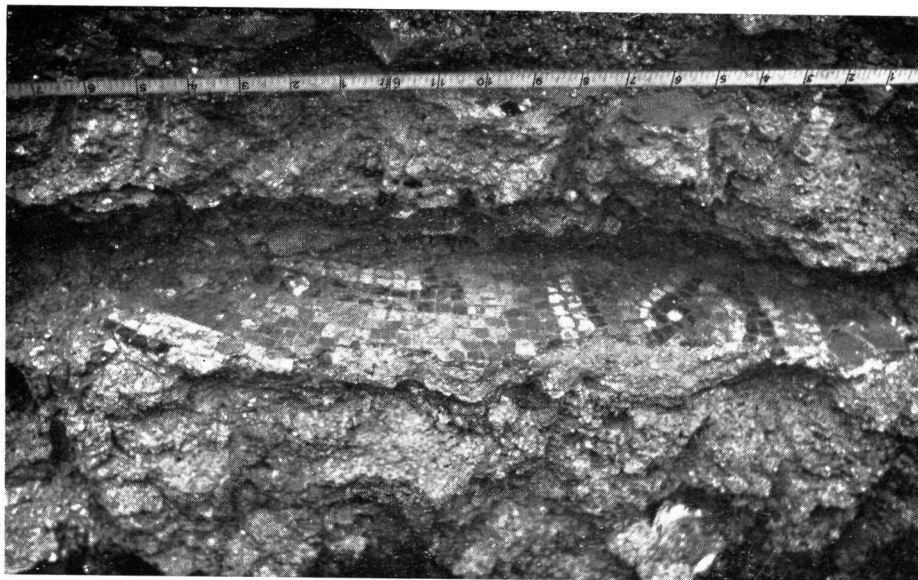
Plate 4 Roman Palace. Patterned mosaic with guilloche border, seen in Room 67
(see Fig. 44). Scale of inches

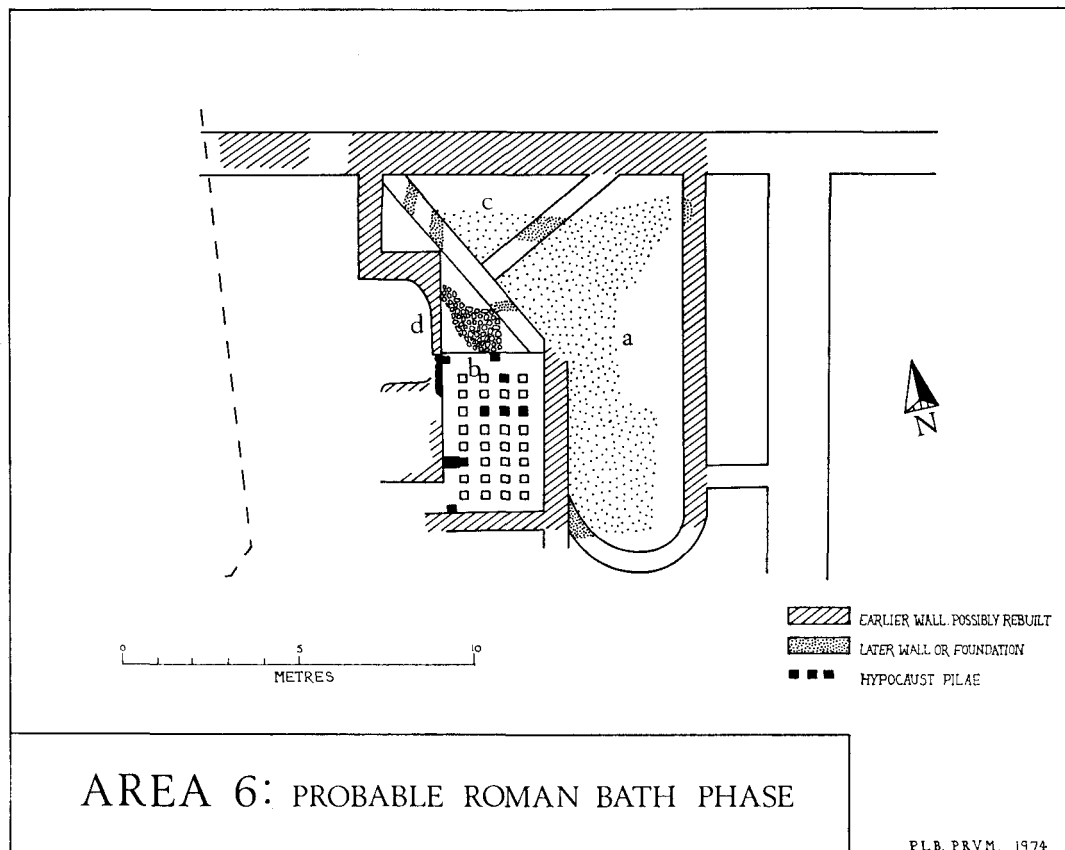
Fig. 24 Roman Palace. Area 6. Evidence of rebuilding in the south wing, suggesting that a small bath suite was inserted

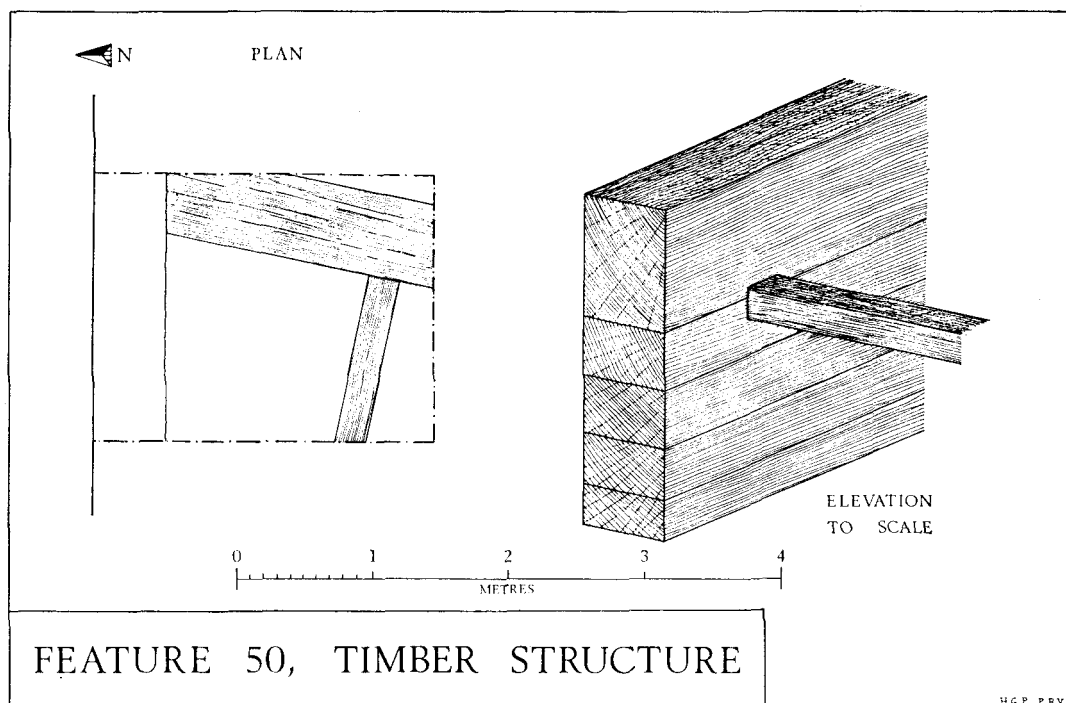
Fig. 25 Roman Palace. Roman timber structure found under Cannon Street Station

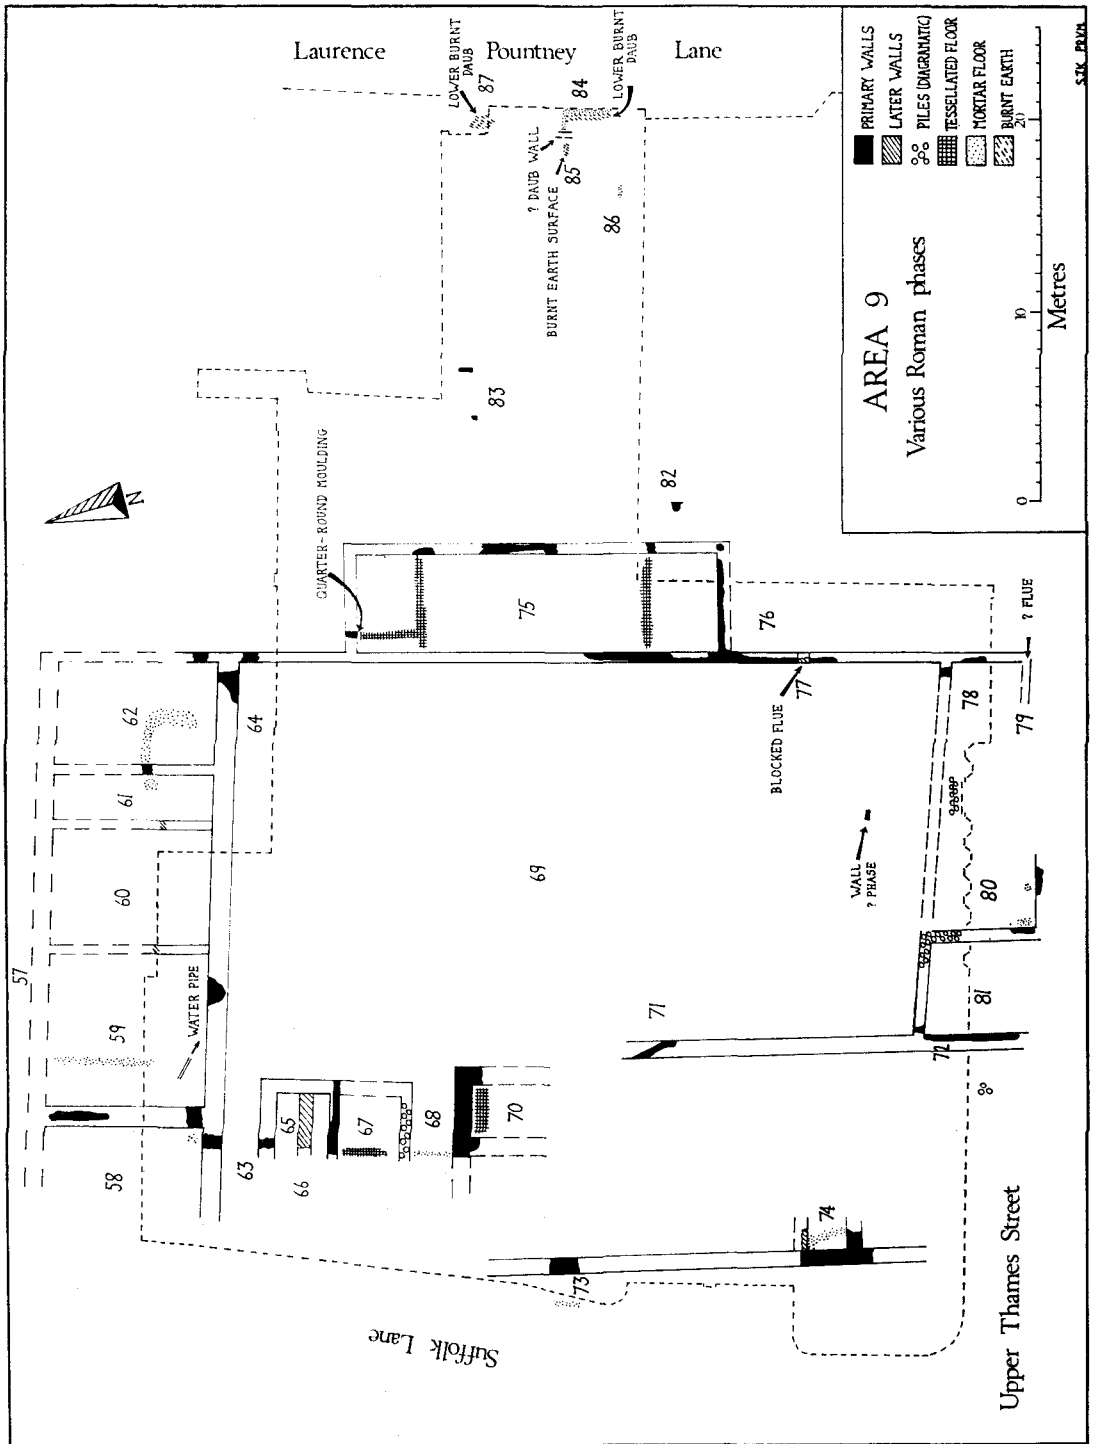
Fig. 26 Roman Palace. Area 9. Roman stone buildings and to the east, beside Laurence Pountney Lane, two phases of wattle and daub building(s)

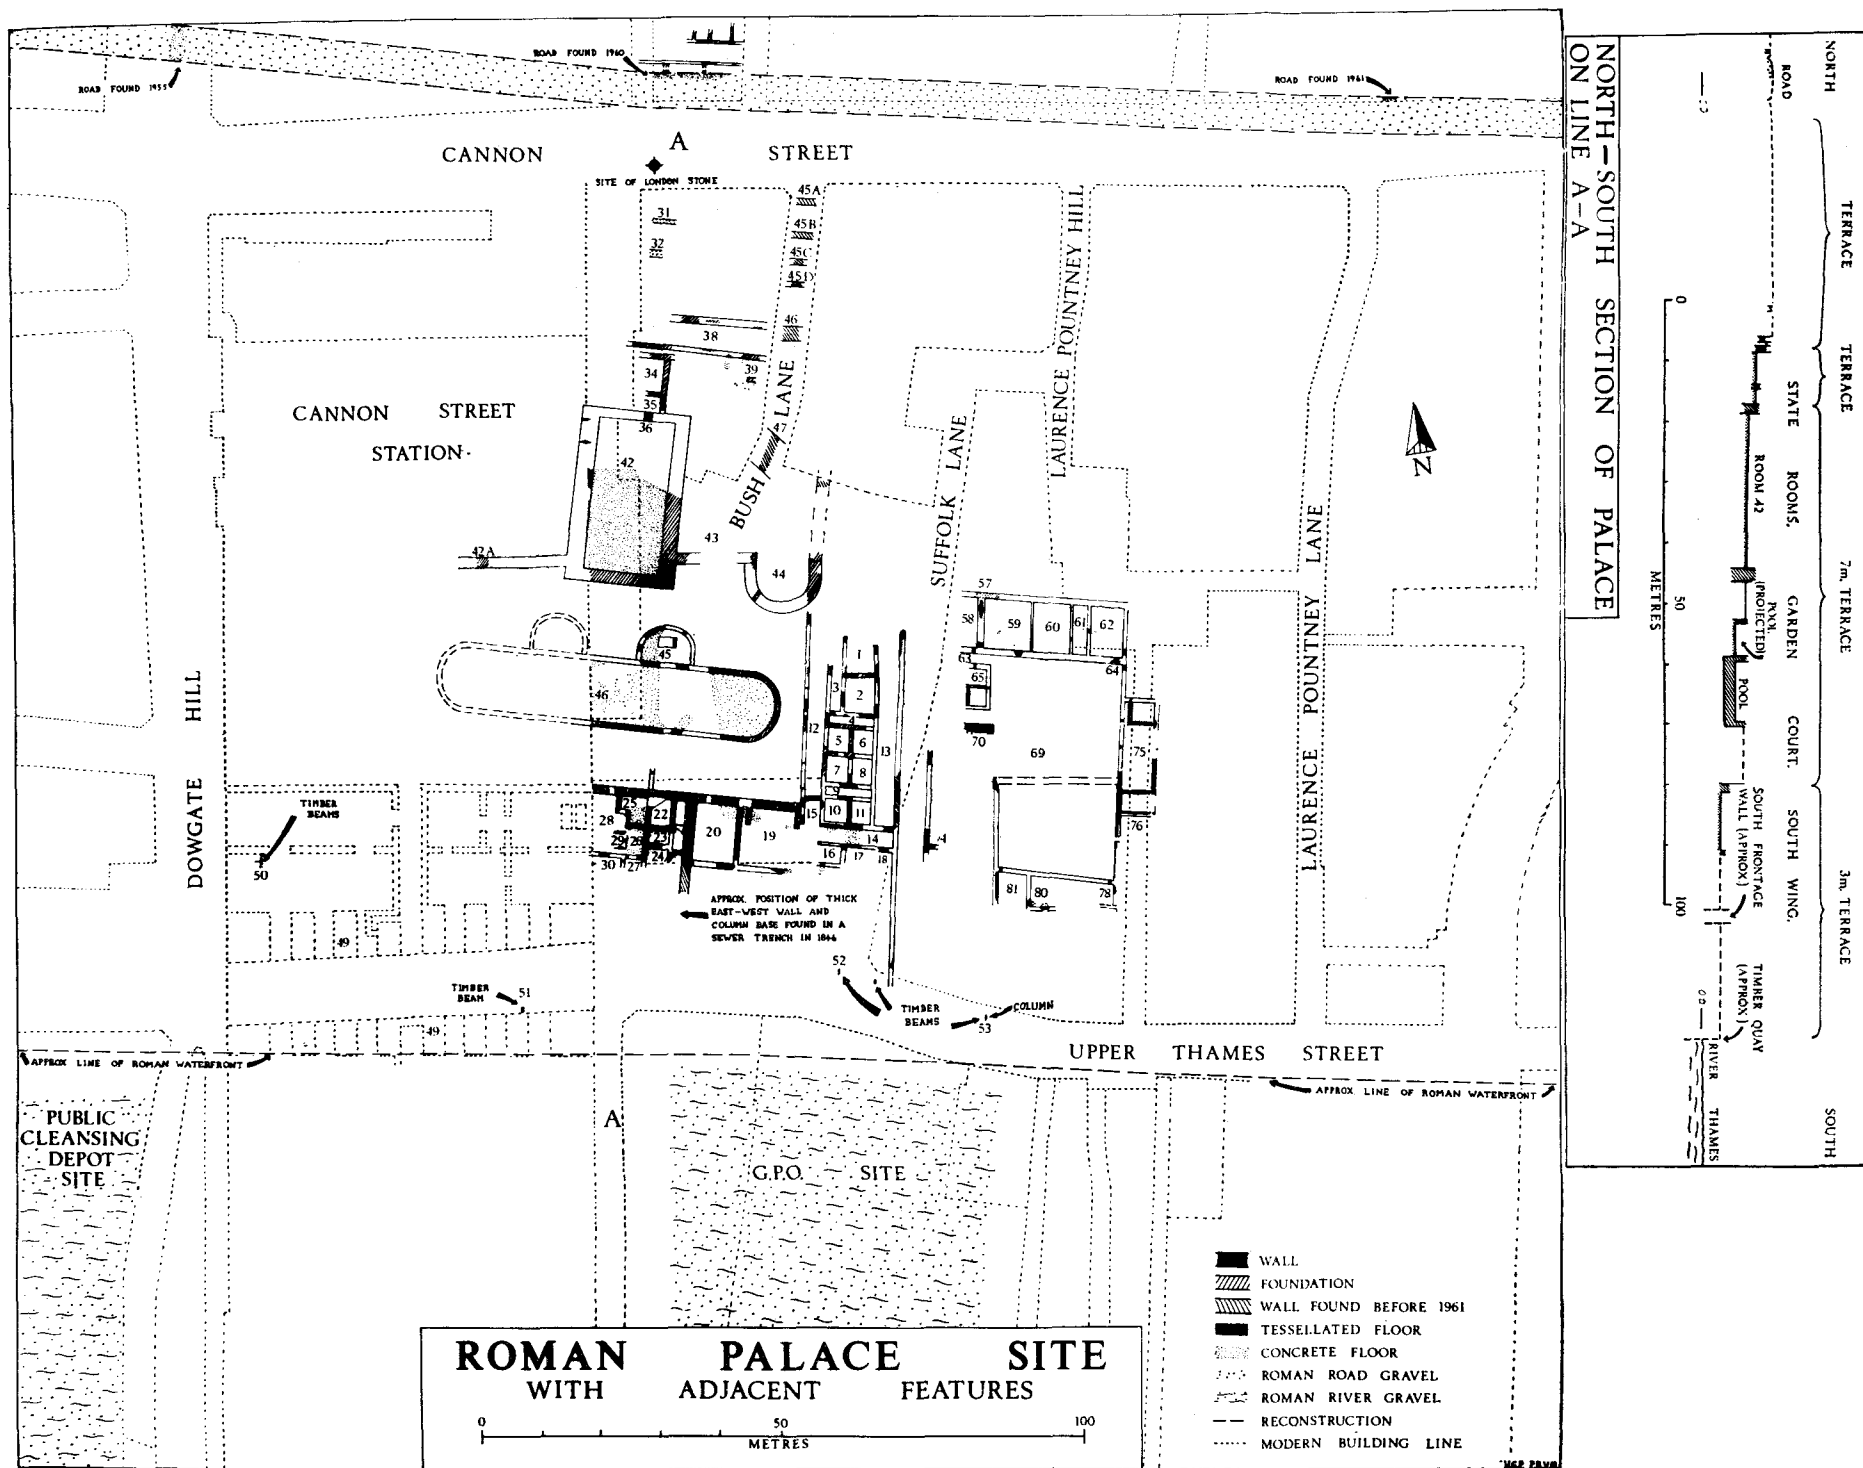
Fig. 28 Roman Palace. General plan of the Roman palace site, and a composite north-south section on line A-A, located just east of Cannon Street Station

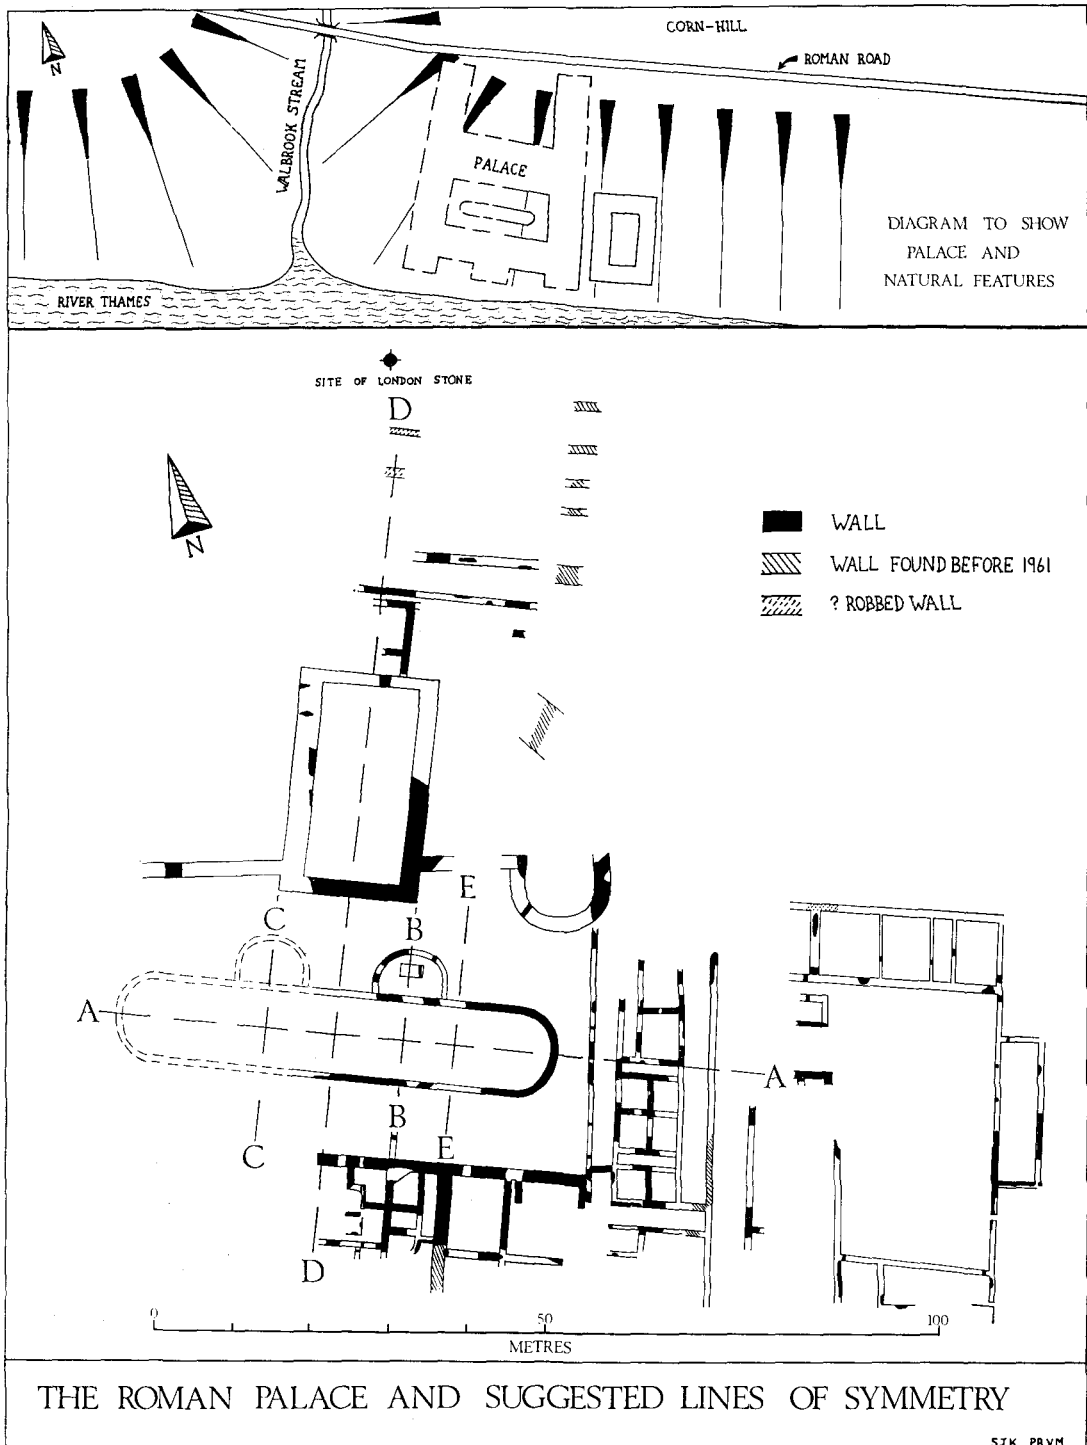
Fig. 29 Roman Palace. Diagram to show the hillside location of the palace, and suggested lines of symmetry

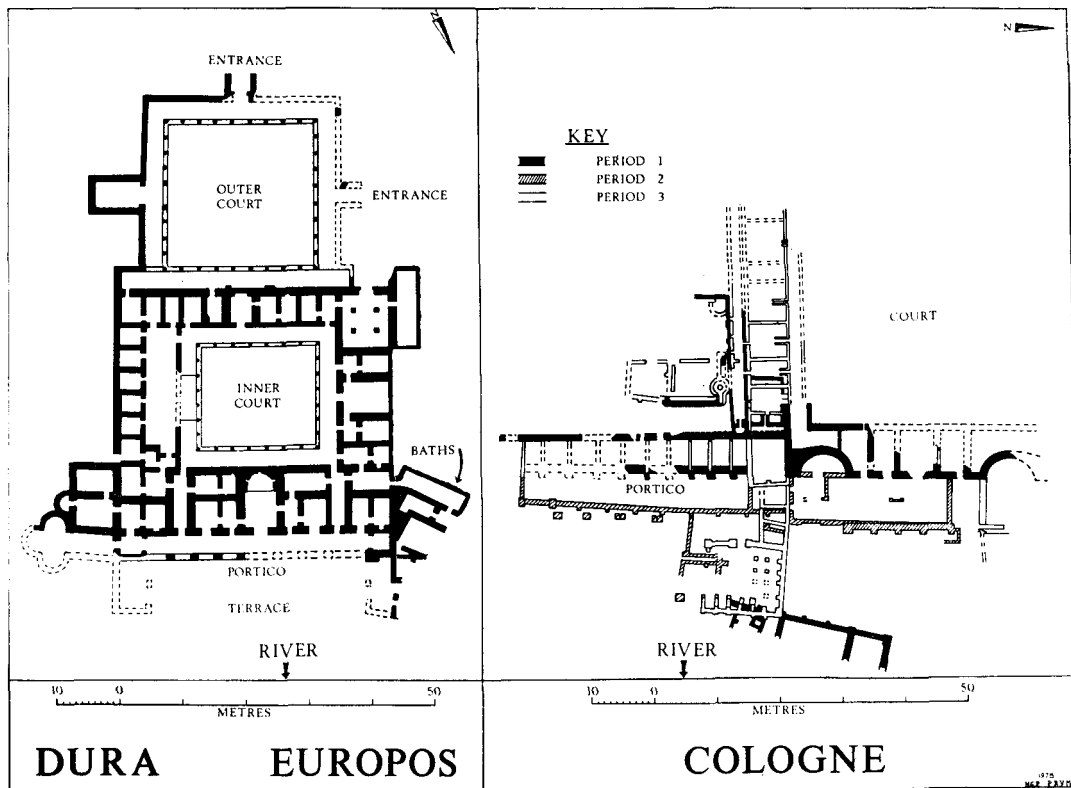
Fig. 30 Roman Palace. Plans of the official Roman palaces at Dura Europos in Syria and Cologne in Germany, showing how the principal residential chambers overlook the rivers

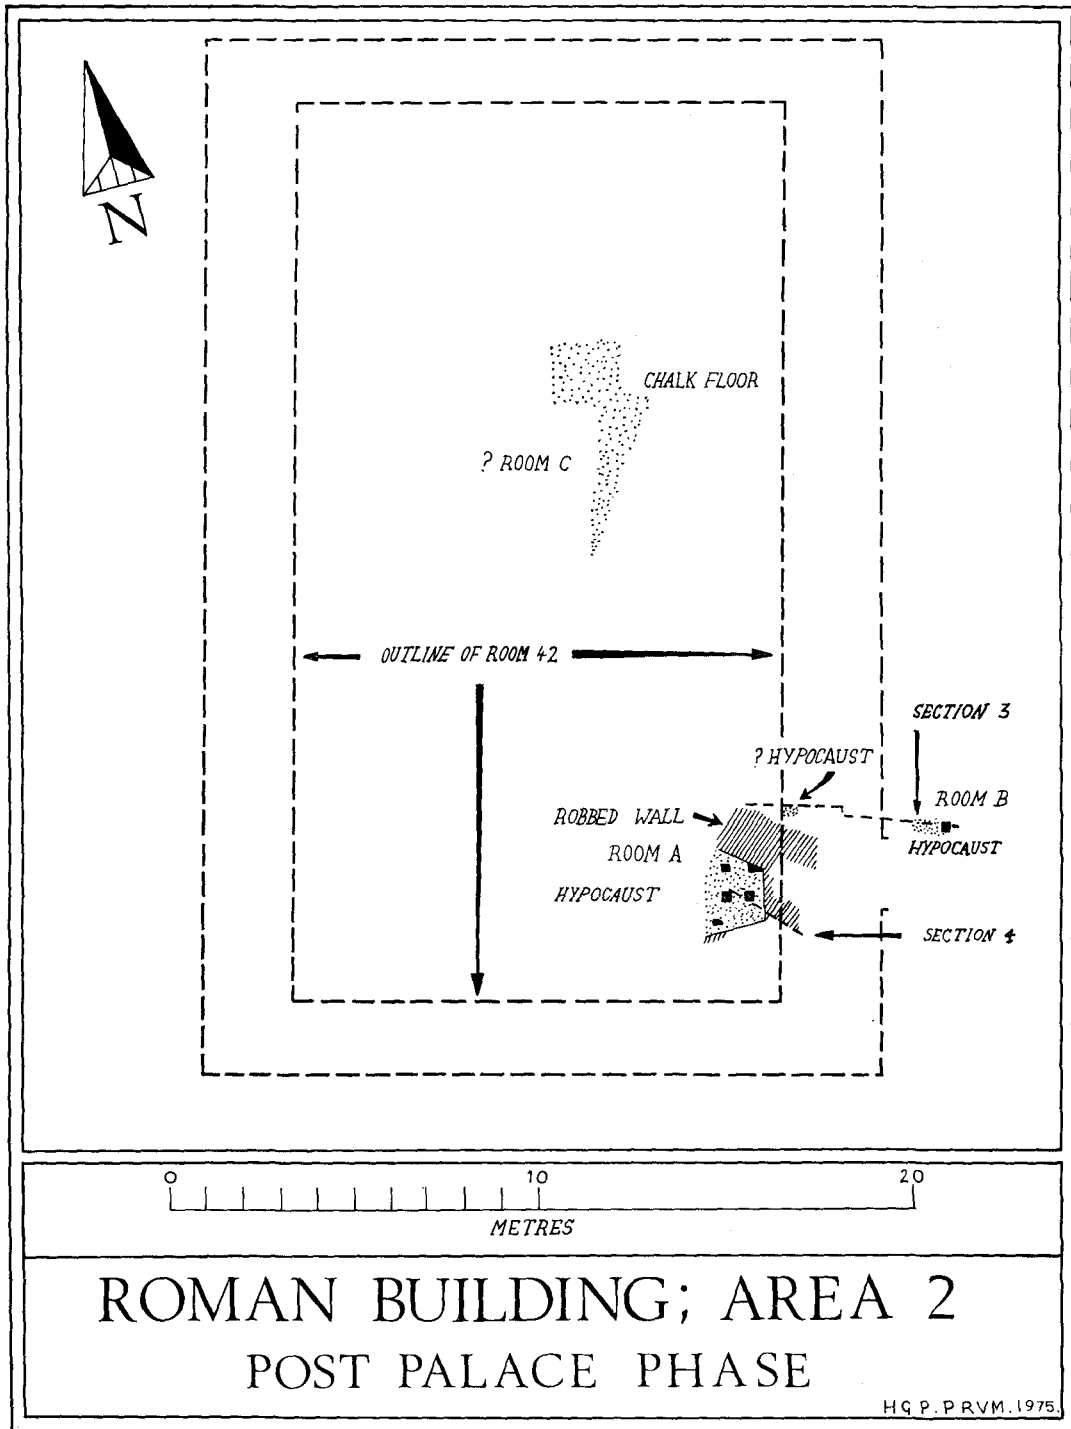
Fig. 32 Roman Palace. Area 2. Traces of a building post-dating the palace. Rooms A and B were heated. Sections 3 and 4 are shown in Fig. 11

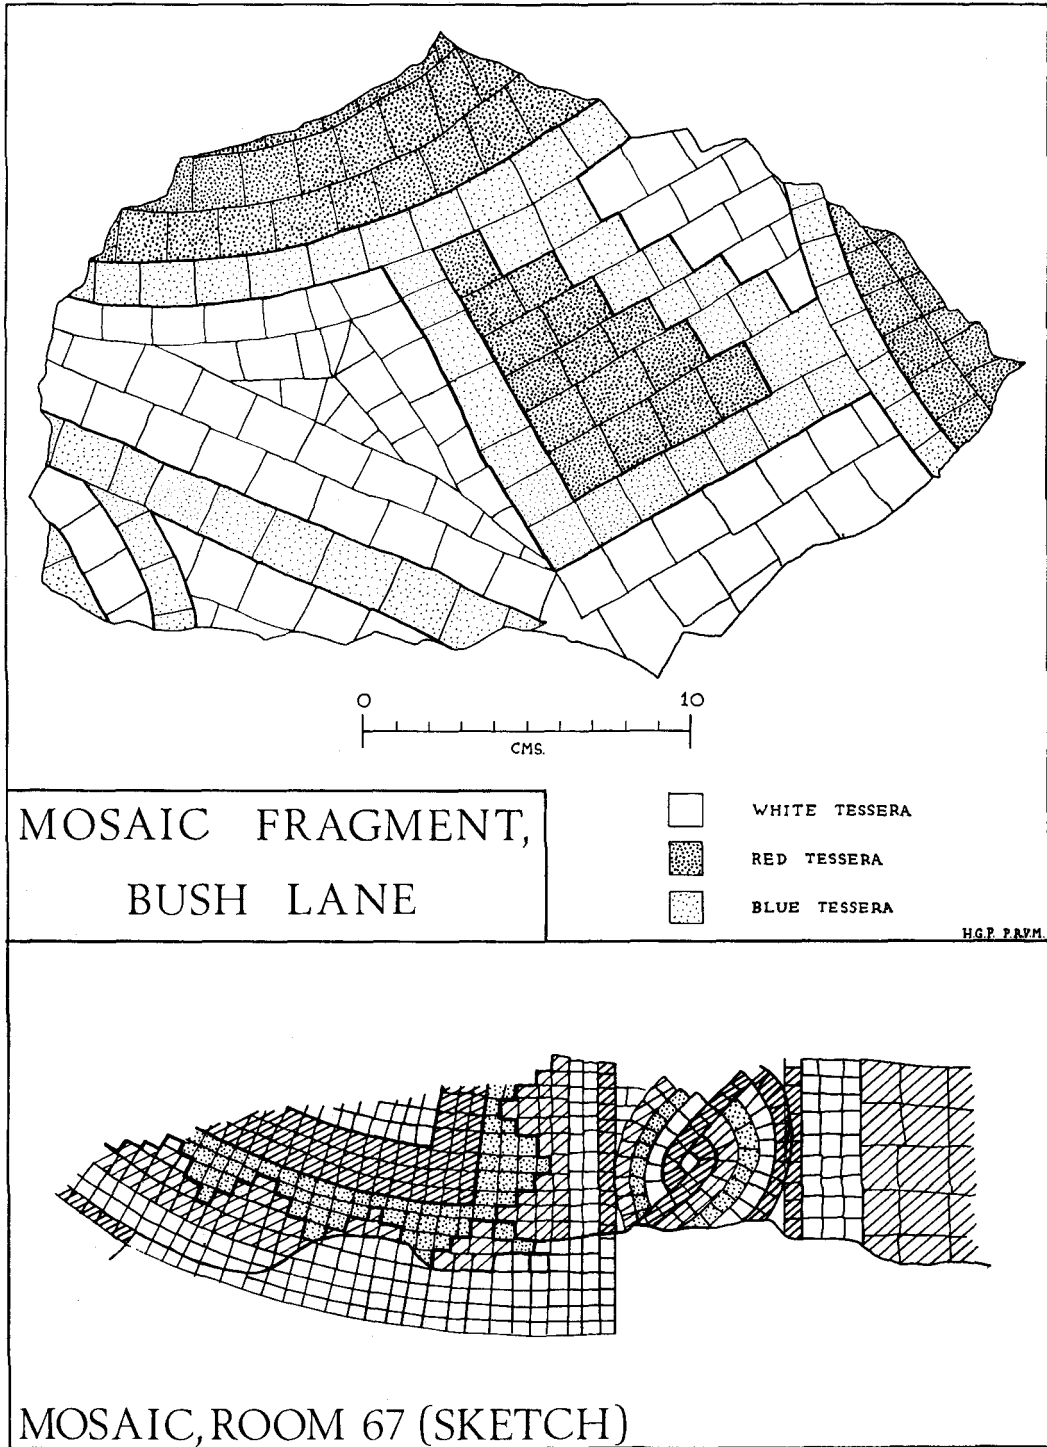
Fig. 44 Roman Palace. Mosaic fragment found in Bush Lane in the seventeenth century (p. 99), and sketch of mosaic fragment found in room 67 (Fig. 26 and Plate 4)
