# TWO ROMAN PUBLIC BATHS IN LONDON

by  
*Peter Marsden*

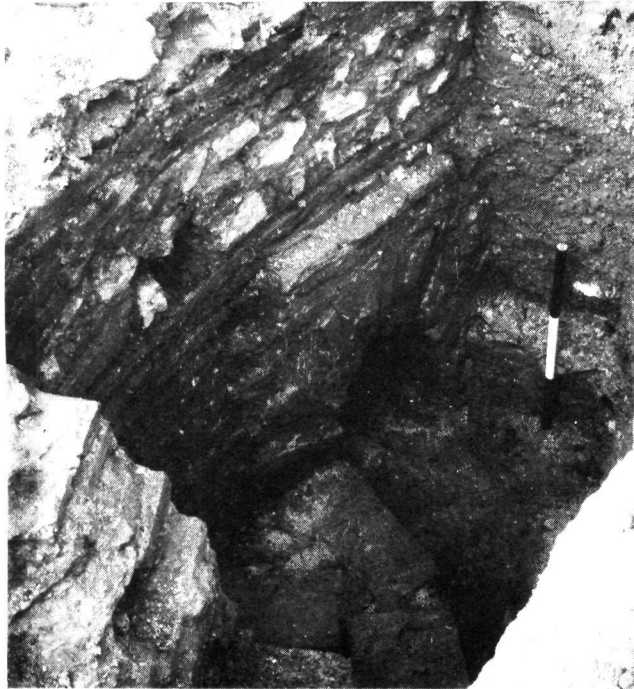
**Plate 1.** Huggin Hill baths: Flue from the furnace, Room 15, in the north-west corner of Room 18, viewed from the south. Scale of feet.

The western end of the apse wall immediately above the lower hypocaust floor was pierced by an arched brick flue (Plate 1) by which heat was originally introduced into the *caldarium* from the furnace chamber, Room 15. The arch, 0.5m wide by 0.55m high, was roughly built into the neat wall construction around it, and was apparently a later insertion. Immediately inside the apse were found flue channels built of bricks, whereas the *pilae* were found in a deep excavation beside the east side of the room. It is possible that the apse contained a hot water bath and that this was supported on flue channels rather than *pilae*.

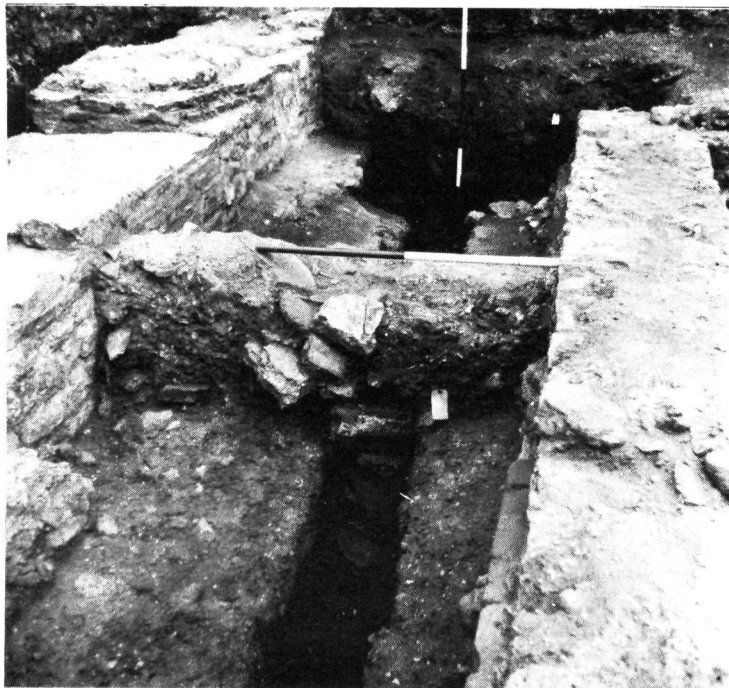
**Plate 2.** Huggin Hill baths: The corridor, Room 29, looking north showing robbed pipe, and dumped demolition debris. Scale in half metre divisions.

**Room 29** (Fig. 7; Fig. 8, section 5; Fig. 9, section 1; Plates 2–3) This was a corridor 1.5m wide separating the cold room (Walls 26 and 27) and Room 28, from the heated Room 30. At its south end the corridor was blocked by a foundation which presumably contained a door giving access to Area 34. The floor of the corridor had been almost completely destroyed when the baths were demolished; but at about 5.38m above O.D., immediately above an offset in the wall forming the east side of the corridor, there was a portion of possible flooring of buff coloured concrete. It is evident that the reason for the removal of the floor was to facilitate the salvage of a pipe, perhaps made of lead, which ran down the centre of this corridor, except at the south end where it swung eastwards under the corner of Room 30 (Plate 3). It is probable that this pipe drained water from the cold water pool or tank (Rooms 21 and 22). The foundation closing the south end of the corridor was roughly faced on its north side as if to suggest that the corridor floor lay below the ground level of Area 34. It is not certain if the walls had been plastered, but this seems unlikely. Instead, the mortar pointing around the rough ragstone facing stones of the western wall had been cut with incised lines to simulate ashlar blocks.

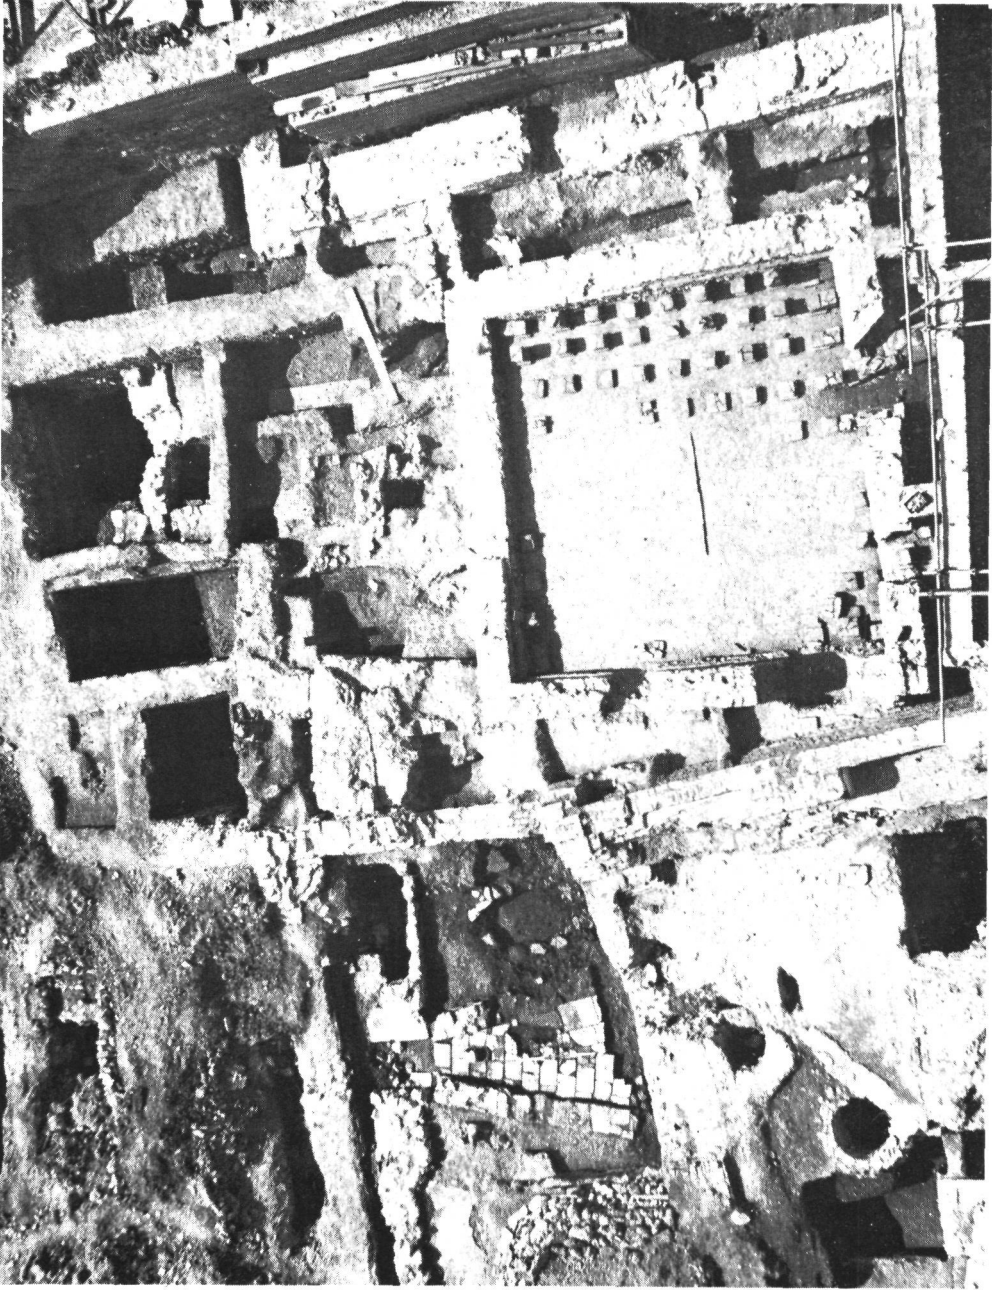
Plate 3. Huggin Hill baths: The eastern part of the baths viewed from the north, showing the square Room 30, and on its right the corridor 29. The *caldarium*, Room 33, is on the left. Scale of feet.

**Room 28** (Fig. 7; Plate 3) Only the eastern side of this room was excavated, and although little of its interior could be uncovered, it is clear that it was an unheated chamber measuring 7.46m from north to south internally. Its walls were constructed of ragstone set in pale yellow mortar, with, at about floor level, a double course of bonding tiles. At its south-east and north-east corners, the

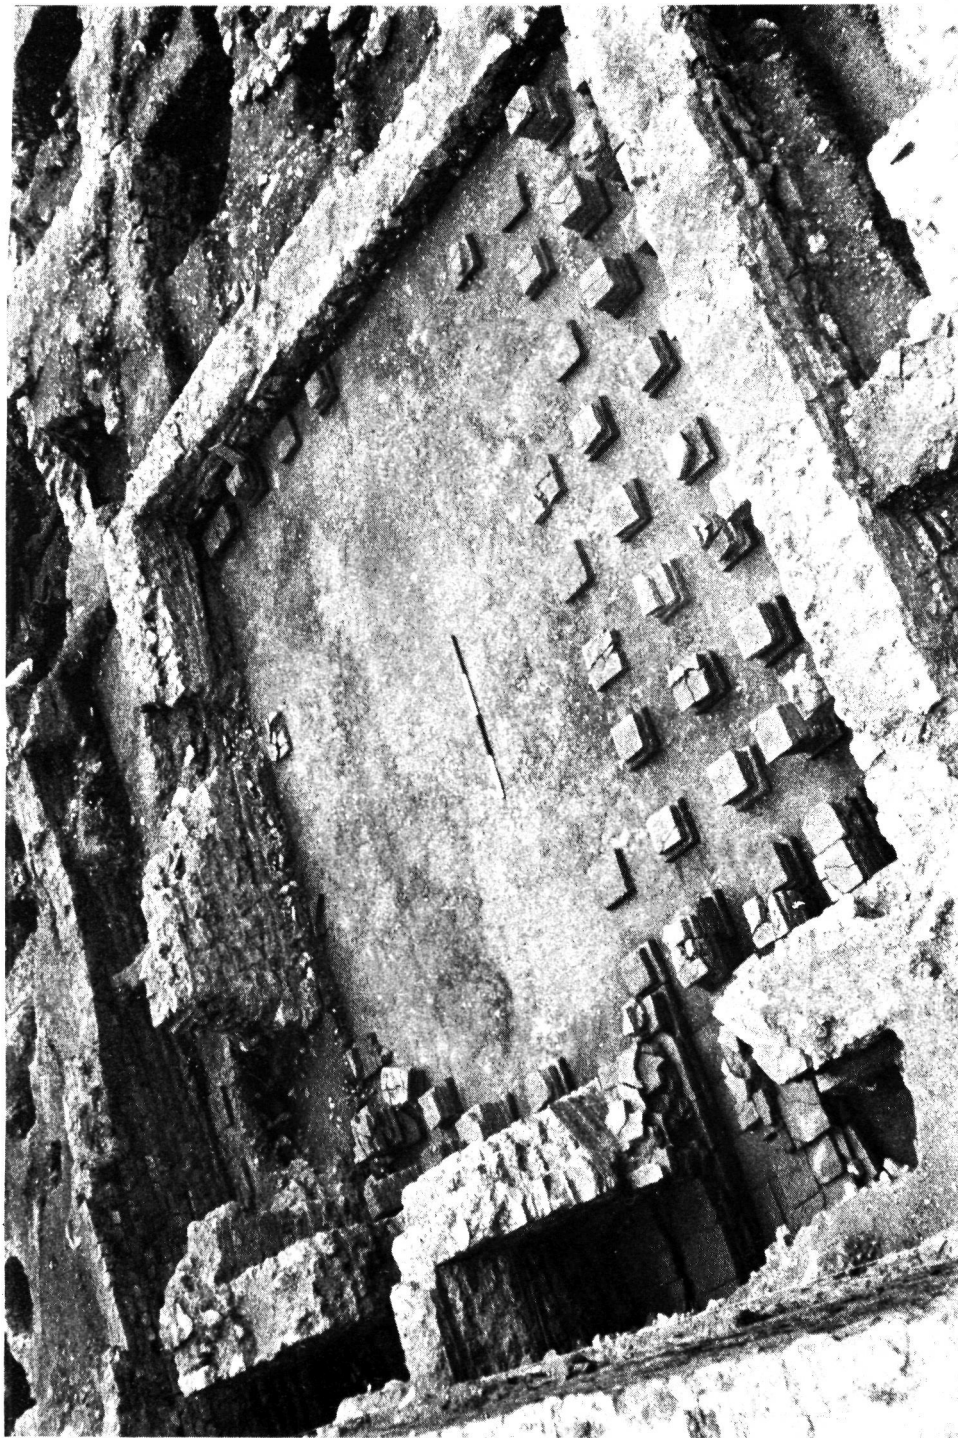
Plate 4. Huggin Hill baths: Room 30 viewed from the north-west.  
Scale of feet.

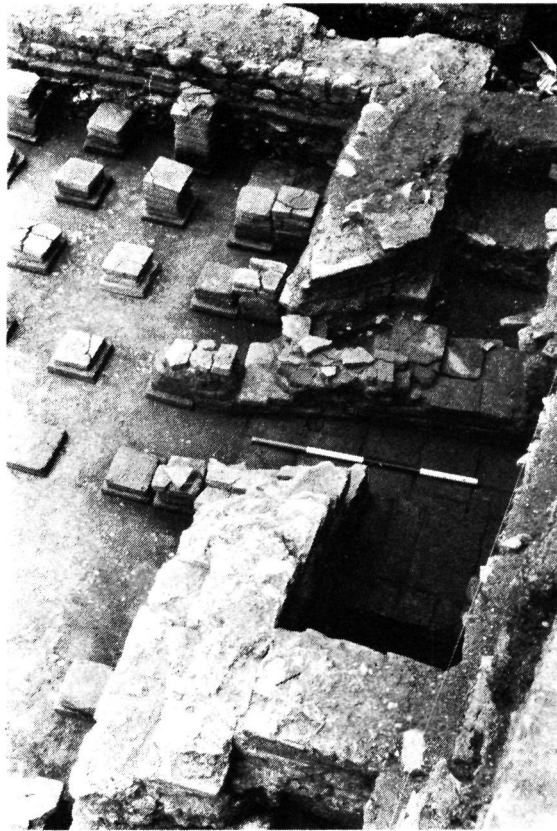
Plate 5. Huggin Hill baths: North-west corner of Room 30 seen from the east showing hypocaust floor level with the flint foundation, and the flue inserted into the diagonal opening between Rooms 30 and 31.

**Room 31** (Fig. 7; Fig. 9, section 2; Plate 5) This seems to have been a small chamber located between the two walls (3.04m apart) which extended northwards from Room 30. Both of the north-south walls appeared to have been built against the north wall of Room 30 and, as they did not relate in plan to the oblique doorway of that room, it is possible that they did not form part of the original construction. The flue channel was built in the final phase and the actual furnace position, to judge from the amount of burning and ash in the flue, lay just north of the limits of the excavation where later intrusions had destroyed the Roman features.

The flue itself (Plate 5) was built of flat red bricks set in yellow clay, both of which had been considerably burnt. It widened to the north, no doubt to accommodate the fire, and on its tiled floor was found a layer of white ash (Fig. 9, section 2, layer 3). It is possible that when the flue was built the west wall of Room 31 was demolished to its foundation, perhaps to allow access to the furnaces from the corridor (Room 29).

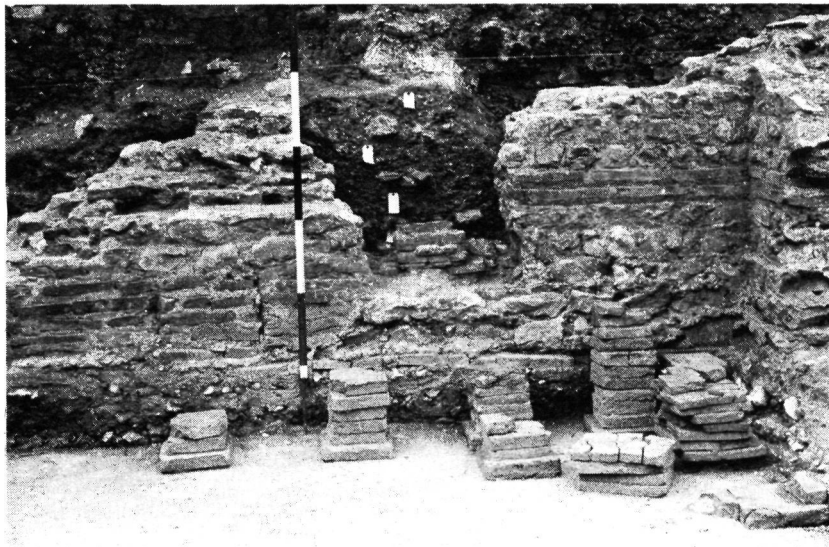
Plate 6. Huggin Hill baths: North-east corner of Room 30 viewed from the south showing the 'mock ashlar' wall to the right of the flue containing a *pila* opening into Room 32. Scale of feet.

**Room 32** (Fig. 7; Fig. 9, section 3; Plate 6) Only a very small portion of the south-west corner of this room had survived. It lay adjacent to Rooms 30 and 31 and its floor was located 0.55m above the lower hypocaust floor of Room 30. The floor of pink concrete was somewhat uneven, and on this there was found a brick-built *pila*. It is probable that this hypocaust belonged to a phase of rebuilding in the baths because a hole forming a flue had been roughly broken through the north wall of Room 30 to allow heat from the hypocaust of that room to pass into the hypocaust of Room 32. In order to strengthen the opening a brick *pila* had been built in the flue opening.

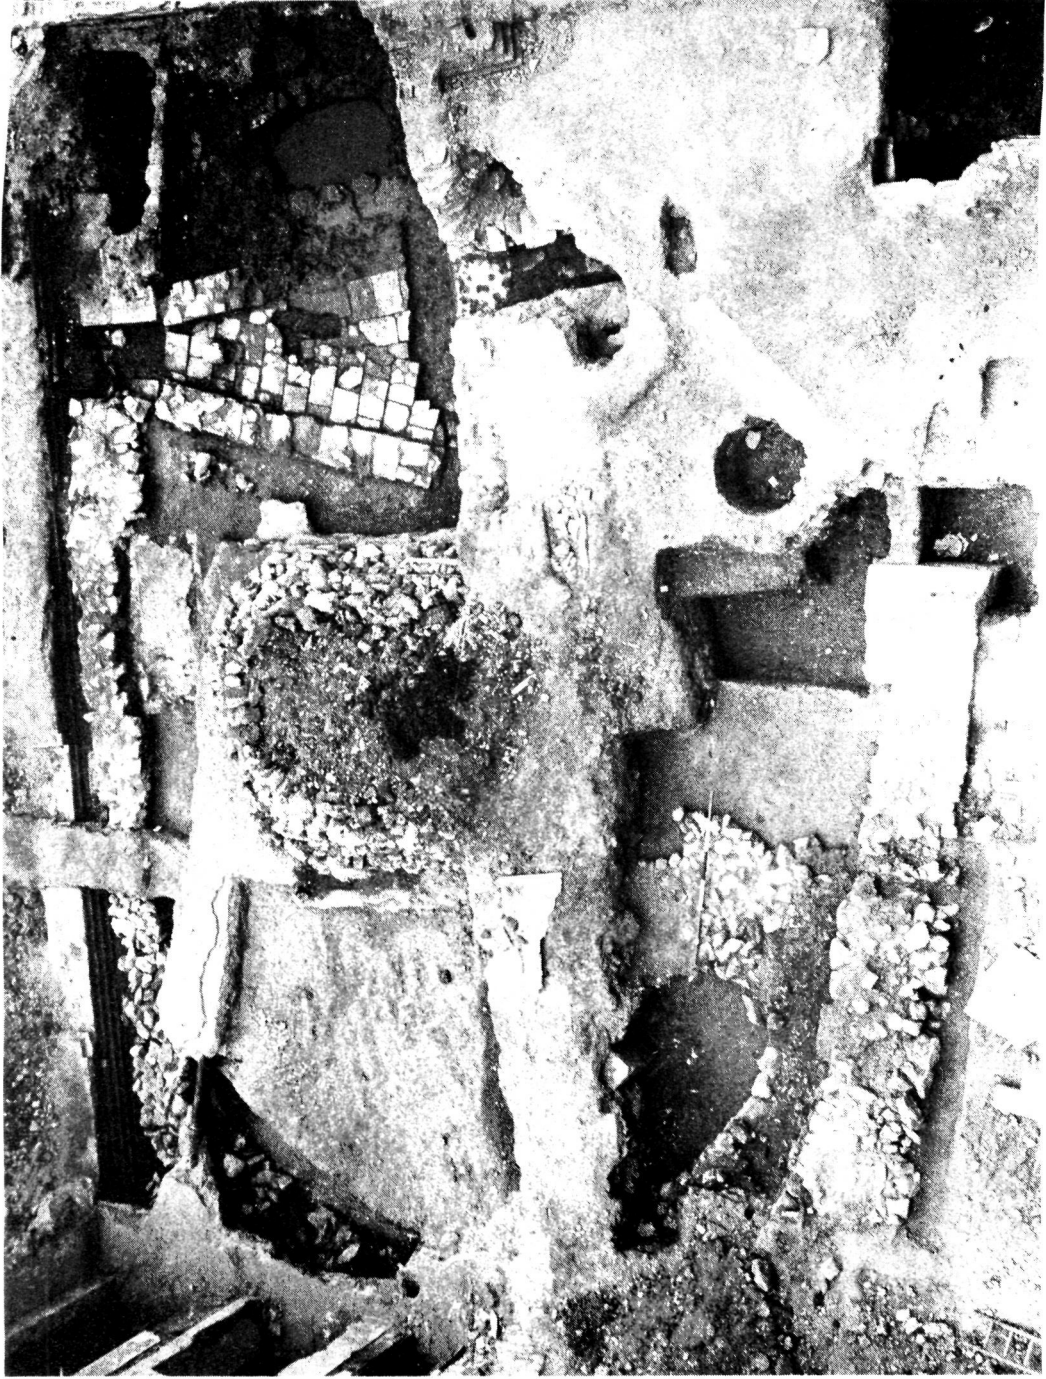
Plate 7. Huggin Hill baths: Foundations of the *caldarium*, Room 33, viewed from the north.  
Scale of feet.

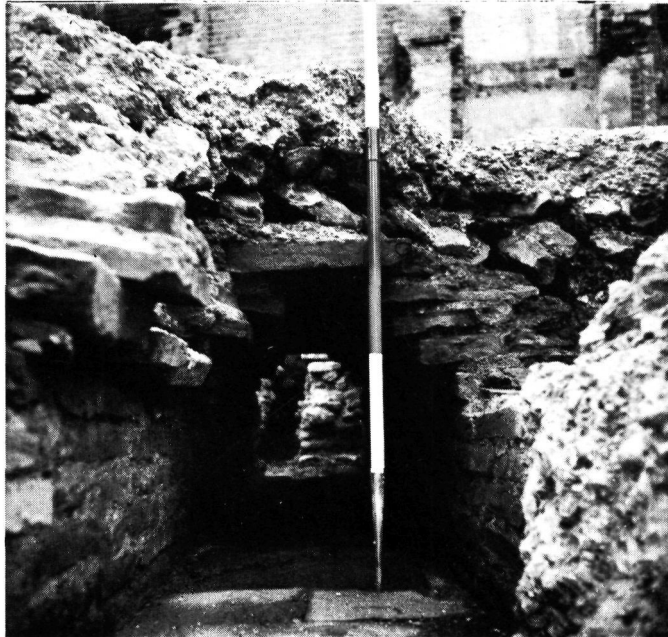
Plate 8. Huggin Hill baths: The west drain beneath the lower hypocaust floor of Room 33. View looking north. Scale of half metres.

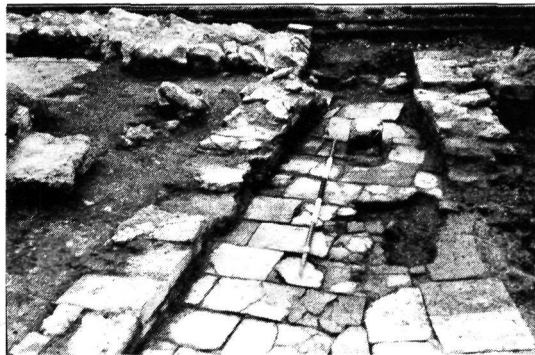
Plate 9. Huggin Hill baths: Junction of east and west drains below *caldarium*, Room 33. View looking south. Scale of feet.

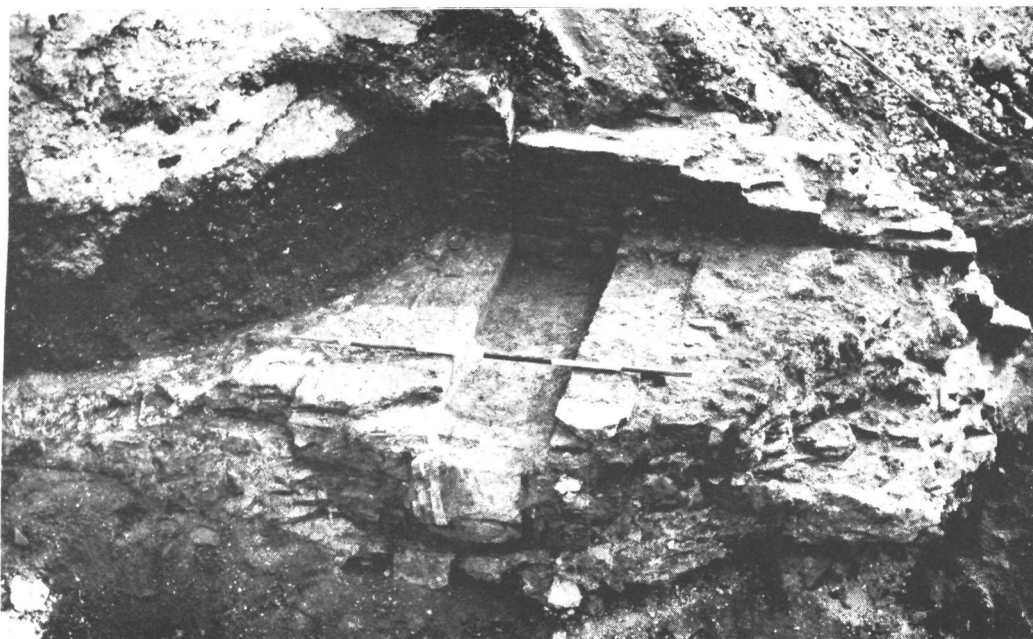
Plate 10. Cheapside baths: Junction of the north end of *caldarium* apse (foreground), Room 5; with (right) stump of phase 1 cross-wall between Rooms 4 and 5; and (left) west wall of Room 6 of phase 2. View to east. Scale of feet.

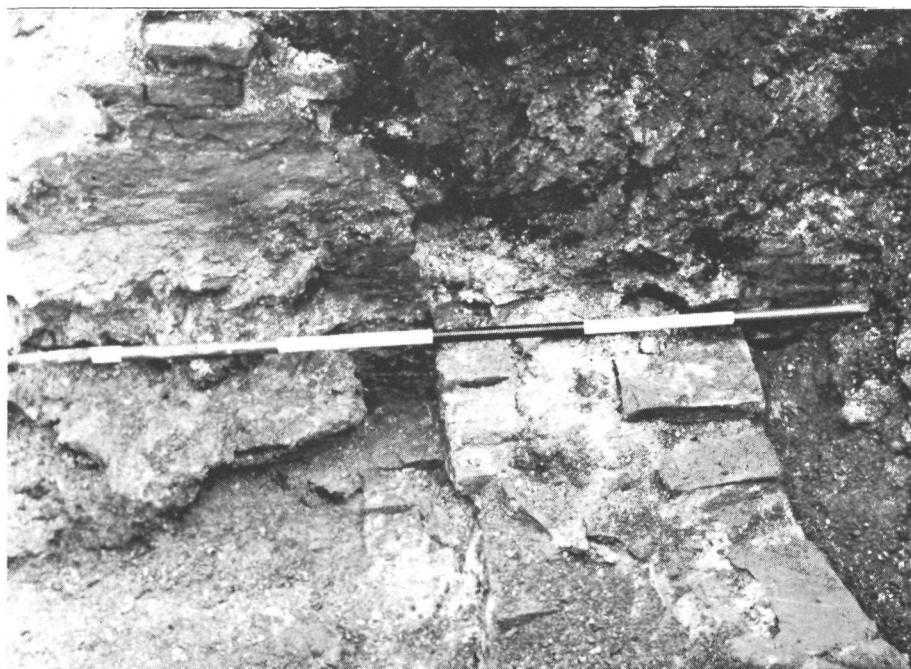
Plate 11. Cheapside baths: The blocked flue 8 between the platforms 9 (right) and 10 for a hot water tank. View from the north. Scale of feet.

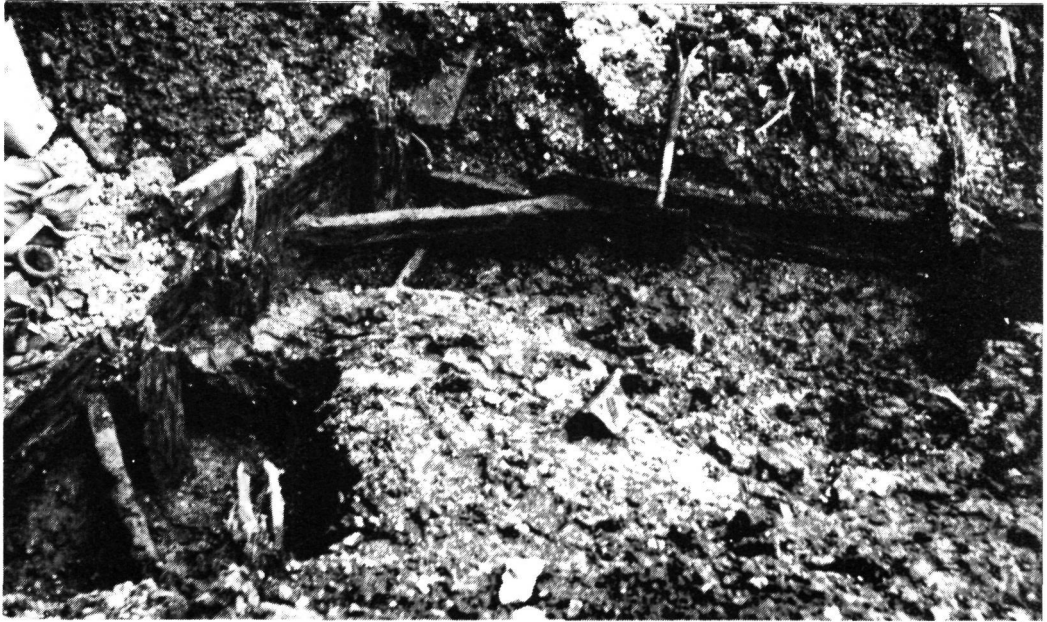
Plate 12. Cheapside baths: North-east corner of the timber-lined water-tank, Feature 2.
