# THE REDEVELOPMENT OF 20 DEAN'S YARD, WESTMINSTER ABBEY 1975-77

GRAHAM BLACK

From February to May 1975 the Inner London Archaeological Unit carried out an excavation at the rear of 20 Dean's Yard, Westminster Abbey, in the eastern third of the sub-vault of the Abbey misericorde. The results of that excavation were published in the Transactions of the London & Middlesex Archaeological Society Volume 27, for 1976<sup>1</sup>.

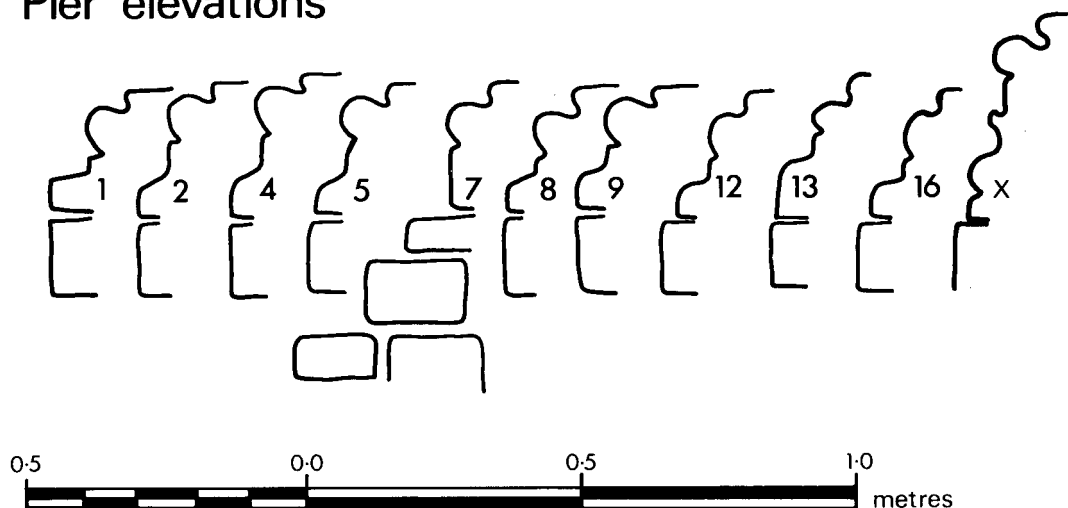
Fig. 2 Westminster Abbey. Redevelopment of 20 Dean's Yard 1975-77. Pier elevations. The numbers correspond to those in Fig. 3. Pier base X is a waterholder base from the west wall of the south transept of the abbey church

The only pier bases which had survived within the sub-vault west of the excavated area were those which had been cut into the surrounding walls. The plinths of the internal piers survived but the pier bases themselves were probably removed when the sub-vault was demolished. Probing with a crow-bar failed to reveal the presence of any sleeper walls under the plinths similar to the one present in the excavated area. The original purpose of the sleeper wall discovered in the excavated area remains unknown<sup>12</sup>.

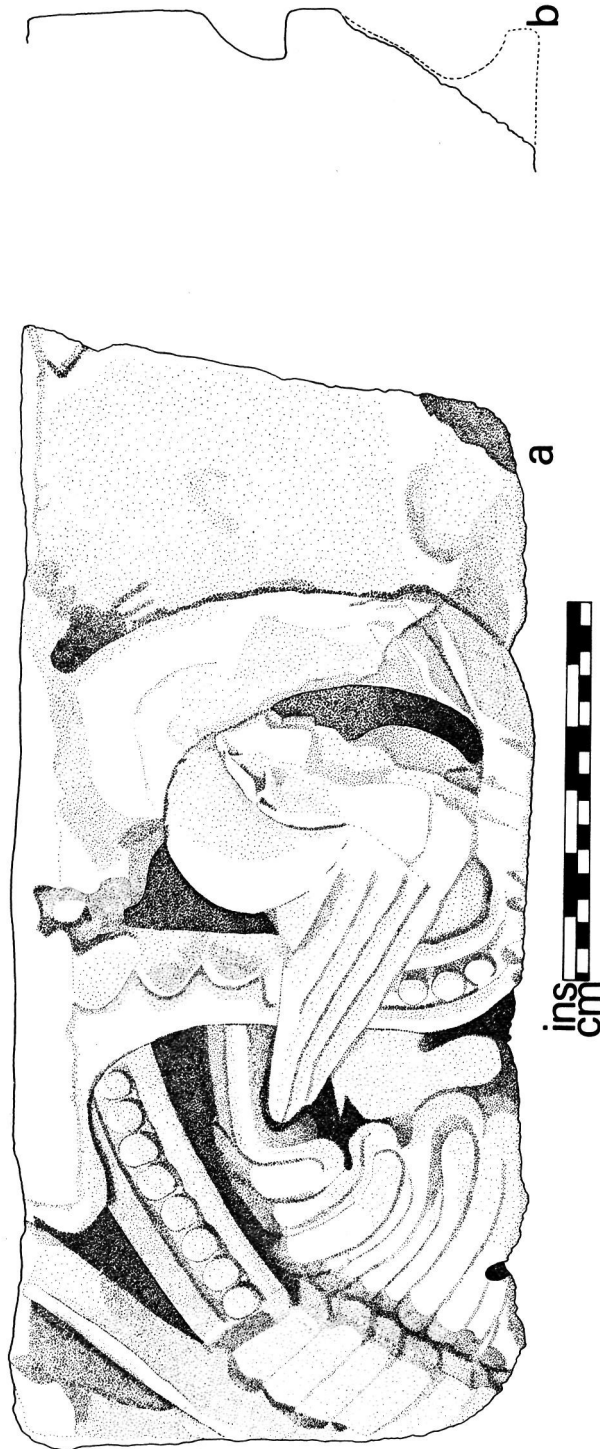
Fig. 6 Westminster Abbey. Redevelopment of 20 Dean's Yard 1975-77. (a) The 12th century sculptured block — face (b) The 12th century sculptured block — profile of plinth-moulding on rear-face

This is a block of coarse Oolite, 0.38m long but broken off, 0.18m high and 0.23m thick. It has been re-worked on the rear-face to form a plinth-moulding, consisting of a cyma brought back to the face below by a relatively large hollow chamfer, all rather roughly tooled but consistent with the third quarter of the 14th century, when much of the refectory and the adjoining walk of the cloister were rebuilt. In view of the proximity of discovery and the material extracted from the south wall of the cloister under Gilbert Scott (Lethaby 1924, 33-37) it would seem likely that the stone derives from the refectory (possibly the main entrance or the lavatory) or the adjoining walk. The lower bedding-face seems original, the front is entirely covered with Romanesque carving, the upper bedding-face, which is now horizontal, seems to belong to the re-working, so that it may have been voussoir-shaped, and the left edge (as seen from the original front) is canted somewhat out of vertical.

The carving is deep but not particularly delicate — less fine than those in Canterbury cathedral crypt (Gardner 1951, 103-4, Stone 1972 pl 33-4, Zarnecki 1951 pl 49-56 (in a better-textured stone)), but about on a par with the cloister-capitals from Reading Abbey (Gardner 1951 fig. 115, Stone 1972 p 36-7, Zarnecki 1951 pl 59-63) some of which are also in Oolite, which, with a few fragments from Westminster itself (Lethaby 1924), are the most obvious technical analogues. The points in common are the tight interlace of three-banded strap-work, with beads or pellets along the central band; the enclosed, finger-like terminals of the foliage, forming three rolls of equal emphasis; and the bulging eye with no pupil marked. Each of these is widespread in English Romanesque; none is very subtle. But *their combination in very ornate works of high patronage makes a telling parallel with the other royal Abbey of Reading* (begun in 1121, fast-moving and probably nearly complete by the burial of Henry I in 1135).

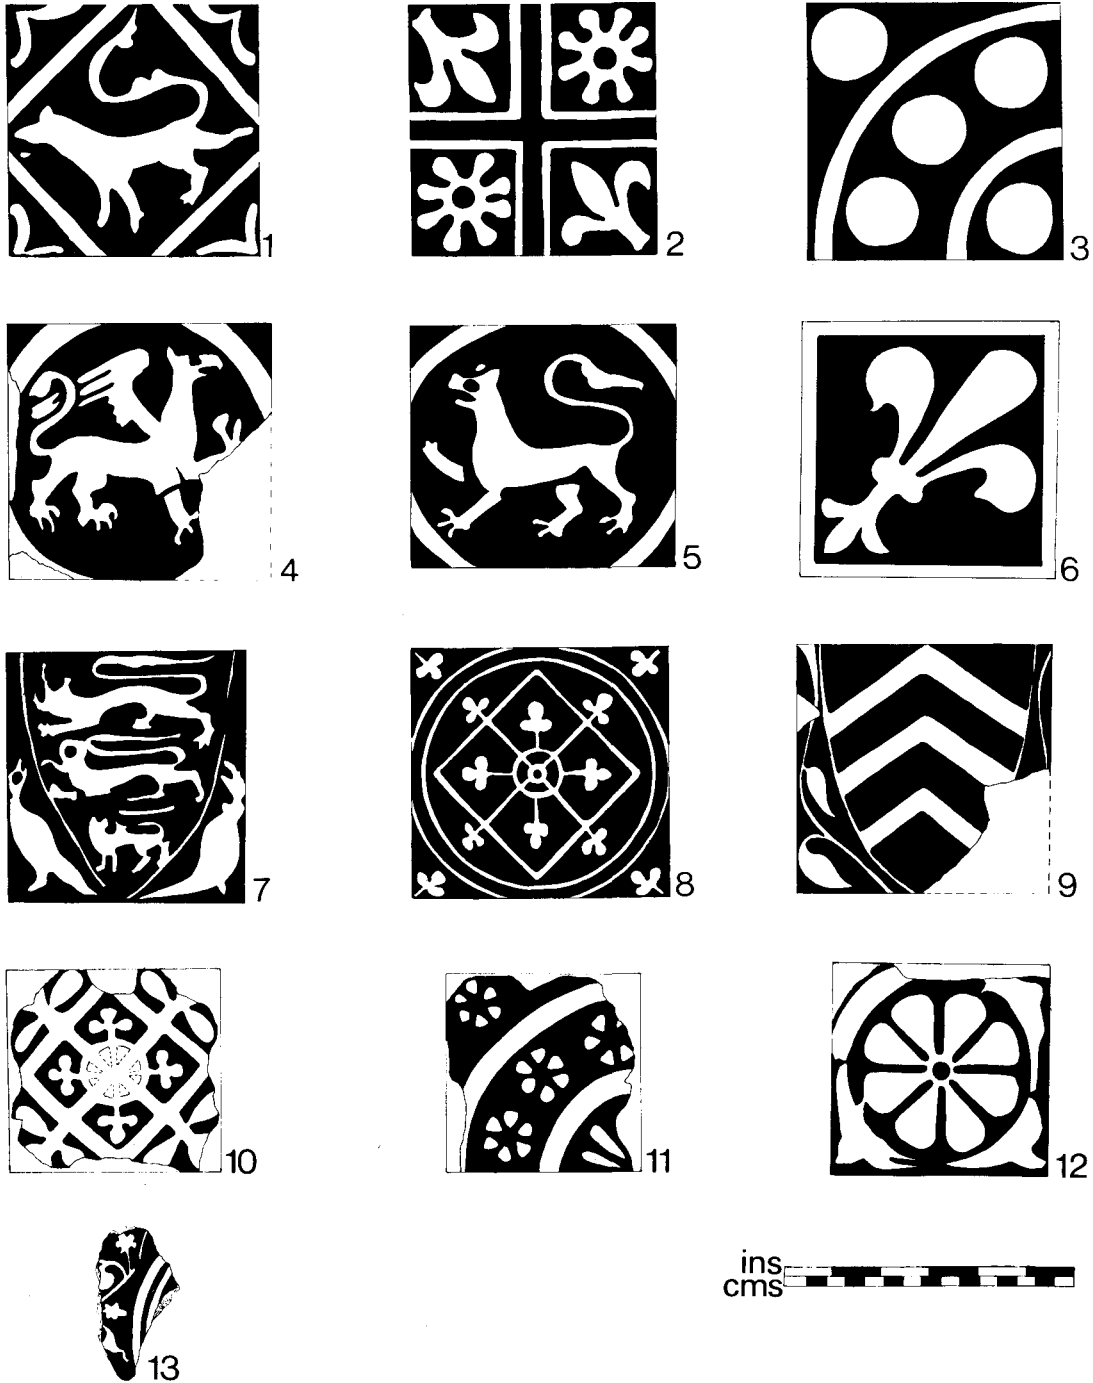
Fig. 7 Westminster Abbey. Redevelopment of 20 Dean's Yard 1975-77. The decorated tiles

The majority of the tiles were recovered during the redevelopment work after the excavation, and although a number were found laid *in situ* they had, in fact, been relaid at least twice and in some cases three times. It is therefore to be expected that a high proportion of these re-used tiles would be the plain tiles used in borders and at the edges of rooms where they would receive less wear. Of the decorated examples, however, the largest number are from what must be a local source (Type I, Fig. 7, 1, 2, 4 to 9). They measure on average 134 mm square and the designs include the Griffin, the Clare Chevrons, the Lion, etc. They would appear to date from the late thirteenth and early fourteenth centuries.

The group also includes plain tiles imported from the Netherlands, with nail holes, and dating from the 14th and 15th centuries, with a preference for the later date.

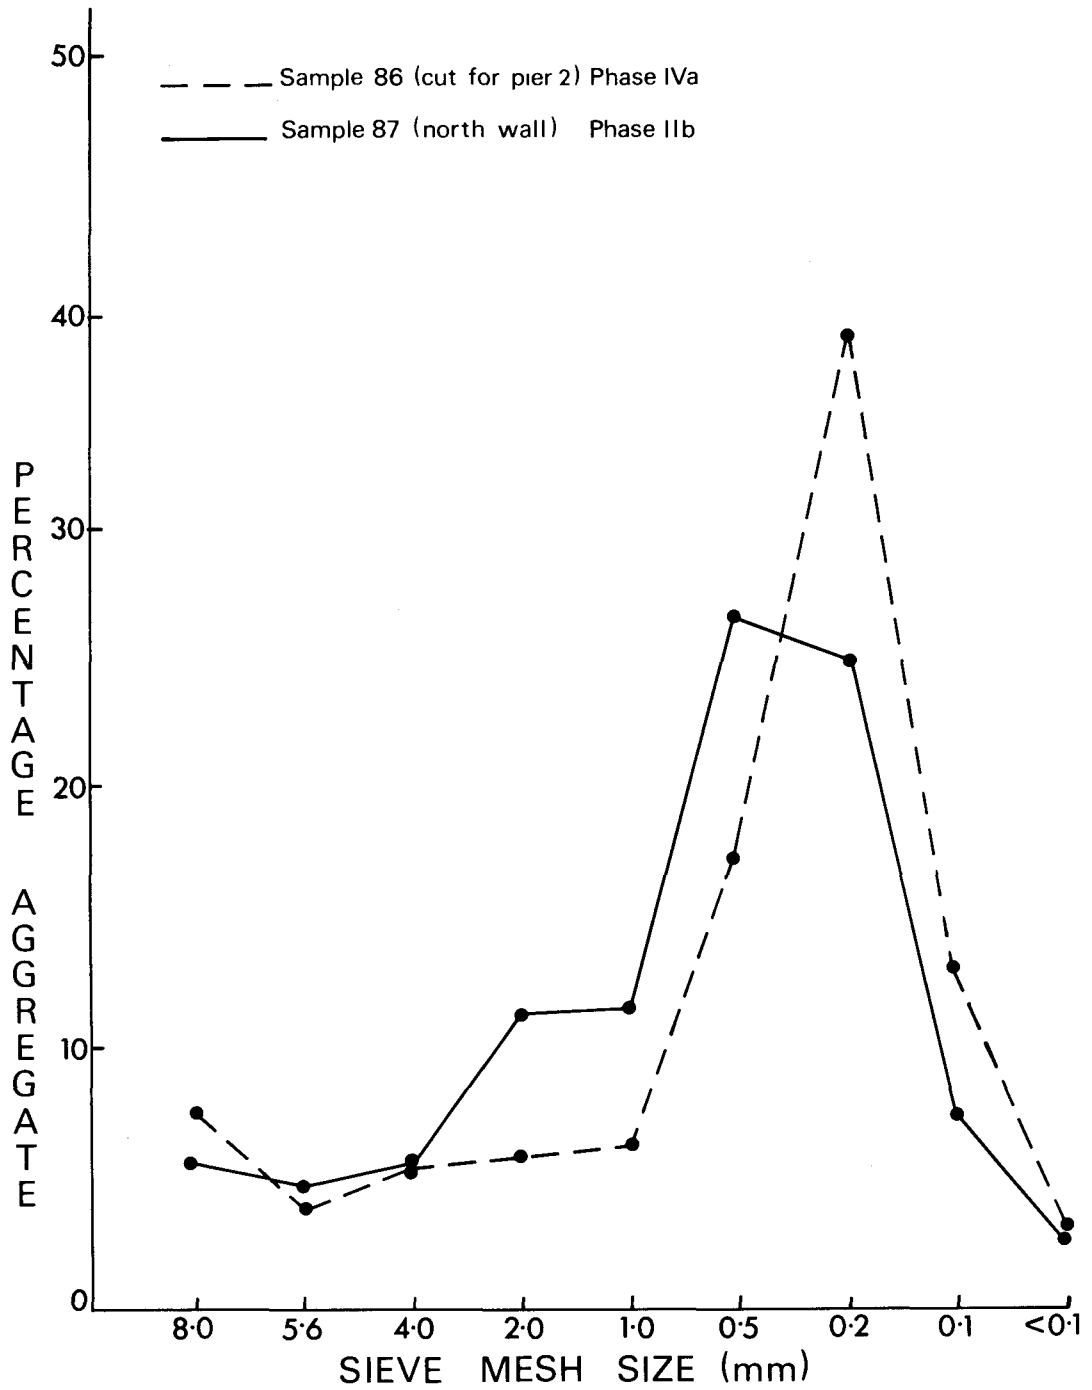
Fig. 8 Westminster Abbey. Redevelopment of 20 Dean's Yard 1975-77. Examples of aggregate distribution curves from the mortar analysis

The samples were first dried at 110°C to constant weight. 200 g. of each sample was then treated with dilute hydrochloric acid to remove acid soluble material (mainly calcium salts) and thus reduce the sample to its aggregate. The aggregate was filtered, thoroughly washed and dried to a constant weight. It was then passed through a series of sieves and the various quantities retained noted. In order to enable comparison of the aggregate distributions to be made, the weights retained were converted into percentage of the total aggregate weight and plotted against sieve mesh size. The results of this exercise are shown in the following diagram (Fig. 8). All analyses were carried out in duplicate and the mean values plotted.

Geological examination of the insoluble aggregate indicated that the larger aggregate (that retained by a 2.00 mm mesh sieve) in all samples was composed mainly of flint fragments showing natural fractures and quartzite pebbles. 14 samples (4, 11, 21, 24, 31, 51, 67, 72, 73, 75, 76, 77, 81 and 82) contained burnt clay fragments, and 8 (33, 45, 50, 52, 56, 70, 74, 87) white/grey clay aggregations. The burnt clay fragments in 21 and 67 were identified as brown glazed tile fragments and a piece of daub (weight 17.5 g) respectively. Several of the flints in the samples had a reddish appearance reminiscent of having been fired, but the absence of sharp fractures suggested that this was a natural phenomenon. Samples 31 and 51 also contained several fish bones.

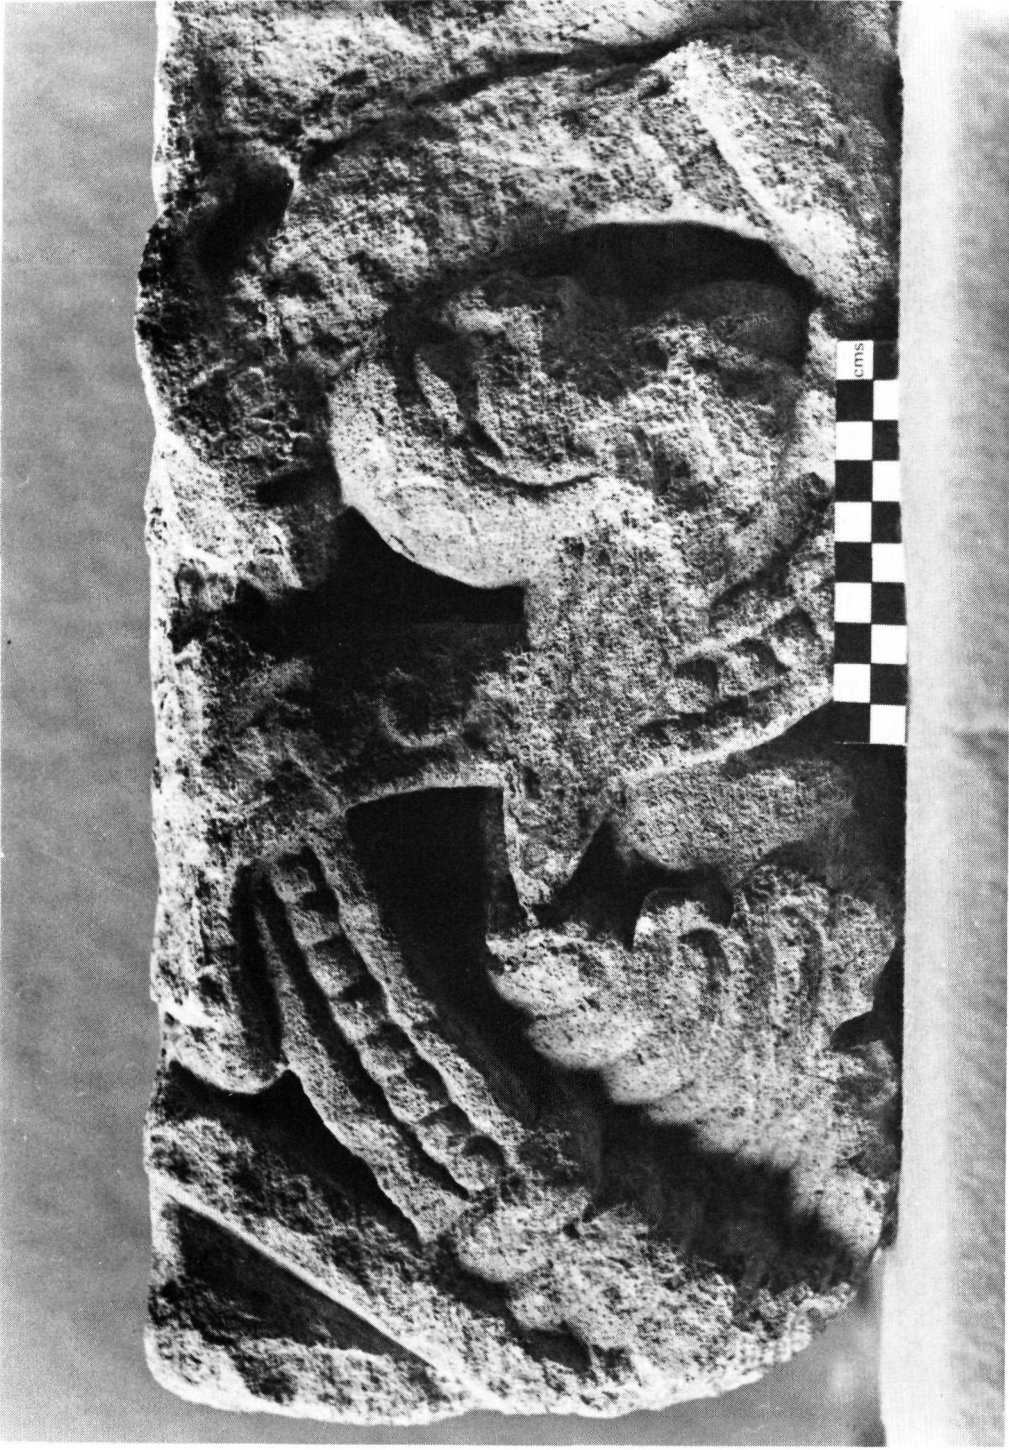
Plate 1 Westminster Abbey. Redevelopment of 20 Dean's Yard 1975-77. 12th century sculptured black (scale cms) (see p. 200)

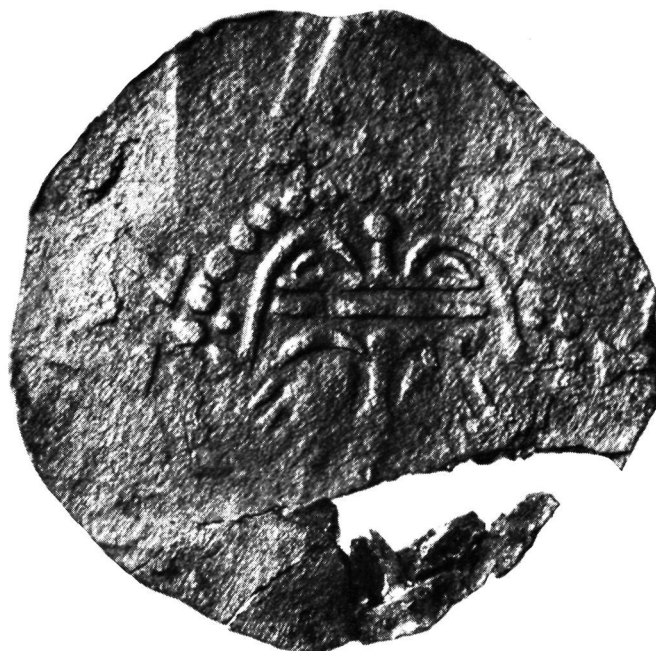
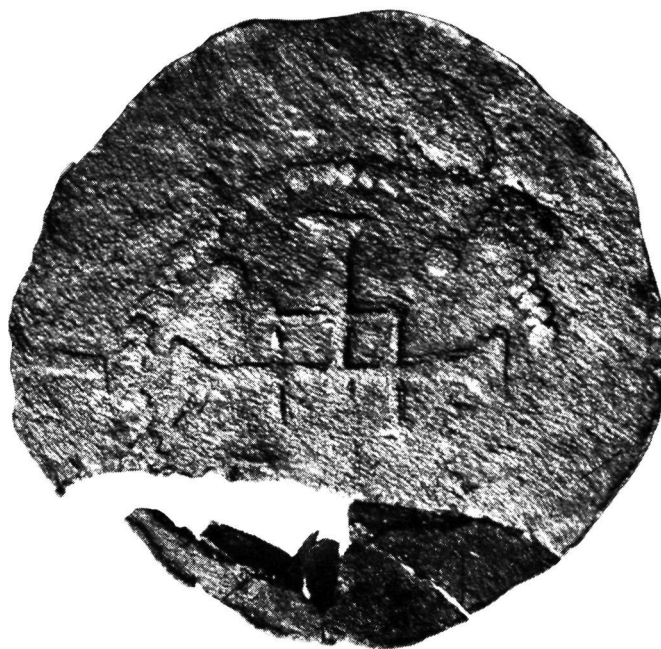
Plate 2 Westminster Abbey. Redevelopment of 20 Dean's Yard 1975-77. Barbarous imitation of Duisberg, Emperor Konrad II pfennig. Obverse (*above*); Reverse (*below*). (Diameter 19.5mm)

COMMENTS — The coin was hitherto unknown to German numismatists. German imperial coins and their copies are very unusual as site finds or in hoards in England. The London Walbrook hoard found in *c.* 1872 and containing some 7,000 coins, concealed in *c.* 1070, included one pfennig of Emperor Henry III (1039-56). A Henry IV pfennig of *c.* 1080-90 was also recently found in London — during the 1974 Seal House excavation in the City.
