EXCAVATIONS AT ELTHAM PALACE, 1975–9

HUMPHREY WOODS

SUMMARY

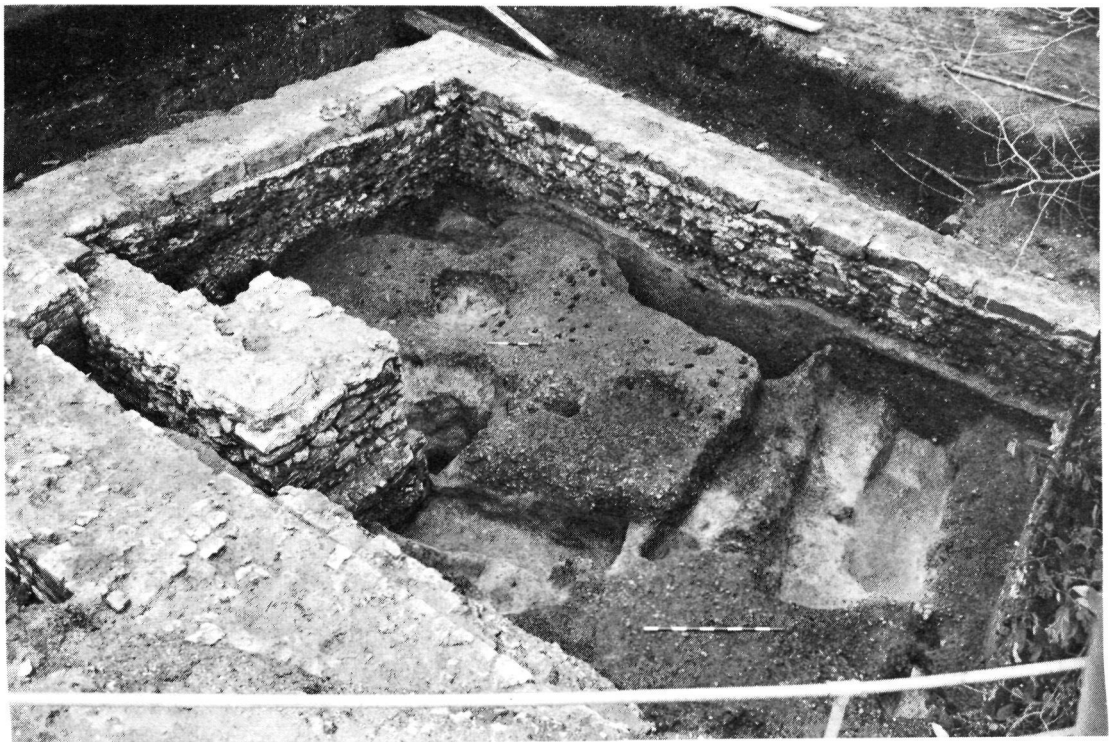
Plate 1. Eltham Palace: The beam slots, D258 and D269, representing one corner of the late 11th-century timber building sealed beneath the Henrican chaplain's house (Photo: Derek Craig).

The earliest structure to be found was represented by two beam slots (D258 and D269) exposed in the extreme north-eastern part of the area excavated (Pl. 1). These clearly formed one corner of a timber building, but

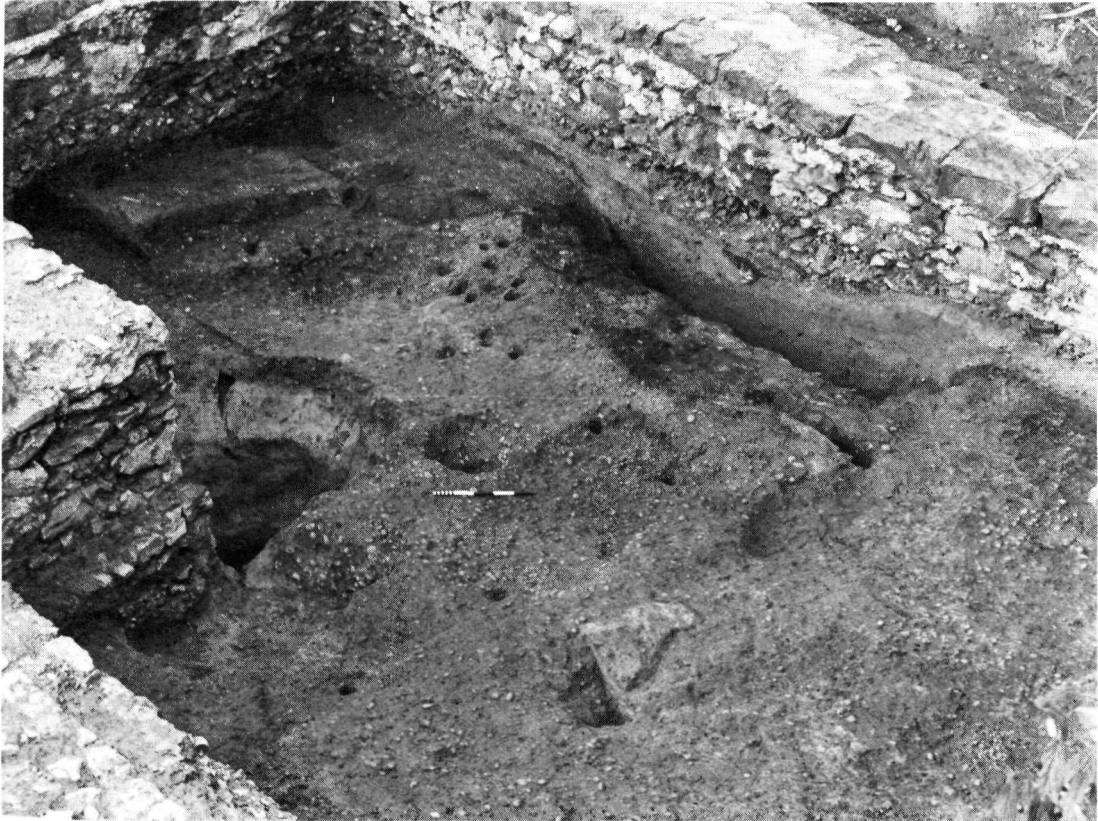
Plate 2. Eltham Palace: The late 12th-century structure, D163, defined by stake holes for supporting the turf walls, sealed beneath the Henrican chaplain's house (Photo: Derek Craig).

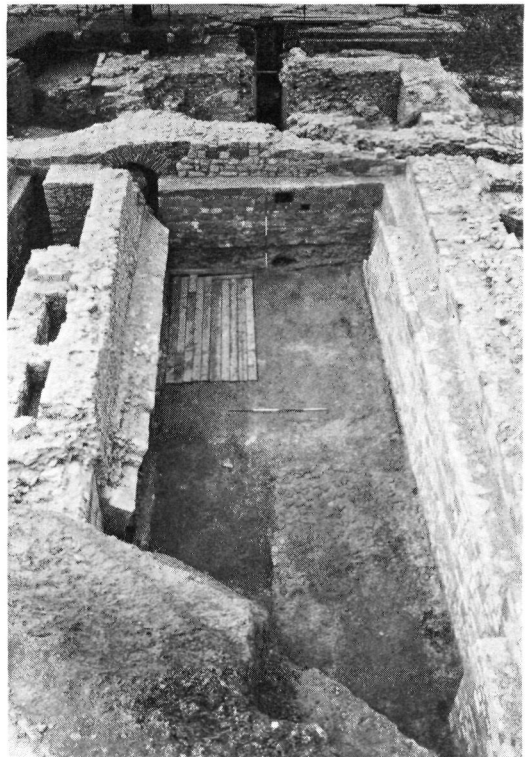
Plate 3. Eltham Palace: Overall view from the east of Bishop Bek's cellar, with the gable wall of Henry VIII's chapel obscuring the view of its west end, and the north wall of Henry's chapel encasing Bek's north wall
(Photo: Derek Craig).

The cellar was 19.7m long by 7.2m wide. The east wall had been destroyed during later building works; a stub of the destroyed wall was found protruding from the buttress at the north-east corner of the building. The north

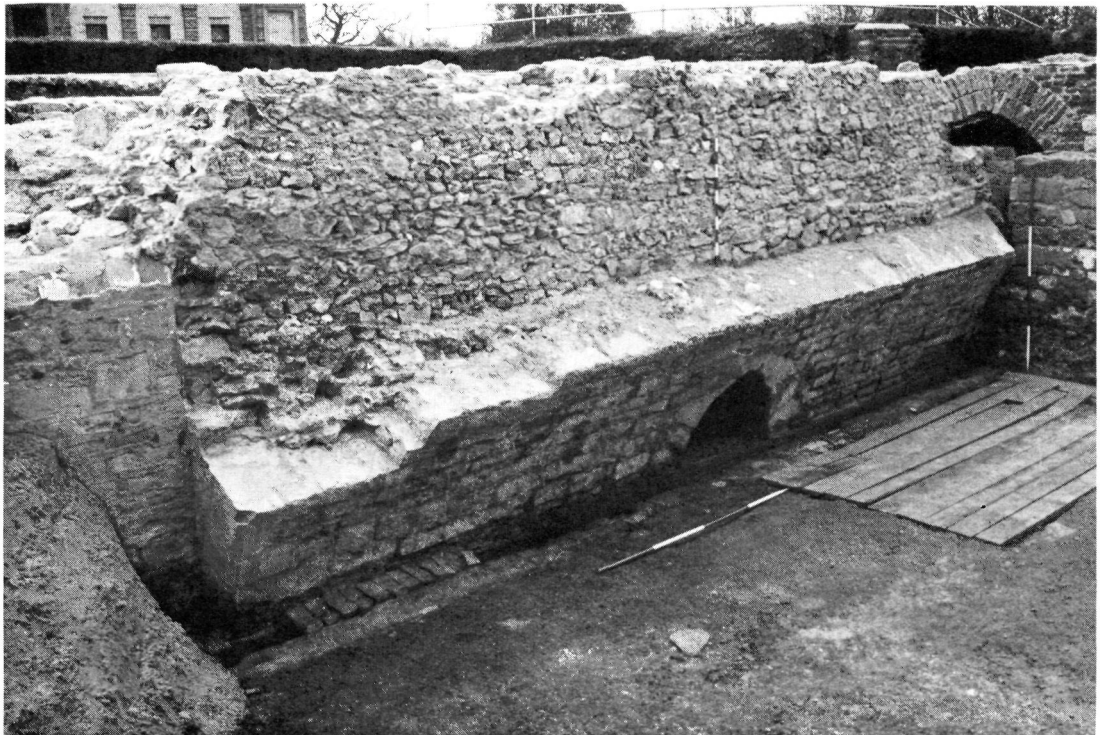
Plate 4. Eltham Palace: Detail of south wall of Bishop Bek's cellar, showing the change in vaulting (left) at the east end, the central relieving arch, and (next to the far ranging pole) the ventilation shaft (*Photo: Derek Craig*).

Half-way along the south wall of the cellar, opposite the central buttress was a relieving arch similar to those in the west wall (Pl. 4). Further west, in the thickness of the same wall, was a ventilation shaft. The top of a second ventilation shaft was found in the north wall: unfortunately, it was largely obscured by the footing for Henry VIII's chapel, which here encased the wall of Bek's building.

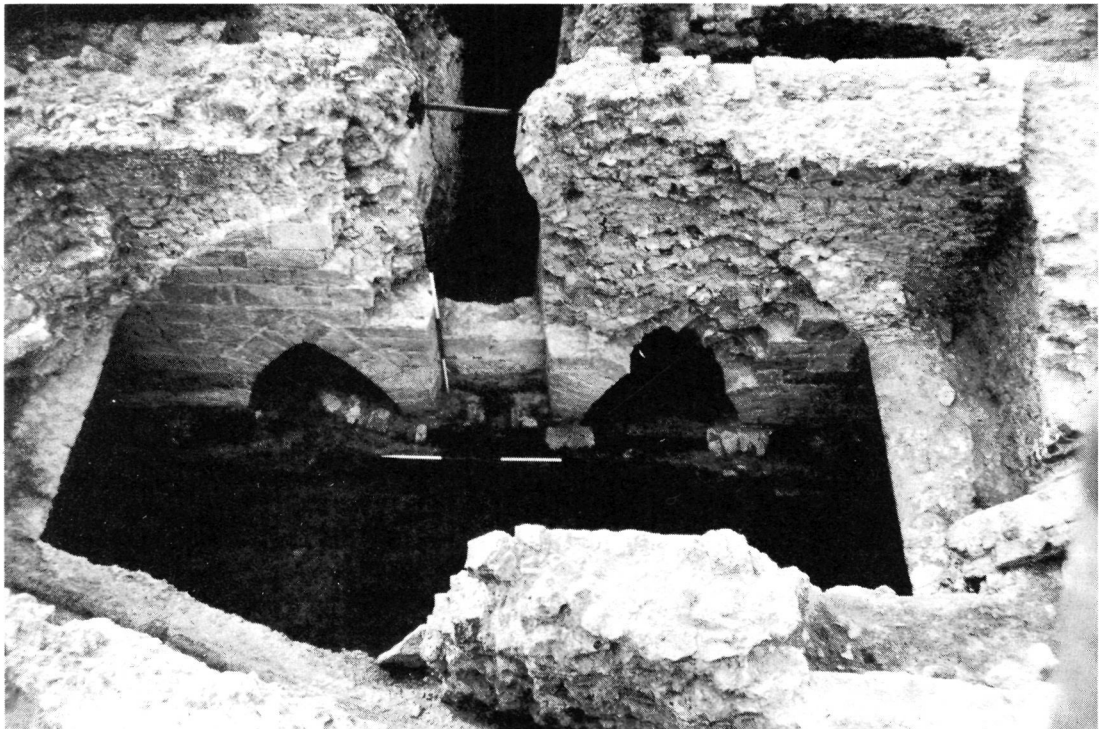
Plate 5. Eltham Palace: West end of Bishop Bek's cellar, showing the springers of the barrel vault, and the relieving arches. The doorway and brick drains are not primary (*Photo: Jenny Tinker*).

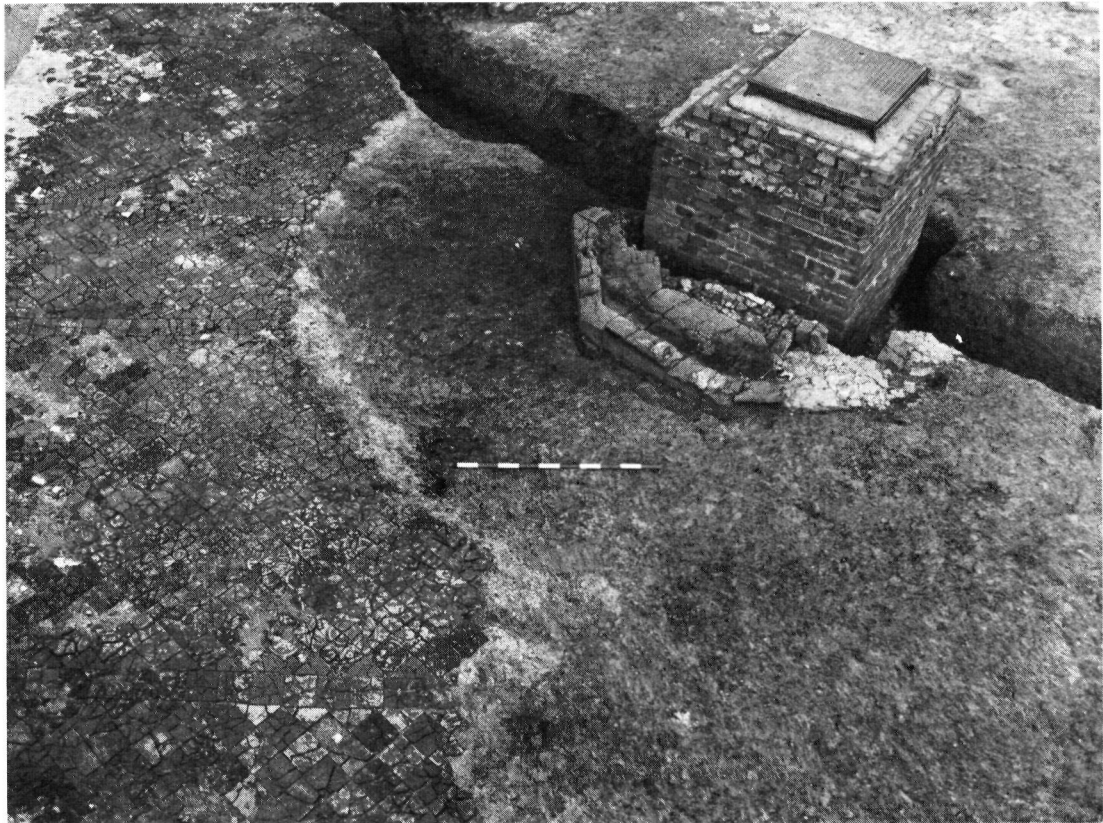
Plate 6. Eltham Palace: Area I of the tile pavement in Bishop Bek's great hall, and the octagonal stone fireplace F39 (Photo: Derek Craig).

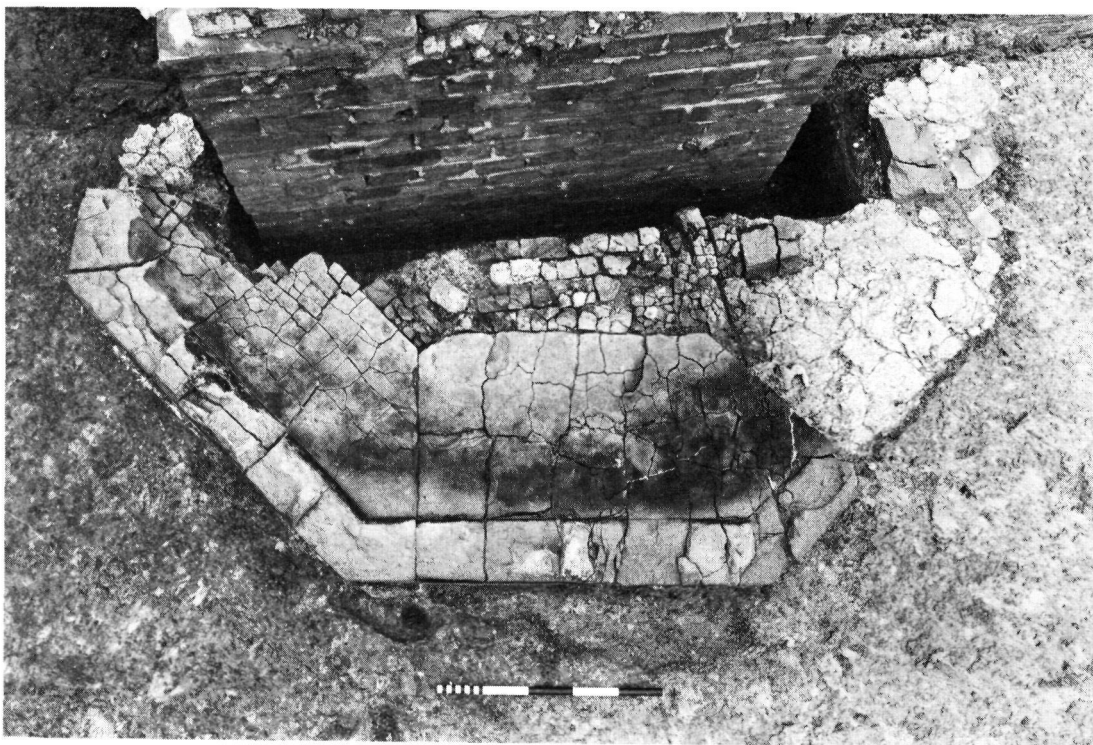
Plate 7. Eltham Palace: Plan view of the octagonal stone fireplace F39 in Bishop Bek's great hall (Photo: Derek Craig).

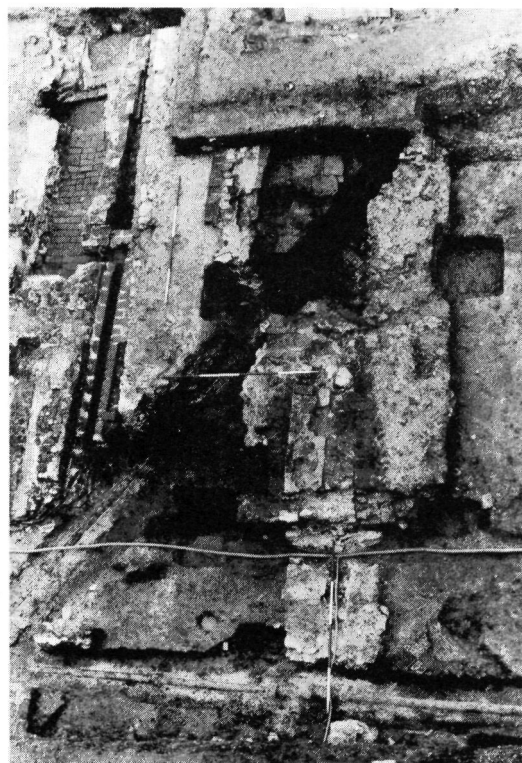
Plate 8. Eltham Palace: The porch of Bishop Bek's great hall, 1979 season, with Areas II and III of the tile pavement. The view is from the south (Photo: Christopher Guy).

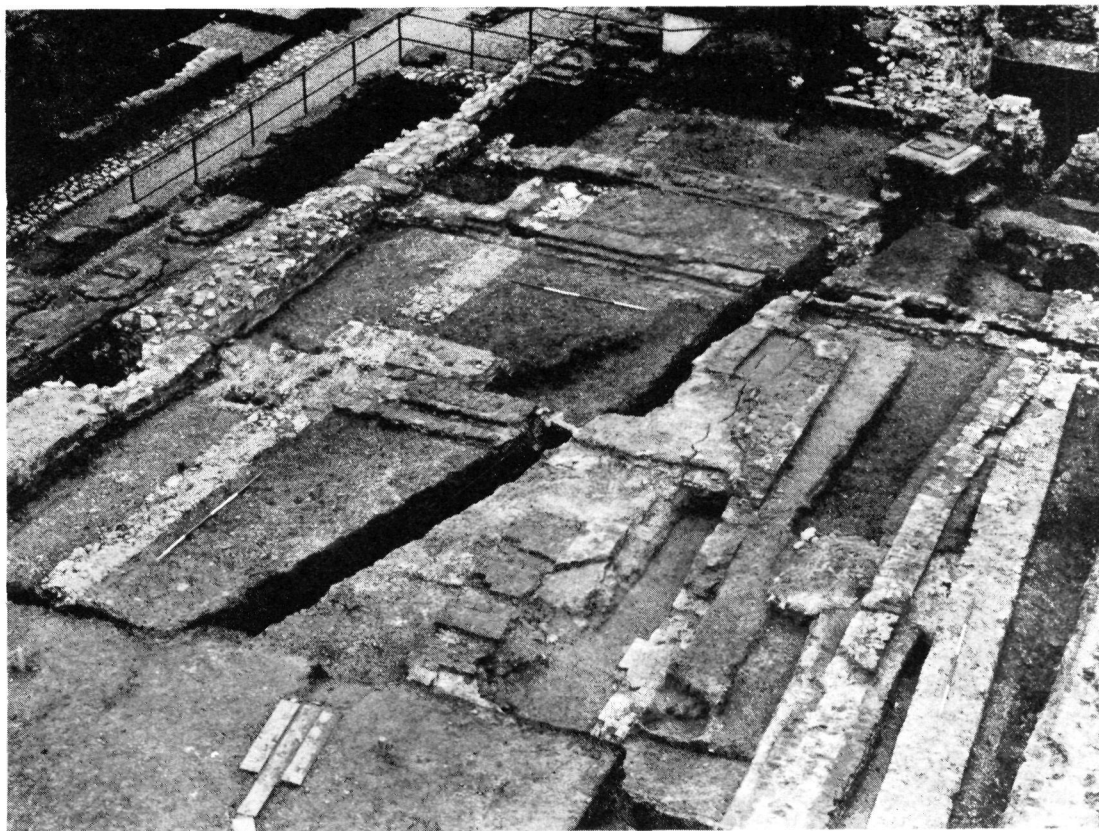
Plate 9. Eltham Palace: The northern end of the range of king's apartments, 1978 season
(Photo: Derek Craig).

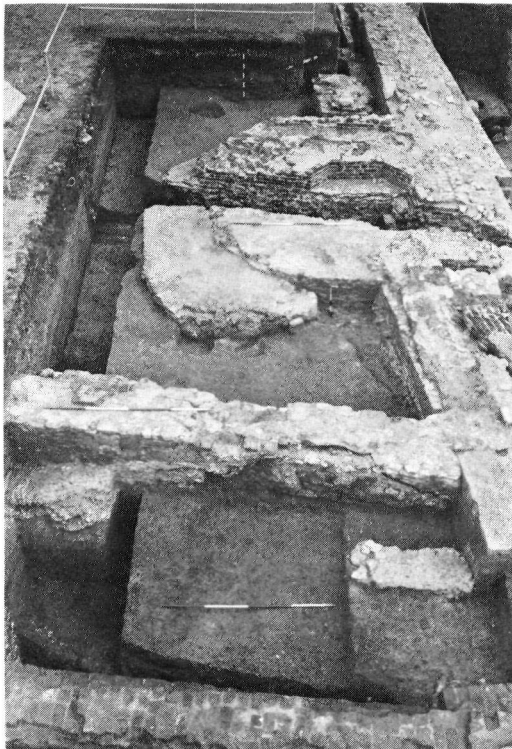
Plate 10. Eltham Palace: The east front of the range of queen's apartments, and the tower at the north-west corner of Henry VIII's chapel, showing the well of the stair
(Photo: Derek Craig).

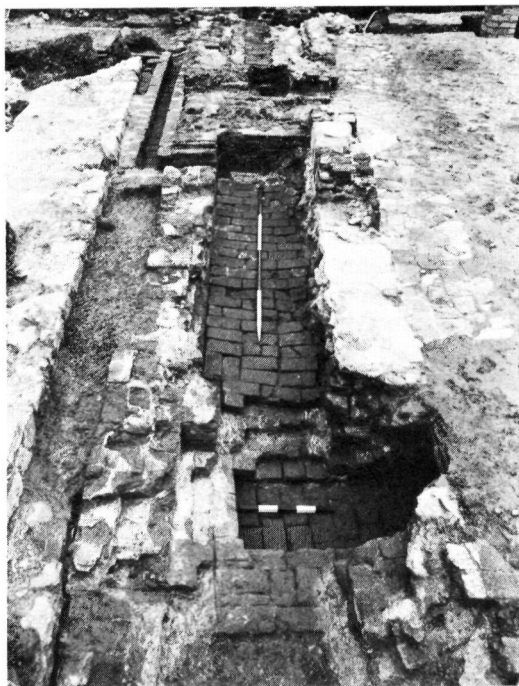
Plate 11. Eltham Palace: Drain G224, cistern G222 and garderobe G141 in the king's apartments of the Tudor period (Photo: Christopher Russell-White).

apartment formed by the new partition, and integral with the new front wall, was a garderobe (G141) served by a drain running along the outside of the wall and carried through it into a cistern (G222, see Pl. 11). The bottom of the cistern was of loosely-bonded brick which could never have retained water, so it seems likely that it accommodated a lead tank. There was probably some kind of trap at the north end of the cistern which could be used to flush the garderobe, though in the absence of the tank this can be no more than conjecture. It is possible, of course, that the garderobe was flushed whenever it rained, the rainwater being carried through the drain and cistern, but the size of the cistern argues against this and in favour of a quite sophisticated example of Tudor plumbing. The garderobe was filled with demolition debris containing a large number of pieces of clear window glass, a pane of glass with its lead

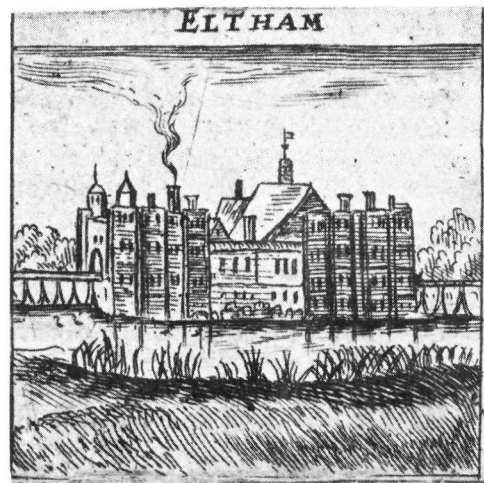
Plate 12. Eltham Palace: Drawing by Peter Stent made *c.* 1650 of Eltham Palace from the west, shortly before its demolition by Colonel Nathaniel Rich (Photo: Derek Craig).

Although the roof of the Chaplain's house is hidden by other buildings in the foreground of this drawing, Stent shows the roof of Edward IV's Great Hall and Henry VIII's Chapel. He shows the pitch

of the hall roof as being much sharper than it actually is, and by analogy it seems likely that his portrayal of the pitch of the chapel roof, which he shows as even sharper than that of the hall, is also inaccurate. Stent's drawing is useful, however, in showing the general massing of buildings just before their demolition.

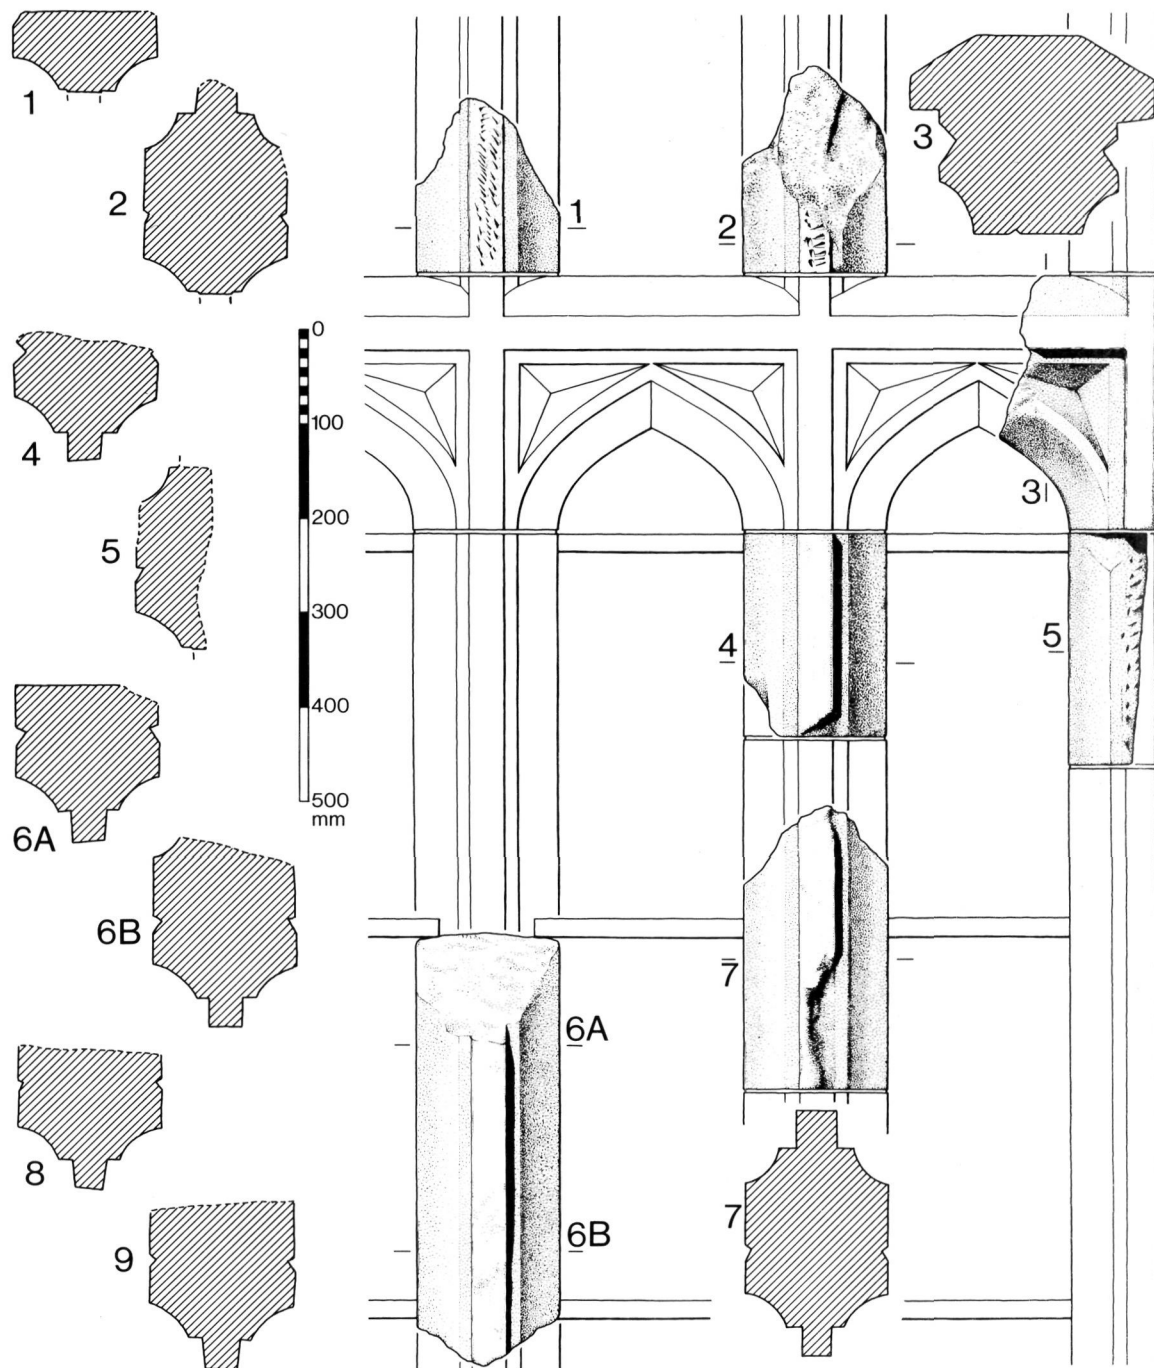
Fig. 14. Eltham Palace: Reconstruction of a window probably from the north gable end of the king's apartments (1/8).

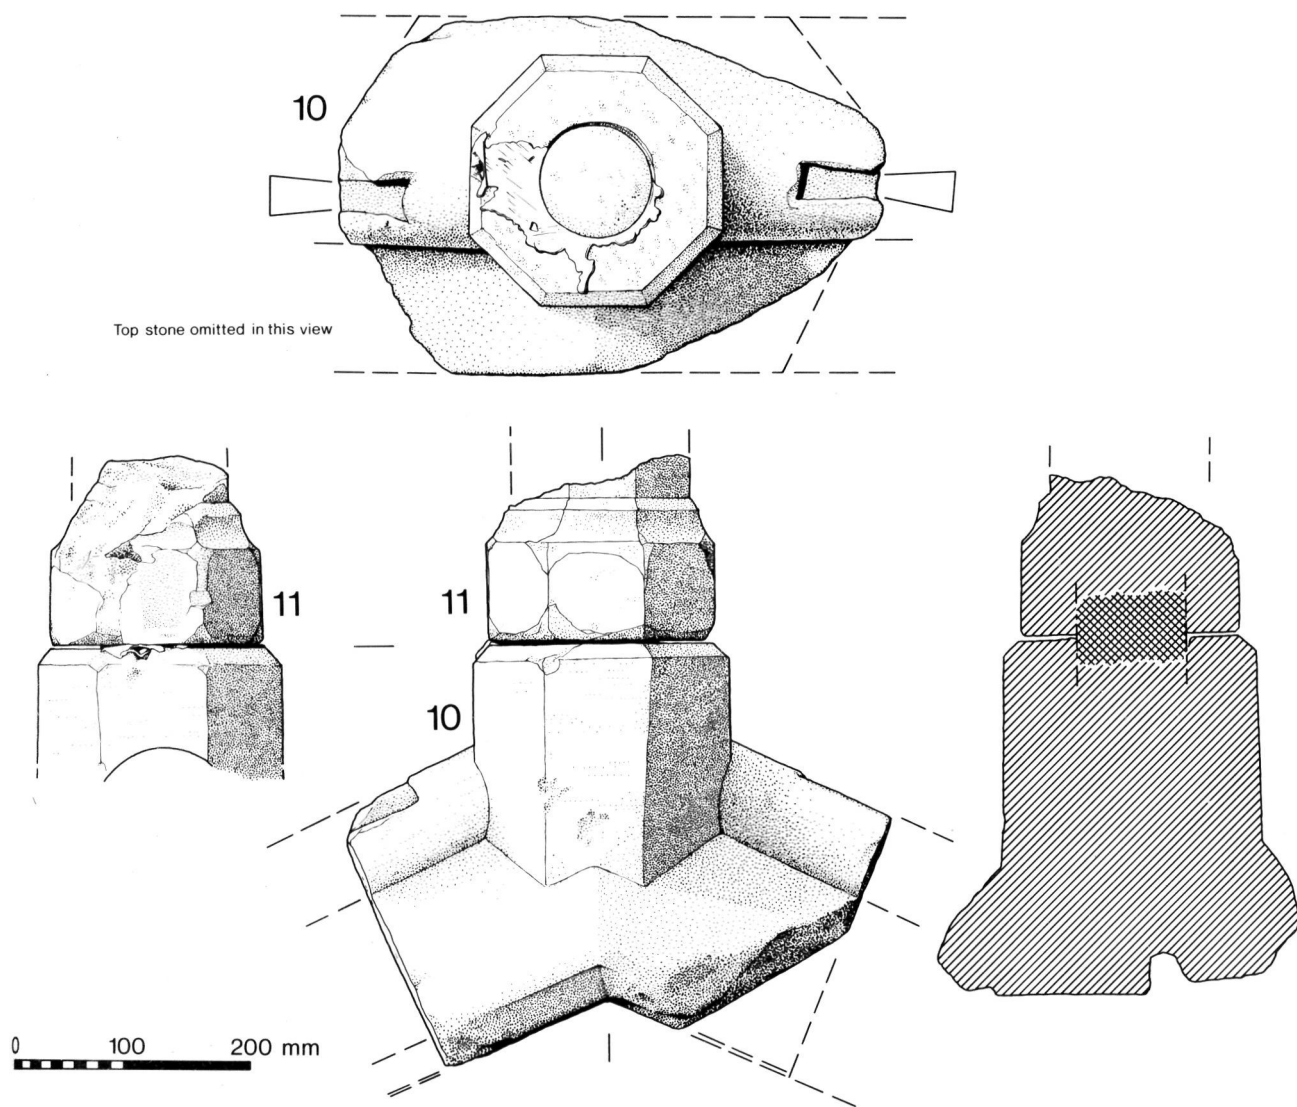
Fig. 15. Eltham Palace: Gable finial from the chaplain's house (1/6).

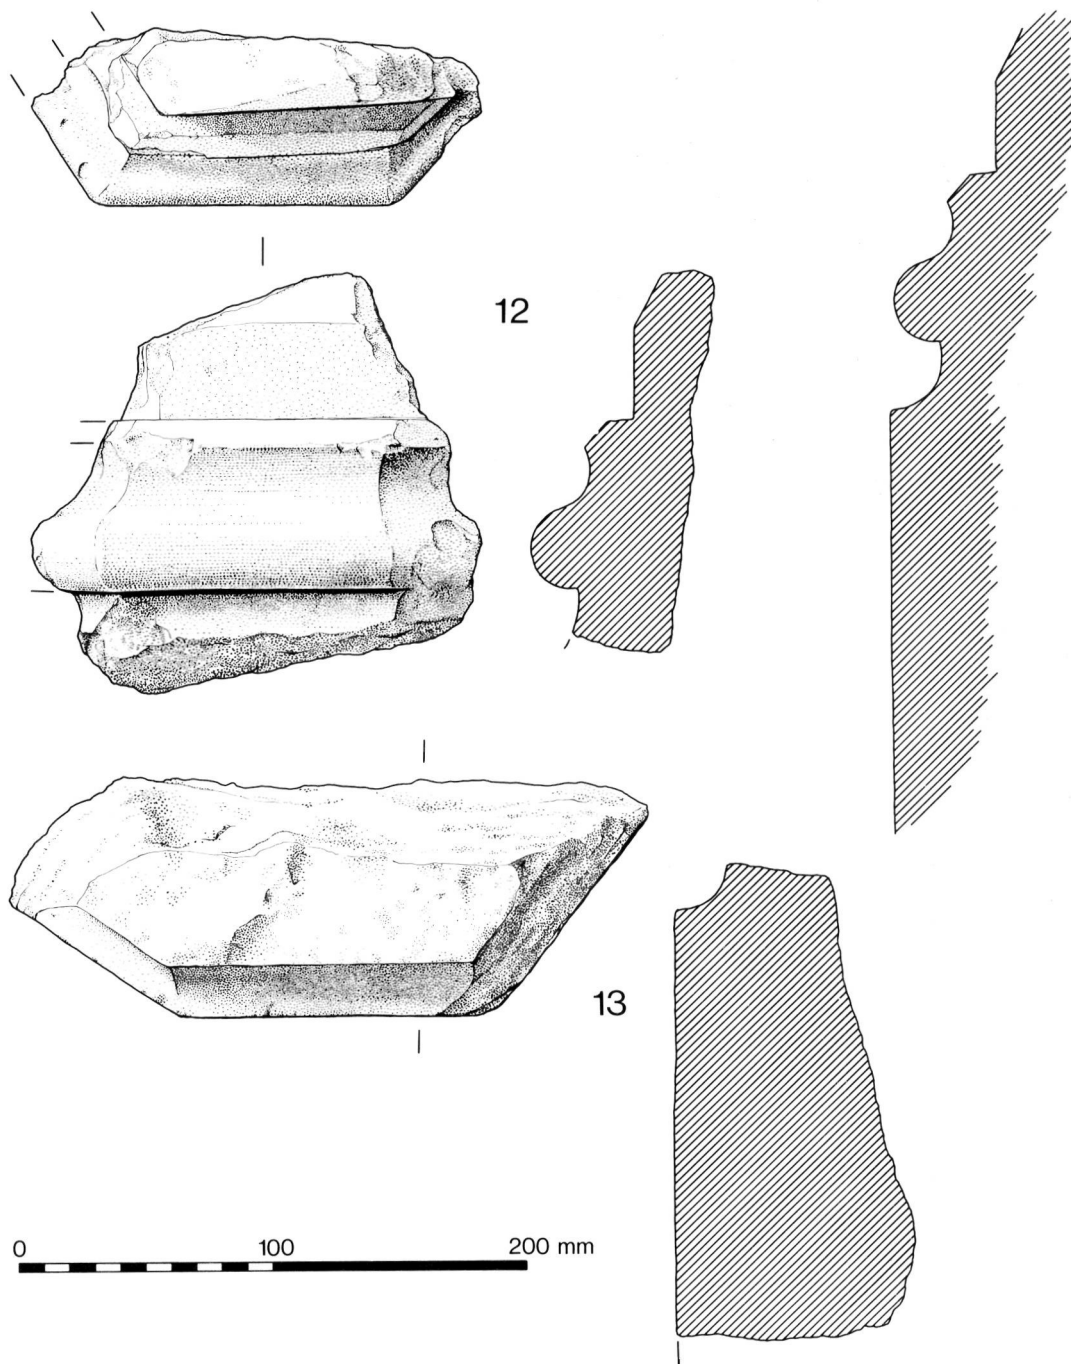
Fig. 16. Eltham Palace: Fragments of shaft base from the king's apartments, and a composite reconstruction of a complete base (1/3).

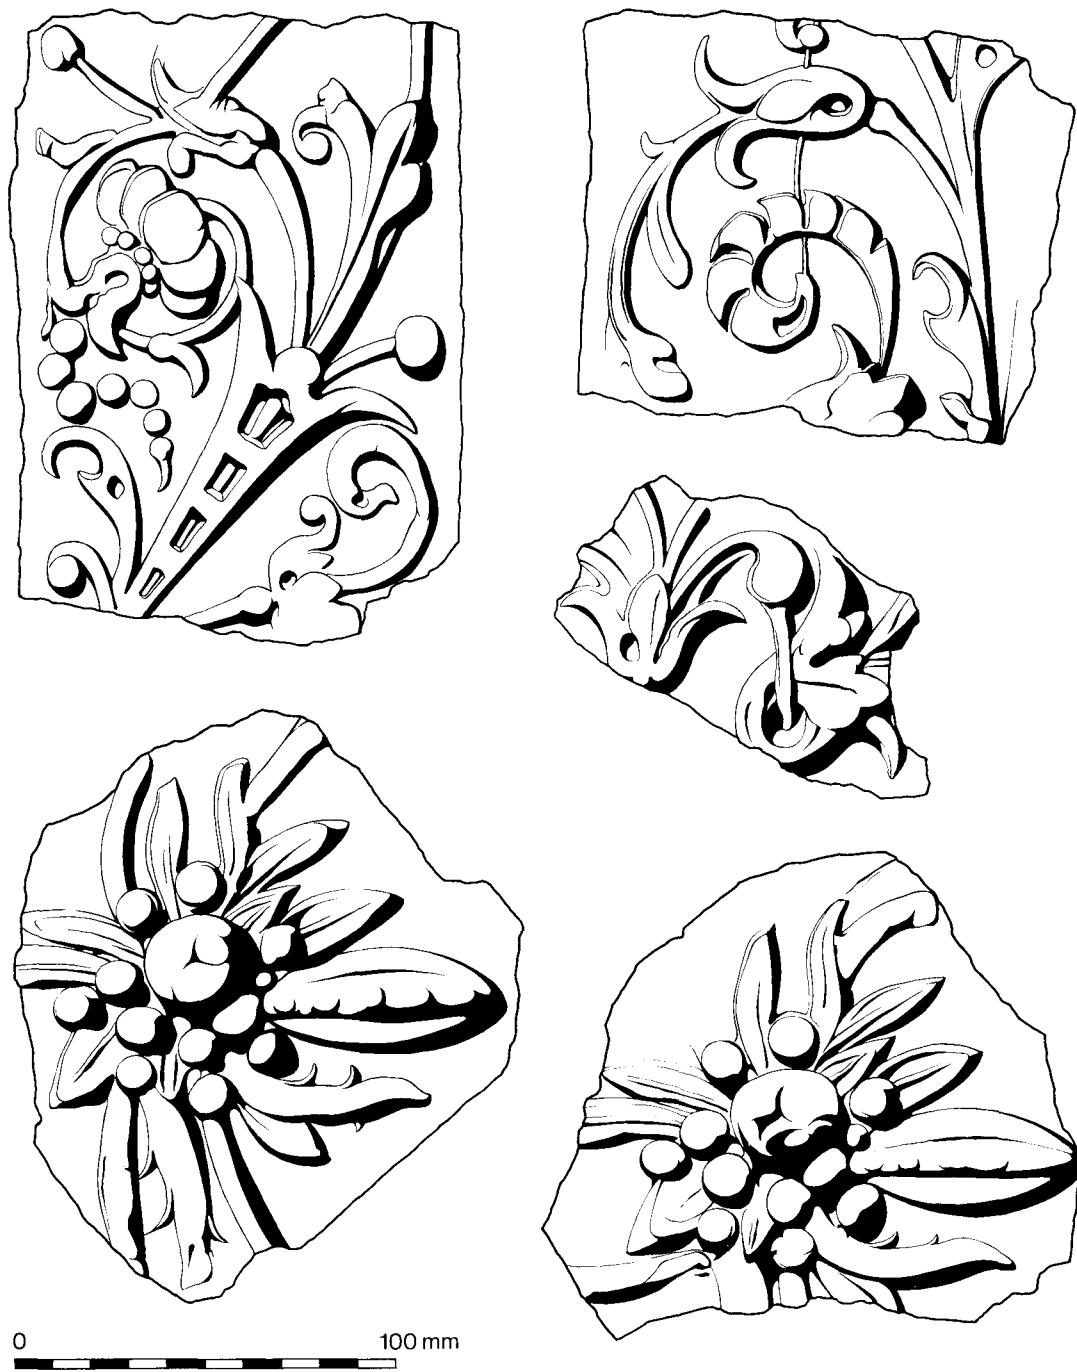
Fig. 20. Eltham Palace: Fragments of stucco (1/2).

The relief, composed of a rather gritty buff plaster averaging 10mm high, has been applied to a thick, coarse, buff-coloured plaster matrix. On one of the pieces (top left, Fig. 20), the fingerprints of the craftsman are

clearly visible on the relief work, where he has pressed this onto the matrix.

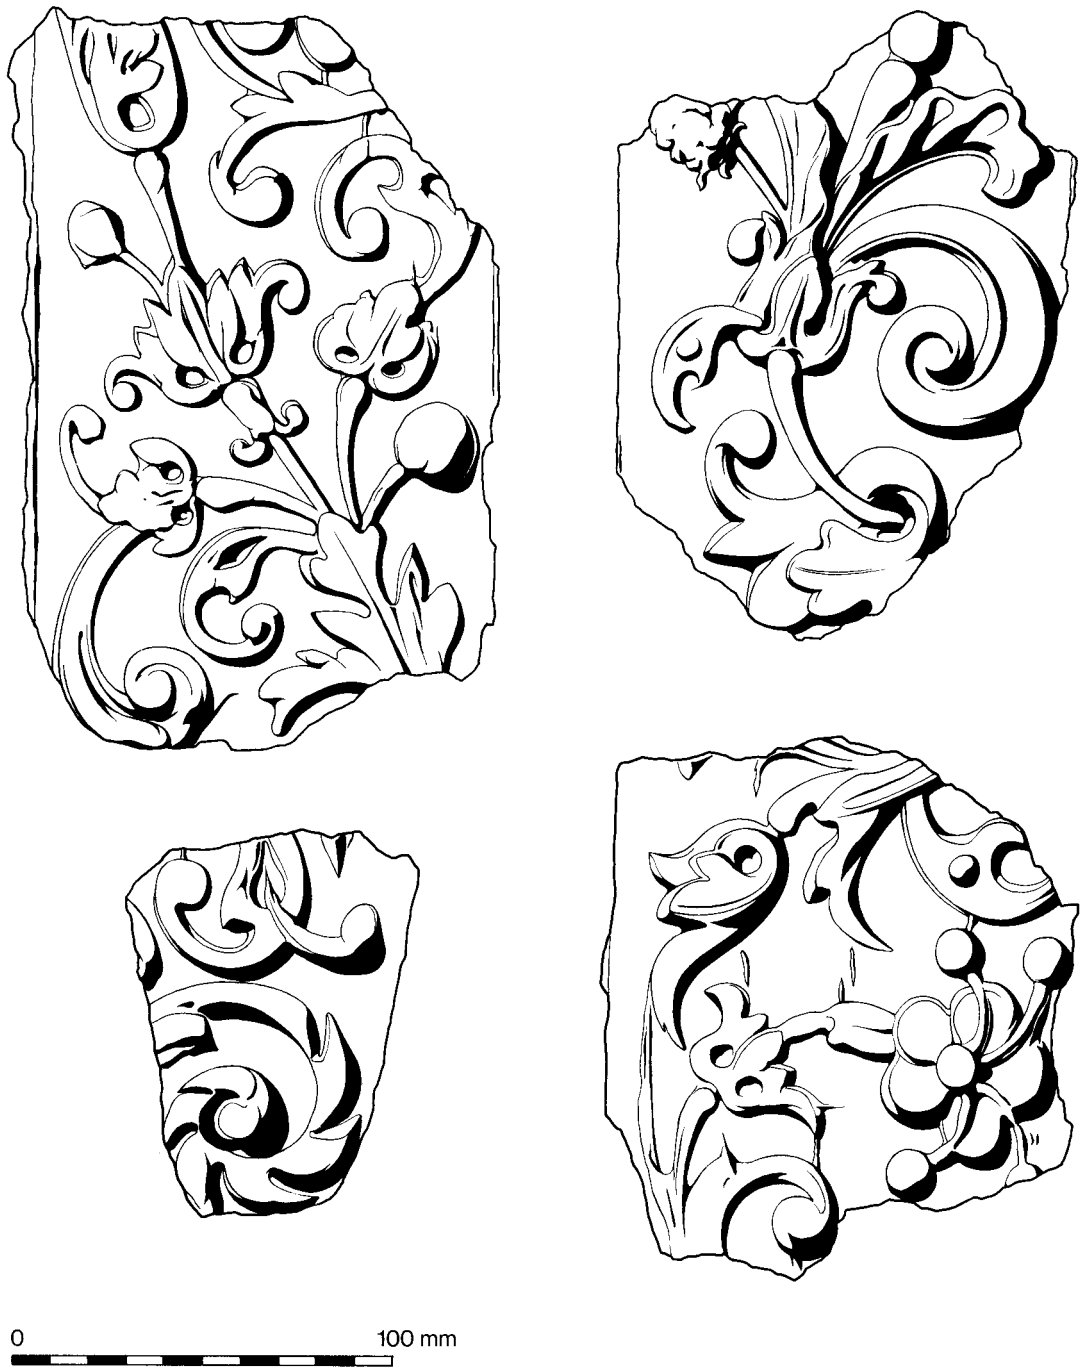
Fig. 21. Eltham Palace: Fragments of stucco (1/2).

discussed and illustrated below (pp. 244–5 and Fig. 14). Also recovered were fragments of a stucco frieze which probably came from the same area as the window (see below pp. 249–51, and Figs. 20 and 21). These window and frieze fragments help to give some idea of the above-ground appearance of the royal apartments in the 16th century.

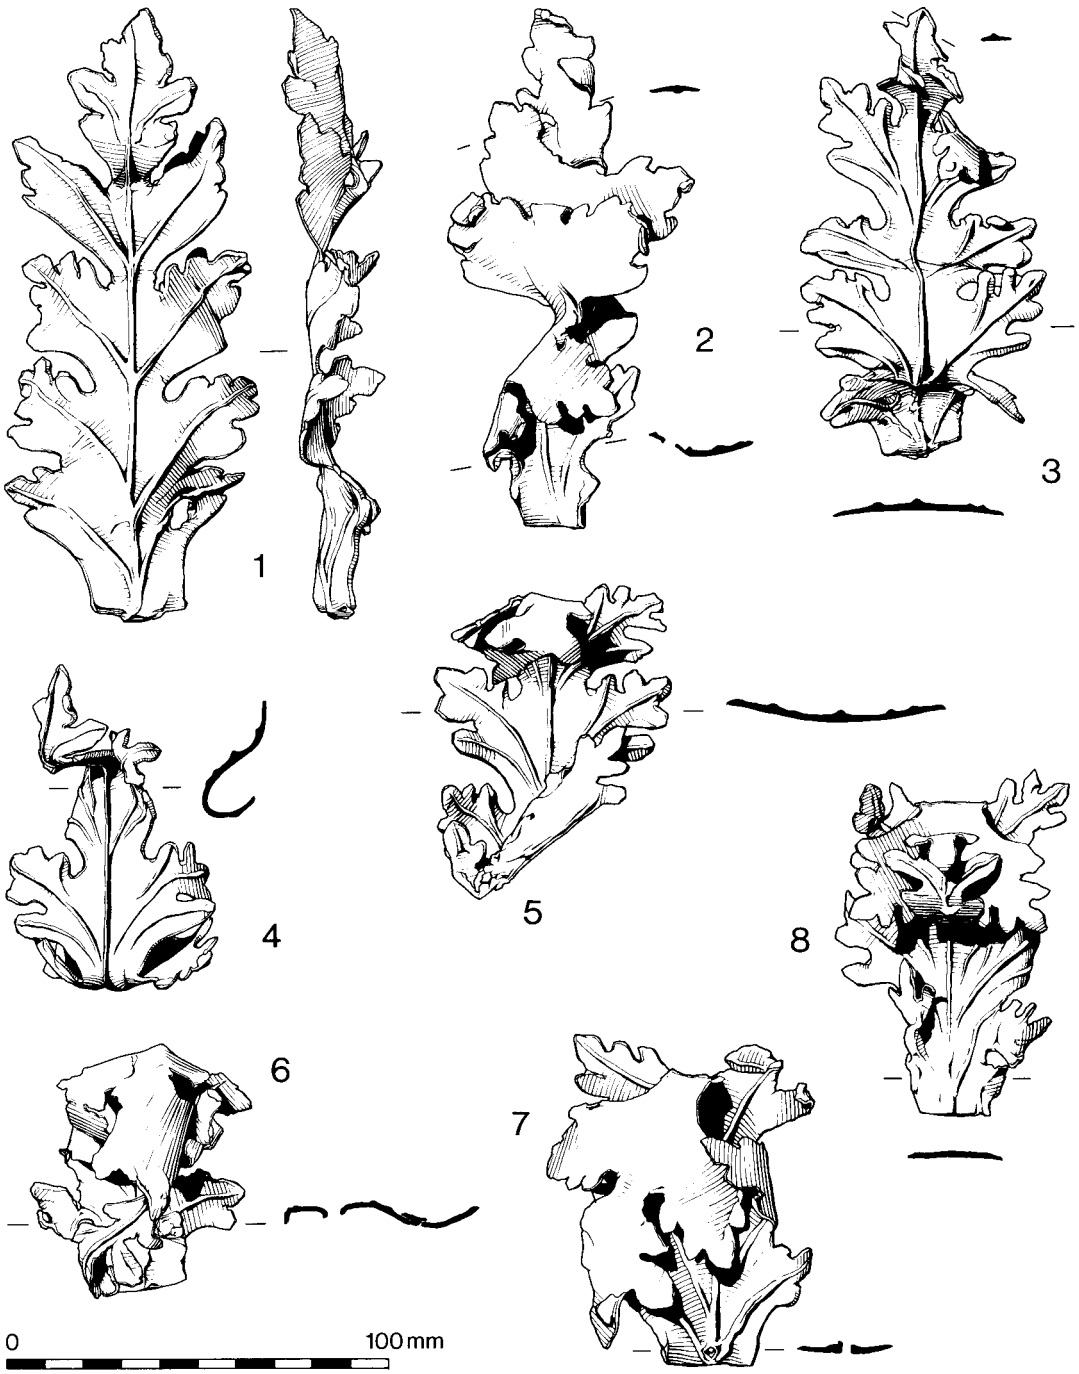
Fig. 22. Eltham Palace: Lead leaves (1/2).

The leaves have been cast in a mould. They

have rivet holes, and in some cases surviving rivets, at the base, presumably for attachment to the choir stalls, or in the case of the example recovered from a garderobe, to the wainscoting.
