# ARCHAEOLOGICAL EVIDENCE FOR THE DEVELOPMENT OF MEDIEVAL HOMERTON: EXCAVATIONS AT LINK STREET, HACKNEY

Kieron Tyler

## SUMMARY

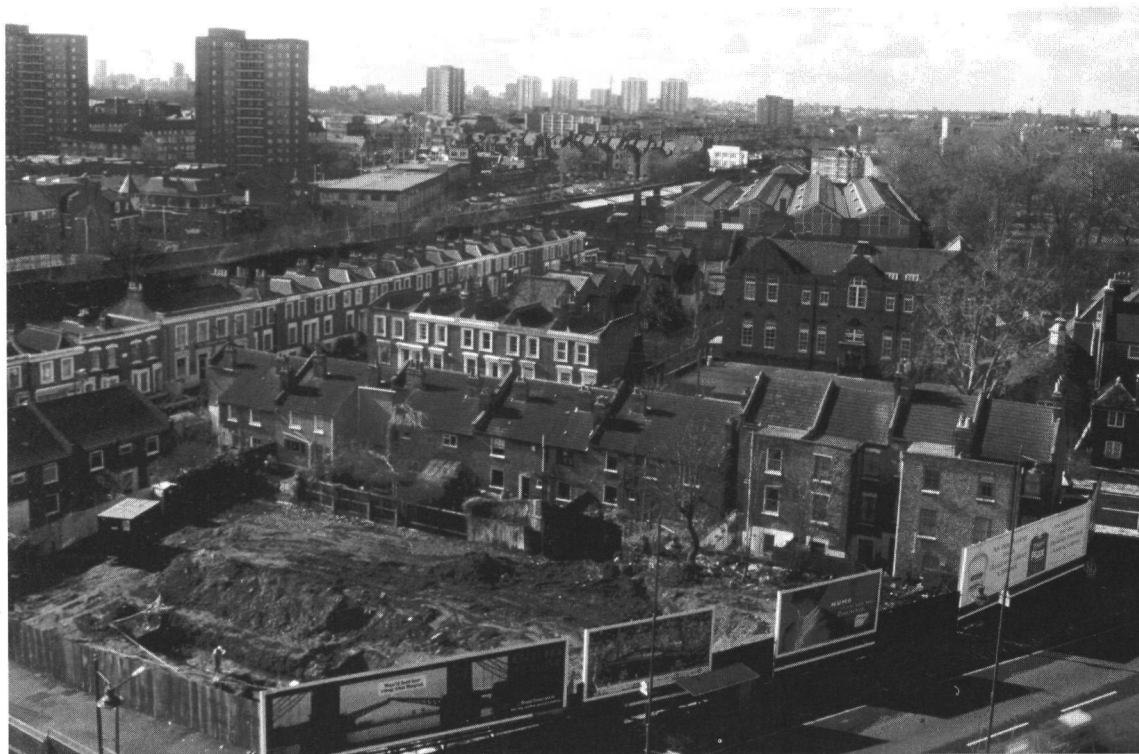
Fig 3. The excavations looking south-west

At the west end of Homerton High Street is the earliest surviving building in the area, now known as Sutton House, seen at the extreme right of Fig 3, and on maps. It was built on a ploughed field for the courtier and diplomat Sir Ralph Sadleir, to an H-shaped plan, shortly after 1535. The plough soil included artefacts dating from the 12th to 16th centuries, indicating

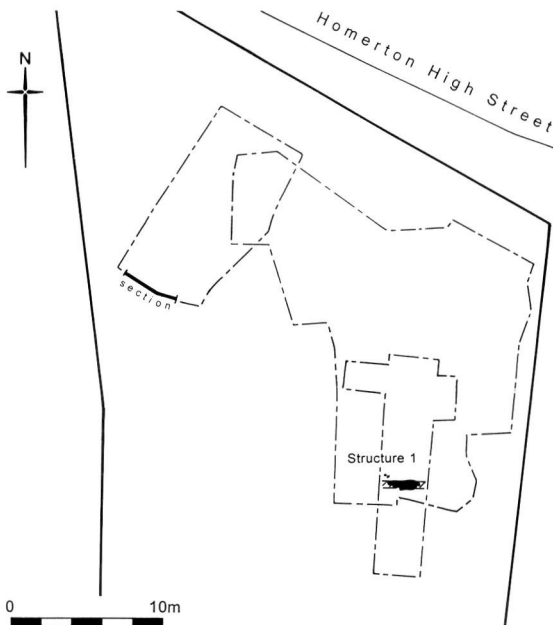
Fig 10. Location of the Structure 1 foundation

Structure 1 was an isolated stone foundation located near the southern limit of the excavation area (Figs 10, 11). This foundation did not relate to any building. It was constructed from uncoursed chalk blocks with some ragstone and flint bonded with pale grey sandy silt which made up no more than 20% of the whole foundation. The bonding material included

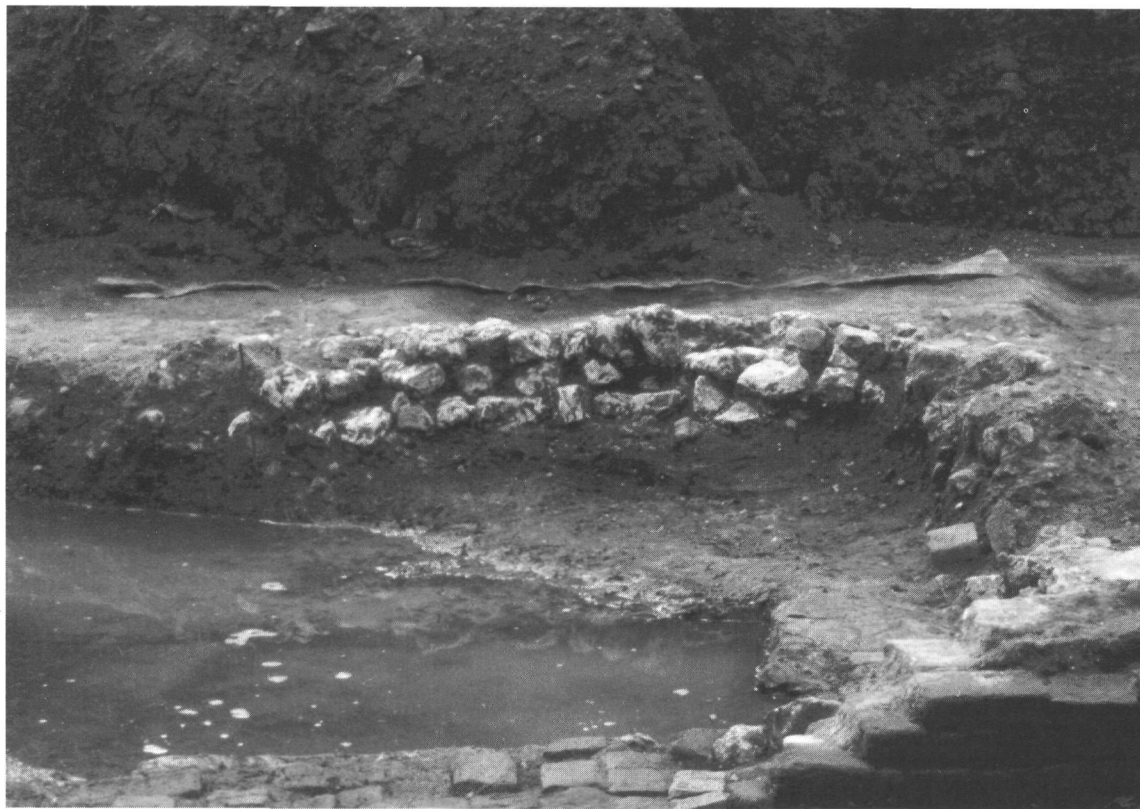
Fig 11. Structure 1 viewed from the north. The foundation measured 2.04m east-west

calcareous London-type ware dated to 1080–1200. The coursing can be seen on Fig 11. The base of the foundation was at c.9.60m OD, and it was truncated at 9.93m OD. The foundation measured 2.04m east-west  $\times$  0.66m north-south. No superstructure survived. As the foundation survived in isolation, little interpretation as to the type of structure of which it was part is possible. The subsequent water related activities indicate that this area of the site was marginal ground, so Structure 1 is unlikely to be part of a building. It was more probably a lining, or part of a feature related to water management.

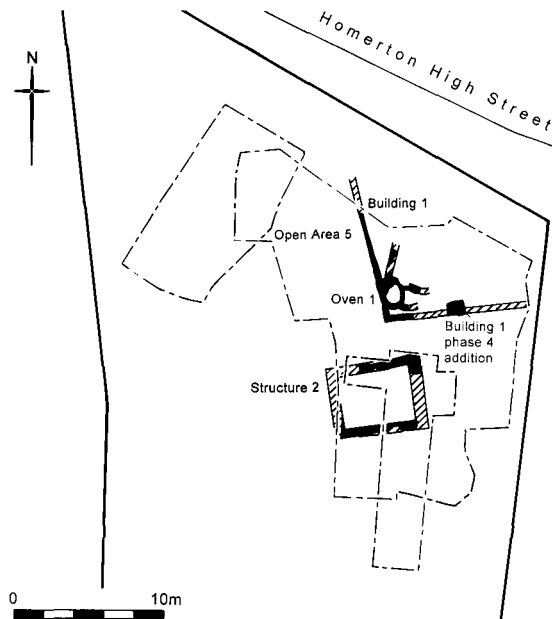
Fig 12. Building 1 with Open Area 5 to the west and Structure 2 (reservoir) to the south

and late 16th centuries. These shared certain characteristics: they were all constructed of chalk and flint, the bonding material was a similar grey mortar, they were all of a sleeper type (*ie* flat based) and they were of similar thickness (between 0.32m and 0.50m) (Fig 12, 13, 14).

The south end of the north-south foundation was abutted by the L shaped foundation of the south-west corner of Building 1 (Figs 12, 13). The corner foundation was constructed from a random coursed mixture of 70% chalk blocks

Within Building 1 were three further abutting foundations which represented the bases of internal features (Fig 12). Each was constructed from a random coursed mixture of chalk blocks, flint nodules, ragstone and peg tile. They were bonded with a light grey coarse mortar with fine pebble and flecks of charcoal or chalk.

Taken together these foundations described an oval/circular feature within Building 1, most probably the base of an oven (internal diameter 1.30m) constructed integral to the building. The disuse of Oven 1 was marked by an internal fill of compacted brickearth deposit. Excavation of the backfill revealed no finds or debris from the use of the oven.

Building 1 consisted of foundations constructed upon make up layers which sealed Open Area 4 (Fig 12, 13, 14). As stated above, the layers which comprised Open Area 4 may have been laid in preparation for the construction of Building 1. The dating of Building 1 is based on it being

In Period 4 the ditches to the south of Building 1 were replaced by a brick lined, rectangular reservoir (Figs 12, 18). This feature respected the alignments of Building 1, which remained standing. During Period 4 the site and the land surrounding came into the ownership of Ralph Sadleir from 1535–50. Some redevelopment would be expected during this period.

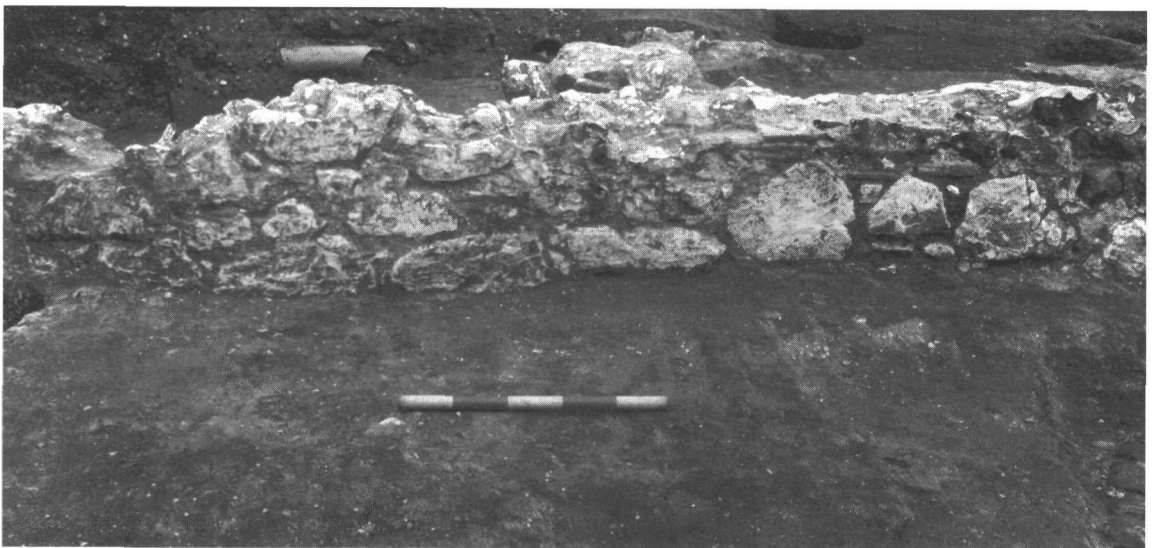
*Fig 14. View east of base of west wall of Building 1. Scale is 5 × 100mm units*

The west side of Building 1 was marked by the most substantial foundation, a random coursed mixture of 80% chalk blocks (up to 360mm) and 20% flint nodules (up to 180mm) with occasional peg tile used as levelling courses (Fig 14). The bonding material was a light grey coarse mortar with flecks of charcoal and chalk. The west and east sides were fair faced. Traces of a mortar rendering survived on the east face. The maximum width of the foundation was 0.43m, with a surviving height of up to 0.52m. A length of 6.90m was recorded, and the foundation extended north beyond the limit of excavation. Base level was 11.20m OD, and the foundation was truncated at 11.62m OD. The south end curved eastwards respecting the outline of a feature within the building.

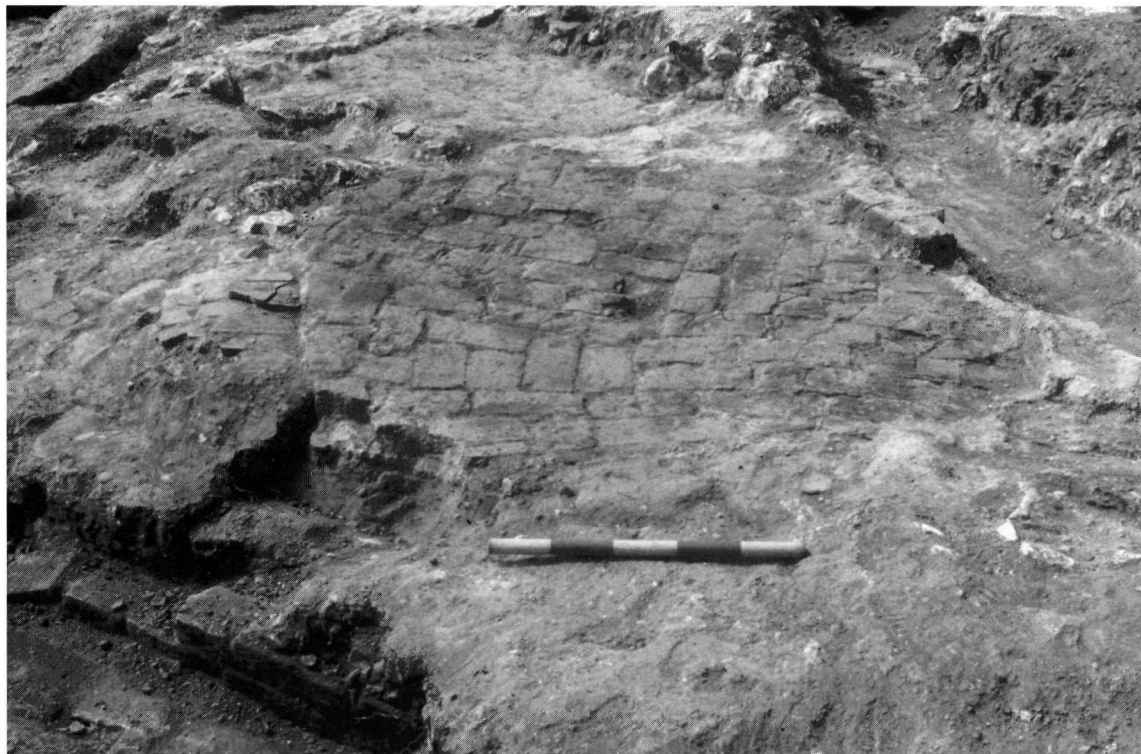
*Fig 15. View west of brick base of Oven 2. Scale is 5 × 100mm units*

The base of Oven 2 consisted of a layer of bricks (surface level 11.32m OD) set into a cut which truncated the foundations which surrounded Oven 1. Overall the bricks were set on a bed in an uneven pattern and bonded with an off-white compact mortar, which also underlay the bricks as a bedding layer up to 40mm thick. Up to 70% of the bricks were whole. Oven 2 was oval (long axis of 1.60m aligned north-west/south-east). The bricks were in a fairly soft orange to red type known to be in use before the Great Fire of 1666 and perhaps a little beyond. In this case the bricks appeared overfired, probably a result of use within the oven. The surface of the bricks were scorched in patches unconfined to one particular area of the feature. The bricks had a size range of 214–20mm × 99–104mm × 45–58mm. Bricks which showed a distinct curve along their stretcher faces were also used and these had a size range of 195–215mm × 92–104mm × 51–5mm. This type of distortion is sometimes caused by overfiring, however as they were within a curved oven feature, they may have been deliberately formed in this shape (Smith in Tyler, 1997 48–9).

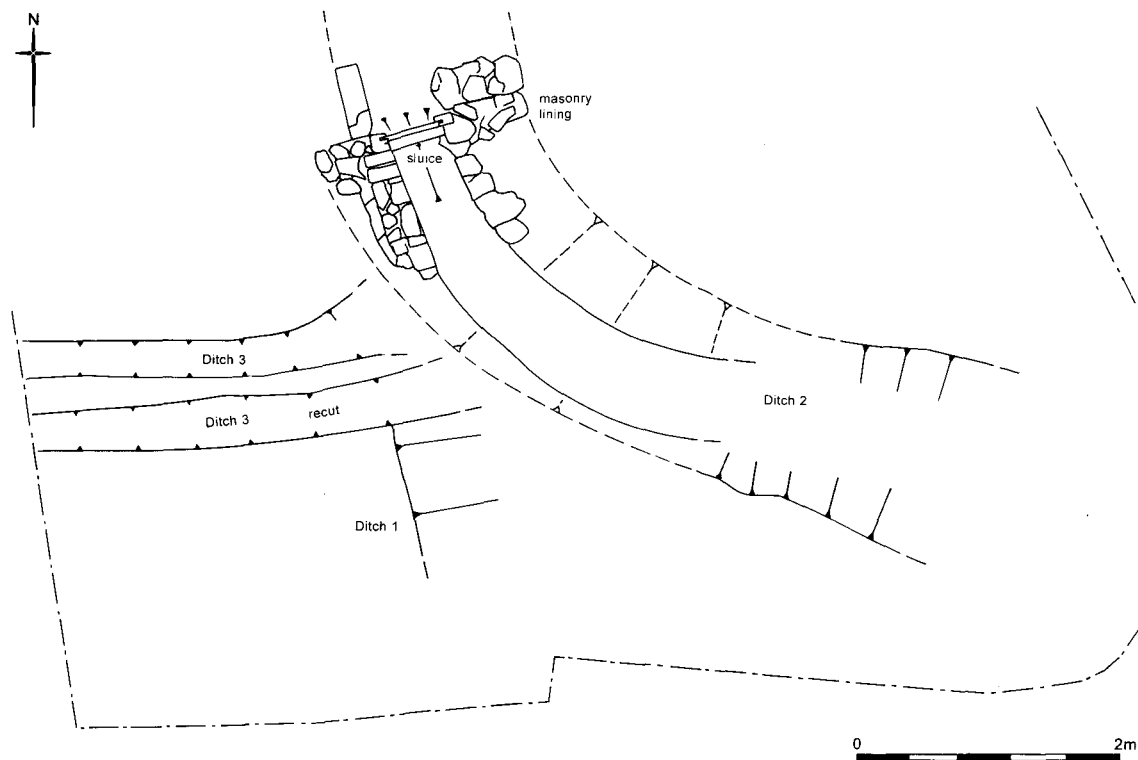
Fig 16. Plan of Ditches 1, 2 and 3. Ditch 2 with sluice

Ditch 1 was replaced by a masonry-sided drain which incorporated a timber sluice (Fig 16, 17).

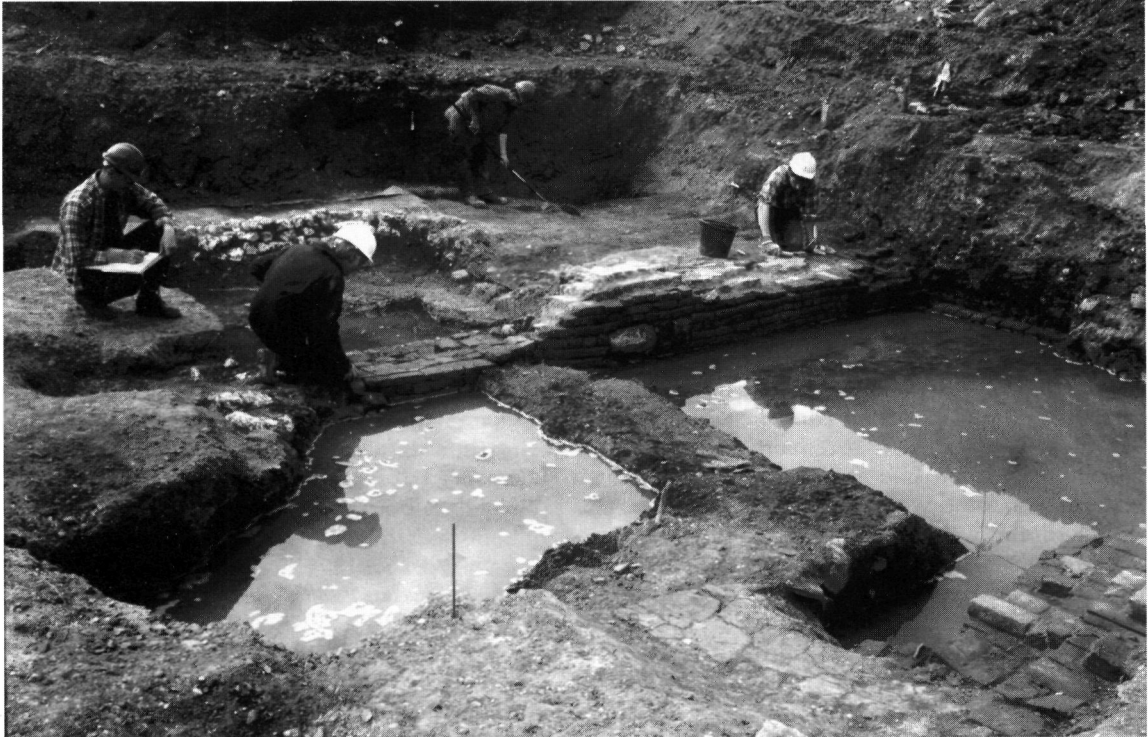
Fig 18. Structure 2, the reservoir, seen from the north-east

The rectangular brick lining of the reservoir had been built against the clay lining. The internal dimensions were 3.60m north-south  $\times$  4.70m east-west. The northern and southern east-west elements were observed. Additionally, the south end of the western north-south element was observed. The main body of the eastern north-south element had been cut away by later intrusions, but the corners where this side joined the east-west elements survived. This level of survival therefore allowed for a reconstruction of the whole extent of the feature.

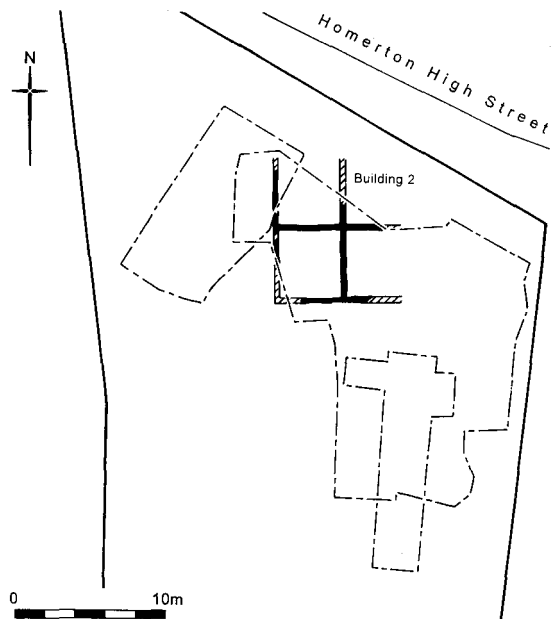
Fig 19. Plan of Building 2

In Period 8 a complex of brick foundations was constructed to the north of the site after the backfilling of the stakeholes discussed above (Figs 19, 20). The buildings represented by these foundation are depicted on maps of 1831 and 1870 (Figs 6 and 7). They were probably constructed shortly after the demolition known

Building 2 represents the remains of the buildings constructed along the newly laid out Link Street after 1800 subsequent to the demolition of the buildings on the 1792 plan (Fig 5). Building 2 consisted of a series of brick foundations constructed at right angles and parallel to each other (Figs 19, 20). The relationships were mainly abutting and the foundations could be of one building, or a group of adjacent buildings constructed together. Map evidence would suggest the latter. No surfaces of internal features survived. The backfill of the construction cuts for these foundations included English tin-glazed ware, yellow glazed border ware, post-medieval redware and imported German Frechen stoneware dated overall to 1600–1800.

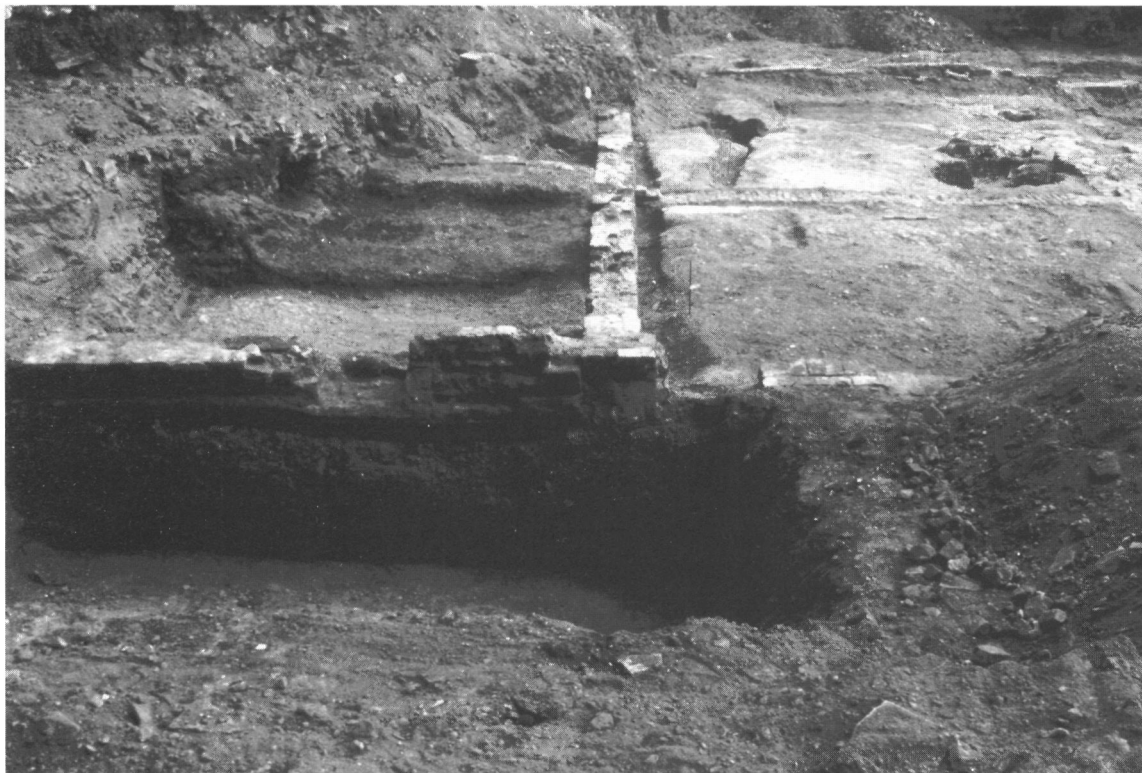
Fig 20. The foundations of Building 2 seen from the west. Scale is  $5 \times 100\text{mm}$  units

The bricks employed were of various types including both pre-Great Fire types and later types indicating reuse of demolition debris. Base level of the foundations was 11.44m OD–11.80m OD. They were truncated at up to 12.27m OD.
