STANMORE PARK: FROM MEDIEVAL AND POST-MEDIEVAL RIBBON DEVELOPMENT TO COUNTRY HOUSE AND ESTATE

Tim Carew and Ken Sabel

SUMMARY

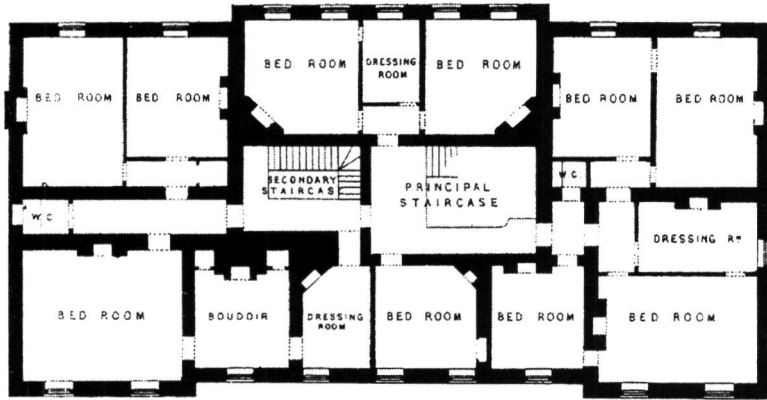
Fig 4. The plan of the ground and first floors of the country house and part of the service complex in 1884

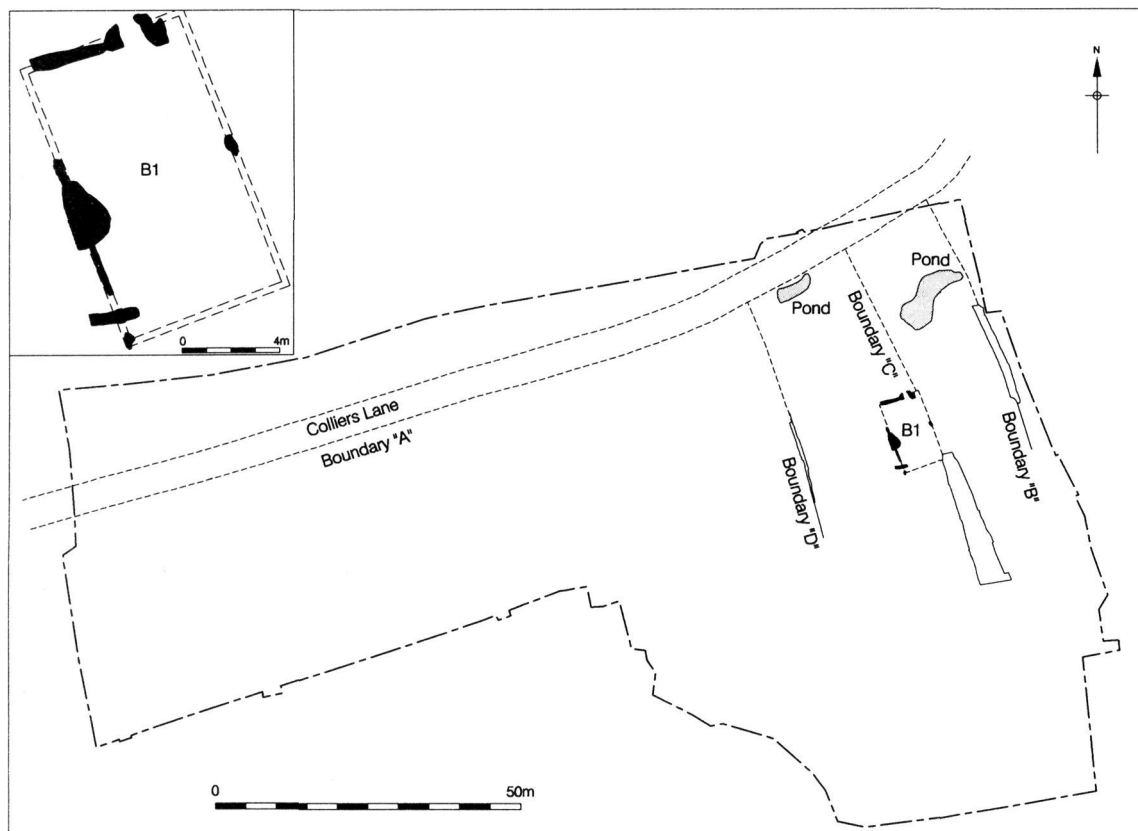
Fig 6. Phase 1: interpretation of site layout (inset: [B1])

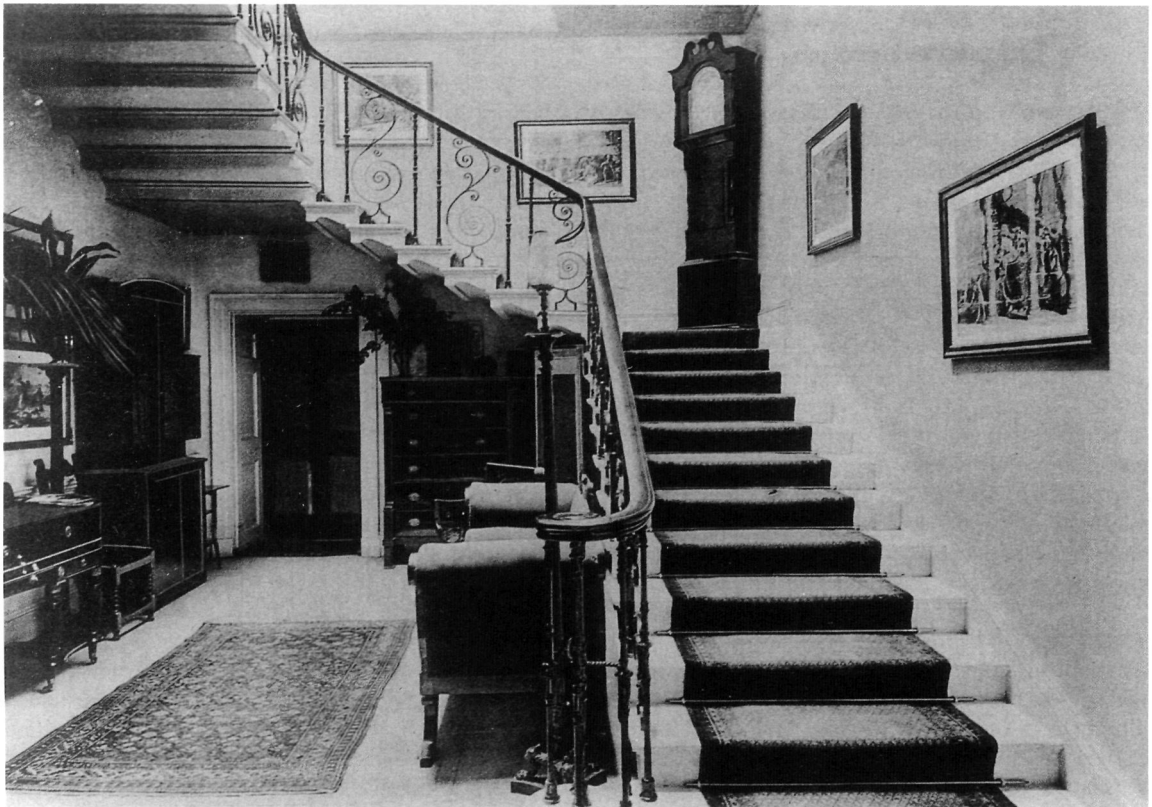
Fig 13. An historic photograph of the main staircase of the country house (NMR: BB75/3979)

The flooring in the basement consisted of Portland stone blocks and laminated sandstone blocks. The former are likely to be original, as Portland stone was imported in large quantities for the construction of the house. The demolition debris found within the rooms of the basement produced fragments of chimney (Fig 14), many of which had lead covered wrought iron cramps that tied the stones together. The stacks above roof level were made of Portland stone, all of which showed signs of internal sooting. The photograph of the staircase (NMR: BB75/3679; Fig 13), shows the wrought iron 'S' shaped balusters and Portland stone stairs, both of which were found in the excavation. In the debris

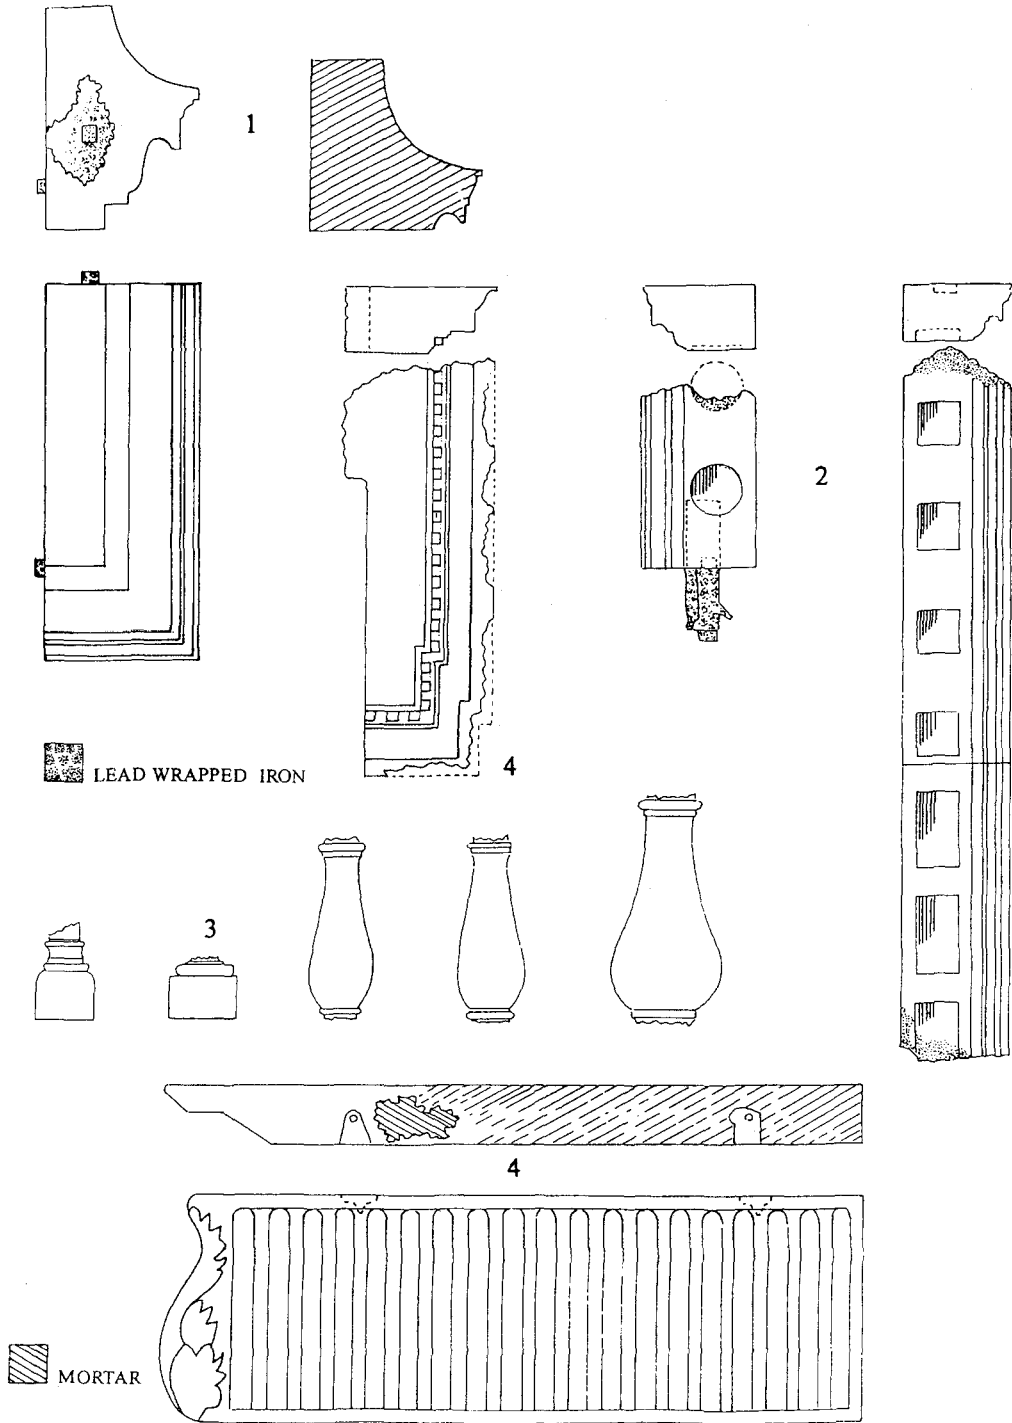
Fig 14. Some of the stone found in the excavation: (1) Two fragments of Portland stone chimneys (one in profile and one in end view) showing the two types of moulding found; (2) Two patterns of balustrade entablature; (3) The range of balusters found; (4) Fragments of marble fireplace

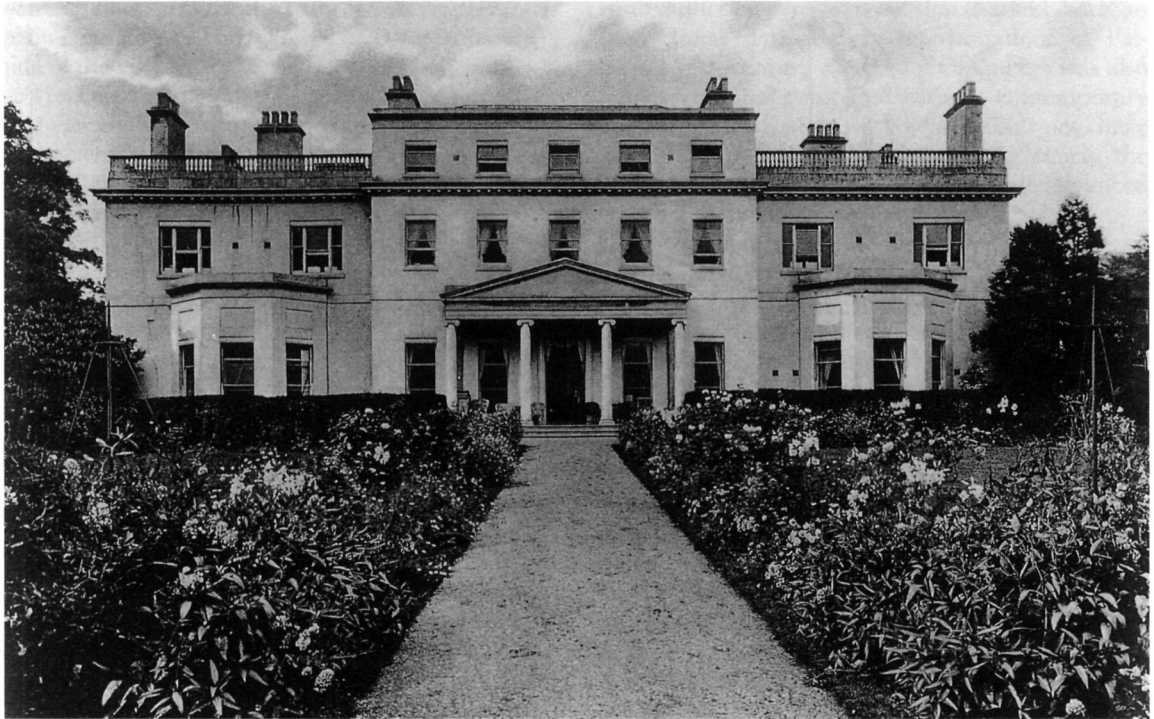
Fig 15. An historic photograph of the rear elevation of the country house (NMR: BB75/3675)

Prints published in 1806 and 1815 (RBS: DR/201/10; Figs 3 and 17) show the house much as it appeared in later photographs (NMR: BB75/3672–3677, 3681 and 3682; Fig 15). The front of the house had two principal floors, ground and first, as well as the basement and an attic. The central five bays at the front of the building were slightly recessed from the outer bays. There was a dentilled cornice above the first floor, above which there was a ballustrated parapet in the central five bays, behind which were five dormer windows. On the outer projections there were triangular pediments, each with a central oculus, above the cornice, that were also decorated with dentilation. There was a central ground floor Ionic portico occupying three bays at the front of the building; this had a plain entablature and no pediment. There was a string course between the ground and first floors.

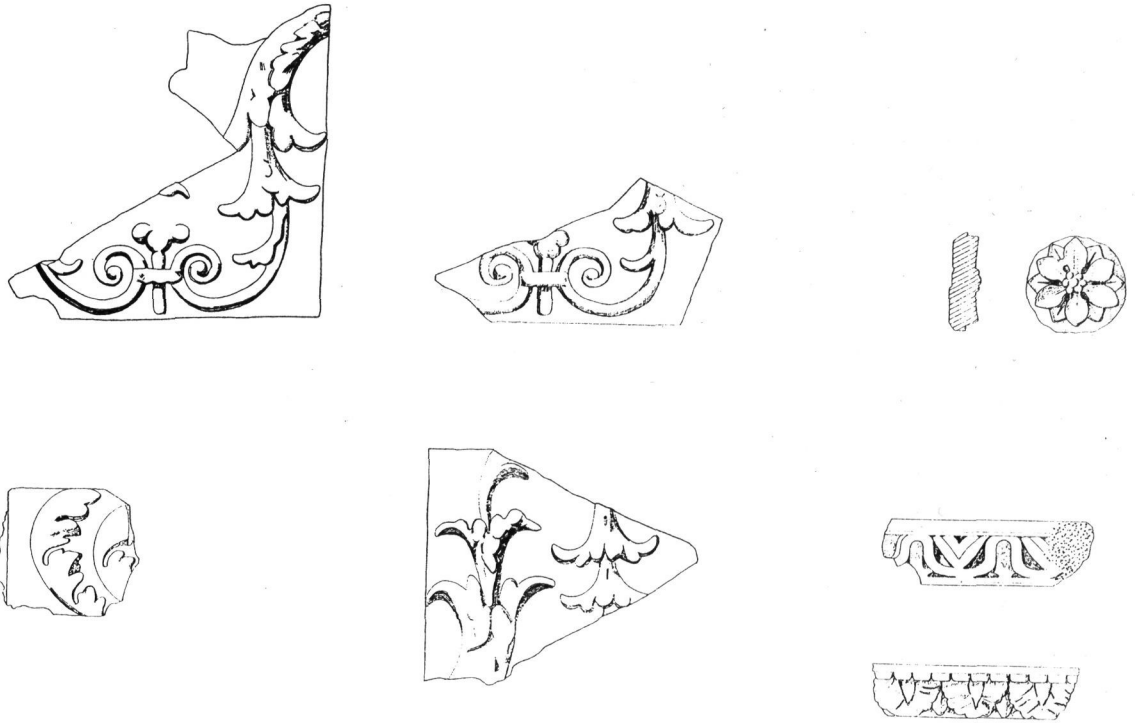
Fig 16. Some of the plasterwork found in the excavation

filling Room 2 there were fragments of ribbed marble fireplace architrave and plain marble hearth slabs, a style that became popular in the 1770s (Callow 1996, 155). Among these fragments of fireplace was a fragment of a marble mantelpiece (Fig 14). These fragments probably came from the fireplaces in the rooms above, either on the ground or first floor. Fragments of Portland stone balustrade were also found, including two sizes of baluster (Fig 14). The smaller balusters were relatively slim and were probably from the roof of the house; they appear particularly narrow on a photograph of the rear elevation (Fig 15). Fragments of plaster recovered from the demolition debris (Fig 16) show the high quality of the interior decoration.⁴

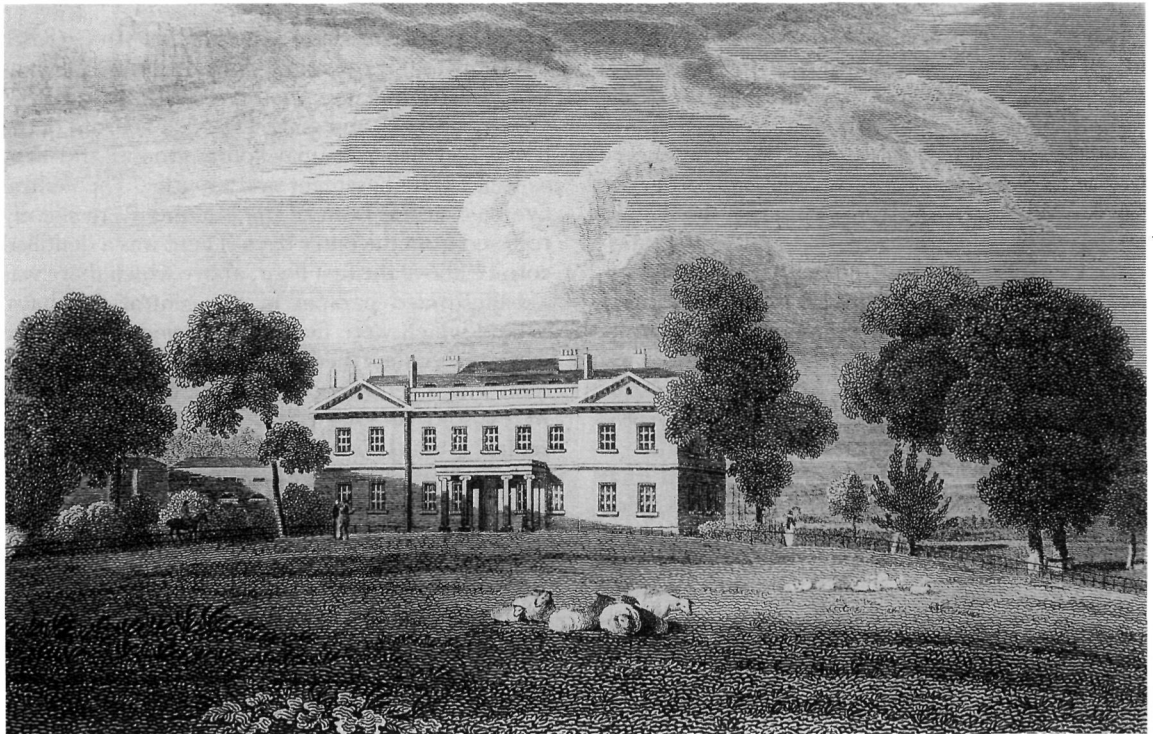
Fig 17. An 1815 print of the front of the country house, reproduced by kind permission of the Royal Bank of Scotland Group

flanking bays, and the attic storey was topped by a plain entablature. The recessed flanking bays either side of the attic storey were topped by balustrades.⁵

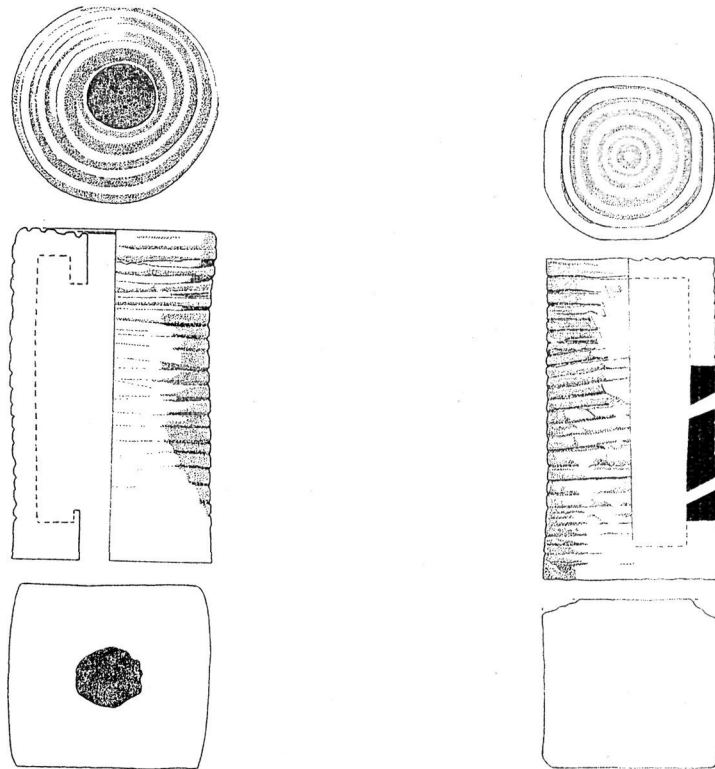
Fig 20. Bottle bricks found in the excavation; scale 1:4

Some of the rebuilding work on the structure of [B8] in Phase 7 is indicated by the presence within the demolition rubble filling the central rooms at the front of the house of numerous hollow earthenware 'bottle bricks', with sub-cylindrical coiled construction and squared-off bases (Fig 20). These were developed in 1785 by the French architect St Fart, as a lightweight vaulting material (Ayres 1998). They may have been made locally at Stanmore and must have been considered a novelty by the manufacturers, as there was little standardisation in their manufacture. Two main types were found. They either had central holes at the

circular end and sometimes at the squared end as well, or were completely closed but with a small hole, or holes, stabbed through their sides to prevent them exploding in the kiln. It seems likely that a timber floor in the entrance hall, or one of the ground floor rooms either side of it, was replaced by something heavier, which would have required the more solid support of a vault. The use of bottle bricks would have reduced the amount of additional weight on the basement walls. The 1839 sale particulars record that the entrance hall was paved in marble, and a photograph shows a black and white marble tiled floor (NMR: BB75/3678), fragments of which were recovered from the demolition deposits.

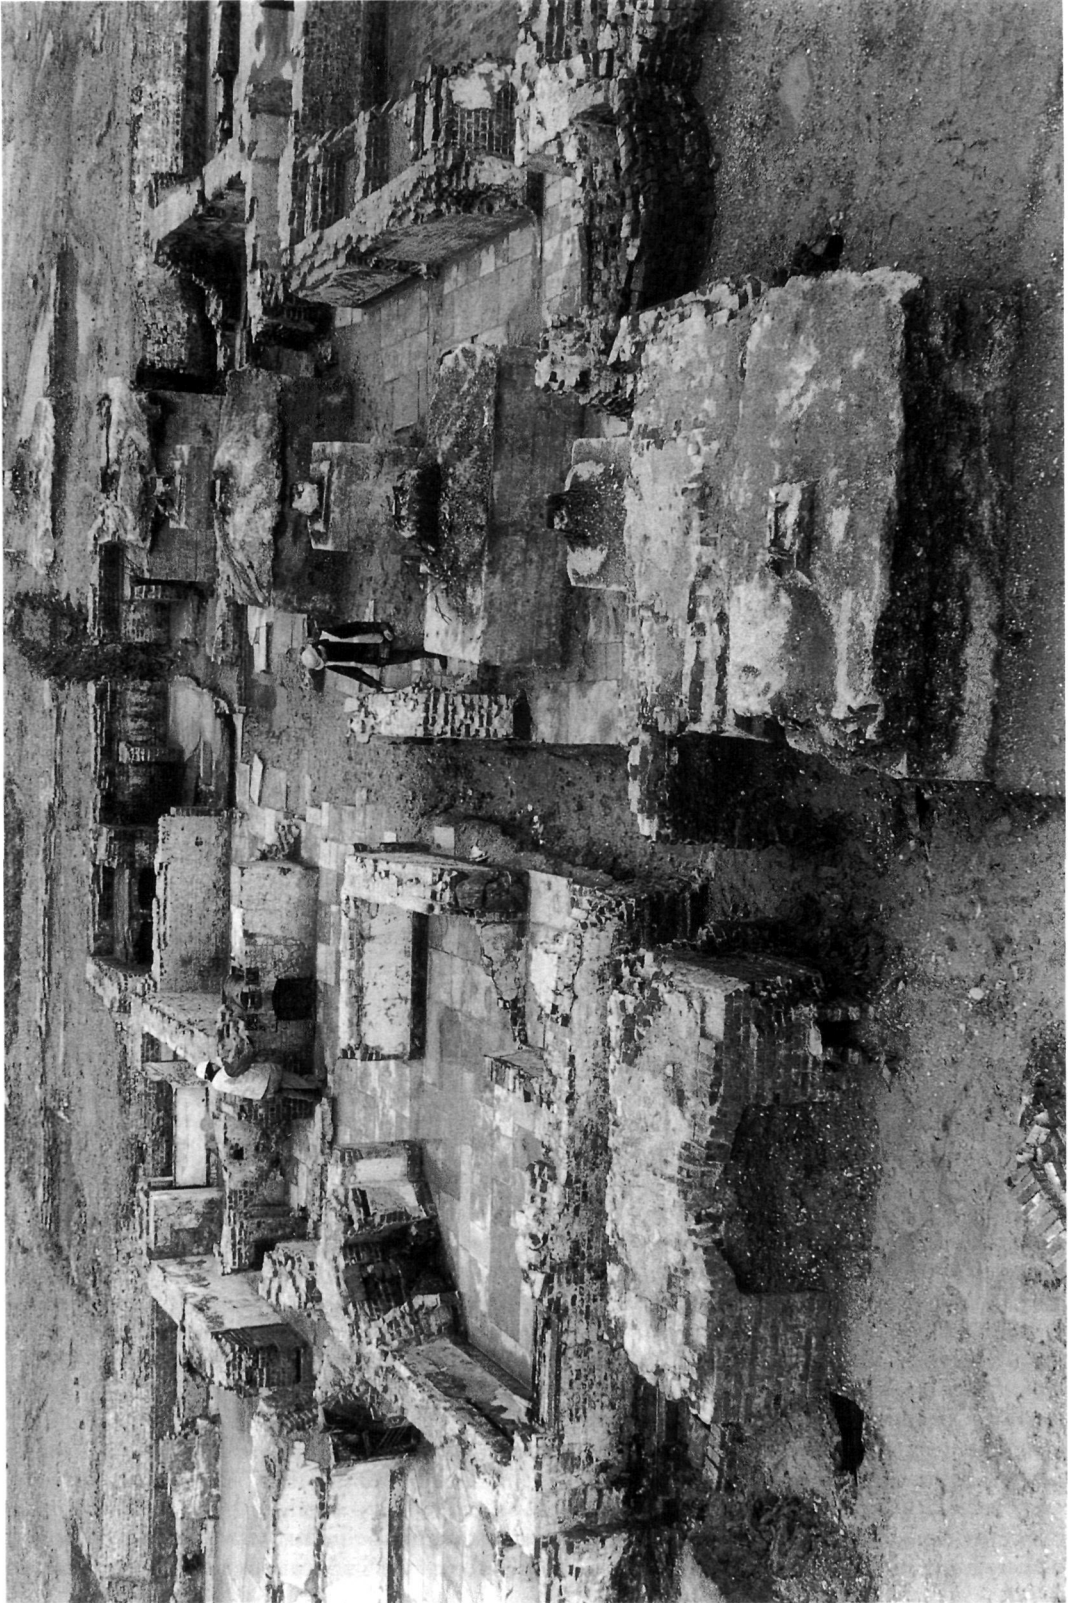
Fig 21. Excavation of the country house (Building [B8]), the central five bays from the rear (south)

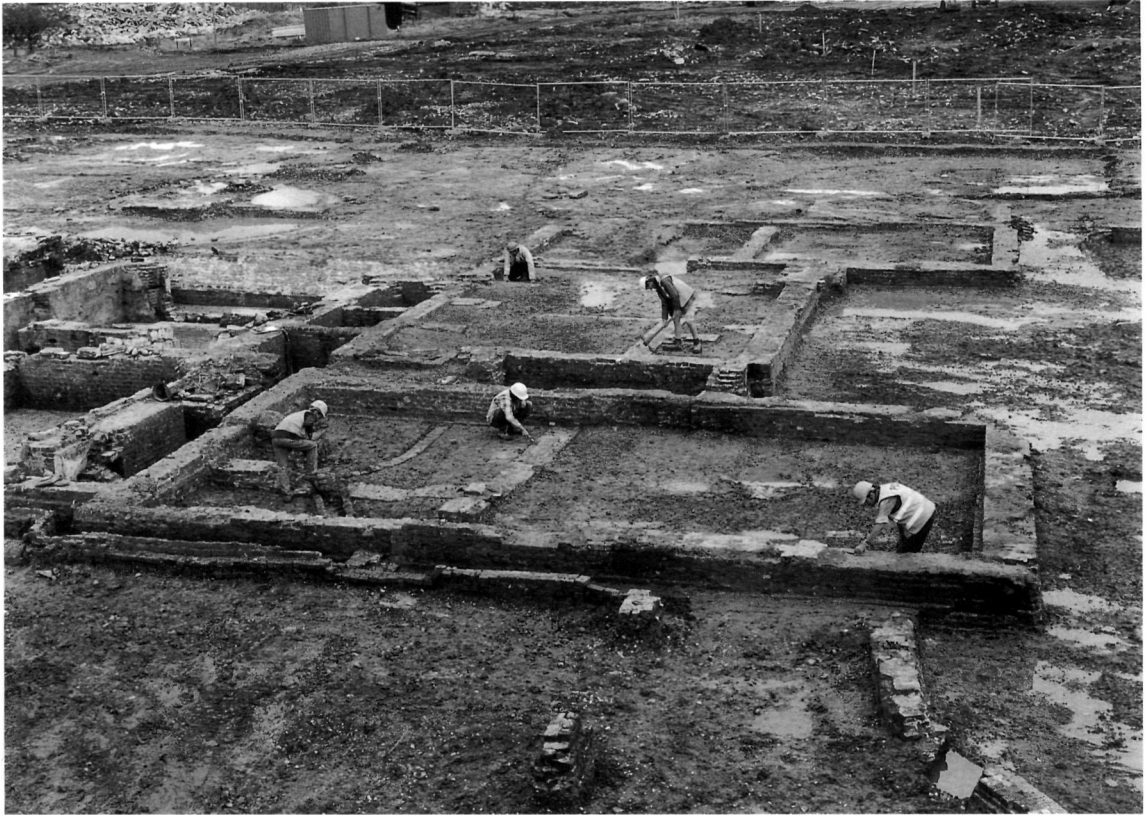
Fig 22. Service building [B12] and the east side of the country house, from the south

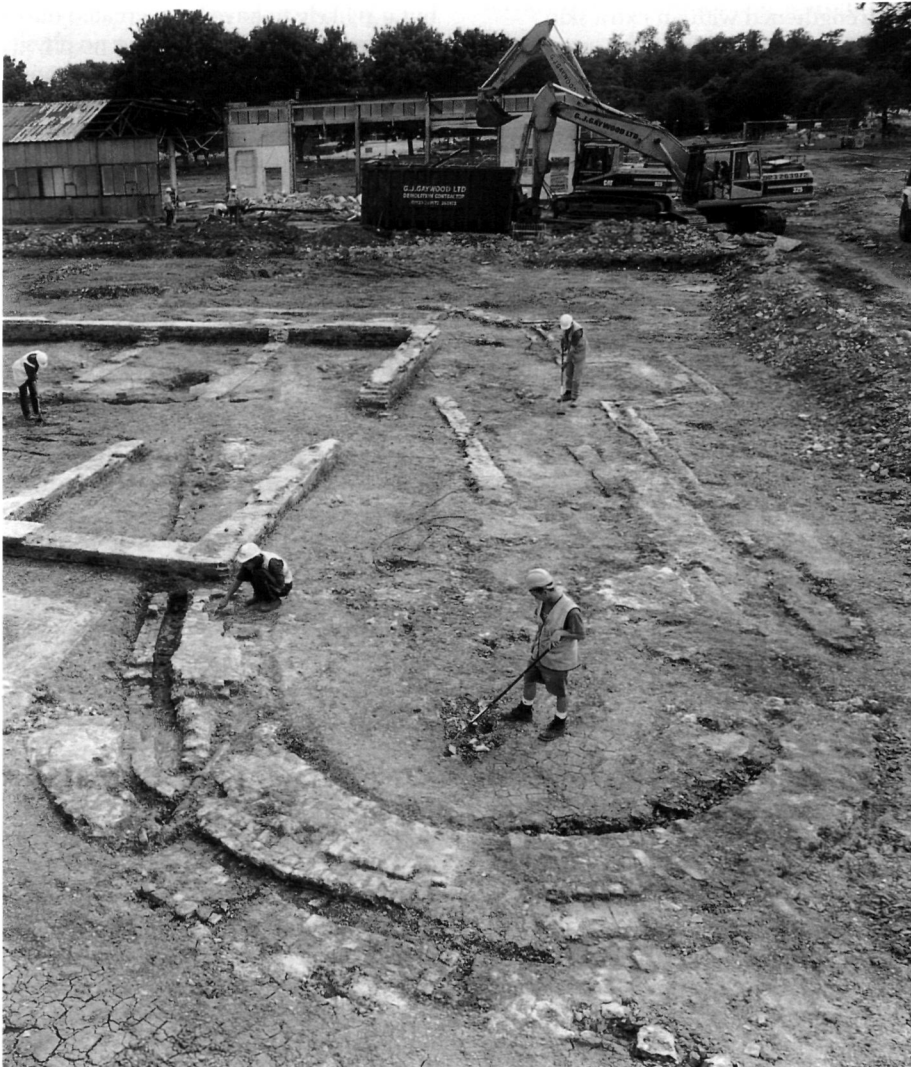
Fig 24. Bow-ended extension of Building [B3], from the north

both its south-west and north-east sides, more than doubling its footprint. The south-west one was 26m long, and occupied the same position as [B2]. Unless this was coincidental it may have been an enlarged replacement for it, with [B2] surviving up to Phase 7. This extension had bowed ends and the north-west façade had a lightwell, although the slope meant that one was not required to the south-east. Part of a brick floor survived within it, and slight traces of walls show the locations of its internal partitions, although insufficient to reconstruct the floor plan. An asymmetrically placed projection may have been a porch, and as this was a different build from the rest of the extension it may have been a later addition. The drain along the outside of this wall respects this projection, and this elevation was strengthened with an extra skin.
