RUISLIP MANOR FARM: RESULTS OF AN ARCHAEOLOGICAL WATCHING BRIEF AND GEOPHYSICAL SURVEY ON THE SITE OF A MOTTE AND BAILEY CASTLE AND A MEDIEVAL MANORIAL COMPLEX

SUMMARY

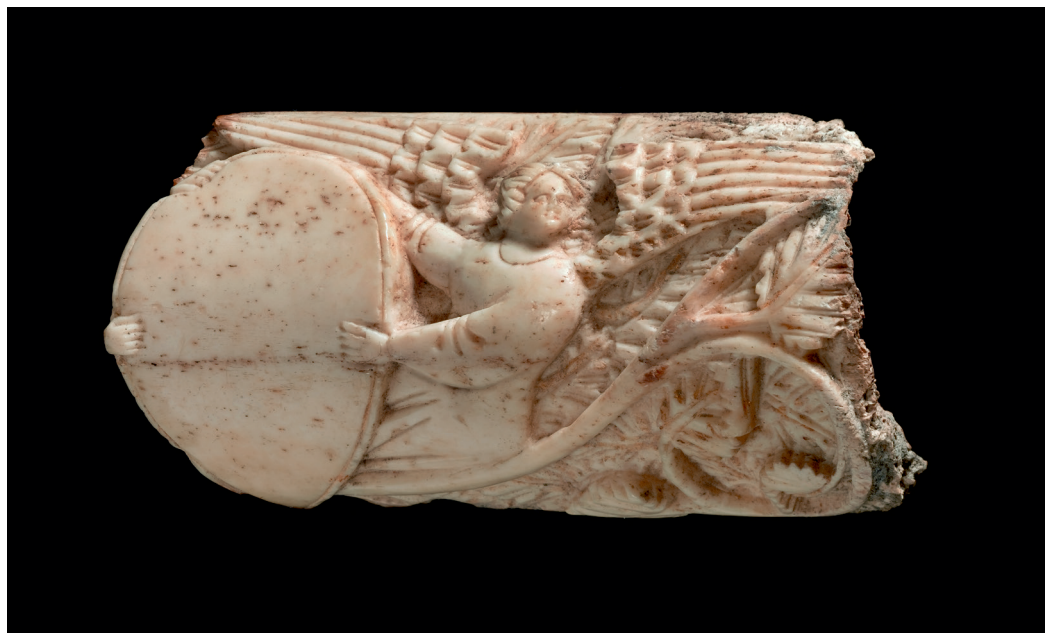
Fig 10. The fragment of medieval carved bone inlay (length 78mm)

The object is an incomplete fragment of carved bone 78mm long (RMO05 <1>), which is now on display in the Manor Farm House at Ruislip (Fig 10). It was produced from an ox metapodial (identified by Alan Pipe, MOLA), which was split in half and then carved in bas-relief on the semicircular surface with an angel on the right supporting an oval shield having a pointed base (the hands, probably of a second angel, at the break are on the left side of the shield); the surviving angel, with wings outstretched, looks out to the right, away from the shield (which hides the lower limbs) and appears to be supported on a stylised foliate scroll with jagged-edged leaves. There are tiny traces of gold on the scroll and angel, and possibly of red pigment at the base of the shield.

The object is likely to be an inlay from a late medieval casket (c.1420), following the style of north Italian marriage versions from the Embriachi family workshop, dated from c.1380 into the 15th century. Many of these have putti or similar supporting a heart-shaped shield uniting the arms of the two partners, all against a foliate background (Longhurst 1929, pl LIX; Randall 1993, cat nos 232, 233, 235).

This fragment, with its angel supporter (facing outwards in contrast to the putti, who look towards the arms they hold), different form of shield and stylistically distinct foliate background, is probably a north European (eg French) adaptation of the Italian caskets, possibly for a specifically religious milieu. No obvious close parallel has been traced. This highly accomplished carving may have been produced at, or for, the Abbey of Bec in Normandy, which owned the manor of Ruislip from c.1087 until 1404 (discussed above). The arms that may be presumed to have been painted on the shield were perhaps those of the abbey. The condition is not that of a buried object but suggests that it may have been found or rediscovered, possibly during the renovations of the farmhouse in the 19th century, and then discarded for unknown reasons.
