THE PROOF HOUSE AND LATER WORKS AT TOWER WHARF, HM TOWER OF LONDON: AN ARCHAEOLOGICAL INVESTIGATION

Anthony Mackinder with contributions by Graham Keevill

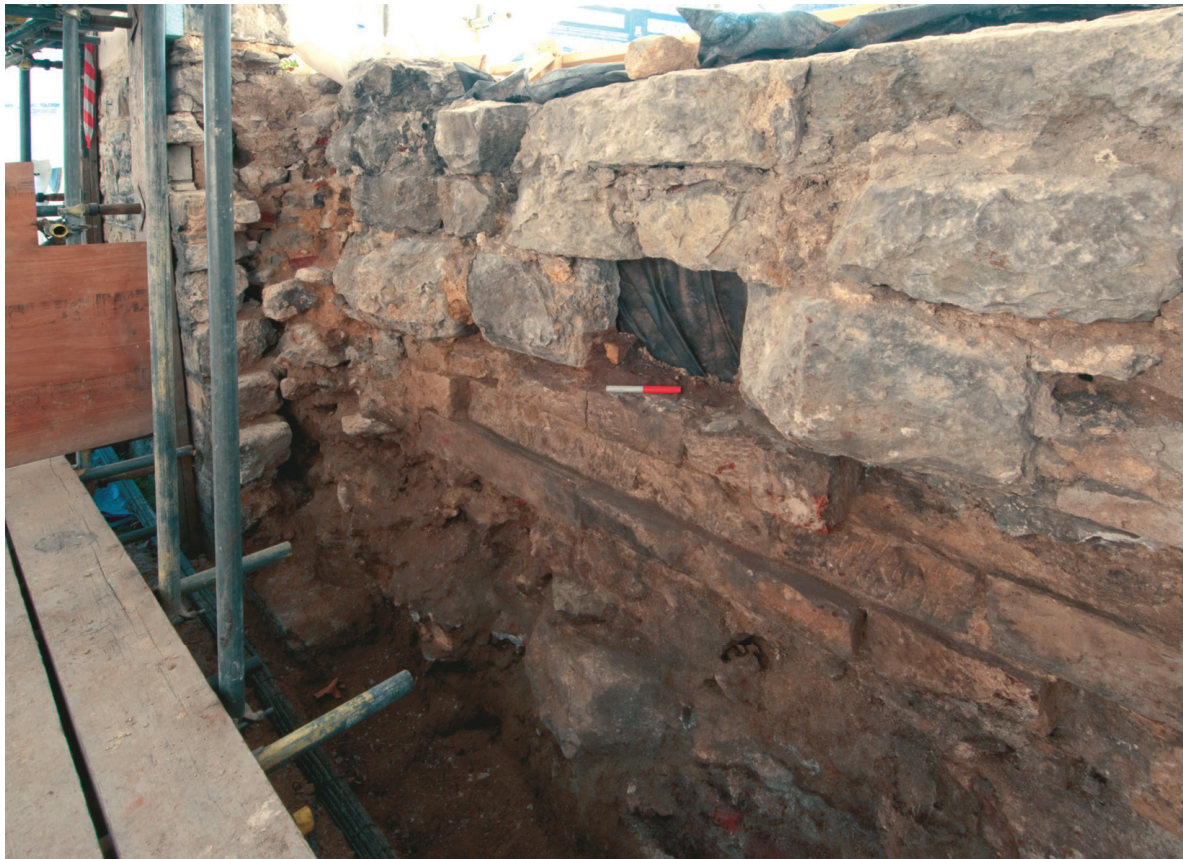
Fig 3. Moat wall (S1) dismantled showing facing associated with the Proof House (B1), looking south-east (0.2m scale)

The repair work to the inner moat wall (S1) also revealed a section of smaller blocks, possibly Portland limestone, with small tool marks located beneath the large tooled Reigate blocks. These blocks had not been seen previously as the south face of the moat wall was obscured by the layer of vertical tiles and render. There was also a distinct step in the build, which probably coincides with the floor slabs of the Proof House (B1) to the south.

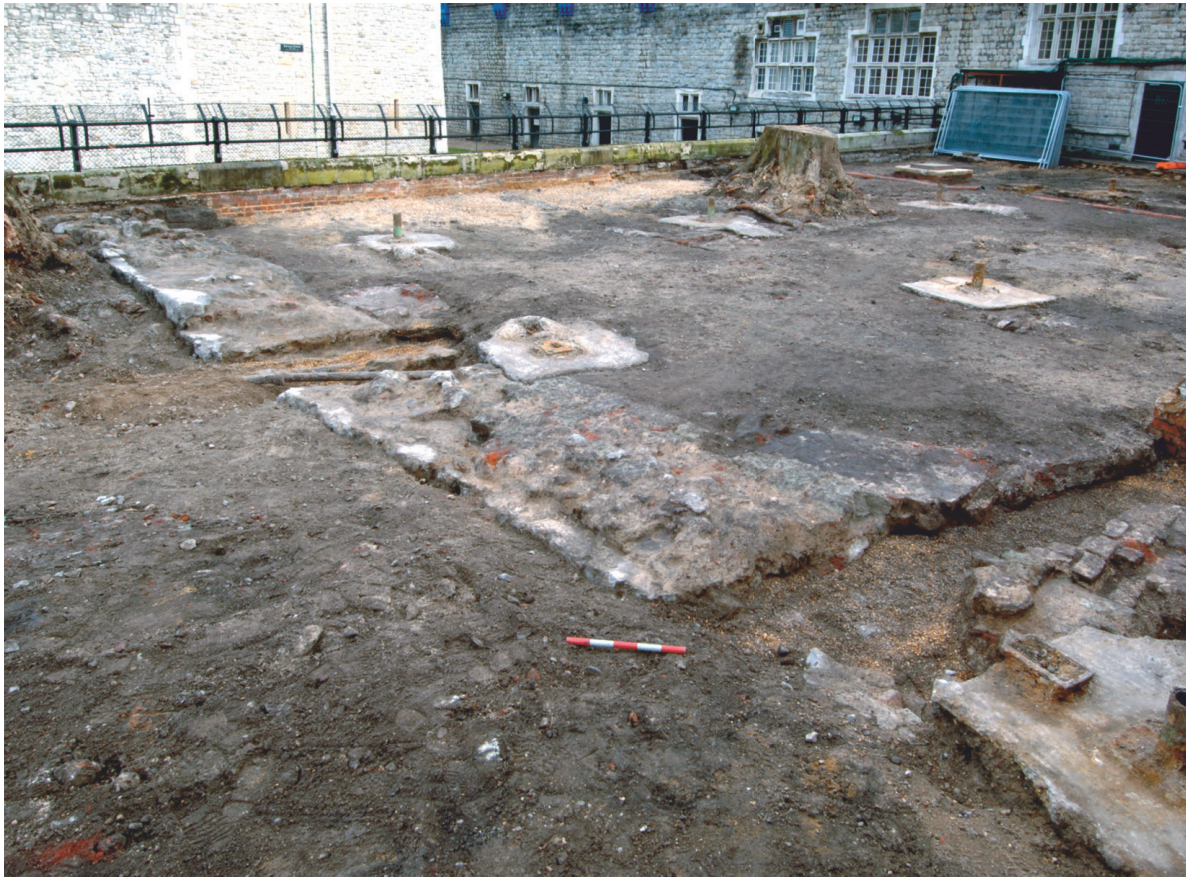
Fig 4. Defensive wall (S2) after initial stripping of 1970s café building (yellow sand in background is area of 2004 moat wall collapse), view looking north-east (0.5m scale)

A north–south aligned masonry wall, constructed mainly of ragstone from Kent and Reigate stone from Surrey (S2, Figs 2 and 4), was built on to the south side of the moat wall. The exposed portion of this truncated wall was 1.60m wide and 13m long (though it continues to the south on contemporary plans), with its highest survival at 5.01m OD. Examination of the upper parts suggests that neither face was original: to the west were large tooled ragstone blocks which may be refacing associated with the construction of the 17th-century Proof House, and to the east greensand blocks probably represent 18th- or 19th-century refacing.

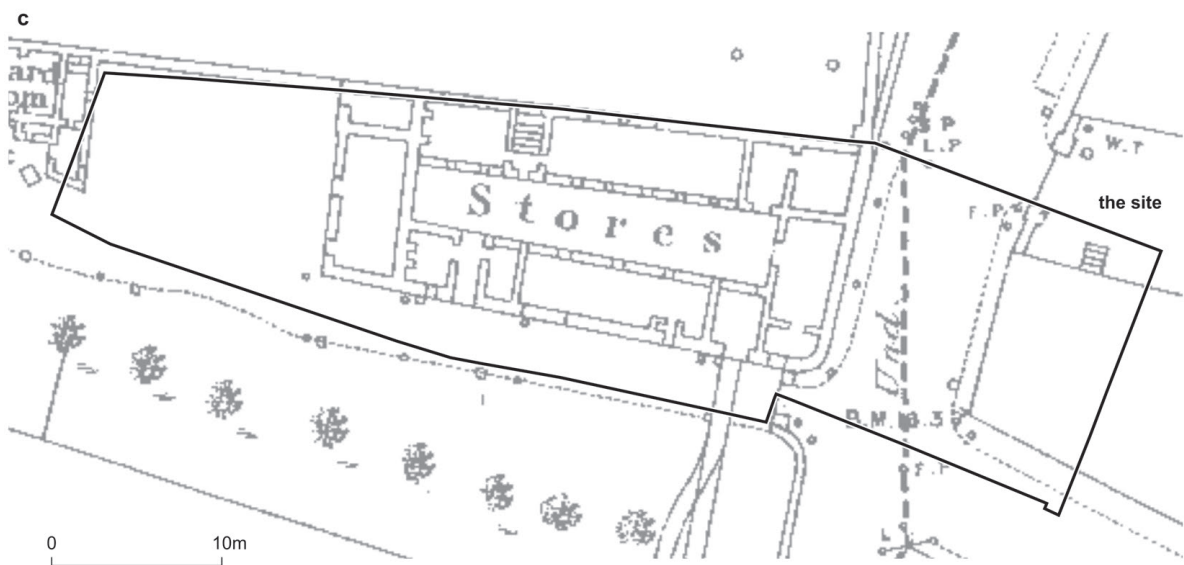
Fig 6. (a) Plan of the east end of Tower Wharf dated 1742, with site outline superimposed to show position of the Proof House and defensive wall (S2) (The National Archive, WORK 31/215); (b) 19th-century additions, Buildings 2–9 and Structures 3–7 (periods 2 and 3); (c) OS first edition 1874 map showing the 19th-century storehouse at Tower Wharf (site outline, scale 1:500)

east end of Tower Wharf in 1742 shows the new Proof House built was now against the moat wall (S1) and the west face of the defensive wall (S2), with a 'Smiths Shop' and a 'Wheelwrights Shed' built against the east face (Fig 6a).

During the early 19th century a series of red brick-built buildings, identified archaeologically (B2–B8, Fig 6b), formed part of the 'Arms Manufactory' built at the eastern

Building 1 is on the site of the Proof House that was built in 1682, against the west face of Structure 2 (Fig 6b). The remains found probably represent the Proof House that was rebuilt in 1709 and shown on a map of 1742 (Fig 6a), with cellar steps adjacent to the moat wall (S1). Only a small portion of Building 2 was found, but based on the same map it appears to be part of a small building within the Proof Yard (Fig 6a and b).

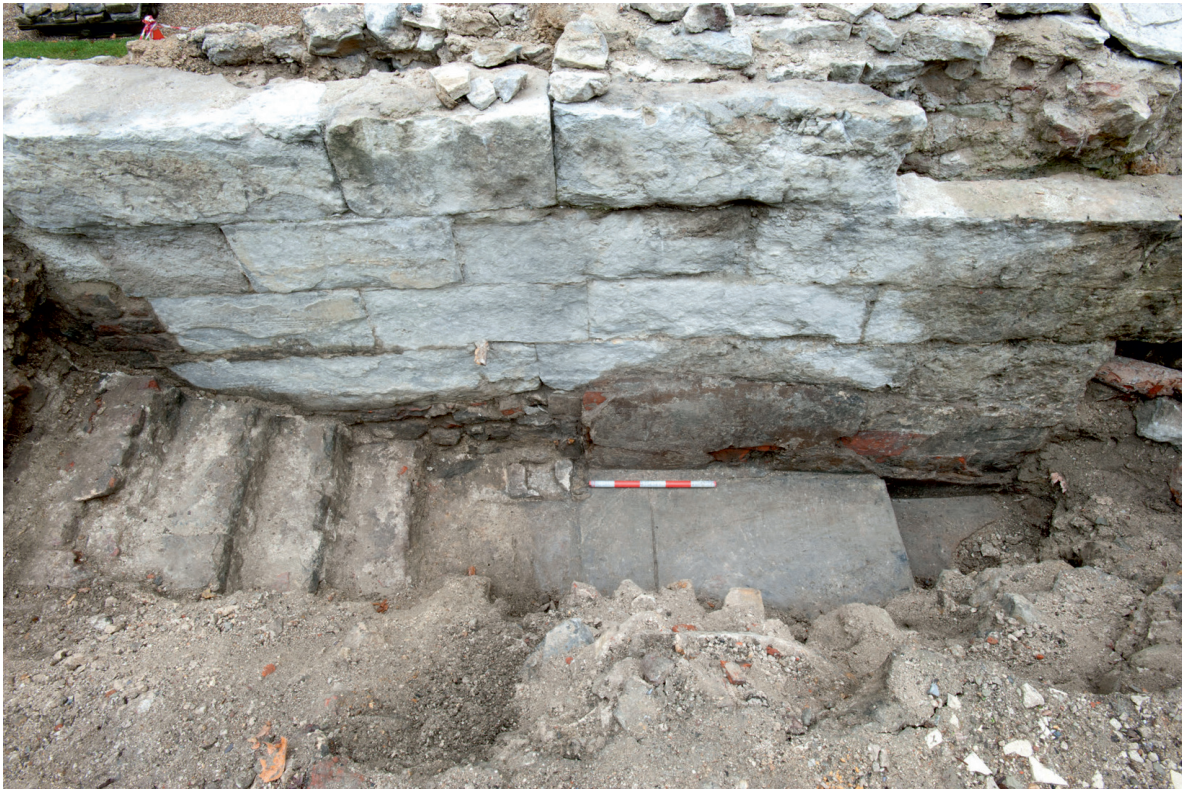
Fig 7. Stone steps built against the moat wall (S1) leading down to the stone floor of the Proof House (B1), looking north (0.5m scale)

Some archaeological evidence of the Proof House (B1, Fig 2) survived with a set of masonry steps (Fig 7). The highest at 4.18m OD led down to the stone slabs paving a cellar floor at 3.55m OD. This was built above an earlier rendered floor, presumably also of stone, lying at 3.35m OD. This earlier floor was associated with a row of vertically set (ceramic) peg roof tiles (0.26 x 0.15m and 12mm thick), also covered by the render to 3.93m OD, that were lining the faces of both the moat wall (S1) and defensive wall (S2). This tiling may be a form of waterproofing intended to keep water out of the cellar of the building where the gunpowder was stored. A layer of demolition debris separated these

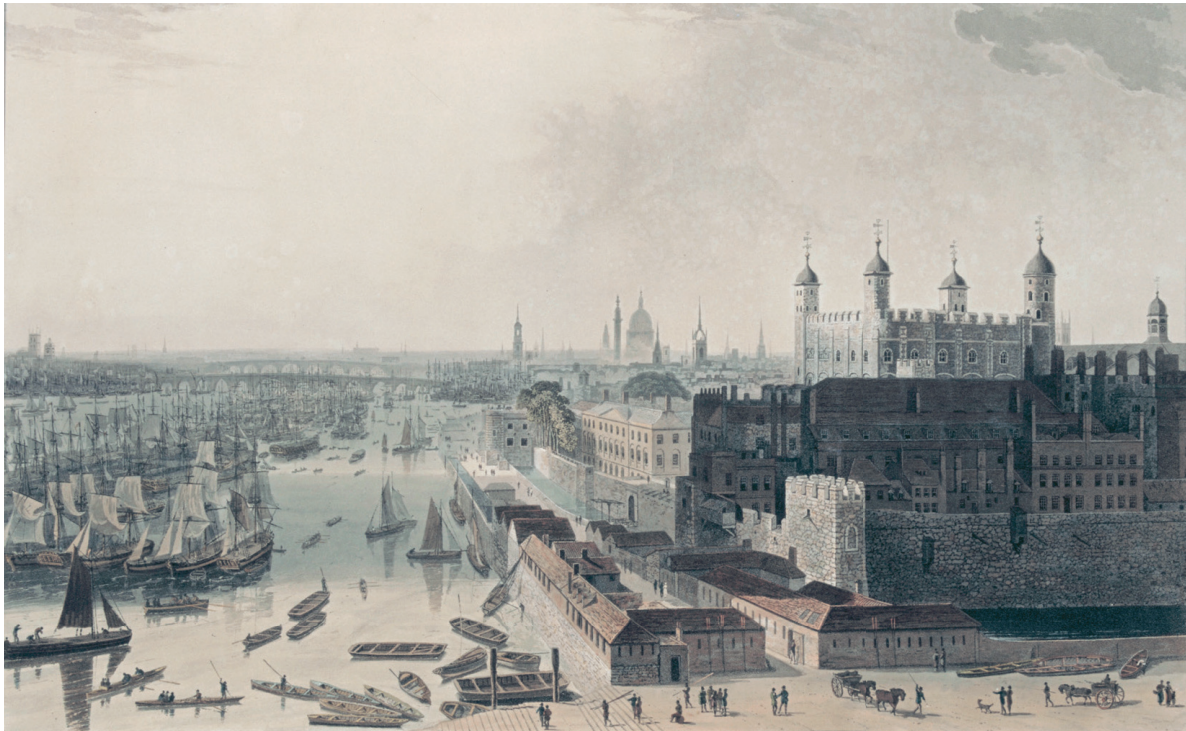
Fig 8. View of the Tower of London from the east in 1804 by T and W Daniell, with the buildings of the 'Arms Manufactory' in the foreground (London Metropolitan Archives, City of London, Collage record no. 31828)

end of Tower Wharf (Impey & Parnell 2006, 68). A view of the Tower of London from the east painted by T and W Daniell in 1804 (Fig 8), shows the Proof House still standing, but it had become incorporated with these new brick buildings lying to the south and to the east of the defensive wall (S2). No contemporary plan of the 'Arms Manufactory', that produced small arms until 1815, has come to light (*ibid*, 69).

The 1804 T and W Daniell painting of the Tower from the east (Fig 8) shows a large number of brick buildings within the area of the site, confirming that Buildings 3–7 are part of the small arms manufactory (Fig 6b). Although Building 2 had now been replaced by Building 3, evidence from cartographic sources show the Proof House (B1) was still standing. It appears that elements of Buildings 5 and 6 were reused as part of the new storehouse built in 1841, and while no plan has been found showing this storehouse, elements of these buildings appear to have been incorporated into the storehouse shown on the 1874 OS map (Fig 6c). The phasing of Building 8 is a little problematic; it may relate to 18th-century activity before the small arms manufactory phase or it may be part of the later 19th-century storehouse (Fig 6). The distinctive remains of Building 9 may post-date the demolition of the storehouse, but it does not appear to relate to Tower Bridge. Demolition deposits sealed all these 19th-century buildings, and dating evidence, where found, was unsurprisingly limited to the late 18th to mid-19th century.

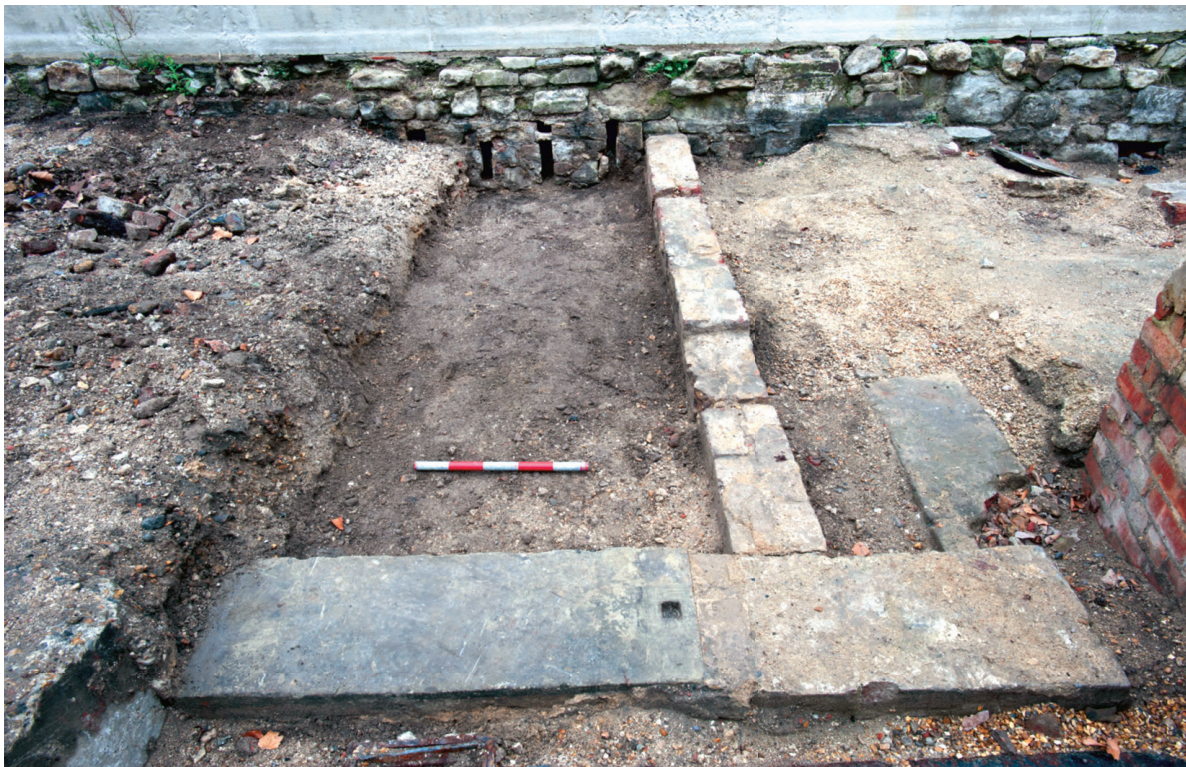
Fig 9. Walls of Building 3, with joist slots cut into the moat wall (SI) (background) and the earlier wall of Building 2 partially exposed (right), looking north (0.5m scale)

Building 3 was built against the moat wall and was at least 17m long and 3m wide (Fig 6b). It comprised a north-south brick wall (1.60m long x 0.22m wide, highest survival at 4.66m OD) and an east-west brick wall (2.25m long x 0.33m wide) which continued to the east and west. This building was divided into two rooms by a further north-south brick wall 2.80m long x 0.23m wide (Fig 9). The eastern room had three areas of surviving brick-paved floor (situated between 4.54m OD and 4.60m OD) and a drain. The western room had a suspended timber floor as the slots for its floor joists had been cut into the face of the moat wall. A stone block may have served as a threshold for the west room.

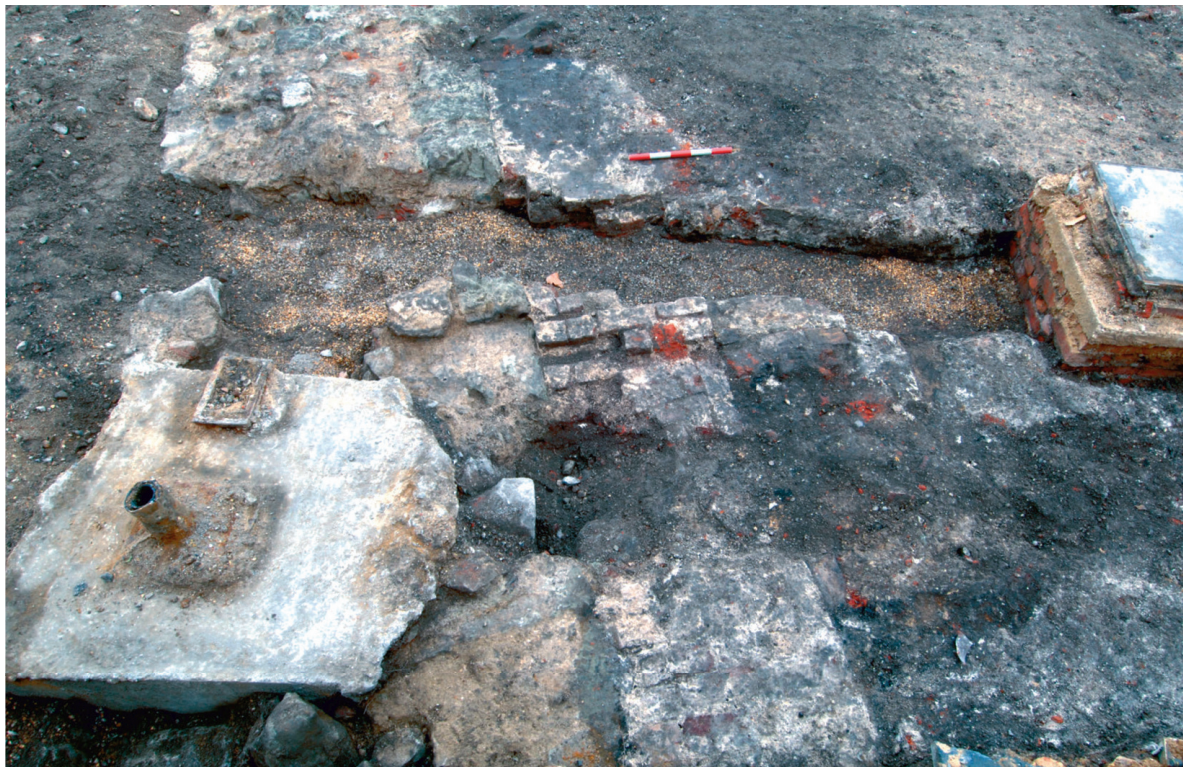
Fig 10. Walls of Building 5 built against the east side of the defensive wall (S2); the possible fireplace base is in the foreground, right-hand side, looking north (0.5m scale)

Building 5 comprised a north–south brick wall (2.0m long x 0.74m wide, highest survival at 4.63m OD) that continued further south (Fig 6b). Also thought to be part of this building was a separate fragment of north–

south brick wall (1.60m long x 0.87m wide) that appears to be the facing of a masonry wall 0.45m wide. Both the brickwork and the associated masonry continued further south. This building had a brick-paved floor at 4.64m OD that abutted the defensive wall (S2) and included a burnt area that suggests the location of a possible fireplace (Fig 10). This building shows some correlation with the storehouse seen on the 1874 OS map (Fig 6c).

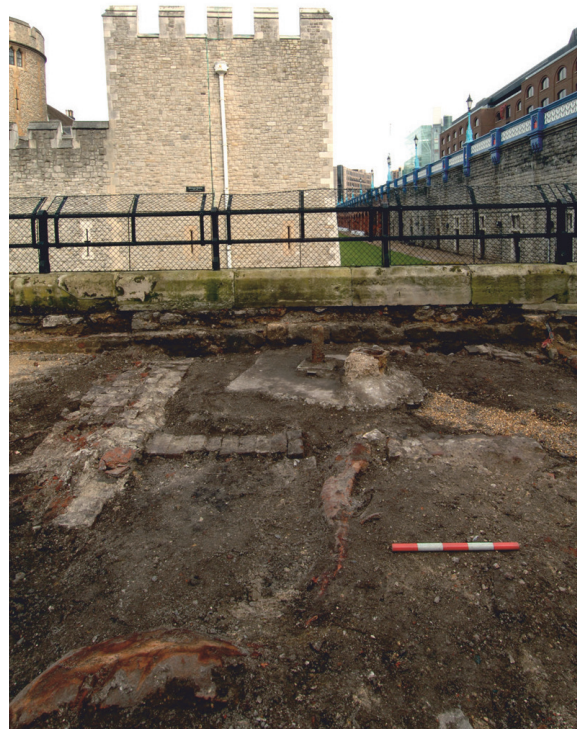
Fig 11. Walls of Building 7 built against the moat wall (S1), with Develin Tower in the background, looking north (0.5m scale)

Building 7 comprised a north–south brick wall (2.60m long x 0.65m wide, highest survival at 4.70m OD), the north end of which was butted against the moat wall (S1) and an east–west brick wall (1.46m long x 0.44m wide, highest survival at 4.68m OD) (Fig 6b). Two more east–west brick walls were internal and included a possible threshold between two rooms (Fig 11).

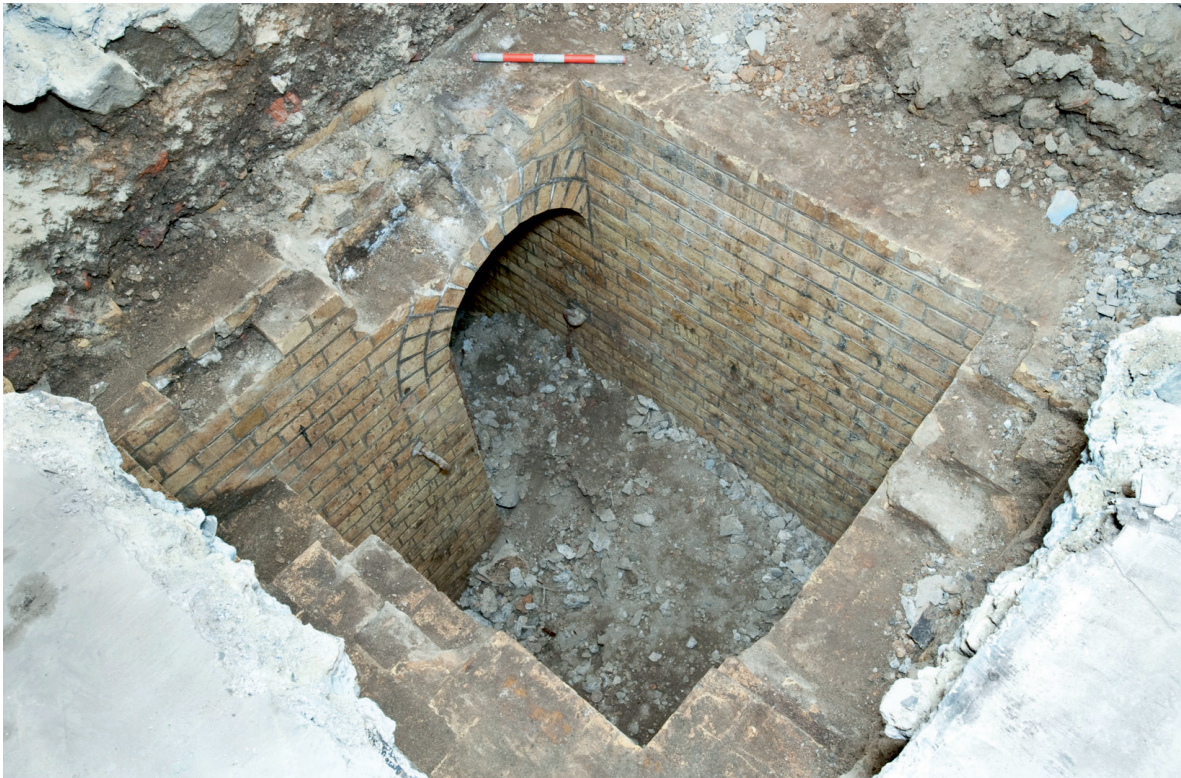
Fig 12. Brick-built chamber (S5) with tunnel entrance, looking north-west (0.5m scale)

During the watching brief monitoring the construction of new drainage trenches within the vaults below Tower Bridge Approach, a deep brick-built chamber, [123], was revealed below the modern concrete floor (Figs 6b and 12). The removal of this floor meant it became partly infilled by rubble. Because of safety considerations it was not possible to fully investigate the chamber as planned (Keevill 2011); all observations had to take place from the top.

the chamber was at least 4.00m deep with a soil deposit at *c.*1.10m OD, suggesting the true base had not yet been reached. The chamber was constructed entirely of yellow stock bricks (measuring 0.11m wide x 0.07m thick x 0.25m long), in English cross bond (alternating courses of stretchers and headers). The type of brick used is indicative of a date of 1840 or later.

In the northern end of the western wall of the chamber was an arched opening (*c.*2.0m high and 0.70m wide) representing the start of a tunnel or passageway leading westwards, the far end of which was blocked by brick rubble. At the western end of the southern wall of the chamber, towards its top, there was a neatly made 'step' (0.60m long and 0.25m deep). It seems unlikely this was to gain access and instead may have been a light well for the chamber. It also seems unlikely that access to such a deep structure was via the top of this chamber as no steps or ladder was visible in the brick faces. However, metal fittings, possibly for iron rungs, were noted next to the base of the arched tunnel, suggesting the tunnel was used to reach a vertical ladder that provided access to the interior of the chamber.
