Breaking New Ground:

An Archaeological Evaluation of Deposits at the
Abbots Staith Warehouse, Selby, North Yorkshire

By Dr Jon Kenny and Mark Simpson, B.A., M.A.

2018

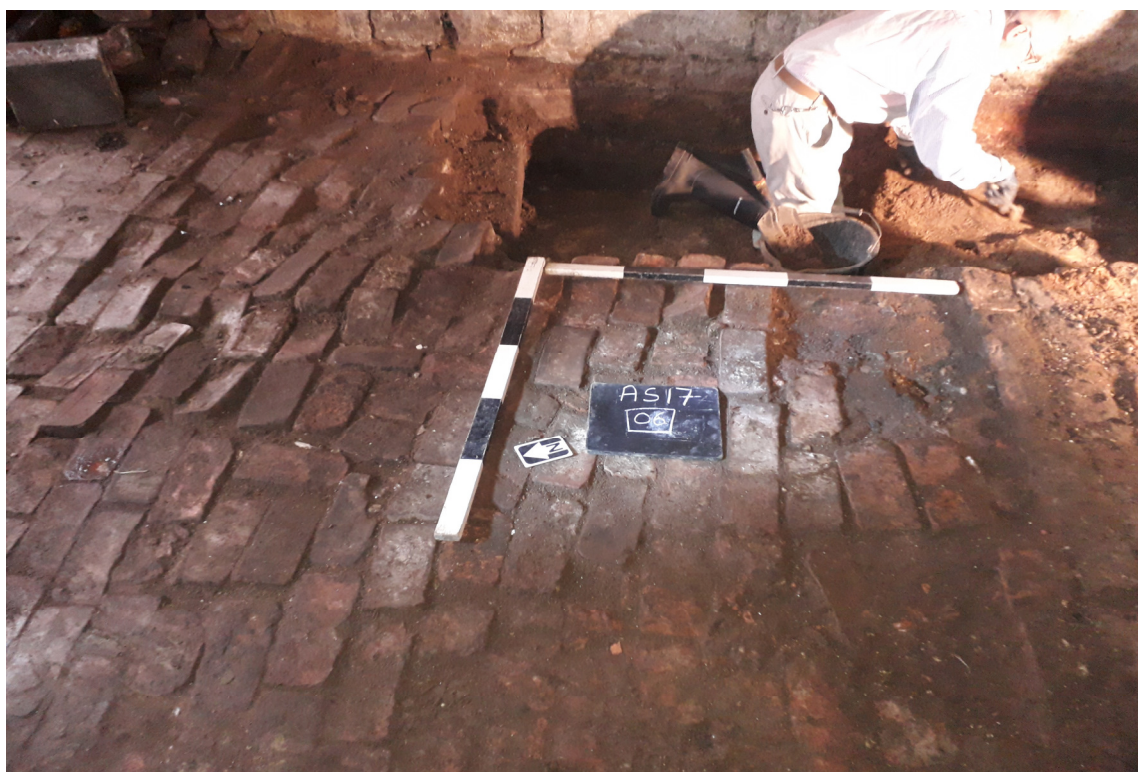
Partially excavated pit on the north east side of the warehouse bay [105]. Dug against the north east wall. Measured 2.2 metres by 2.3 metres with a depth of approx 0.36 metres. Laid in the bottom of the pit were level concrete paving slabs (61cm x 76cm x 5cm), one of which was extracted from the excavated portion of the pit. Possible foundation for a piece of machinery, now removed, from the last couple of decades. The pit was backfilled with a wide variety of rubble (brick and limestone fragments) and some modern rubbish [101] including plastic wrappers (with barcode) and a pen from a betting shop. Backfilled pit was then roughly recovered with a poorly made-up brick floor [106], different in appearance to the better made brick floor [108] of the rest of the bay.

Context 106 - Relaid Brick over Modern Pit

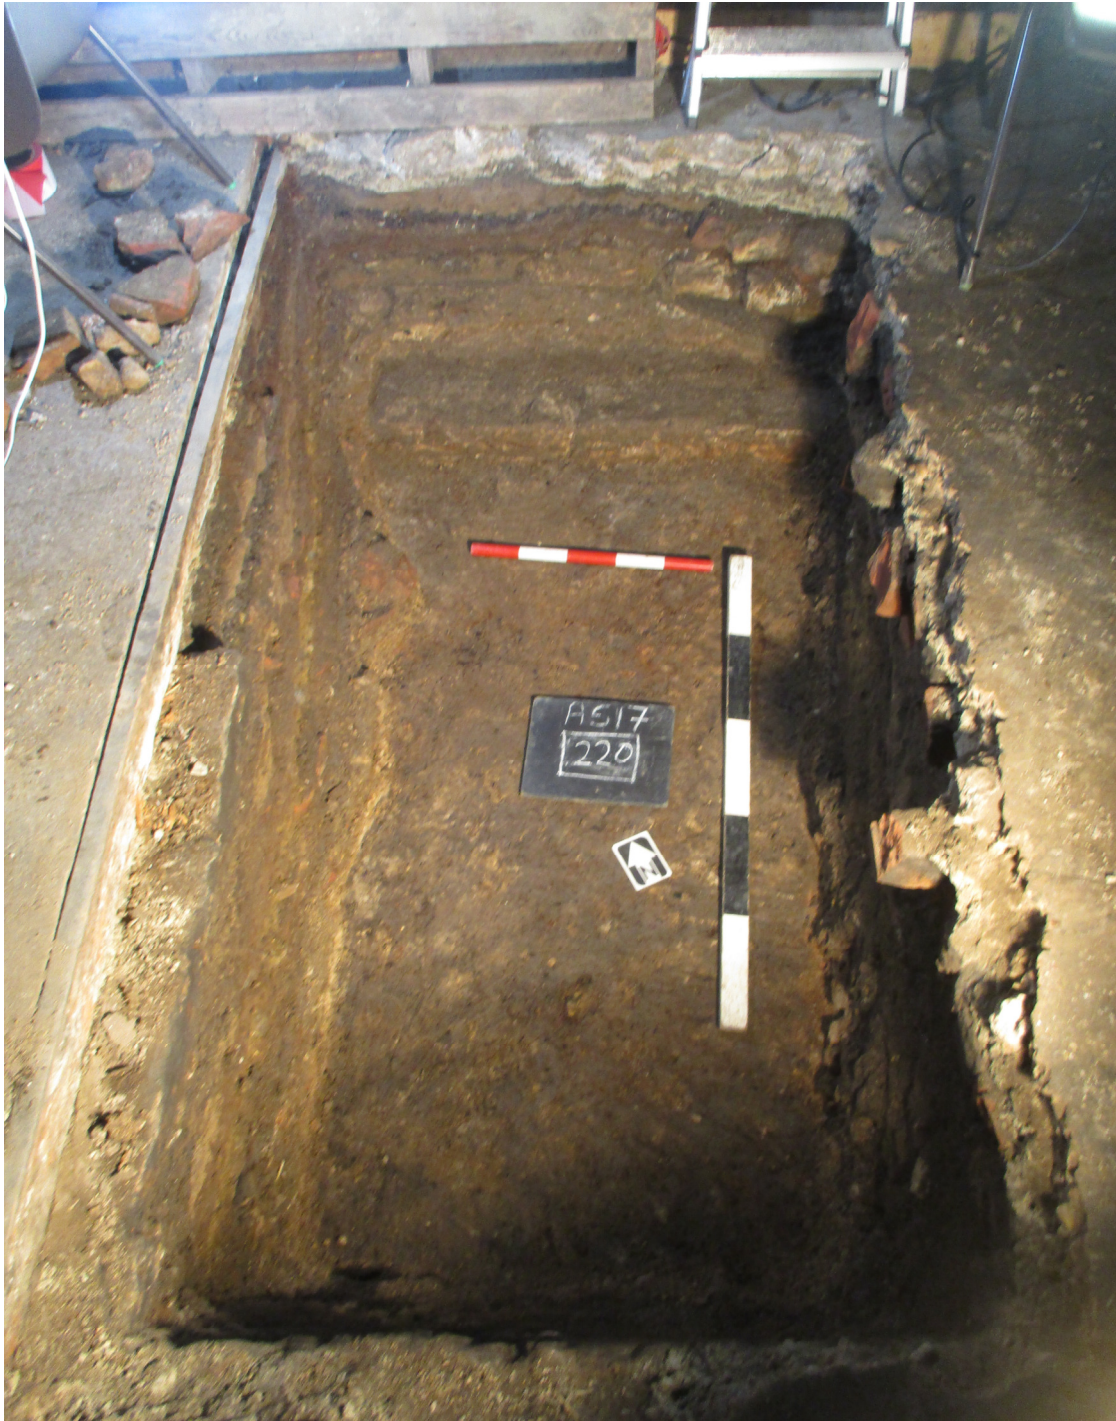
Threshold in Trench 2 with Context [220], possible setting for flagstone floor, removed

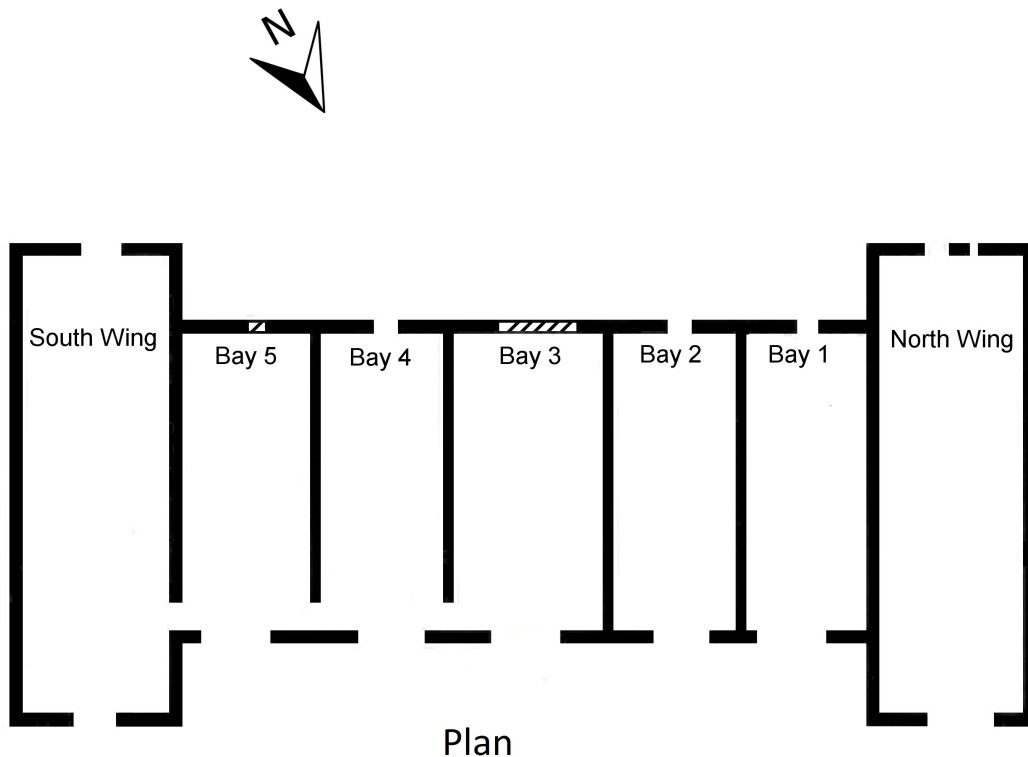
Plan of Staith Warehouse showing bays as sampled by Nottingham Tree Ring Dating Laboratory

The dendro analysis which took place in the summer of 2018 by Nottingham Tree Ring Dating Laboratory, as part of a programme of roof repair by Selby District Council and Historic England, shows that there was some remodelling of first floor levels (Bay 5 and south wing) around the 1580s, post-reformation, and this could fit with the building passing into secular use after the dissolution of Selby Abbey. There was further evidence in one bay of floor timbers being changed in the 1680s (Bay 2) and this could indicate repair work having been carried out on the floors put in a century earlier. Unfortunately, analysis of timbers in some of the central bays was inconclusive (See Appendix 5 for further information).⁽²⁰⁾

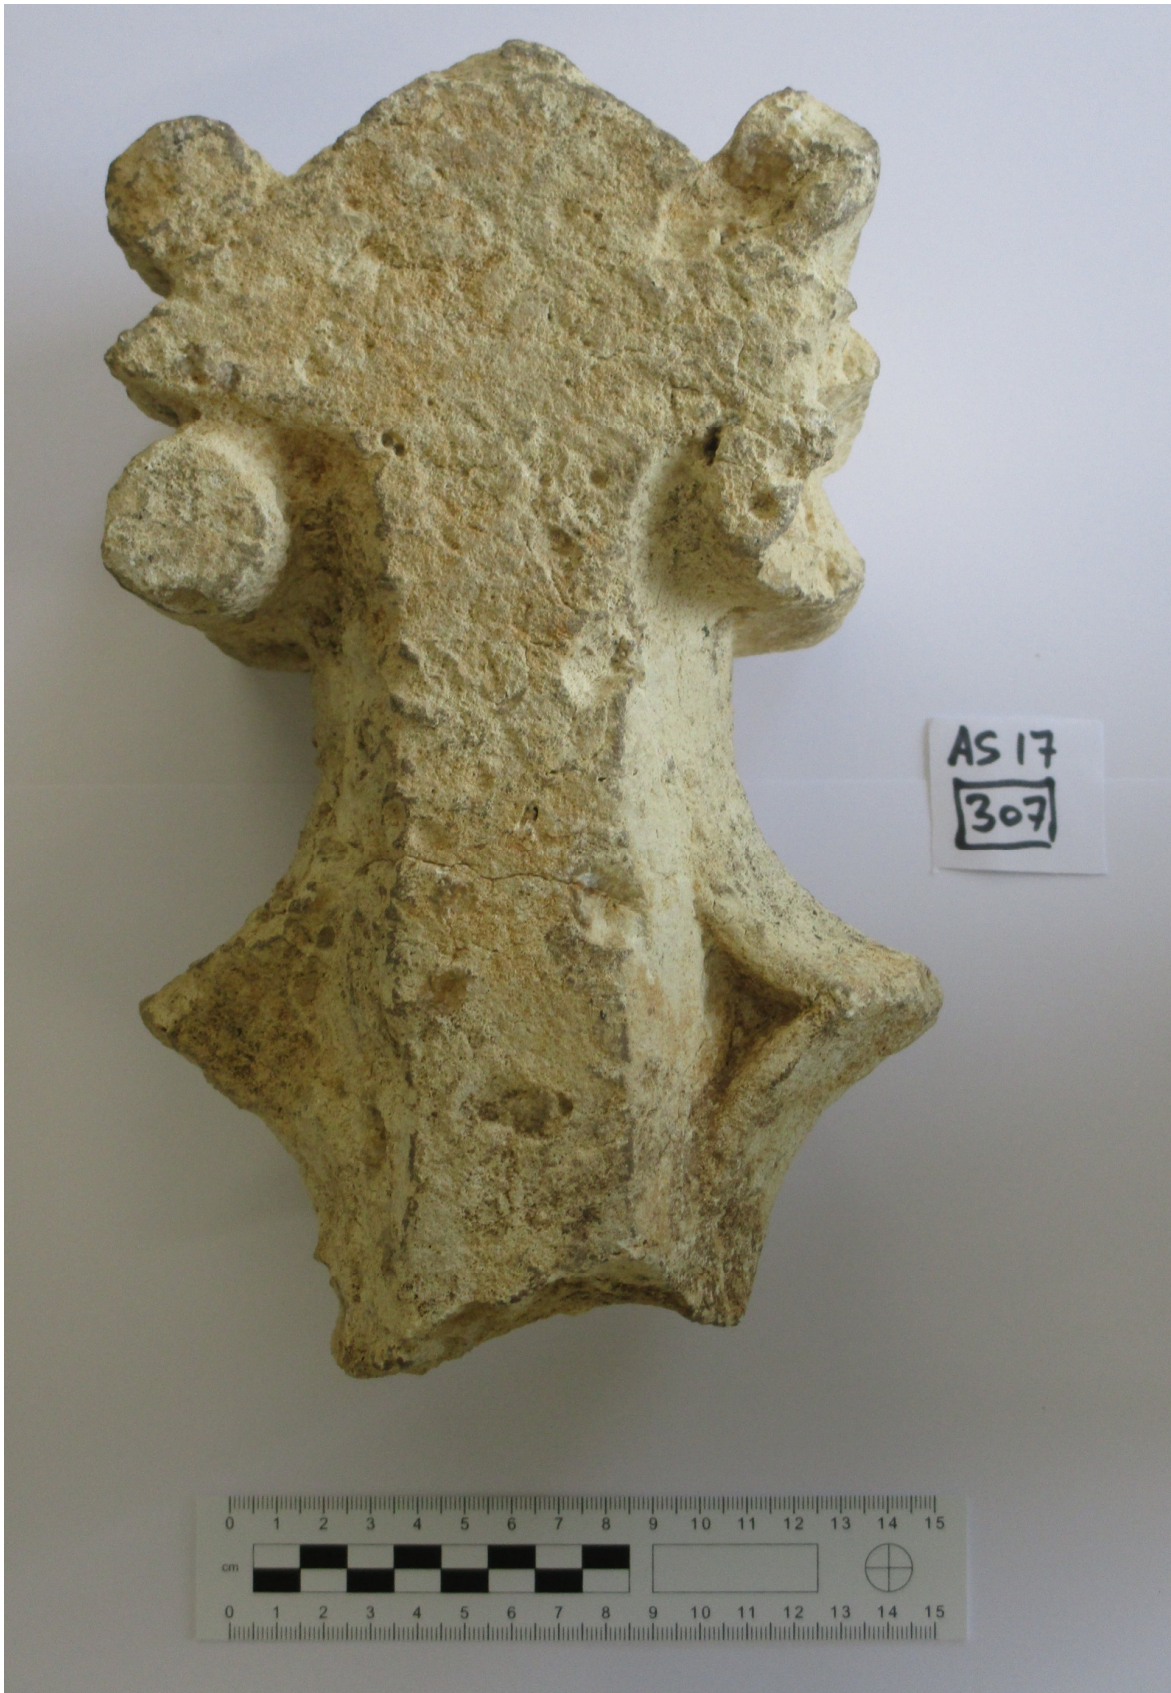
Decorative Finial. Likely a mason's reject that should have gone to the Abbey - 16th Century

No evidence for materials stored in the warehouse was found. The bay that contained Trenches 1 and 3 did reveal an architectural fragment (a finial), that may not have been a properly finished piece, possibly being damaged in the carving process. This might suggest that such carving was taking place nearby, maybe even in this bay.
