Site/Project Name: **A355 Beaconsfield Eastern Bypass phase 2**

Site Code: BERR 18

Site/Project Type: Excavation

Year(s): 2018

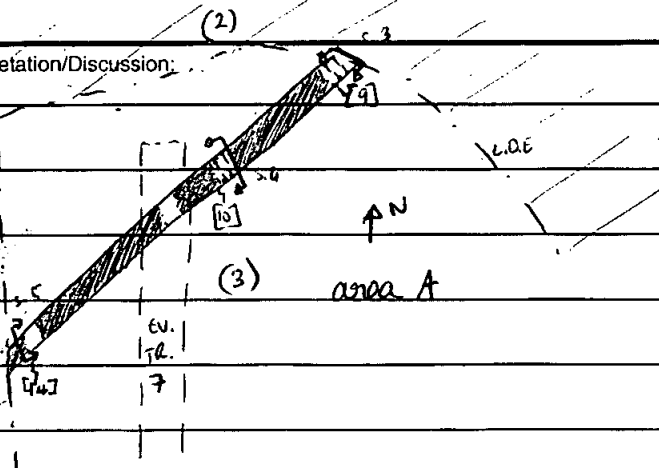
NE-SW aligned ditch,  
probably a boundary ditch  
No finds, no dating evidence  
no truncation

IRREGULAR WIDTH ALONG ITS LENGTH LIKELY

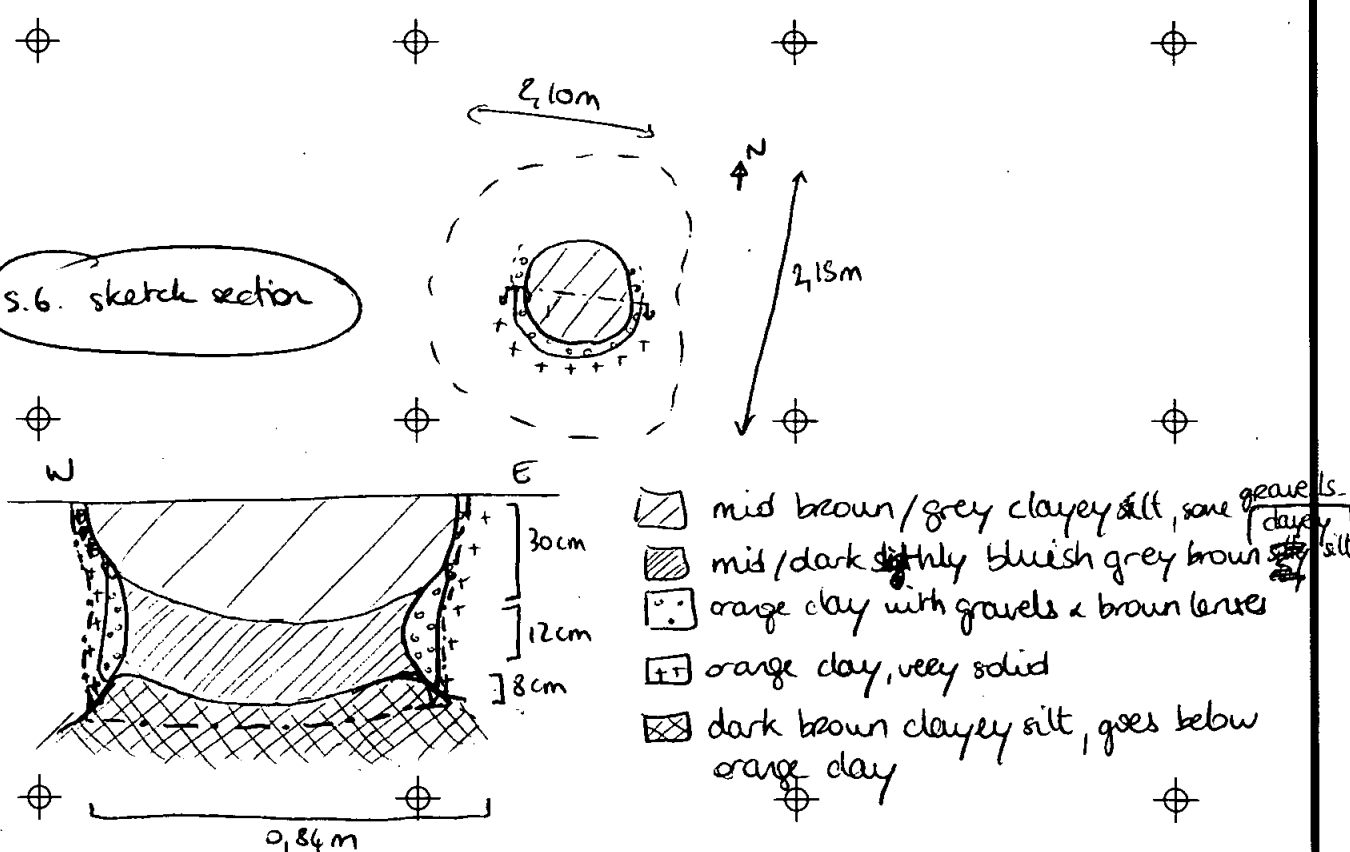
s.6. sketch section

modern pit, not fully seen in plan. Modern glass + CBM found  
Hand excavation stopped at 0.50m depth, due to a dark  
brown layer underlying what was thought to be the natural not  
clear in plan what is the real extent is. Very hard compact fill  
due to be machined to see full extent.

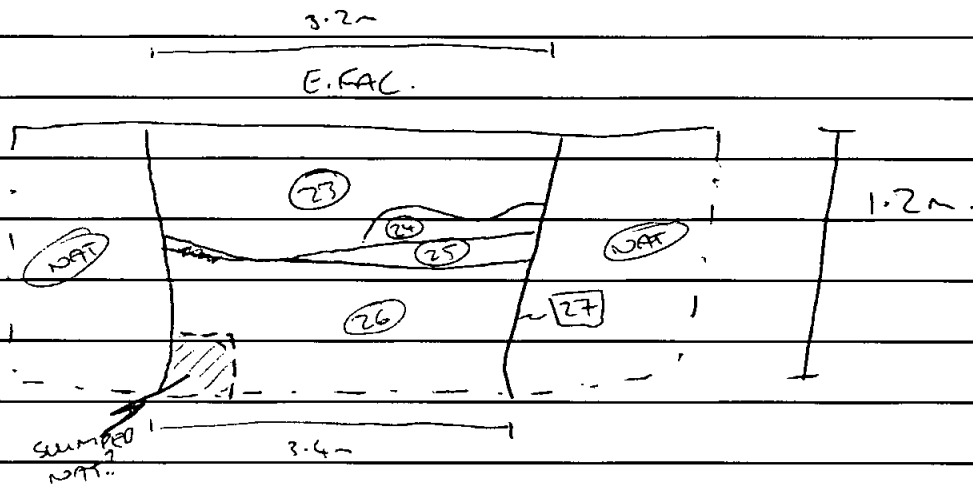
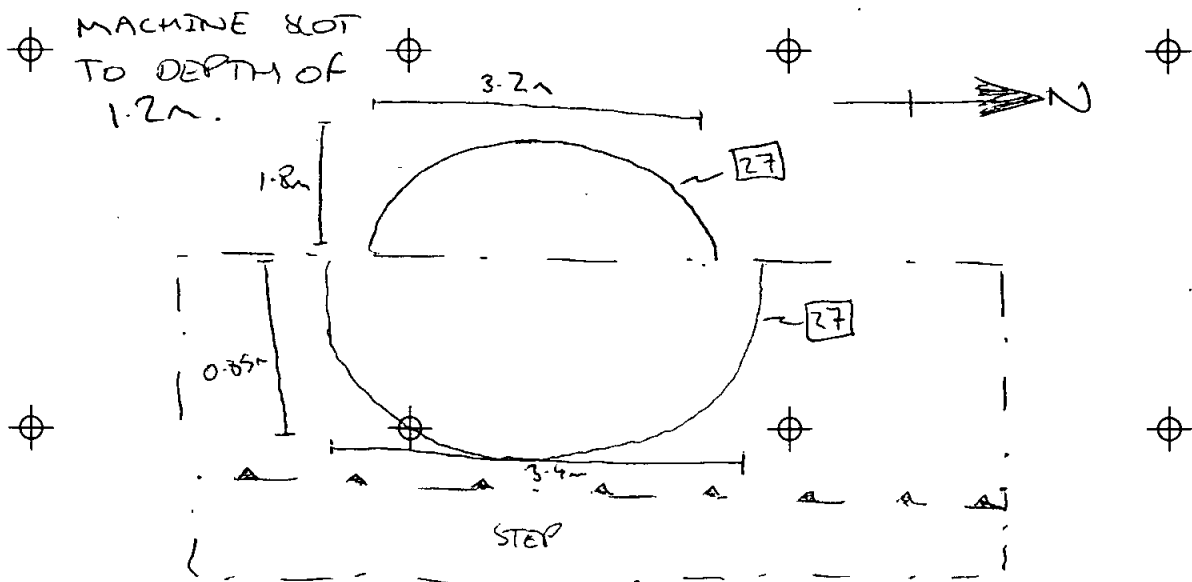
SHEET NO. 1

FEATURE 27 EXCAVATED BY MACHINE AS HALF SECTION DOWN TO 1.2m. (ORIGINALLY 1/4 EXCAVATED BY HAND DOWN TO 1.2m). PHOTOSTAKED (68-72) AND NEW SECTION (S.14) DRAWN. FEATURE APPEARS TO START GETTING WIDER AT THE DEPTH OF 1m. NEXT WITH MACHINE DEEPER.

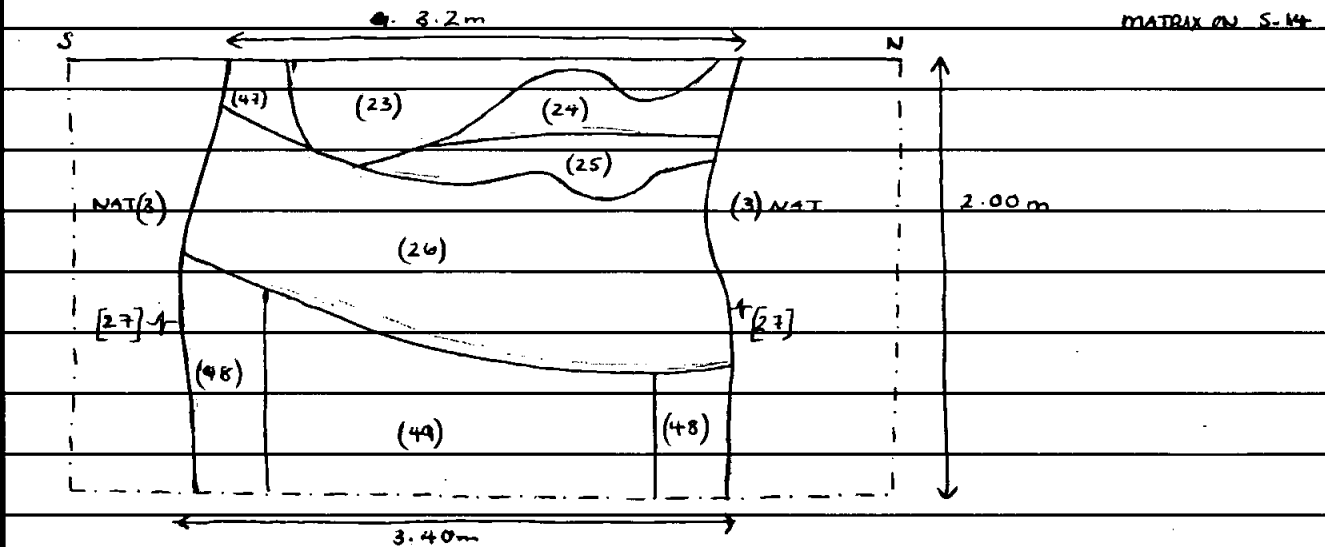
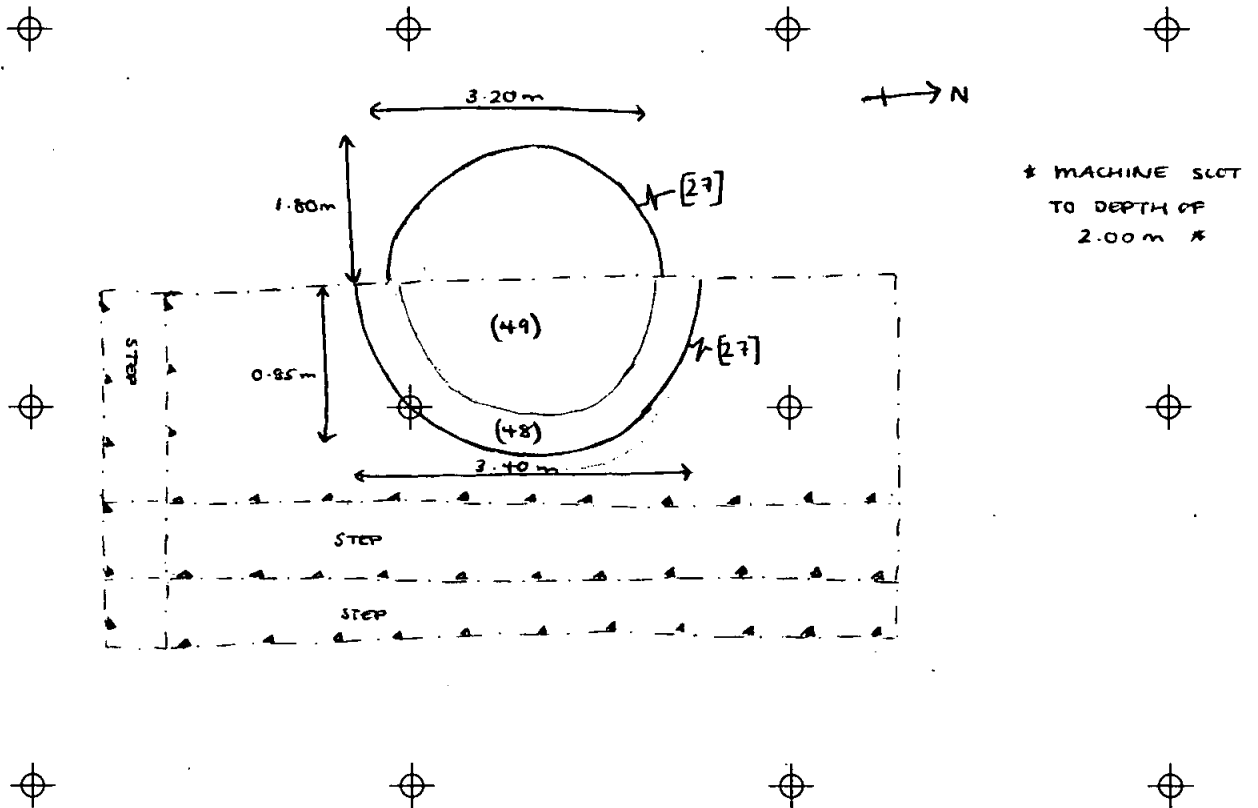
FEATURE [27] - EXCAVATED BY MACHINE AS HALF SECTION DOWN TO 2.00m PHOTOS TAKEN (35-34). SLOT TOO DEEP TO ACCESS SO SKETCH SECTION + PLAN DRAWN BELOW (ALL DIMENSIONS APPROX). FEATURE STILL CONTINUING DOWN BUT TOO DANGEROUS TO EXCAVATE FURTHER - SLOT BACKFILLED.

FEATURE PROBABLY A SINGLE - ALL FILLS HOMOGENOUS AND STERILE - NO EVIDENCE TO SUGGEST HUMAN ACTIVITY - PREVIOUSLY THOUGHT COULD BE GRAVEL EXTRACTION PIT BUT TOO DEEP.

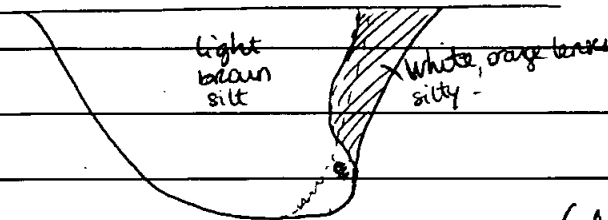
(s. 16)single fill ~~deposit~~ (scraped)naturally accumulatedsilts in tree throw - no finds orany trace of human activity nearby(fired clay, charcoal, etc)

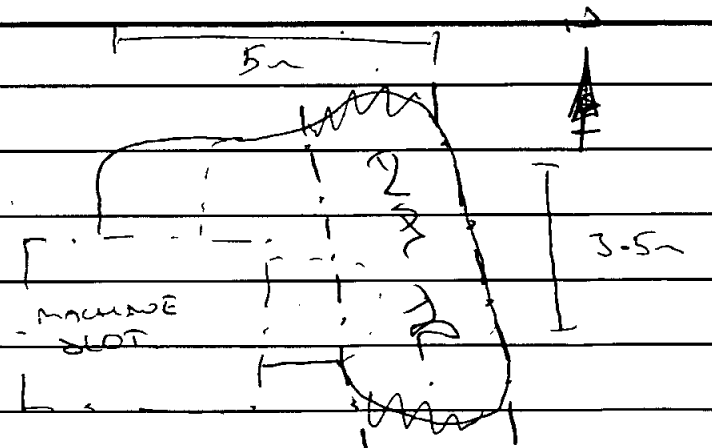
AT LEAST 3 INTERCUTTING  
PITS. ALL MODERN.  
EACH WITH <sup>ISS</sup> SINGLE MAP  
FILL. EACH FILL CLEARLY COLOURED - MACHINERY  
NAT/BS/TOP SOIL AND TUFF  
CHAINED TOGETHER.

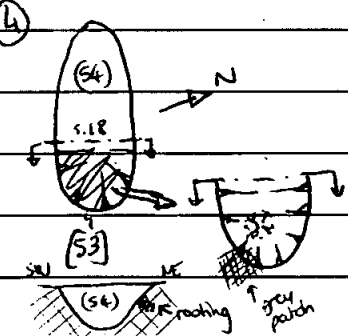
| Description (See check lists):<br>① <b>ovoid / elongated oval</b> ② <b>moderate sides</b><br>(a bit irregular)<br>concave base ③ <b>0.27m deep; 0.68 x 1.90m</b> | | <b>STRATIGRAPHIC MATRIX</b><br> | | |
| Interpretation/Discussion:<br>This feature could be a natural feature (tree throw), as it has evidence of rooting at the base; but as it contained a struck flint and has a fairly regular profile overall, there is a strong possibility that this is a pit. Its function though is unclear (no related features nearby?) | | | | |

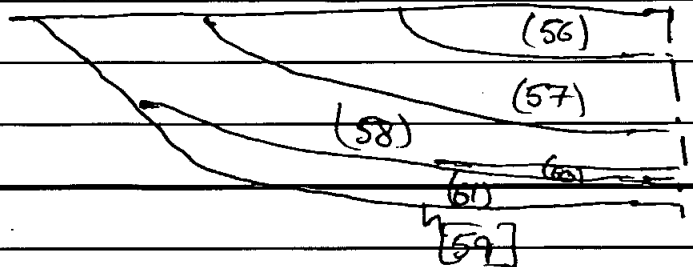
- 1) CIRCULAR
- 2) STEEP SIDES, FLAT BASE
- 3) 12.5M IN DIAMETER X 1.6M DEEP

APPEARS TO BE A HOLLOW / CRATER POSSIBLY NATURALLY FORMING AS A SINK / SOLUTION HOLE POSS. USED / FORMING A POND (6) FOR SOME TIME BEFORE BEING DELIBERATELY FILLED ((60), (58), (57))

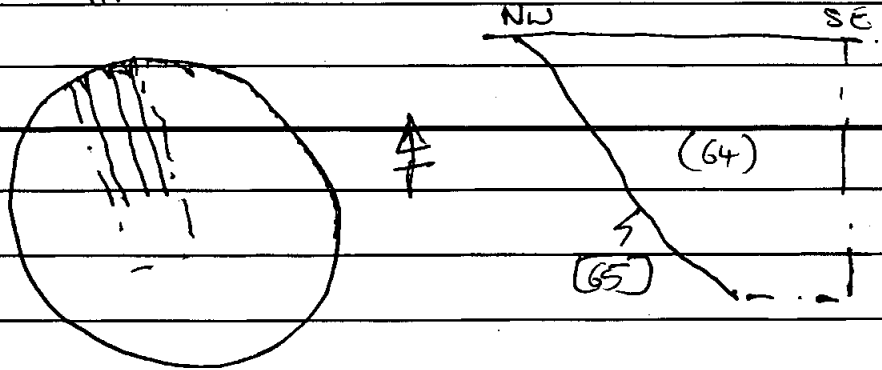
- 3) 7M IN DIAMETER X > 2-3M DEEP
- 4)

PROBABLE SOLUTION/SINK HOLE WITH VERY STERILE/HOMOGENOUS FILL

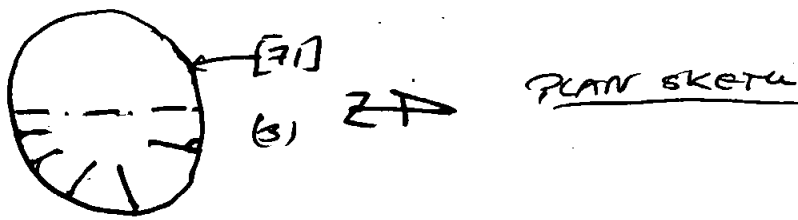
BERR 17  
CONTEXT 71

- OUT-CUTTING NAT. GEOLOGY (3)
- FILLED BY (72)
- ROUND, 0.32m 92m WIDE, 0.17m DEEP, MOD. STEEP AND GENTLY SLOPING SLOPE, X CONCAVE BASE

TREE HOLE TREE TUNNOL

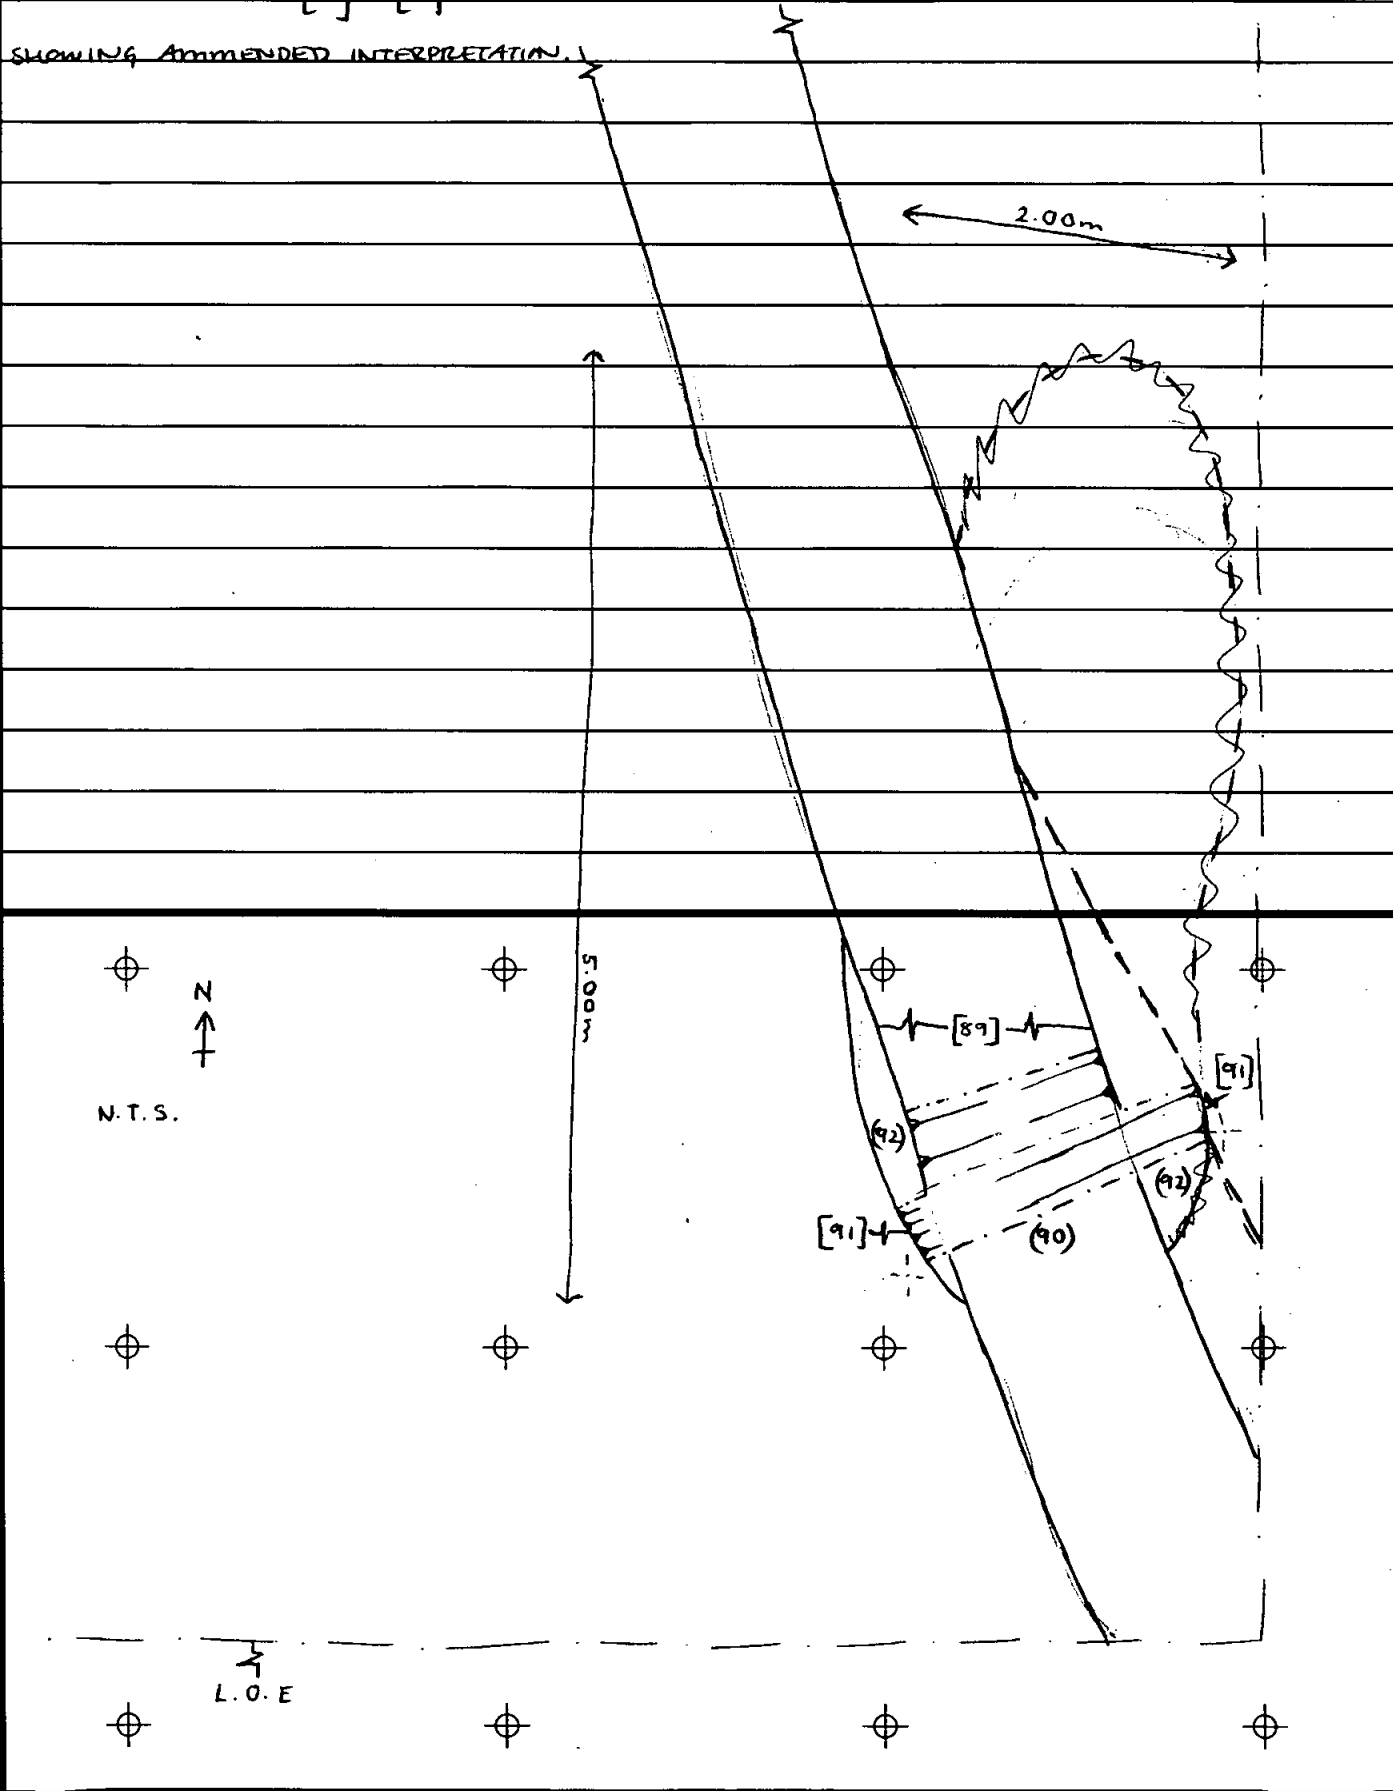
PLAN OF DITCHES [89] + [91]

SHOWING AMMENDED INTERPRETATION.

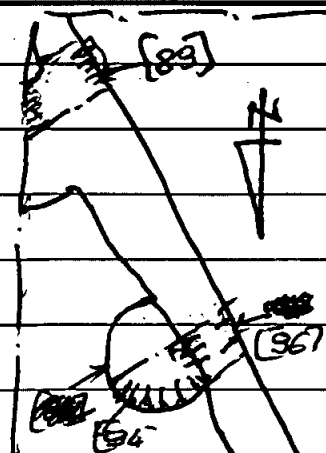
PLAN SKETCH

**SINK-HOLE (WATER SOLUTION HOLE)**

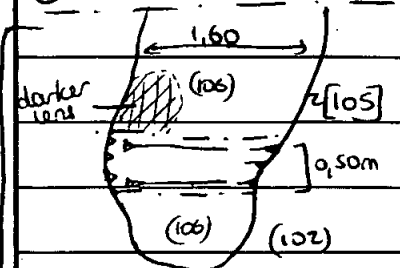
*In plan, thought to be 2 features: one larger feature truncated by an oval smaller/darker pit. It turned out to be only 1 feature with a darker lens in it. It is likely to be a natural feature (tree throw?), as the shape & sides are not regular ~~the darker~~ no finds were found.*

\* EXCAVATED FURTHER 09-08-18 - SEE ADD SHEET \* - TREE THROW.

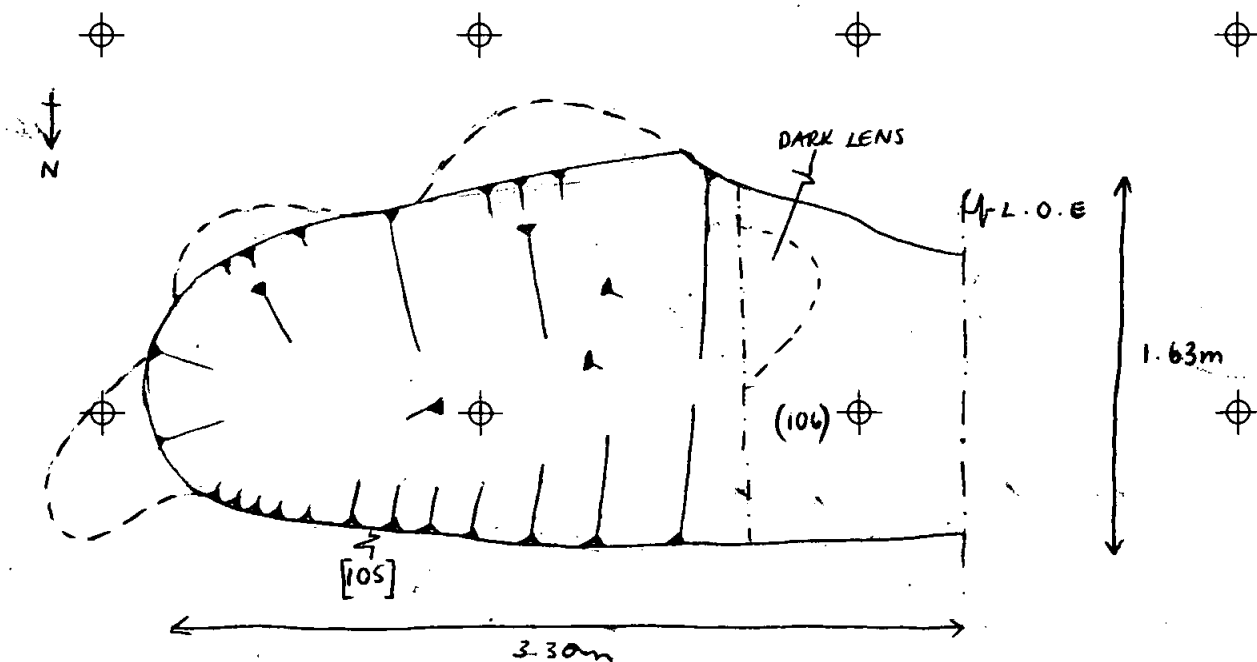
SHEET NO. 1

*SKETCH PLAN OF TREE THROW [105] AFTER FURTHER EXCAVATION*

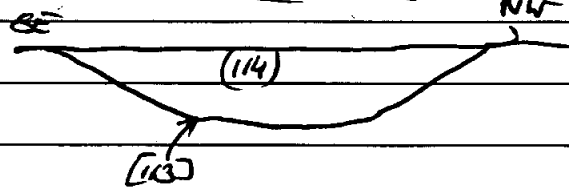
SECTION SKETCH

**RELATIVELY REGULAR AND SYMMETRIC FEATURE, BUT MOST LIKELY A TREE TROW.**

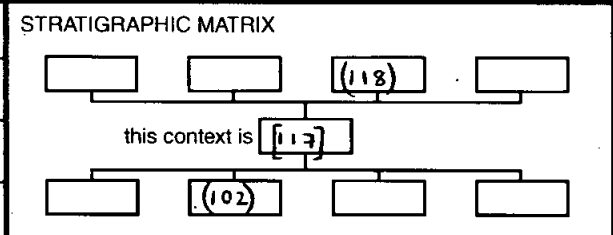
CUT OF SMALL LINEAR SHAPED FEATURE. EASTERN SIDE UNDERCUT. FILL CONTAINED OCC. CHARCOAL, IRR + ROMAN POT FRAG + SLAG ON SURFACE.

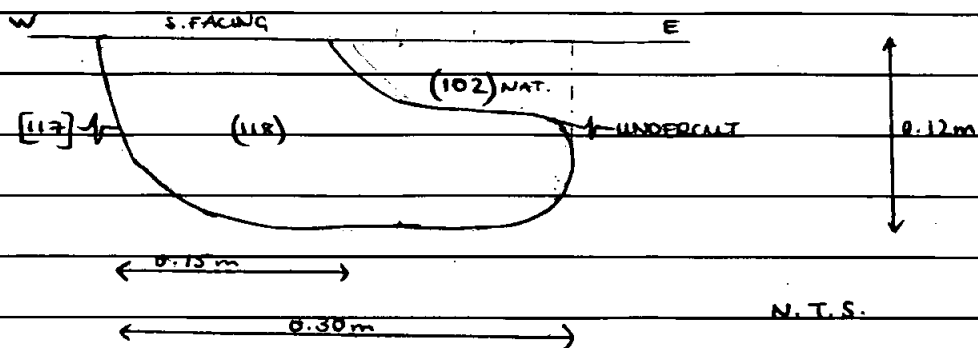
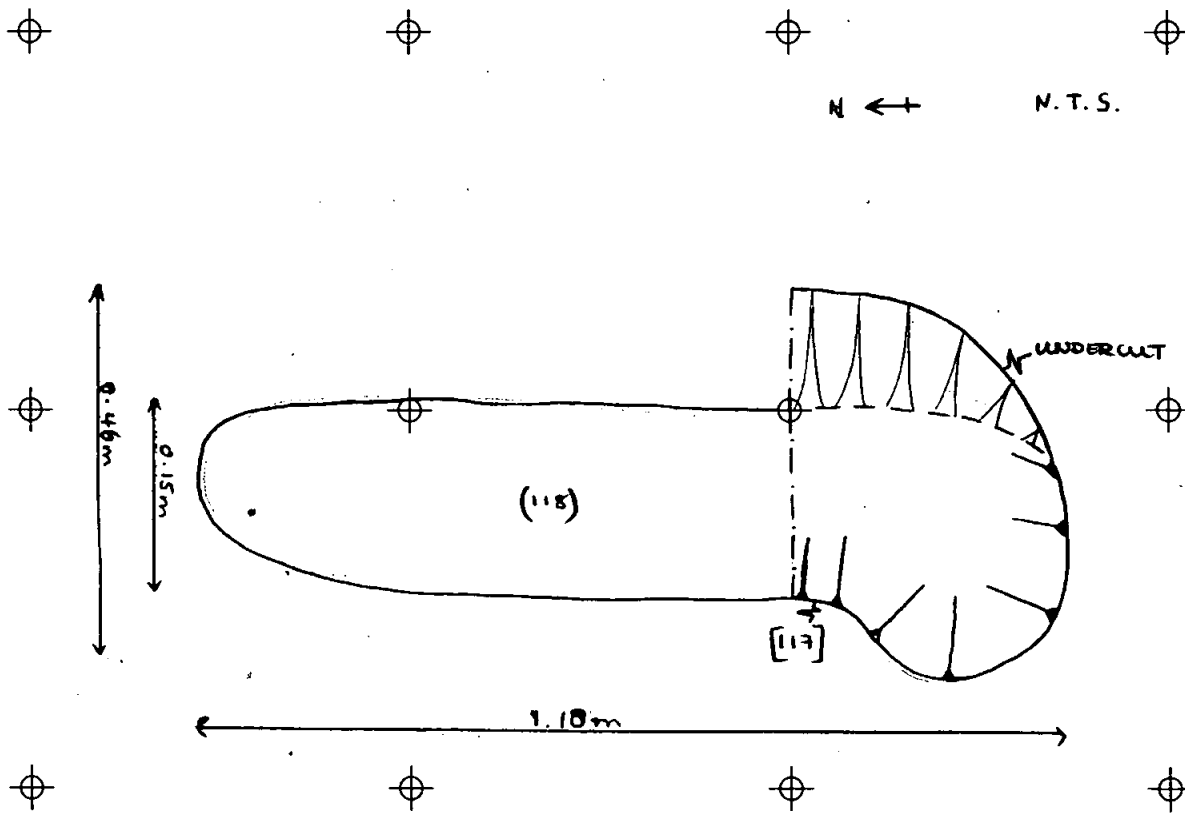
SHEET NO. 1

- (101)
- |
- (118)
- |
- [117]
- |
- (102)

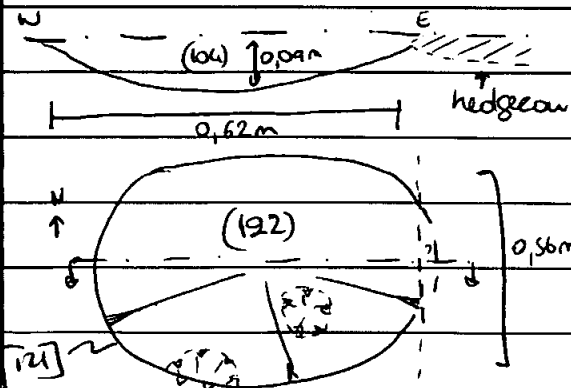
Clearly rooting or animal burrowing, not archaeological (no finds) = brown, loose leaves continuing deeper / undercutting sides, through natural orange gravelly sand.

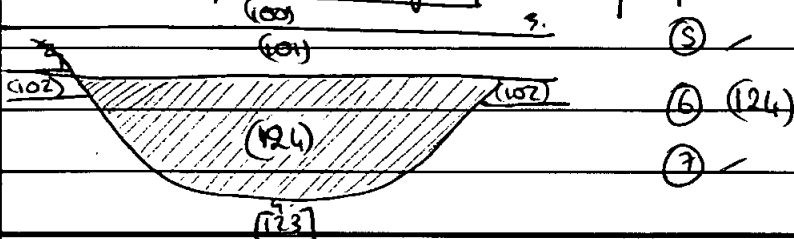
① linear (NW/SE) ② fairly steep NE side, moderate SW side - Base ~~not clearly defined~~ concave - ③ 1.20m wide, length unknown, 0.38m deep - ④ see group sheet for plan

NW-SE aligned ditch, probably a boundary ditch part of a field system - no finds in this slot.

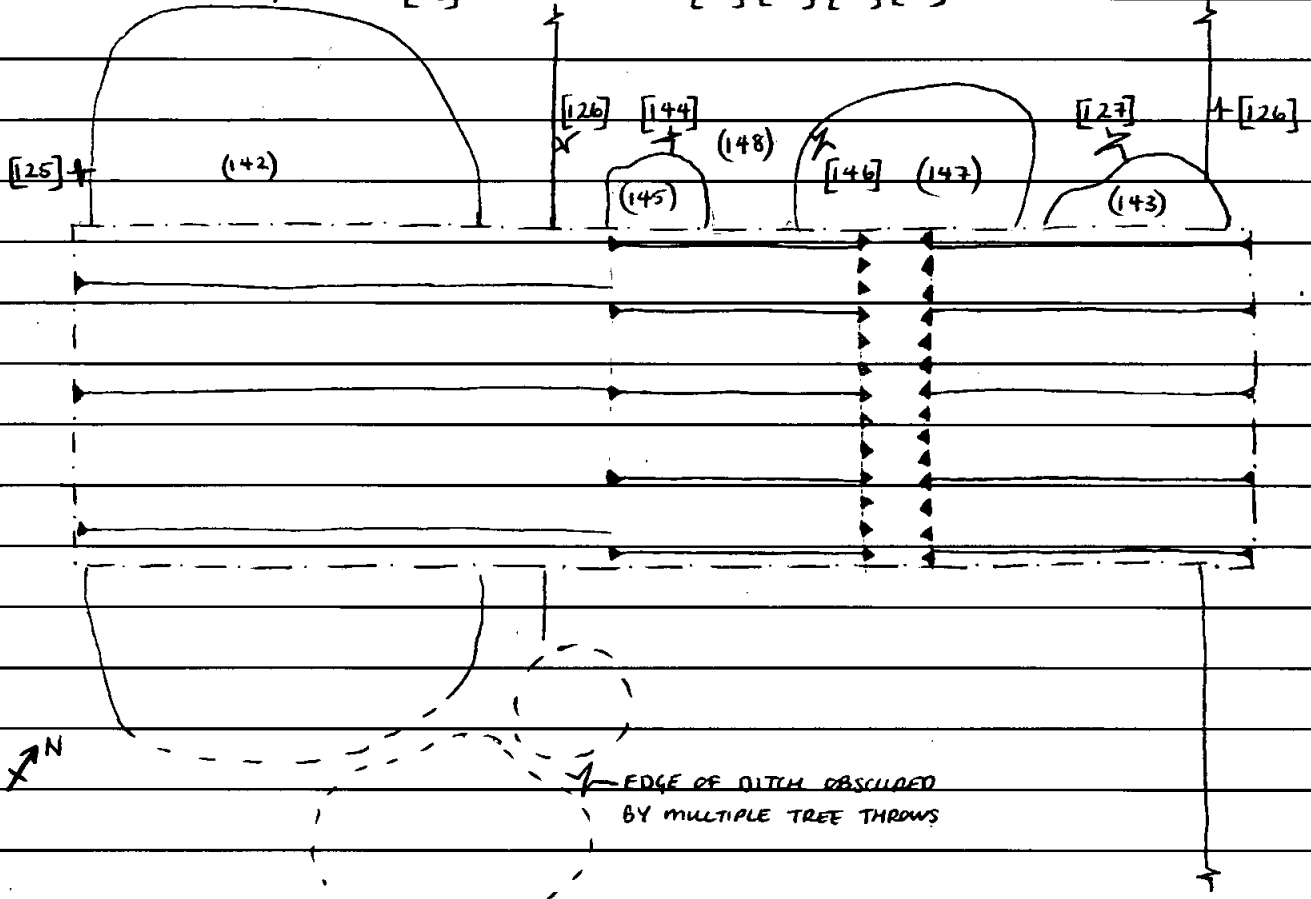
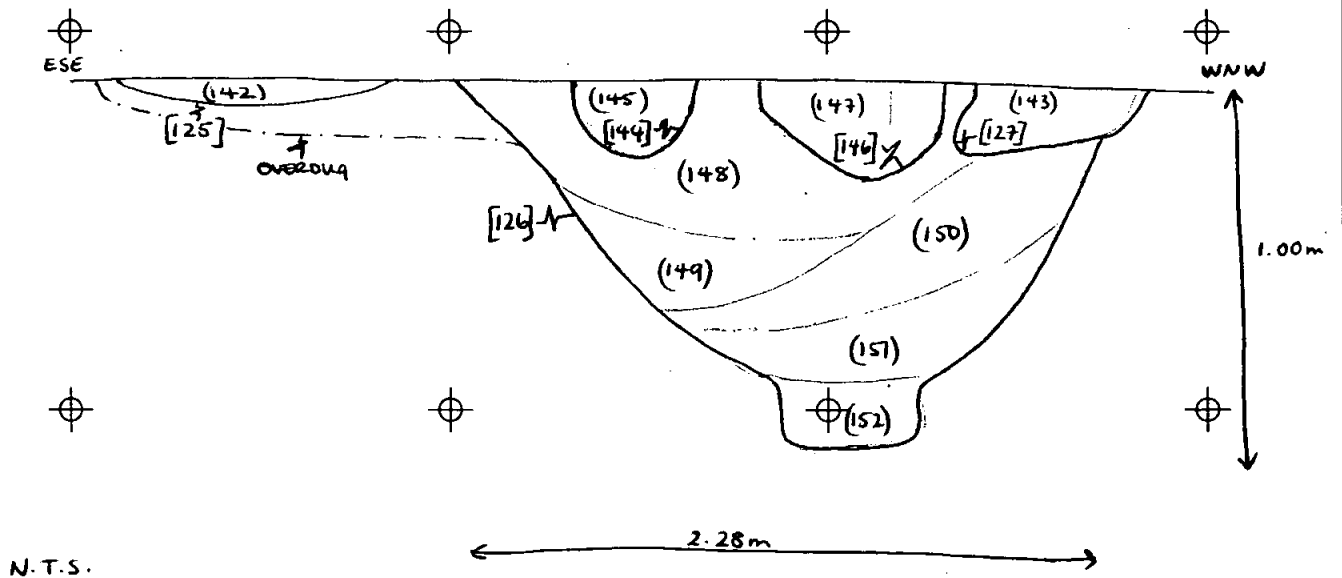
SHEET NO. 1

SKETCH OF SLOT THROUGH DITCH [126] + TREE THROWS [125] [144] [146] [127]

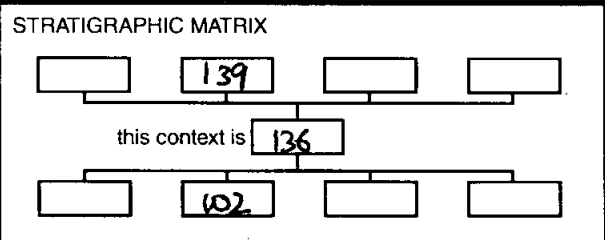
*Small pit, possibly used as a fire-pit??*

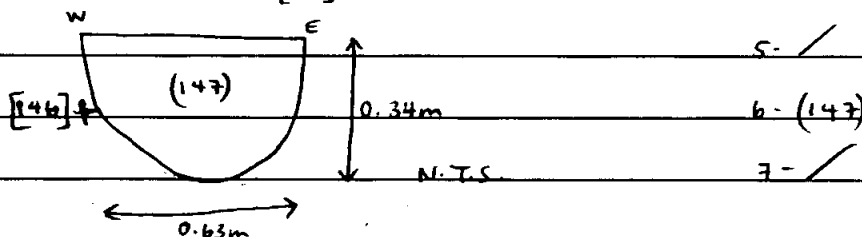
- 1- *ROUGHLY CIRCULAR*
- 2- *IRREGULAR CONCAVE BASE / SIDES NEAR VERTICAL*
- 3- *DIAMETER 0.63m D.P. 0.34m AS EXCAVATED*
- 4- *SEE ADD SHEET [126]*

*CUT OF TREE THROW. CUT INTO FILL (148) OF BOUNDARY DITCH [126]. FILL STERILE.*

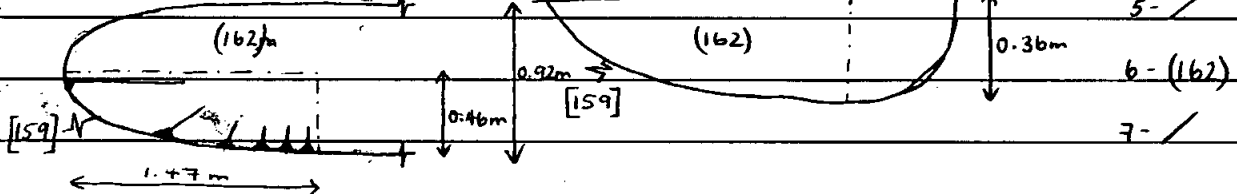
CUT OF DITCH TERMINUS - CONTINUING SOUTH. PROBABLE ROMAN DATE

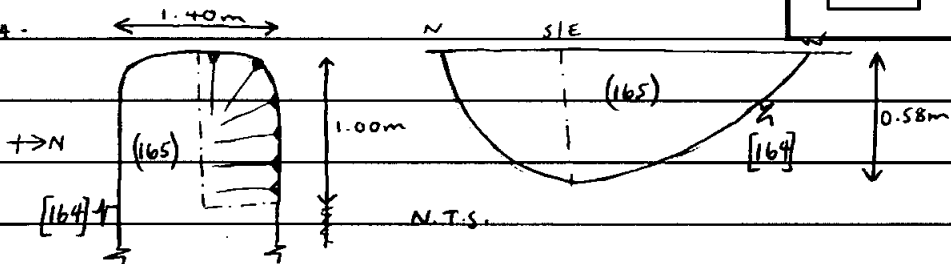
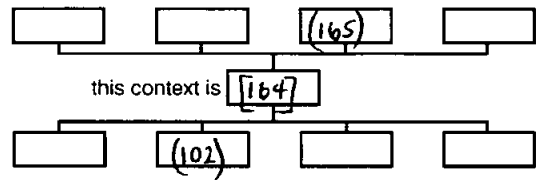
*3- L. 1.00m x W. 1.40 x D. 0.58m*

*CUT OF TERMINUS OF DITCH CONTINUING EAST - PROBABLY TERMINUS OF RECT VISIBLE IN OTHER SLOT.*

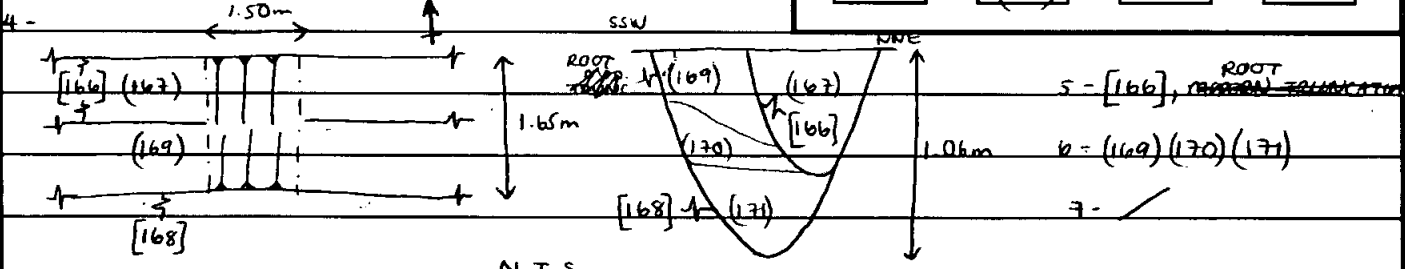
- 1- *LINEAR E-W*
- 2- *BASE SHARP CONCAVE / SIDES SHARP*
- 3- *L. 1.50 x 4.0m W. 1.65m D. 1.06 AS EXCAVATED*

*CUT OF E-W DITCH CONTINUING EAST INTO BULK. RE-CUT [166].*

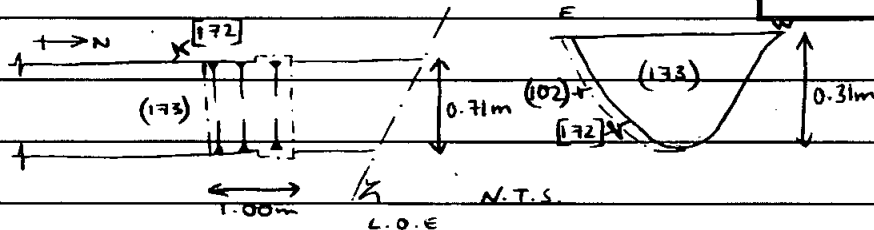
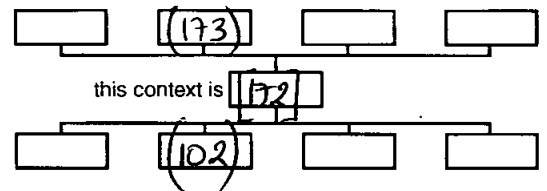
*1- LINEAR N-S**2- CONCAVE BASE / SIDES MODERATE**3- 1.00m W 0.71m D 0.31m AS EXCAVATED**4-*

*CUT OF N-S LINEAR EXTENDING INTO L.O.E TO NORTH OF SLOT. SINGLE STERILE**FILL (173) - DATE UNKNOWN - AS ONLY SMALL PART OF DITCH VISIBLE IT IS DIFFICULT**TO DETERMINE FUNCTION - MAYBE SHALLOW ENCLOSURE/BOUNDARY?*

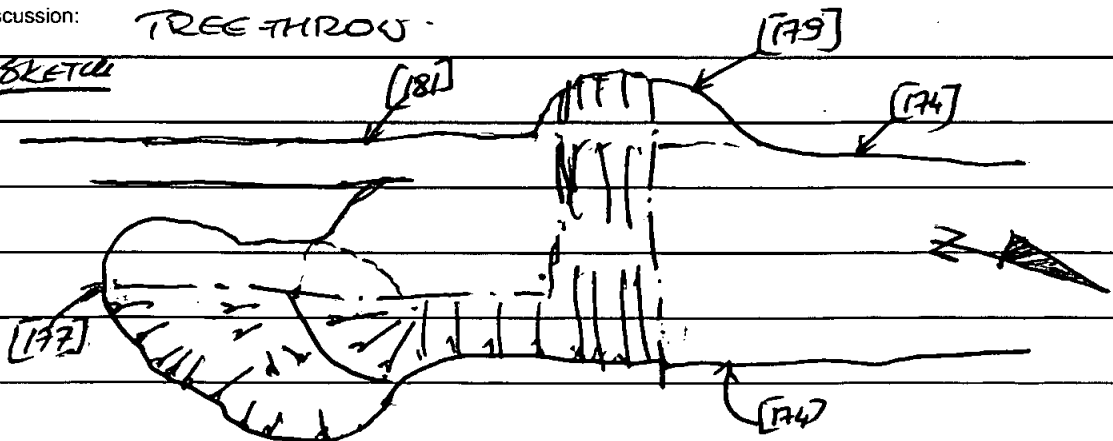
PLAN SKETCH

**TREE THROW**

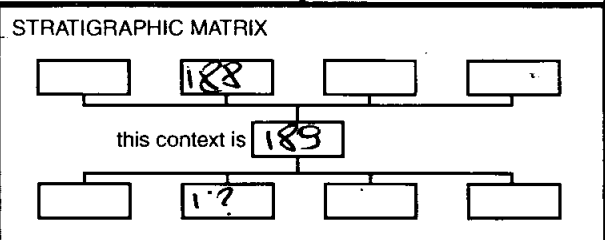
Description (See check lists):  
**FRAGILE, VERY DARK GREY SANDY SILT WITH PIECES OF TIMBER (90%) -> -> DECAYED WOOD, CUT BY A SAW BRANCHED, SAWS OF TREE TRUNKS WITH ROOTS - BASICALLY A LAYER OF TIMBER TO 0.45M THICK. BASE NOT REACHED AS THE PIT WAS EXCAVATED BY A MACHINE AND WE REACHED DEPTH OF 2.2M BELOW SUBSOIL (UNSTABLE SIDES). THE DEPOSIT MAY BE EXCAVATED IN ANOTHER PART**

Interpretation/Discussion:  
**OF [187] IF IT IS DECIDED SO DURING SITE MEETING FOLLOW THE ~~THE~~ MANY OF THE PIECES OF TIMBER ARE NOT CUT, THERE ARE NOT DECAYED FULLY (WORTHY TIMER) - ONE WOULD EXPECT THE TIMBER TO BE FULLY OR AT LEAST WELL DECAYED IN THIS SAND AND GRAVEL SURROUNDING CONDITION. FOR SKETCHES SEE CONTEXT SHEETS 187 AND 188.**

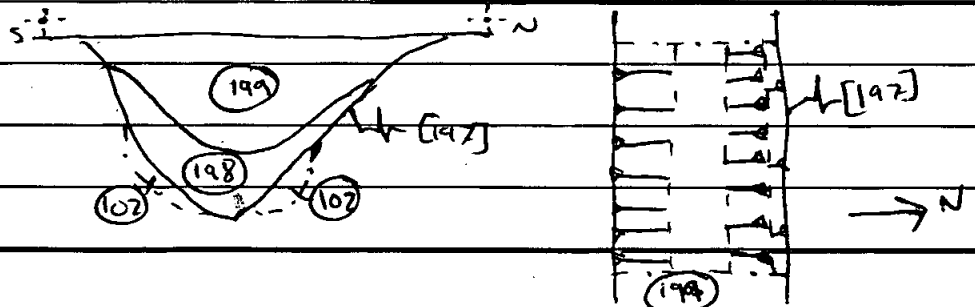
Cut of linear ditch [197]. Possible enclosure ditch - Iron Age (Lile)  
 pit excavated. Runs on roughly E-W alignment before turning on 90°  
 angle on roughly NNE-SSW alignment.

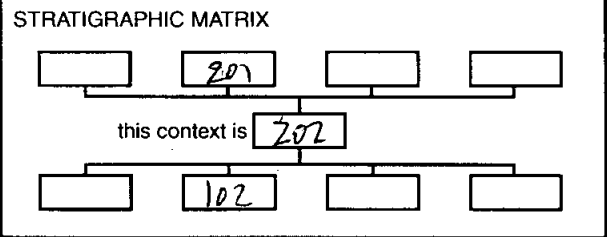
An E-W aligned ditch  
its fill contained pot.

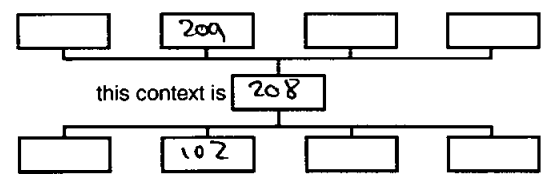
1. Linear (2.5m L)
2. shallow straight sides, wide rounded base.
3. 0.29m W x 0.57m L x 0.11m D
4. See add sheet for [210]
5. Truncated by ditch [210].
- 6) (209).

Solution hollow truncated by Ditch [210]. Relationship slot given context number for recording purposes.

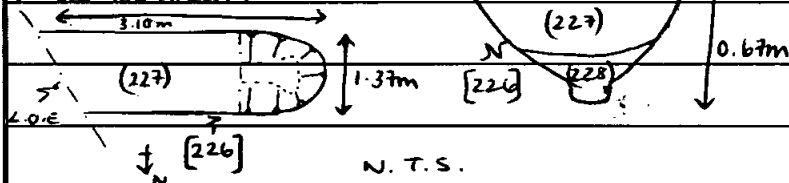
*1- LINEAR TERMINUS**2- BASE FLAT / SIDES MODERATE TO NEAR VERTICAL AT BASE**3- L 3.10m x W 1.37m x D 0.67m (L TO L.O.E)**4- SEE ADD SHEET.*

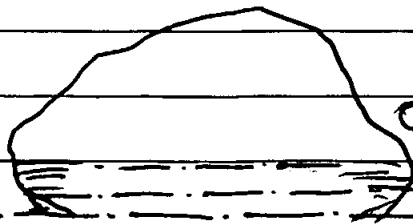
**GEOLOGICAL DEPRESSION - TROUGH LIKE "TROUGH" LIKE**

Interpretation/Discussion: **CHARACTER OF THE FILL IS NOT TYPICAL - ONE WOULD EXPECT A SILT DEPOSIT.**

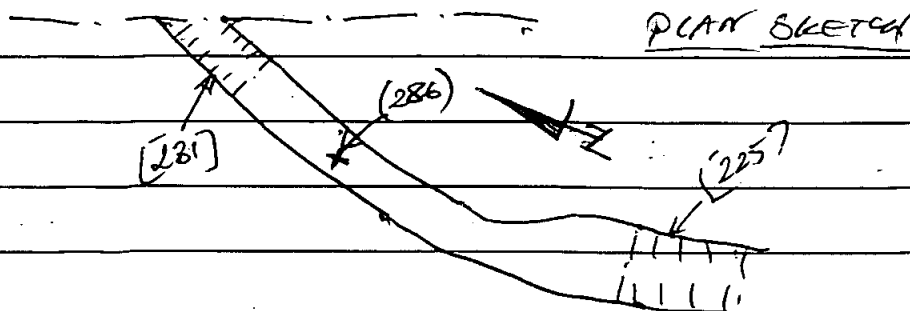
LINER, ALIGNED AT POINT N-S,STEEP SIDES, SLOPING BACKS OFSLOPES, A FLAT BASE, 3 FILL,PIECE OF POTTERY, OCCASIONAL CRACKSFRAGS (RANDOM CRACKS) 1.3m WIDE X 0.6m DEEP IN A1.2m LONG SLOT - FOR SECTION SKETCH SEE CONTEXT SHEET(232)

ENCLOSURE PIT - TALLIA

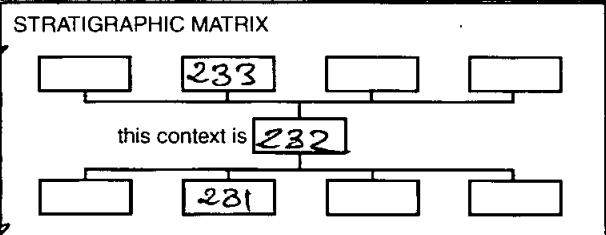
Description (See check lists):  
*FIRM, REDDISH-GREY SLTY CLAY WITH  
 ONLY OCCASIONAL SMALL VIZGY PIECES  
 OF FLINT AND QUARTZ. 0.1m  
 THICK, 1.2m HONY SLOT EXCAVATED  
 WITH HAND TOOLS IN DRY AND WALK CONDITION*

Interpretation/Discussion:  
*PRIMARY / BASAL FILL OF THE ENCLOSURE DITCH*

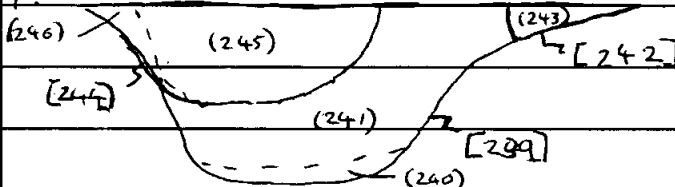
1. **LINEAR**2. **CONCAVE BASE, MODERATELY STEEP SIDES**3. **WIDTH = > 1.34m DEPTH = 0.72m**

5. **[242] [244]**6. **(240) (241)**7. **-**

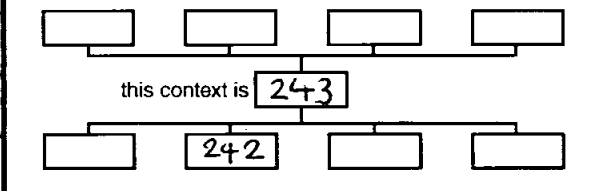
1. VERY FIRM
2. DARK RED / BLACK
3. SILTY-SAND
4. FREQ. CHARCOAL/ORGANIC MATERIAL FREQ. MANGANESE
5. DEPTH = approx. 0.24m
6. WIDTH = approx. 0.68m
7. —
8. MATTOCK/SHOVEL DRY CONDITIONS

MIXED FILL OF PROBABLE TREETHROW.

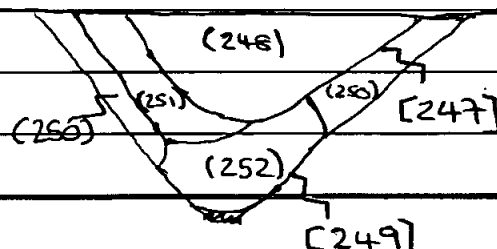
This is a possible re-cut of earlier ditch [249]

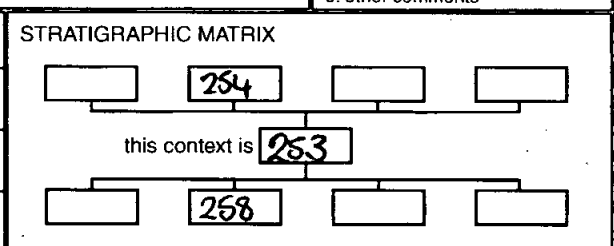
⑦ ~~253~~ **POSSIBLY GROWS WITHIN DITCH THEREFORE SIMILAR DIMENSIONS TO DITCH (257)**

**CUT OF TREETHROW [253] - POSSIBLE MODERN - PROBABLY CUT THROUGH DITCH [257], WHICH HAS <sup>DISTURBED</sup> ~~ALTERED~~ THE NATURAL WITHIN DITCH.**

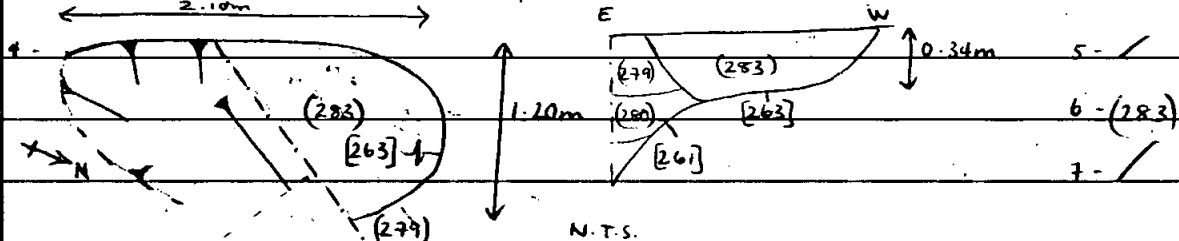
3 - **6 2.10m x 1.20m D 0.34m**

**CUT OF TREE THROW WITH SINGLE FILL (283) - TRUNCATES DITCH [261] - SLOPE OF BASE COULD BE CAUSED BY SLUMPING INTO LESS COMPACT FILL.**  
**RELATIONSHIP WITH TREE THROW [284] LOST.**

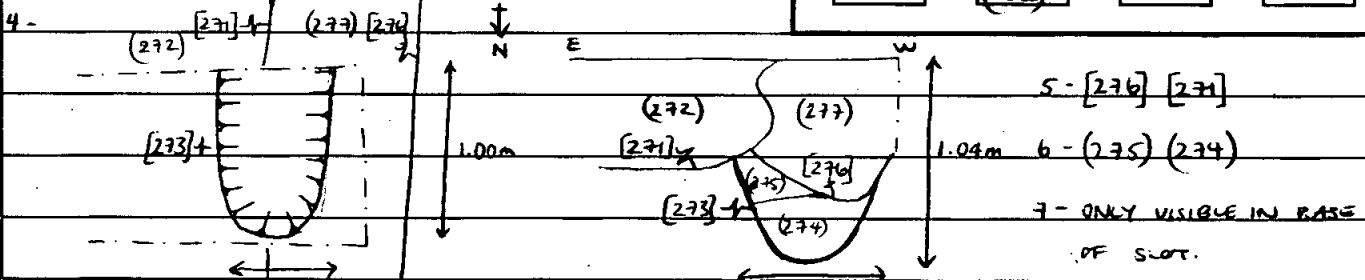
- 1 - **LINEAR TERMINUS**
- 2 - **SLIGHT CONCAVE / SIDES NEAR VERTICAL**
- 3 - **L. 1.00m W. 0.70m D. 0.4m AS EXCAVATED**

Interpretation/Discussion: **TERMINUS OF DITCH CONTINUING SOUTH - POSSIBLY OR LATE IRON AGE / EARLY ROMAN**  
**DITCH VISIBLE IN FURTHER SLOTS - WAS RESULT [276] POSS. FUNCTIONED AS BOUNDARY?**

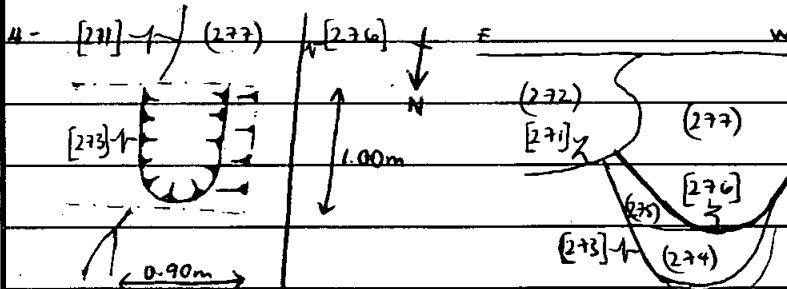
- 1- LINEAR N-S
- 2- BASE CONCAVE / SIDES NOT VISIBLE
- 3- L 1.00m W 0.90m x D 0.78m AS EXCAVATED

*N-S LINEAR - RESULT OF EARLIER DITCH [273] - POSS. FUNCTIONED AS A BOUNDARY? - NO FINDS - OTHER SLOTS HAVE PROVIDED EARLY ROMAN DATE.*

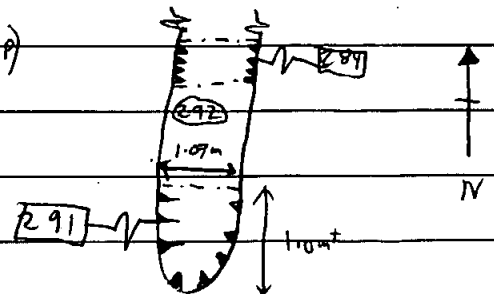
Cut of possible ditch, terminates at southern end, homogeneously sterile fill, possible geological feature, same as [289]

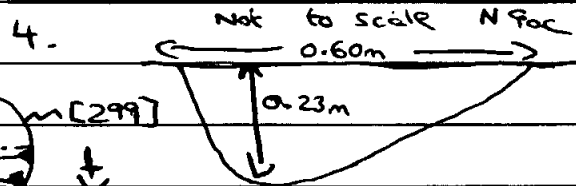
This is a possible breethrow due to the uneven sides
