4355 BEACONSFIELD  
EASTERN RELIEF ROAD  
BORRIS

B. PRIMARY CONTEXT DATA 300-399

Site[A355 Eastern Bypass ] Site code[BERR18]

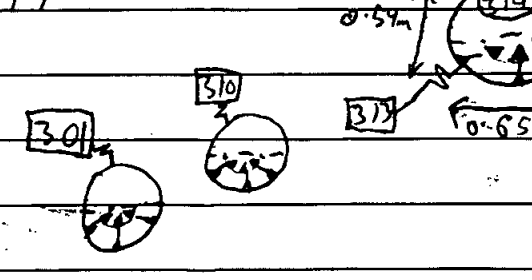
cut of ~~cut~~ possible pit, homogeneously sterile fill, possibly related to other possible pits [310] and [301] to create a structure, no dating material

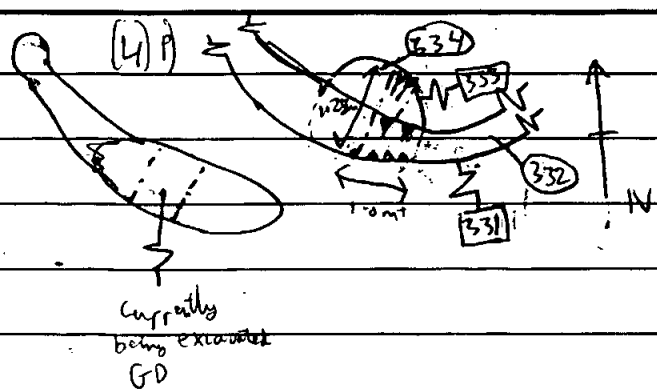
Cut of ditch, no debris material,  
homogeneously sterile, ~~is~~ later  
than tree throw [333]

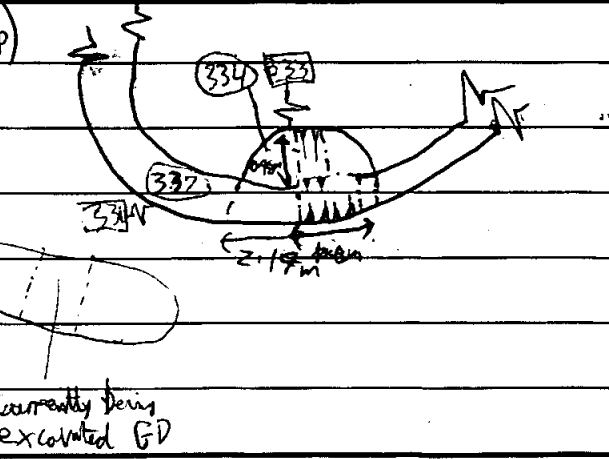
(4)p  
cut of tree throw, natural feature, no dating material  
homogeneously sterile, is earlier than ditch [331]

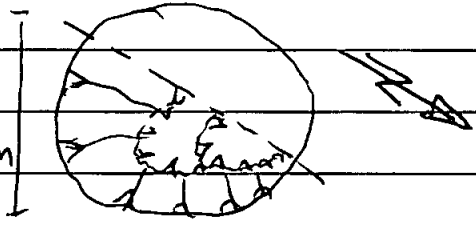
- 1) Friable
- 2) Light reddish grey
- 3) Sandy silt
- 4) Many small to medium pebbles
- 5) Up to 0.18m deep
- 6) Roughly circular area 0.8m  $\phi$
- 7) Disturbed by later animal burrows.

Lens of loose material in surface of natural (387). Caused by root action penetrating natural and allowing soil to work its way down when roots rotted off. Material further disturbed by burrowing animals making use of the softer material.

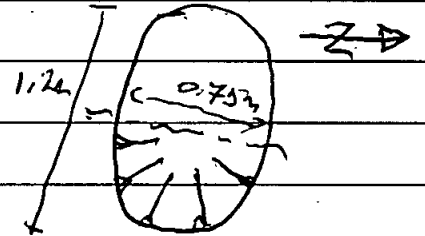
- 1) Friable
- 2) Pale grey brown
- 3) Sandy silt
- 4) Many small-medium pebbles
- 5) Up to 0.2m in depth
- 6) Roughly oval area  $\approx 1.2m \times 0.75m$  in size, steep sides, concave base.

Area of loose material caused by tree root action, disturbing conifer of natural. Later mixing with soils as the tree roots rotted out.

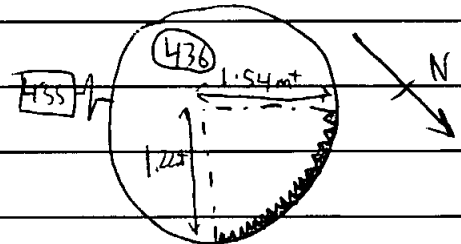
Cut of sinkhole, one quarter ~~to~~ excavated, base not found, beyond limit of excavation, possible struck flints recovered, probably washed in with alluvial fill

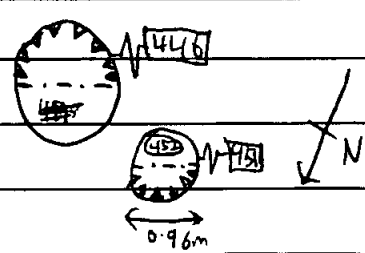
(4)P Cut of sinkhole, base unexcavated, beyond LOE, possible ~~work~~ struck flint recovered, likely washed in with fill as part of the colluvial layer

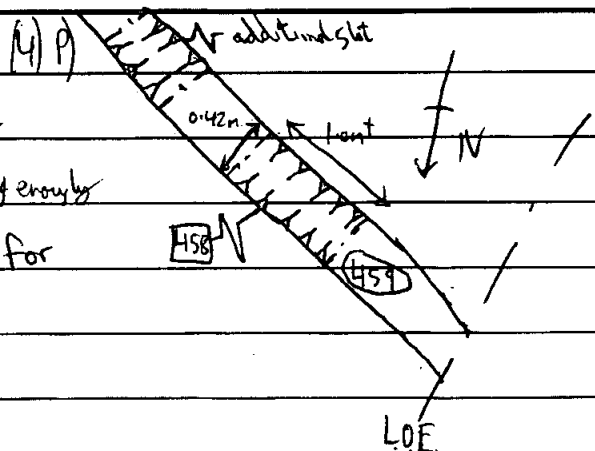
Cut of gully, most likely used as a boundary or possibly drainage, no datable material, homogeneously sterile, an additional slot was excavated for finds but were corded

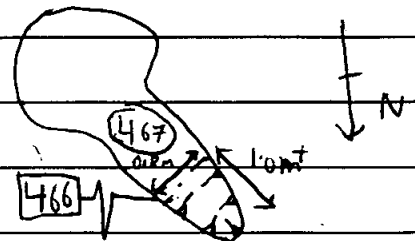
*Cut of gully terminus, no dating material found, homogeneously sterile, possibly used for drainage*

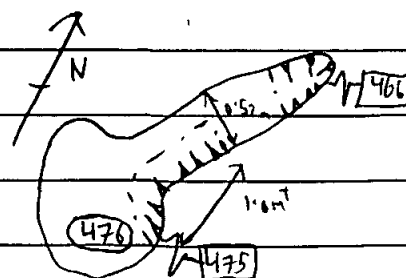
*cut of gully, possibly used as drainage, no datums**material, homogeneously sterile*

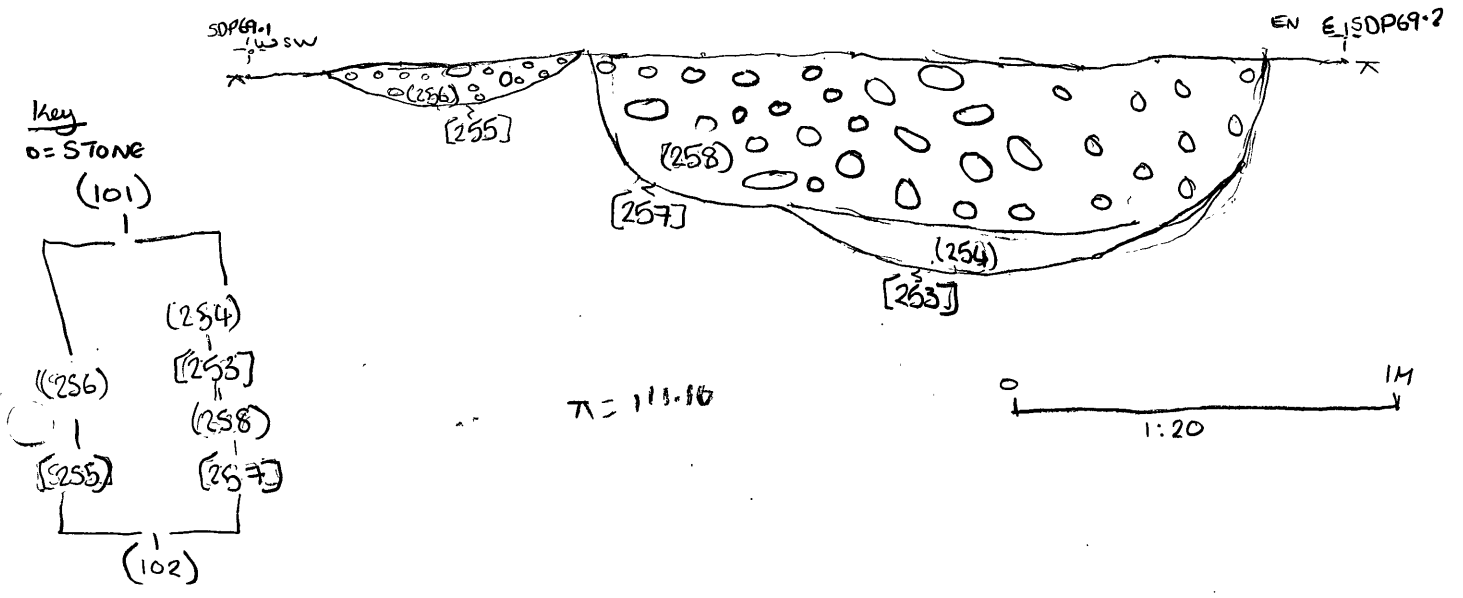
BERRIS  
S.69  
1:20  
EF  
16/08/2018

NORTH FACING SECTION OF DITCH [257] & TREETHROW [255]

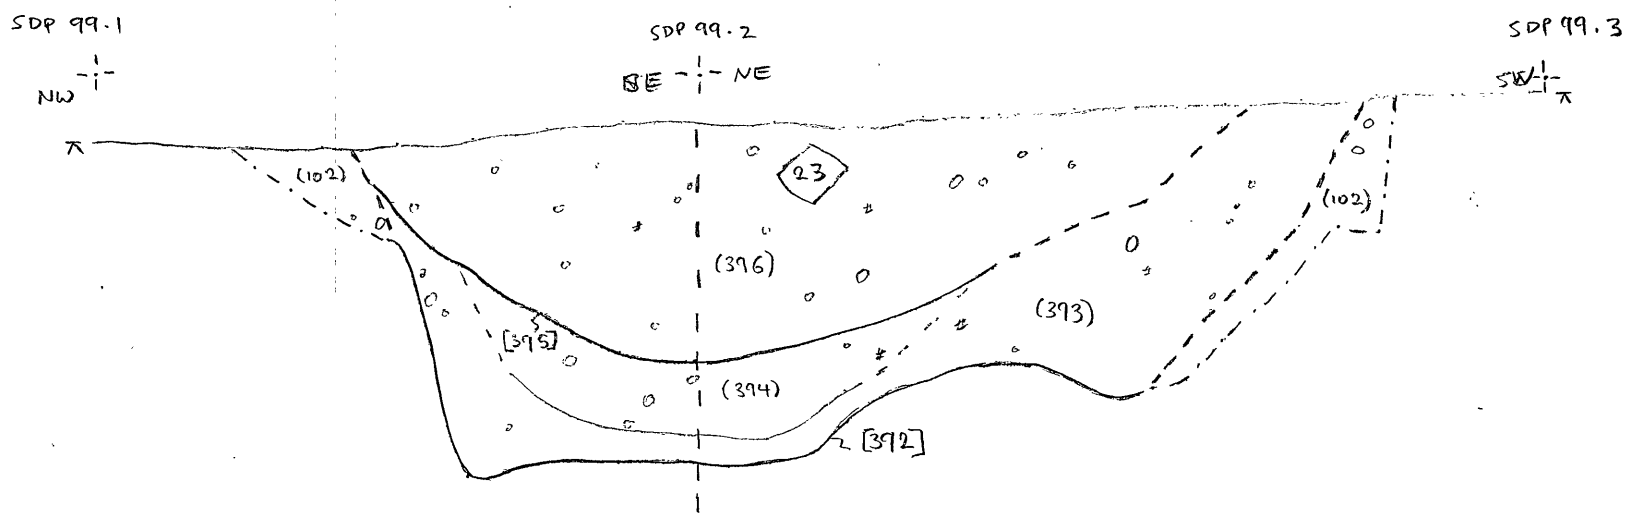
BERRIS  
 SECTION 99  
 SECTION OF [392] NATURAL FEATURE AND  
 [395] POSSIBLE PIT.  
 SCALE 1:20  
 SB  
 07/09/18

KEY  
 ◇ = SAMPLE NO.  
 ○ = STONES  
 # = CHARCOAL
