TRENCH RECORDING FORM

SITE NAME <u>REDHAYES, BLACKHORSE /</u>		SITE CODE		AREA		TRENCH No. <u>10</u>	
Length <u>30M</u>		Width <u>3.5M</u>		Ground level (AOD) <u>—</u>		Max. depth <u>0.4M</u>	
Plan Nos	Section Nos	Colour photos Film Frames	B & W photos Film Frames	Digital Photos	Co-ordinates <input type="checkbox"/> Site Grid <input type="checkbox"/> OS		
<u>GPS</u>	<u>—</u>	<u>—</u>	<u>—</u>	<u>100:2001 - 0008</u>	<u>—</u>		
Context No.	Context type	Description			Dimensions	Context Sheet	
<u>1000</u>	<u>LAYER</u>	<u>TOPSOIL: LOOSE BROWNISH GREY SANDY SILT; <5% SUBANG STONE <200MM. MANY ROOTS AND BURROWS.</u>			<u>LOE <0.2M THICK</u>	<u>/</u>	
<u>1000A</u>	<u>LAYER / DEPOSIT</u>	<u>SUBSOIL: LOOSE BROWN-PINK SANDY SILT; <5% SUBANG STONE <200MM. SOME ROOTS AND BURROWS. POSSIBLY BANK MATERIAL REDEPOSITED FROM FIELD TO N. AND SUNKEN LANE TO S.</u>			<u>LOE <0.2M THICK - NOT DUG TO FULL DEPTH</u>	<u>/</u>	
<u>NO ARCHAEOLOGY, NO FINDS - VERY STERILE</u>

FIELD BOUNDARY RECORDING SHEET

WATCHING BRIEF
RECORDING SHEET

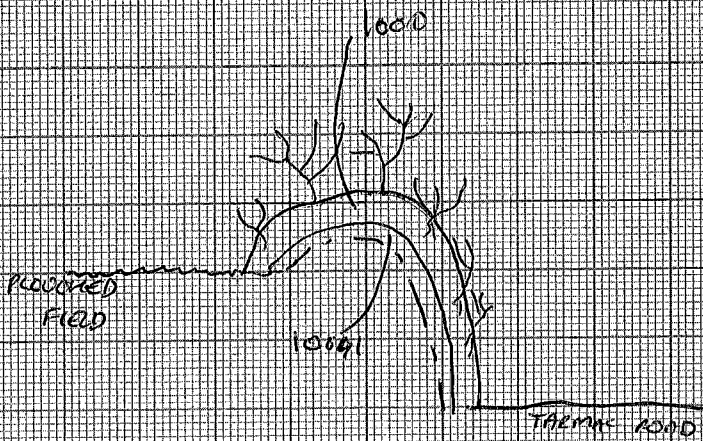
NTC

<u>OBSERVED STRIPPING OF TOPSOIL + SUBSOIL IN 30M STRETCH OF BANK THIS WAS REMOVED TO TAKE OUT MAJOR ROOTS AND BIOLOGICALLY 'STERILISE' AREA PRIOR TO REMOVAL OF BANK AT A LATER DATE.</u>							
FINDS							
Material	Context No.	Qty	Material	Context No.	Qty		
<u>—</u>							
Registered Artefact No. <u>—</u>				Sample Nos <u>—</u>			
Recorded by: <u>MJB</u>		Date <u>25/5/16</u>		Checked by:		Date

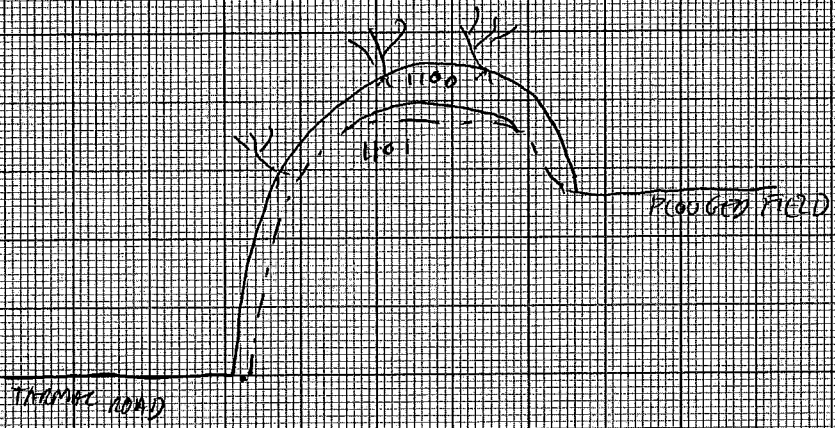
NTB - FACING NORTH

SITE NAME REDWAYES, FITTHERBARO/ BLACKHORSE LANE LINK (WB)		SITE CODE		AREA		TRENCH No. 11	
Length 35m		Width 3.5m		Ground level (AOD)		Max. depth 0.4m (mainly 0.2m)	
Plan Nos	Section Nos	Colour photos Film Frames	B & W photos Film Frames	Digital Photos	Co-ordinates <input type="checkbox"/> Site Grid <input type="checkbox"/> OS		
OPS	—	—	—	101-0001- 0008	—		
Context No.	Context type	Description			Dimensions	Context Sheet	
1100	LAYER	TOPSOIL: SLIGHTLY RED BROWN, LOOSE SAND SILT, ROOT DISTURBED, < 5%. STONE < 300MM			LOE; 0.1 - 0.2m THICK	—	
1101	sub deposit LAYER	SUBSOIL: FRAGILE ORANGE BROWN. SAND SILT, SOME ROOT DISTURBANCE. < 5%. STONE < 200MM. REDEPOSITED FROM SUNGLAN LANE TO W. TO MAKE BANK — NOT REACHED IN ALL OF TRENCH.			LOE; NOT EXPOSED IN ALL OF TRENCH < 0.2m	—	
NO ARCHAEOLOGY — STERILE, A FEW MODERN FIRMS (NOT RENT)							
OBSERVED STRIPPING OF TOPSOIL + ROOTS FROM SECTION OF BANK, DONE TO ENSURE BIOLOGICAL STERILITY PRIOR TO REMOVAL AT AT LATER DATE.

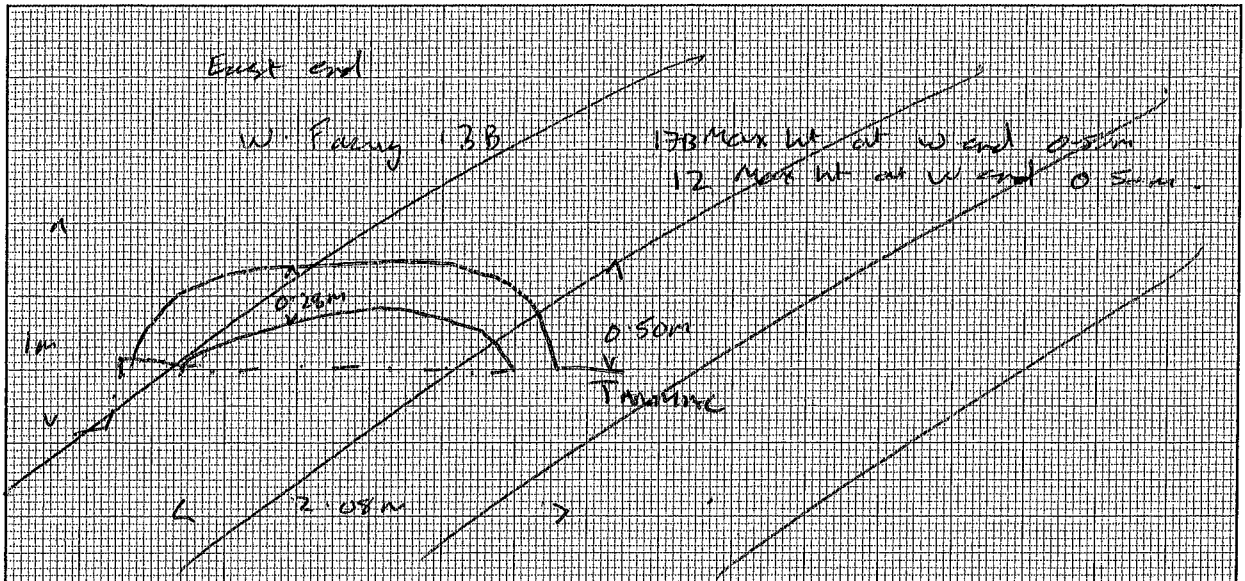
H012 Approx 135m

NB At west end the bank 12 is

0.50m ht on north side (terrace road) +
 south side erode field. Mounded flush with
 Recul.

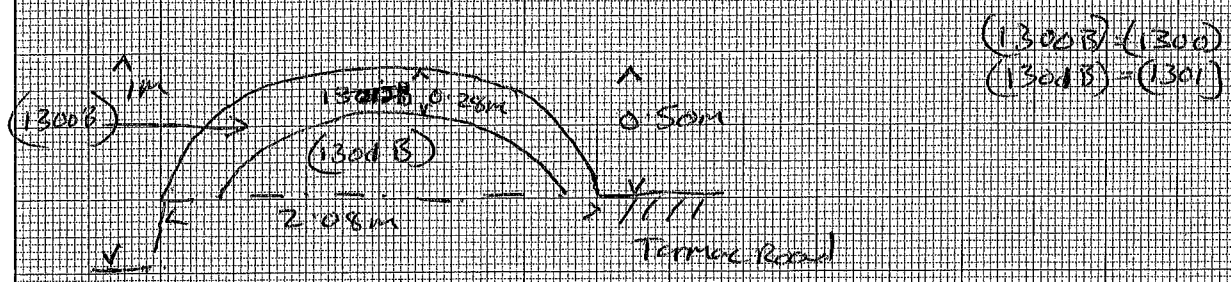
West Facing - East end of 13B

13B + 13C have a max ht of 0.50m to road surface + 1x contemporary land surface (top soil) on N side (13B 13C only has deep to land surface).
~~13B~~ 13C is 0.50m either side of road + land surface.

- 13A Approx 20m
- 13B Approx 41m
- 13C Length Approx 46m

It showed a made ground deposit (1503) which was made of topsoil mixed with 'tarmac fillings', 'crushed concrete' and plastic. The soil was a mid to dark silty clay. This layer overlaid/obscured a field drain [1503] (1504). This respected the northern side of 13B/3C. Approx dimensions were 0.3m wide x @ 46m long. The fill was a mixture of crushed concrete + pea grit predominant clay to most of its length from W → E. At the eastern end it was more digger and a lighter grey silty clay. Possible this was a road cut into a pre-existing ditch following the Hedgebank. See Day Sheet for sketch.

Strip to the north and reduce 13C to level flush with existing road surface shown as follows:-

Depth stripped variable between 0.20m + 0.30m

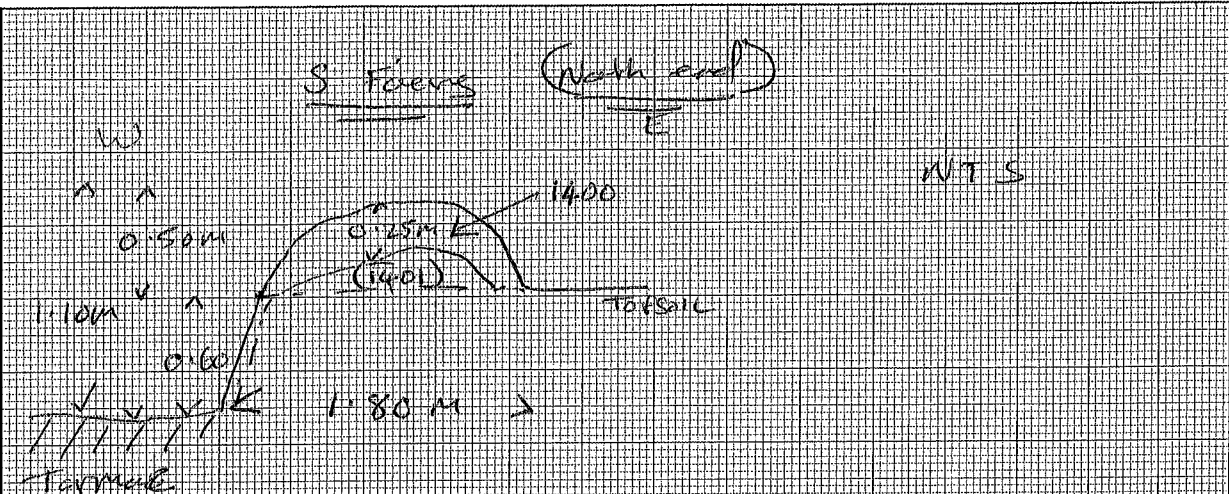
Approx 35m long

Battered bank filled with Topsoil on east side.

Maximum W of bank excavated at South end 0.400m flush with field east side. 0.250m on west terrace side.

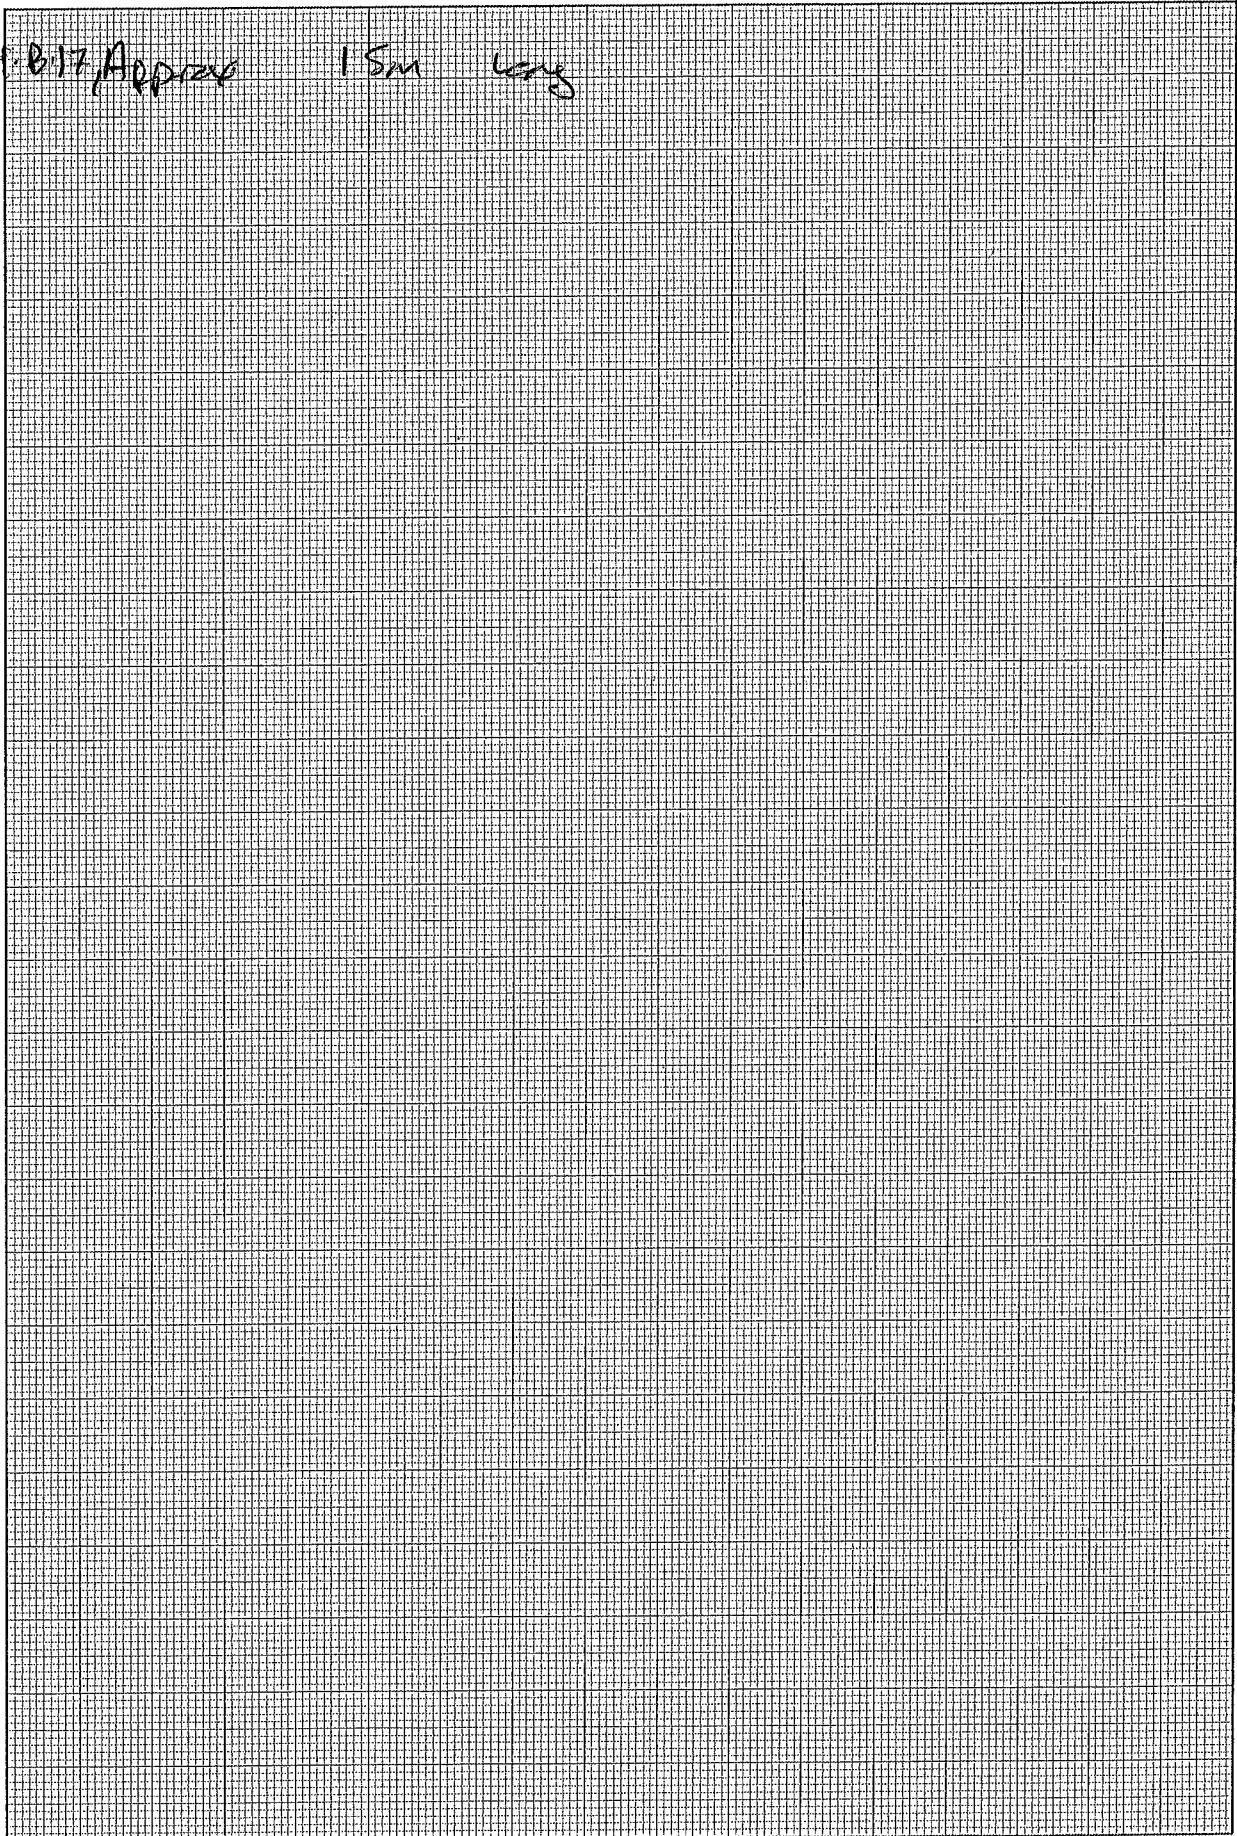
H-B-17 Approx 15m long

Revetment	<input type="checkbox"/>	Coursed	<input type="checkbox"/>	Random Rubble	<input type="checkbox"/>
Context No.	Context type	Description			Dimensions
<i>1700</i>	<i>layer</i>	<i>mid to light greyish brown. Some organic root inclusions. Silty clay-loam friable</i>			
<i>1701</i>	<i>Deposit</i>	<i>mid to light red brown silty sand, firm. rare subangular sand stone inclusions.</i>			
<i>NB!! This is on internal field bank.</i>					
Plan Nos	Section Nos	Colour photos <i>Film</i> <input type="checkbox"/> <i>Frames</i> <input type="checkbox"/>	B & W photos <i>Film</i> <input type="checkbox"/> <i>Frames</i> <input type="checkbox"/>	Digital photos <i>numbers</i>	OS co-ordinates
<i>G.P.S</i>	<i>17.1</i>			<i>100-0025 → 0026</i>	
FINDS					
Material	Context No.	Qty	Material	Context No.	Qty
Recorded by:	<i>J.A 23/8/16</i>	Date	Checked by:		Date:

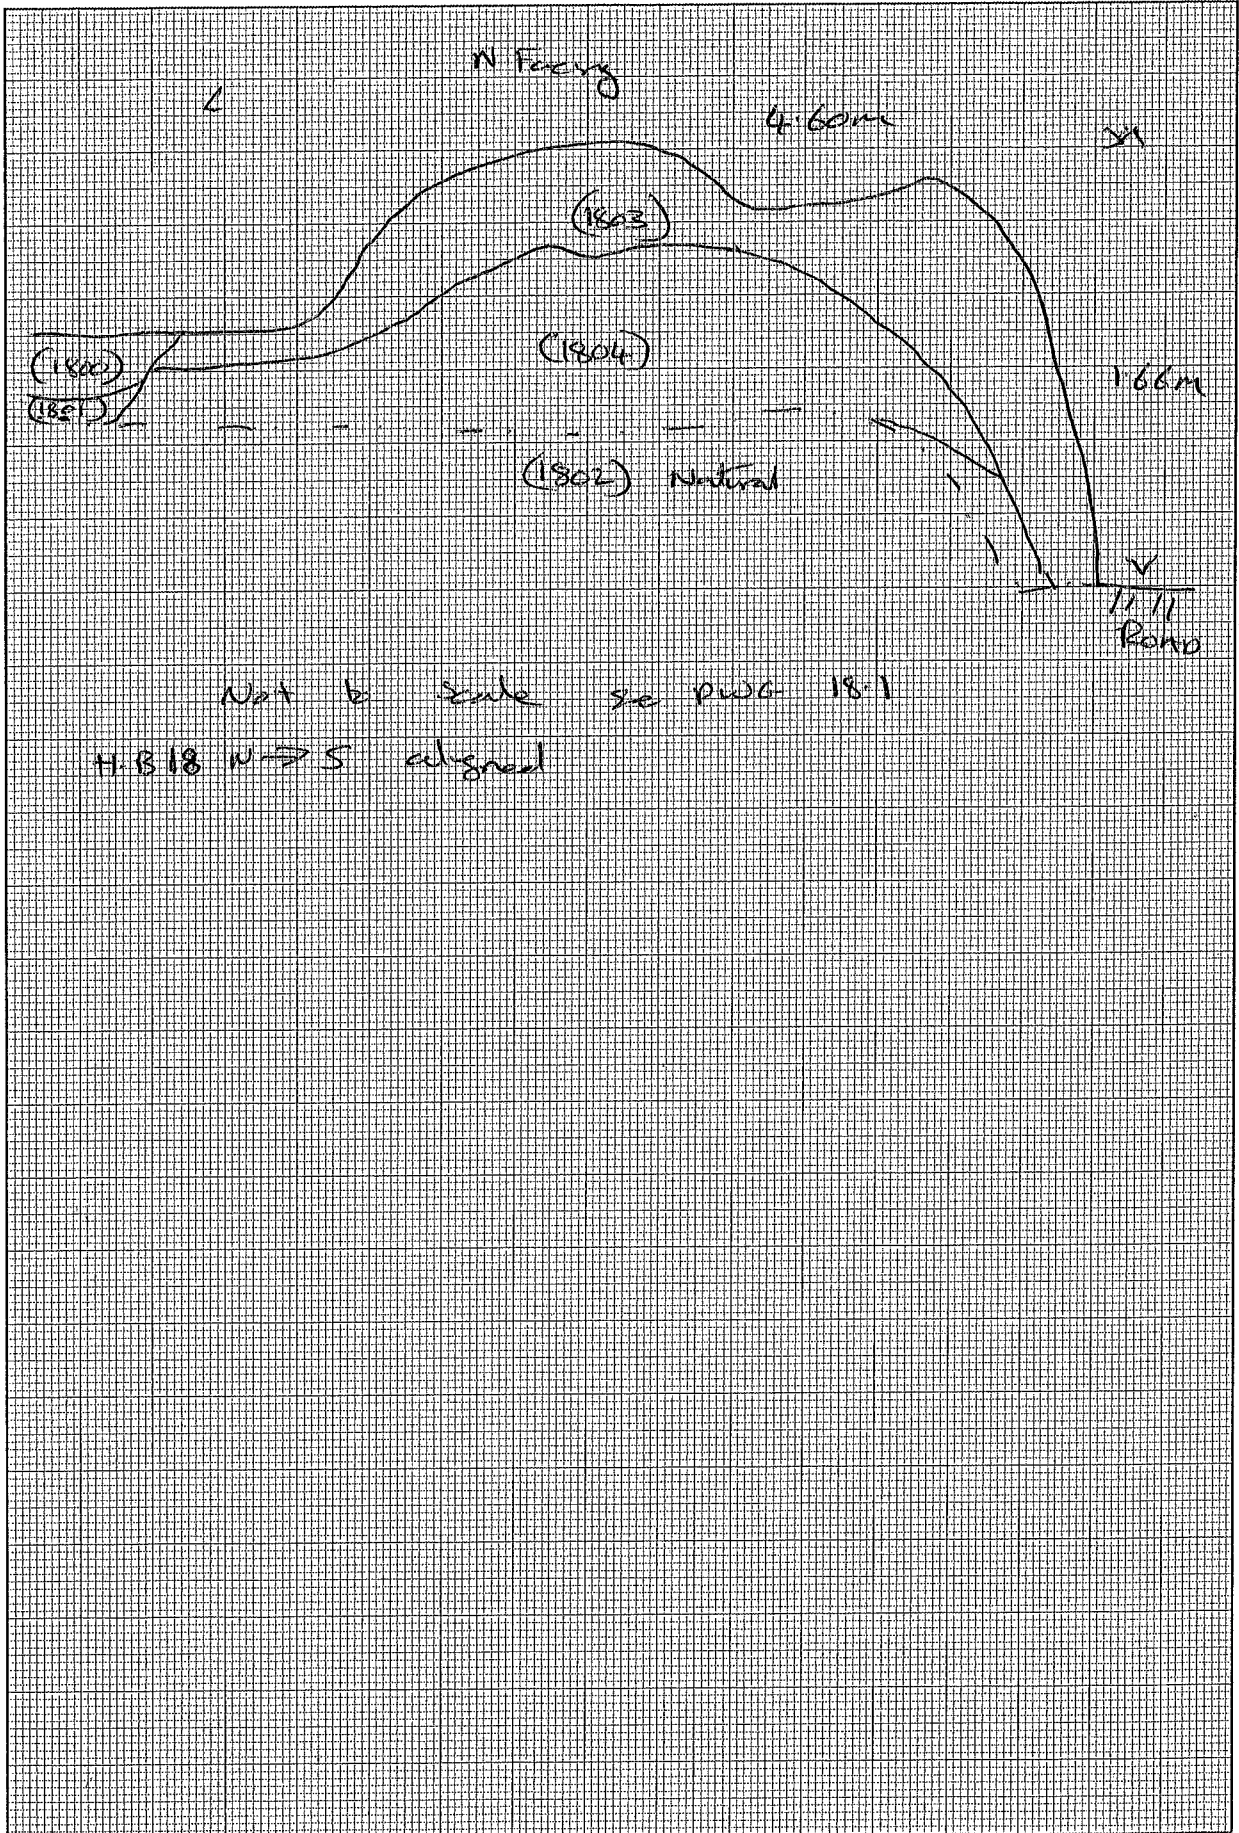
H.B.18 N → S aligned

4.60m

(1800)
(1801)

(1803)

(1804)

1.66m

(1802) Natural

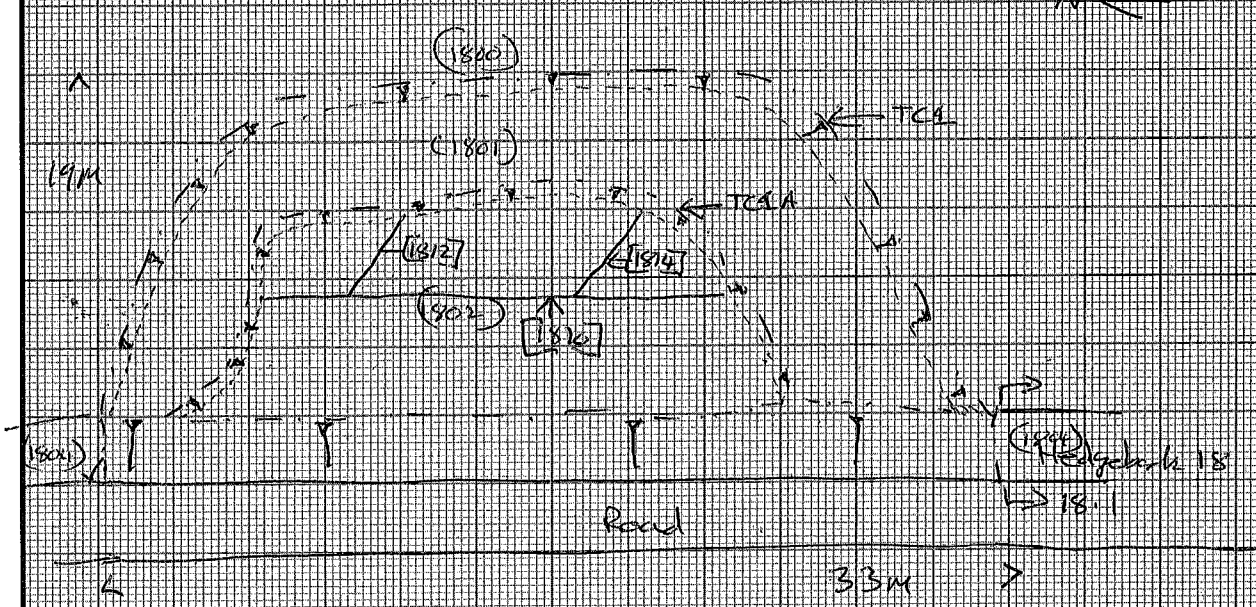
Turning Circle 1

Methodology: - hedgebank 18 remained then battered to road level 1818m. (See H.B. 18)

Area stripped off grass behind sea area TCL above - will be the by of the latter. Area TCLA then stripped of its subsoil to natural. Final depth is going to be 0.80m below road brown level. Approx 2m+ reduced dig.

Subsoil deeper in the south approx 0.10m and approx 0.10m in north.

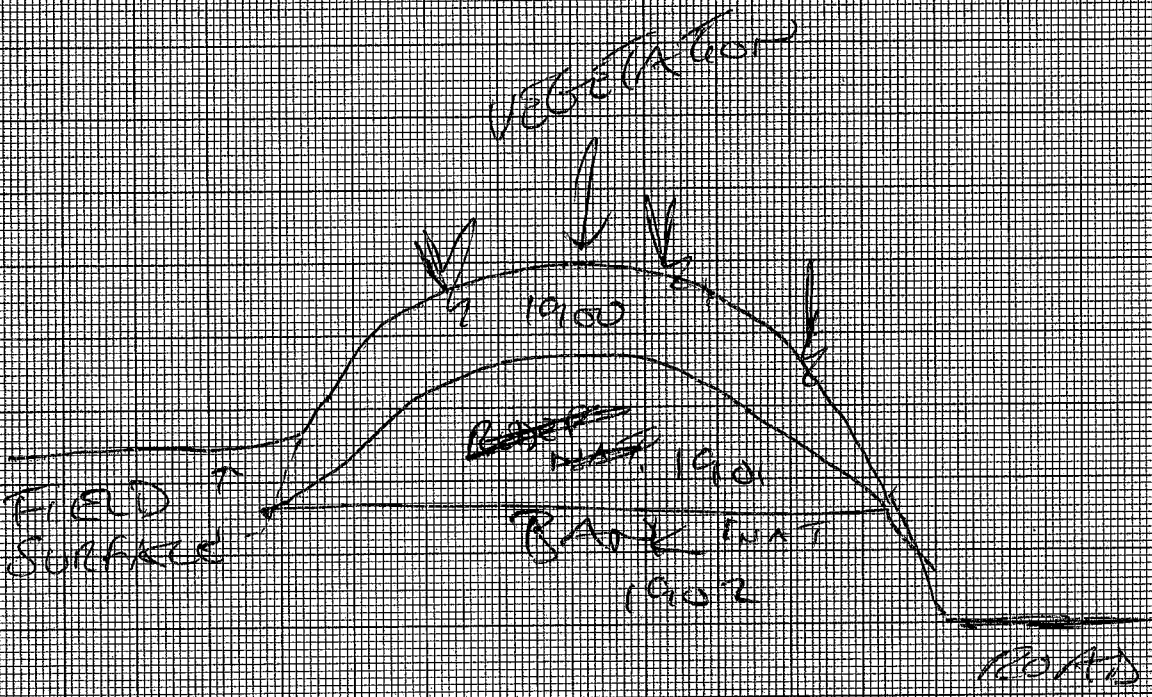
H.B. 191

Top
Soil -
