HALL BARNs FARM

HISTORIC BUILDING RECORDING

HALL BARNS FARM
STONYHURST
LANCASHIRE

SITE CODE: SHB'21
REPORT CODE: FAS2021 808 SHB782
NGR: SD 6926 3876

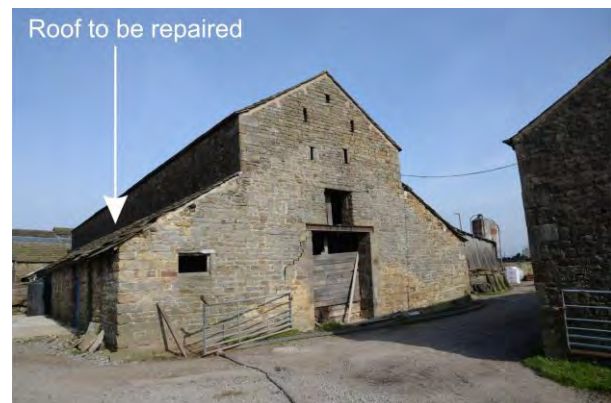
Plate 3 Southeast elevation of the barn

The southwest outshut of the barn is in a deteriorating state of repair and requires re-roofing (Plate 3). Listed Building Consent has been granted (Ribble Valley planning application reference 3/2020/0308), with the following condition:

The consented works would involve the removal of the existing roof covering, replacement of any rotten timber components with replacement equivalents, and then covering the roof with a breathable membrane, fitting new softwood battens and re-roofing with the roof tiles set aside. Any shortfall in roof tiles would be filled using tiles of matched colour, size and appearance salvaged from elsewhere on the estate.

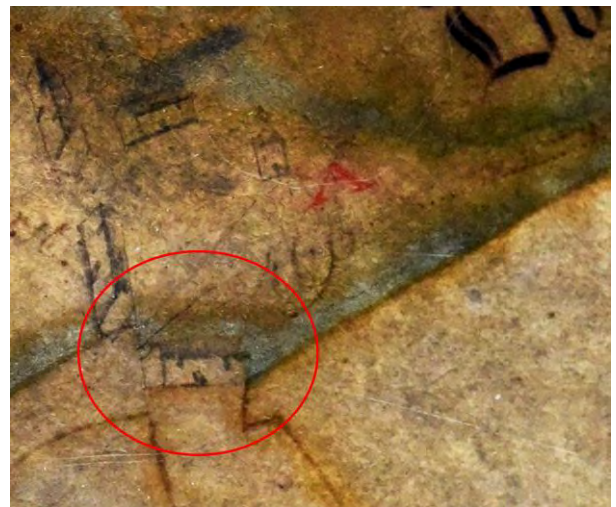
Plate 8 Detail from 1733 Duchess's map (oriented with north to the left, with the barn of interest circled)

The 1733 plan shows the farm, with a series of stylistic buildings (Plate 8). The map shows the track that now leads past the farm, dividing these two fields; this splayed out at its northern end to form an irregular, roughly triangular, yard. Of particular note is a barn that stands at the eastern end of Barn Hey (Plate 7). When overlaid onto the Ordnance Survey mapping, this barn appears to be in the location of the barn forming the focus of this report and notably appears to be directly connected to the parcel of land labelled as Barn Hey.

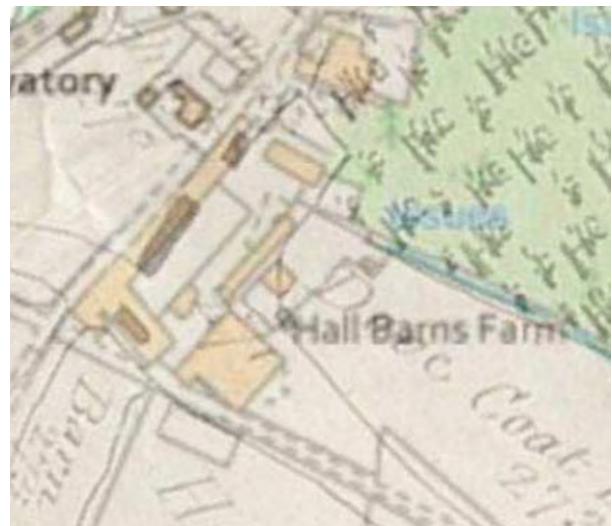
Plate 10 1774 plan overlaid and oriented to Ordnance Survey mapping

The 1774 plan shows a similar arrangement, with perpendicular buildings, presumably the two Listed barns, and a small structure to the east (Plate 9). When overlaid onto Ordnance Survey the barn at the end of Barn Hey does appear to correspond with the location of the barn of interest (Plate 10).

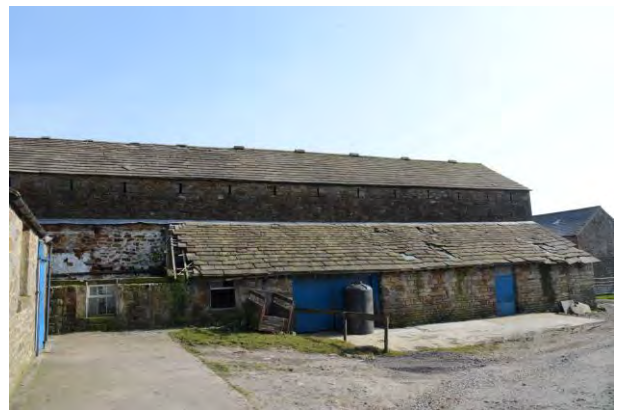
Plate 14 The southwest side of the barn

The southwest elevation of the single-storey outshut centres on a large double door (Plate 14; SHB001, SHB002; SHB010). Evidence indicates that this double door, and the roof above, fill what would have been an open space between two separate outshuts, providing direct access to the main body of the barn through a large arched opening. This would have mirrored the current situation on the opposite side of the barn.

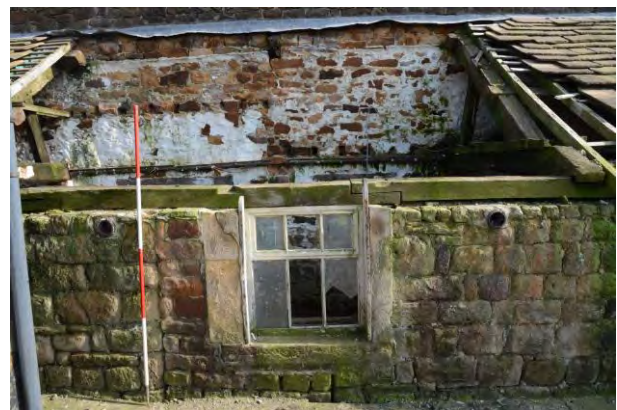
Plate 15 Window inserted in doorway, southwest elevation

The window to the immediate north of double doors represents either an inserted window, or an opening that has been enlarged (SHB017). The next window has been inserted into a blocked door opening (the door opening appears to be an original feature)(SHB016, SHB024, SHB050; Plate 15). The two windows at the northern end are also either insertions or enlargements (SHB012-013; SHB014-015). The northernmost window is blocked. The remaining three windows contain timber transom frames; the two to the north are of the late 19th century, that to the south is of mid- to late 20th-century date. The former two frames provide a likely date for when the windows were inserted.

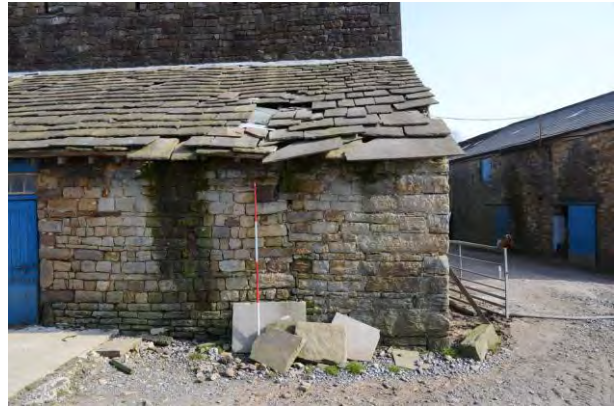
Plate 16 Vertical break in the fabric of the southwest outshut

To the south of the double door the fabric consists of smaller sandstone blocks (SHB003-005; SHB022; Plate 16). These blocks are regularly coursed until close to the south end of the building where there is break in the fabric (SHB021). This break suggests that this end has been repaired or extended, or possibly indicates a much larger opening in this part of the elevation.

The main features of note are a blocked ventilator (SHB023), a door opening (SHB020) and a further blocked ventilator towards the south end (SHB022). The door opening contains a timber frame with overlight and a ledged and braced door. All openings in this part of the elevation appear to be primary to the fabric; the door itself is a later replacement. The break in the fabric towards the southern end of the elevation is near vertical (SHB021; Plate 16).

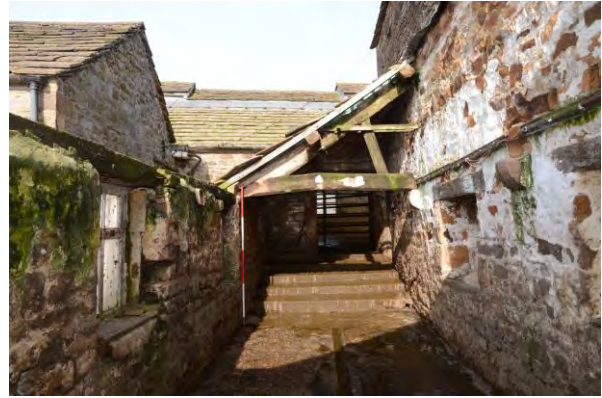
Plate 18 Interior of the north end of the outshut on southwest side

Views of the window openings on the external elevation show a mix of materials around the jambs, which again would suggest either insertion or opening up of existing openings (SHB026; SHB034-035; SHB042-045). Evidence for the blocked door opening which has had a window inserted is also visible on the interior of the building (SHB049).

The internal wall (conjoining with barn) has a series of window openings with timber lintels (SHB027-SHB031; SHB033; SHB38-040). Although some are now blocked, these may have served as catchlight windows, to provide light into the main body of the barn which, otherwise, without the main doors open, would have been quite dark. A timber, ledged door at the southern end provides access between the outshut and the main body of the barn (SHB041). The door is likely to be 20th century; a cut in the jamb may indicate the former location of a latch for an earlier door. Above this opening, evidence for old service routes, and a row of secondary sockets that may have held racking in the roofspace.

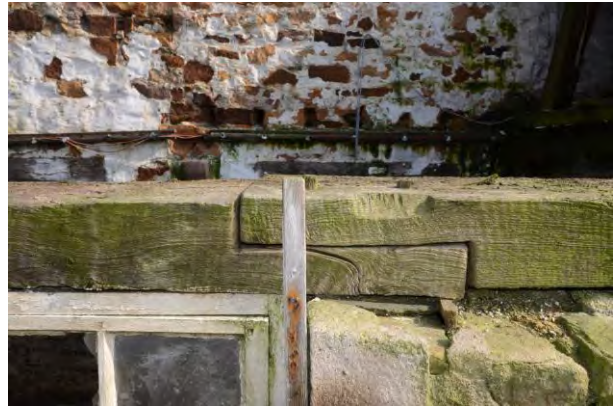
Plate 19 Wall plate towards the north end of the southwest outshut

The recorded elements on the removed timbers include details of the joints that would have secured the tie beams on the wall plate (SHB140), corresponding to the cut outs observed in the exposed wall plate (see Plate 19).
