**Archaeological Trial Trench Evaluation at  
5, 6 and 6b Beckham Place, Edward Street, Norwich**

ENF131521

July 2013

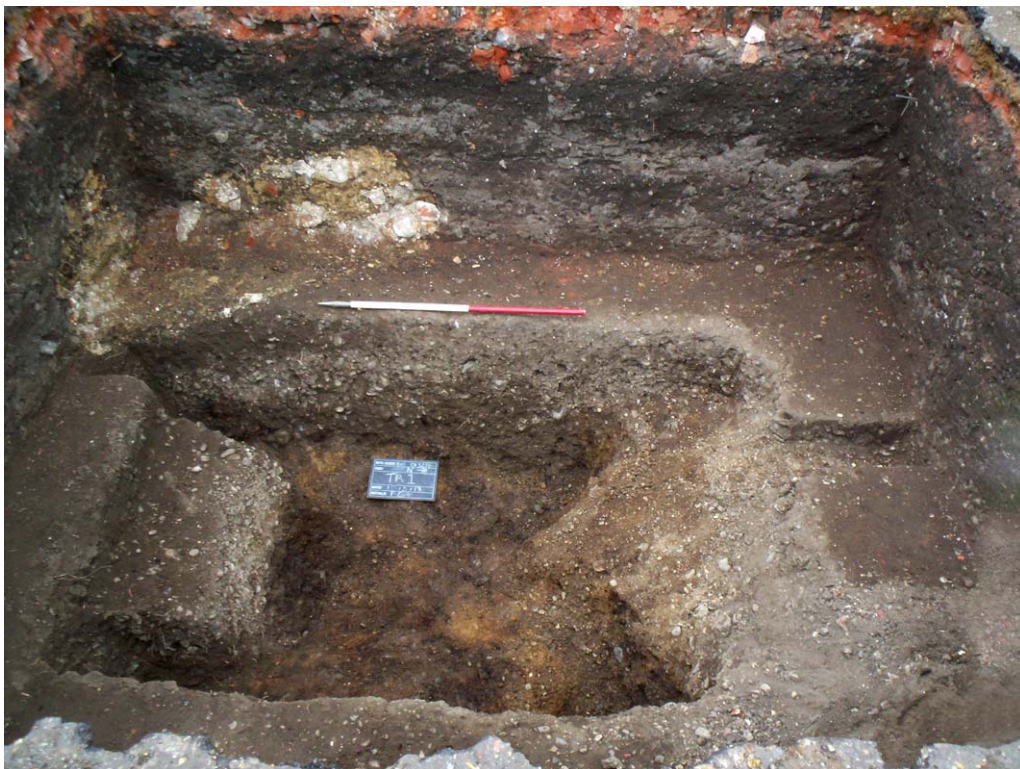
Plate 4. Trench 1, showing excavated feature [17], looking west, 1m scale

Overlying this primary fill was a very stony grey deposit ([15]). Approximately 80% of this deposit was formed from pebbles with small rounded flint gravels and stones between 2cm and 7cm in size. This material was within a matrix of grey sand silt with grits. Extremely sparse charcoal flecks were the only cultural inclusions noted from the considerable quantity of this deposit excavated. This fill had the appearance of a layer which was up to 0.37m in depth in the western section (Fig. 4 Section 4) attenuated at its northern and southern limits, this maximum depth defining its approximate centre. One tentative interpretation for this deposit is that it might have identified a trackway or path. Its appearance in the eastern elevation of feature [17] was less convincing in regard to such an interpretation, though here its appearance in profile is thought to have been affected by possible cutting features. Overlying this stony deposit was mid brown stony humic sand silt [09]=[18] which was 0.45m in depth and present across the whole of the upper part of feature [17]. A small quantity of pottery of Late Saxon date was recovered from this deposit which also contained very occasional charcoal fragments. Associated with this feature were two post-holes with a further possible example also recorded. The best defined example of these ([02]) was present in the western side of the feature [17]. This was circular or sub-circular in plan with steep, slightly irregular sides to a concave base. It measured 0.70m in diameter and had a depth of 0.45m. Its fill ([19]) was mid grey brown silt sand with iron concretions present at its interface with the underlying geological deposits. A sloping horizon of gravels and stones in the upper part of this deposit might indicate the slumping in of deposit [15]. In the eastern side of the trench post-hole [24] was probably sub-circular in plan with a diameter of 0.50m and depth of 0.45m. Vertically sided with a concave base, its fill was dark brown humic silt sand [25] which contained

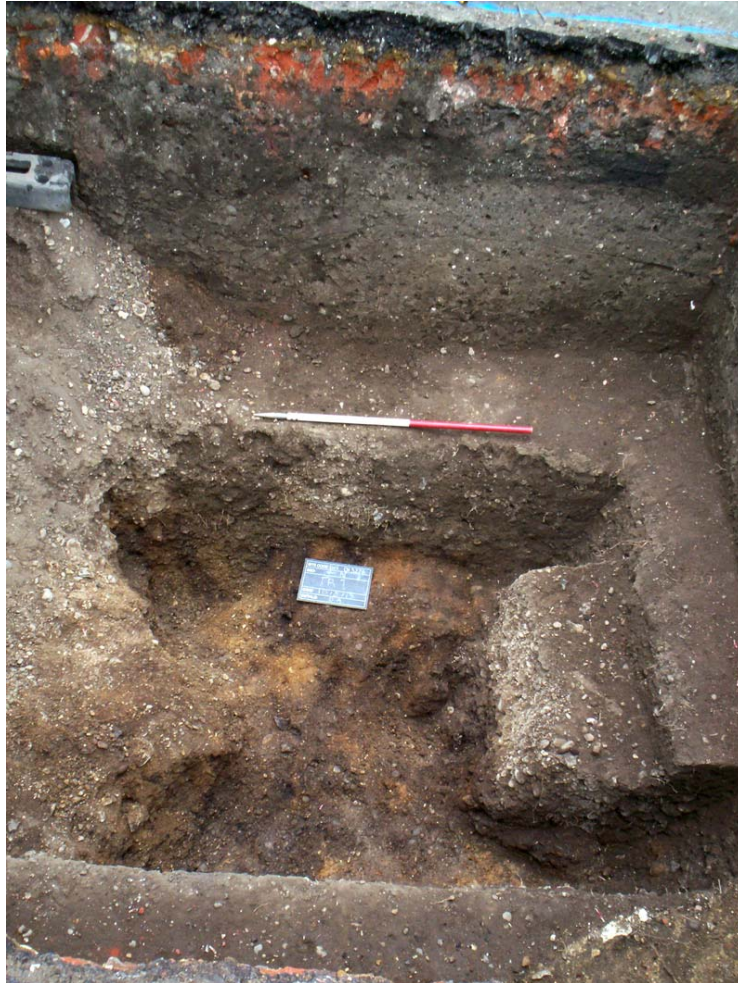
Plate 5. Trench 1, showing excavated feature [17], looking east, 1m scale

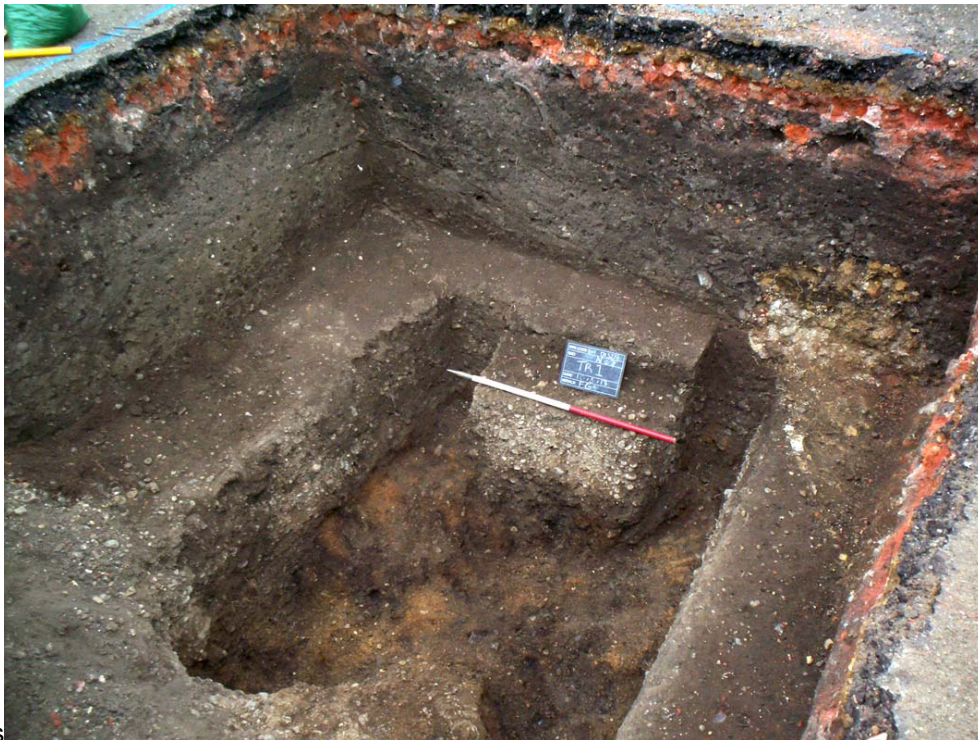
Plate 6. Trench 1, showing excavated feature [17], looking south, 1m scale

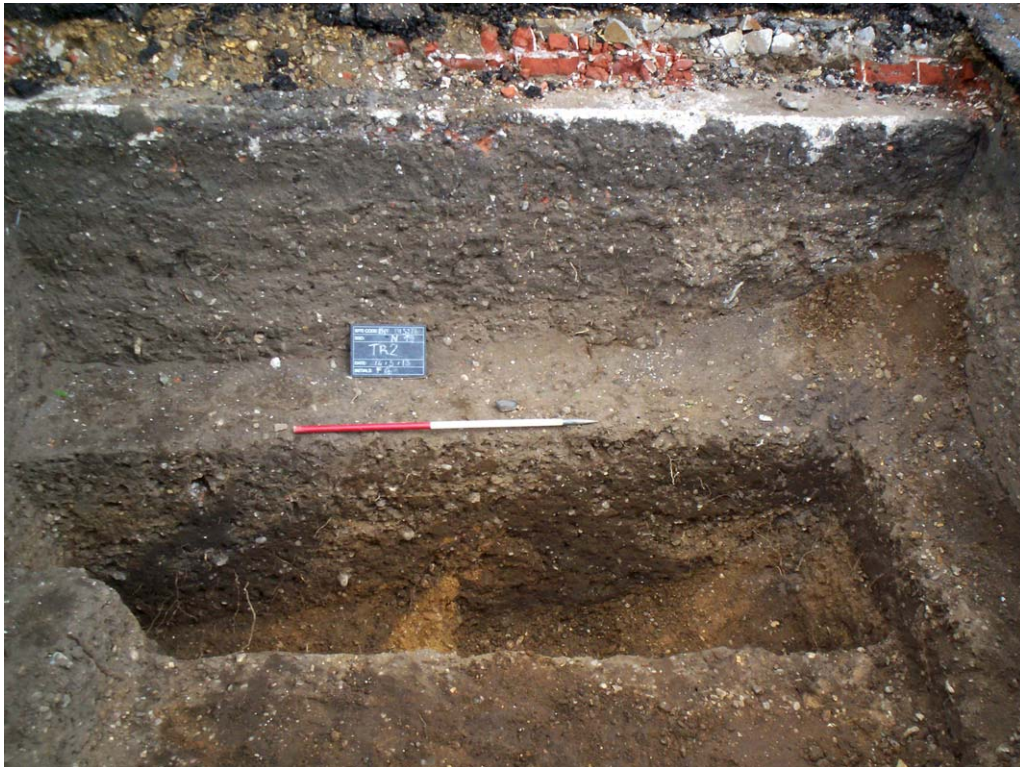
Plate 8. Trench 2, pits [30], [45], [49] looking north, 1m scale

The remaining fills of this pit are characterised as dark grey brown sand silts with occasional chalk and charcoal flecks (deposits [31], [59], [61]) or thin layers of yellow brown sand and gravels ([57], [58]) with the appearance of redeposited geological deposits. The upper fill ([31]) of this pit contained a small quantity of pottery of 16th- to 18th-century date as well as residual pottery of 10th- to 11th-century date.
