Report 2740

**An Archaeological Watching Brief at
St Peter & St Paul's CEVC School,
Church Street, Carbrooke, Norfolk.**

ENF126527

June 2011

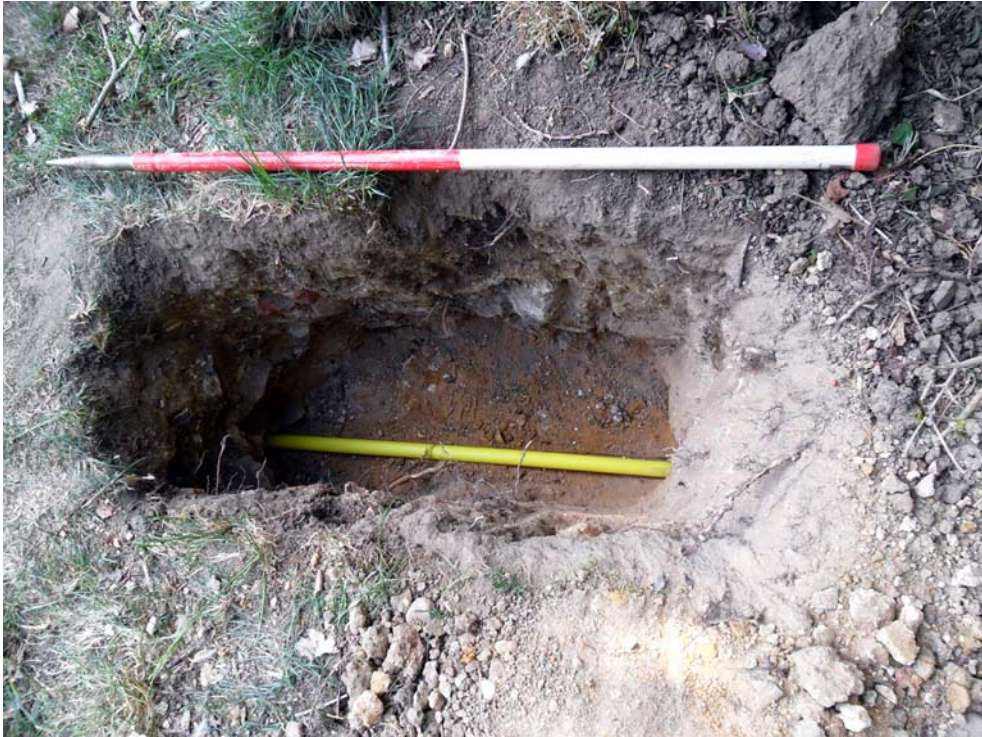
Plate 1. Inspection pit [14]

Pit 14 was an additional inspection pit, necessitated because the mechanical mole became stuck at this point. Once the pit was dug it was clear that the obstruction had been caused by large sub-rounded flint nodules surrounded by mortar (4) (Plates 1 and 2, Figs 2 and 3 section of pit 14).

It is difficult to be certain what this masonry represents – the flint was not well bonded in the mortar so the feature may even represent compacted rubble. Dating is also problematic; the material could well be of medieval date however the red-brick inclusions may suggest that it is of later origin.

This masonry could represent either the remains of a flint wall or the foundations for a wall that doesn't survived any higher and if so, this may have been a wall associated with Preceptory structures to the east, or with the church of St Peter and St Paul which lies to the north of the site. It is quite possible that the brick observed in pit 14 is a later introduction to the build. Masonry remains of a similar nature, interpreted as foundations for timber structures associated with the Preceptory were uncovered during the 1998 excavation of the site on which the school's extension stands (Hutcheson and Noble 2006) and it is quite possible that this is part of one of those features.

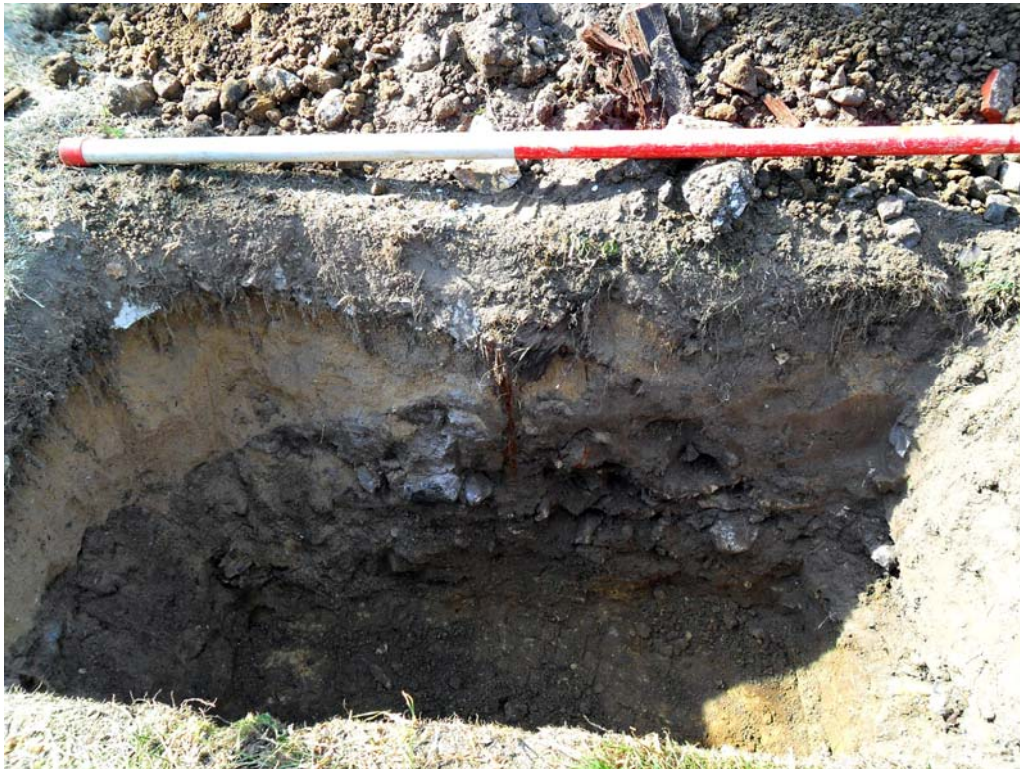
Plate 3. Inspection pit 16

Inspection pit 16 (Fig. 2) contained a layer of very fine, clean, pale yellow sand (5) lying directly underneath the topsoil (Plate 3). The sand appears to have been contained by a thin wooden structure with flint nodules at the base (Fig. 3 section of pit 16). It is possible that this represents a backfilling of a previously excavated feature, or perhaps a sand pit that has been covered with topsoil and turf.

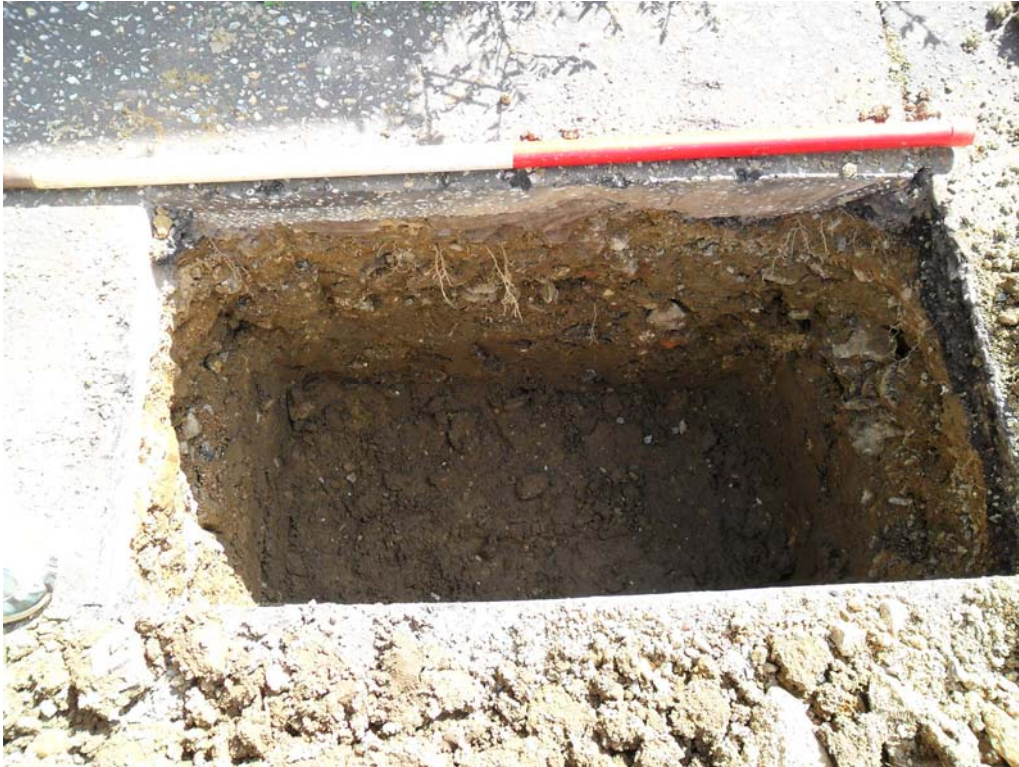
Plate 4. Inspection pit 19

Pits 19 to 21 were excavated in the school yard (Fig. 2), where a layer of concrete seals make-up layer (6) which consists of gravelly sand, flint nodules and brick rubble (Plate 4). No topsoil was present.

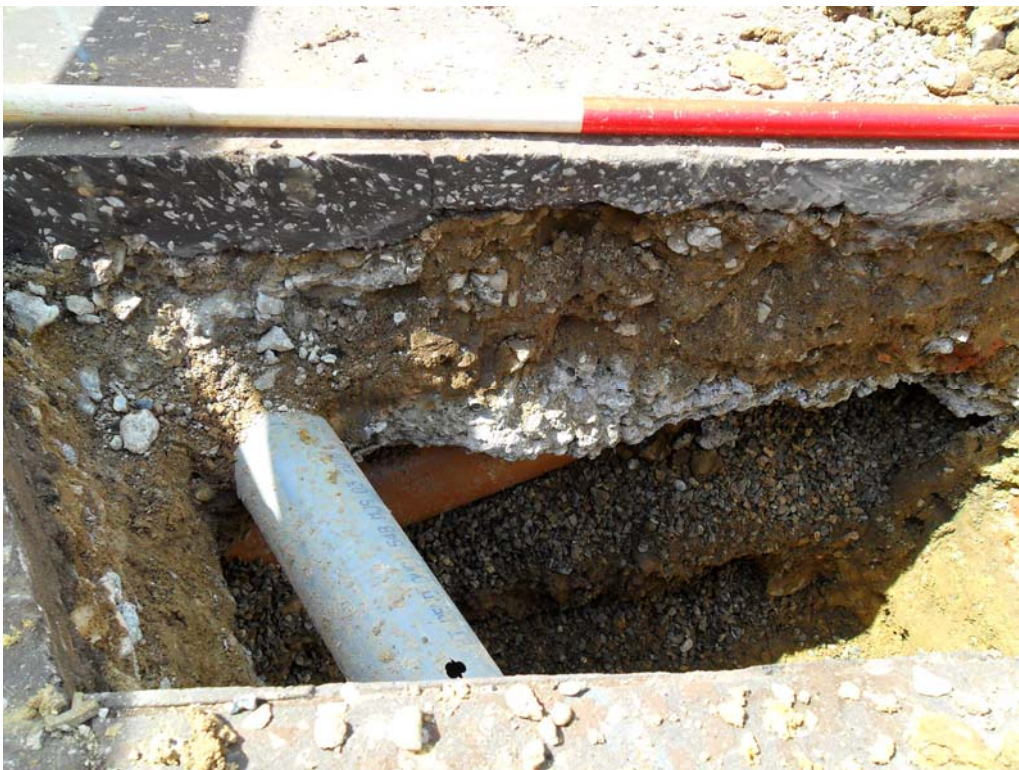
Plate 5. Inspection pit 20

Heavy disturbance from service pipes was observed in pit 20 (Plate 5). However below this the same subsoil layer (2) described above could be seen (no natural deposit was observed as this lay below the limit of excavation in this pit).

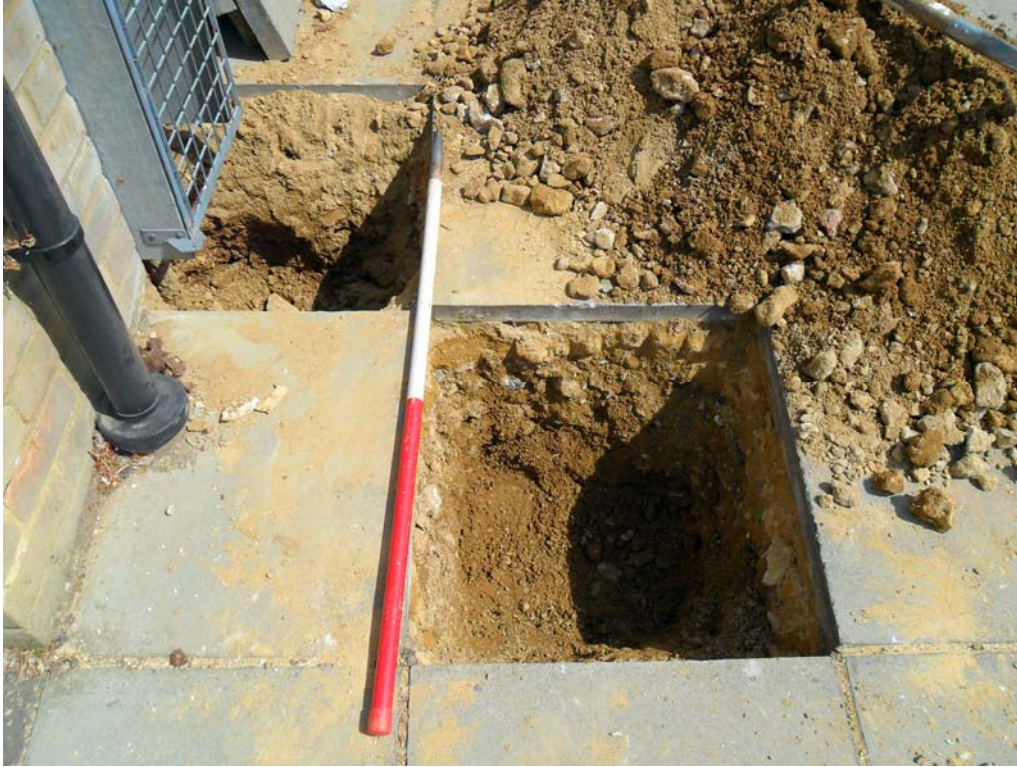
Plate 6. Connection to plant room

In addition to the 21 pits, two paving slabs were removed in front of the school's plant room (Fig. 2) on the south side of the school buildings to in order to connect the new gas supply to the new extension. The resulting two inspection holes created were only 0.40m deep and no archaeological evidence was encountered (Plate 6).
