Report 2674

**Archaeological Watching Brief at
Bowthorpe Youth and Community Centre,
Bowthorpe Hall Road, Bowthorpe, Norwich**

ENF126501

July 2011

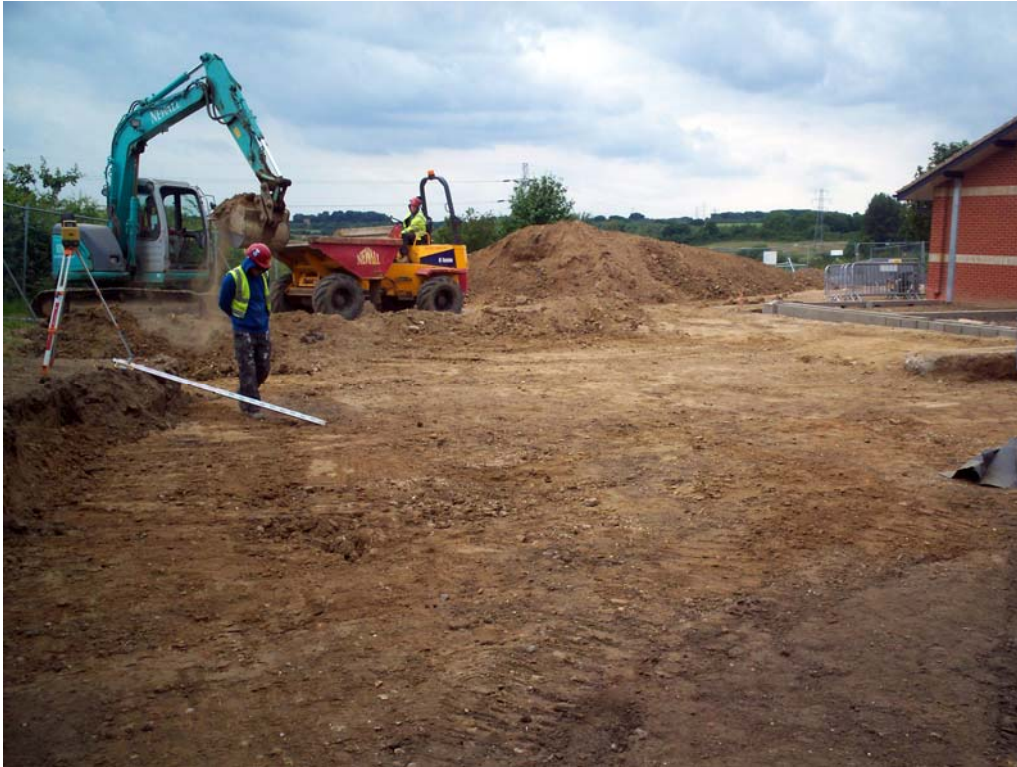
Plate 1. The hard play area facing west

This area was stripped to a depth of 0.6m bgl at its east end and 0.2m bgl at its west end (due to the slope of the ground surface at the time of construction). At this level the natural subsoil was visible. There was considerable disturbance caused by service trenches, especially near to the community centre. The topsoil contained a large proportion of building rubble.
