Report 2513

Archaeological Watching Brief at St John the Baptist Church, Garboldisham, Norfolk

ENF125507

July 2011

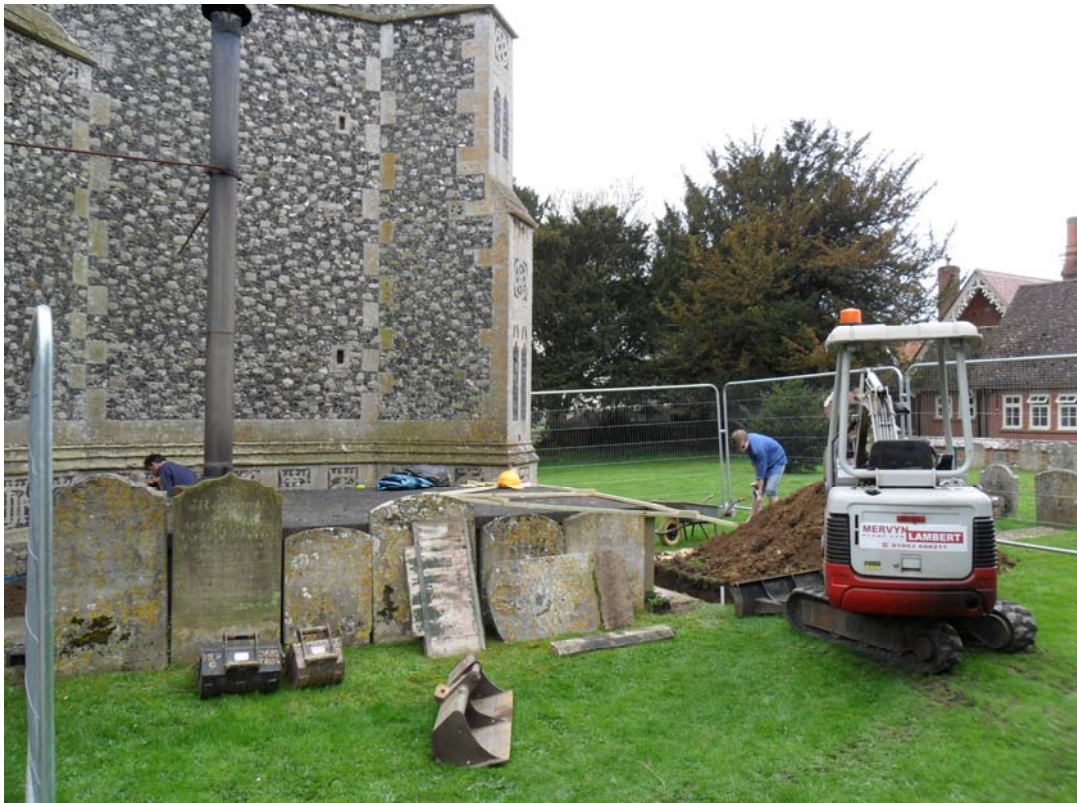
Plate 1. General view south-west showing the location of the boiler room.

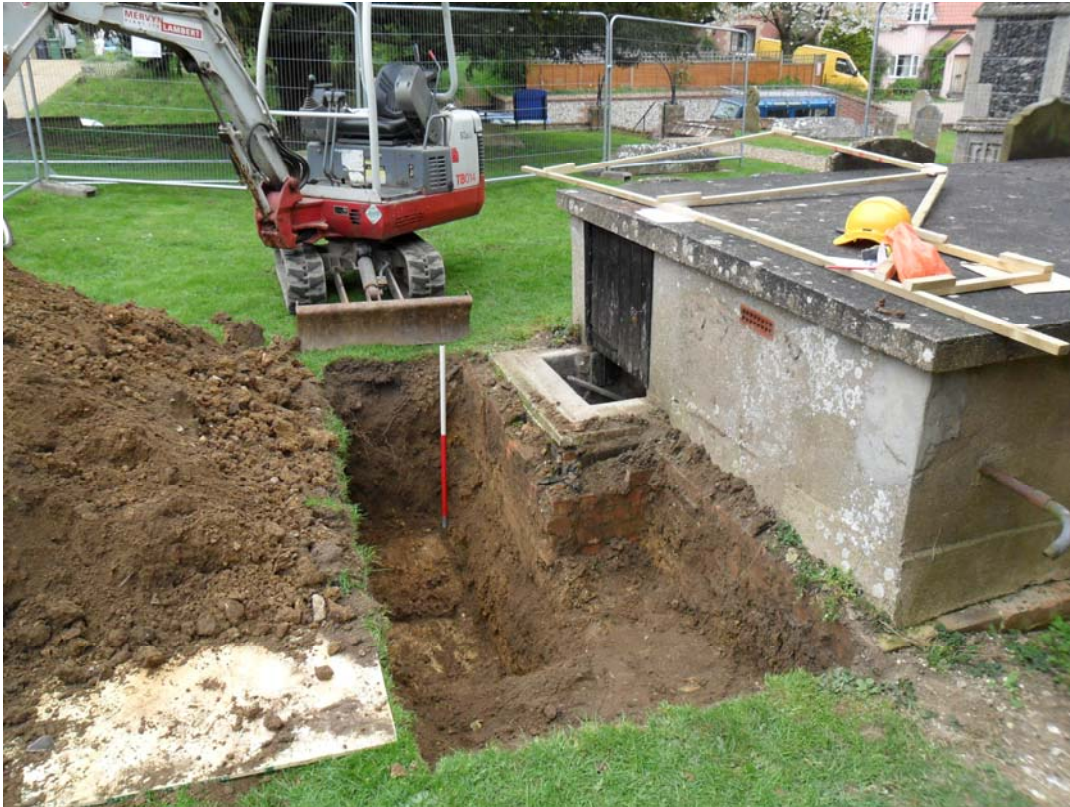
The excavation required for the new stairway measured c.3m x 1.4m, was of varying depth and was located against the west wall of the boiler house. Three partial burials (Burials 1, 2 and 3) were exposed, all of which had already been truncated by the construction of the boiler room (Fig. 2 and Plates 2 and 3).

Plate 2. View north-east showing location of the new stairway and the three partial burials at the north-eastern end on the trench.

The burials consisted of the partial remains of the upper body of three individuals, all laid in a supine position on a roughly east-west alignment. Burial 1 had been laid in a coffin, evidenced by wood staining along the south side of the grave cut and, even though there was no evidence, it is reasonable to suppose that the other two burials had originally been coffined.

Burials 1 and 3 had been truncated just below the pelvis and Burial 2 was truncated through the base of the ribcage.

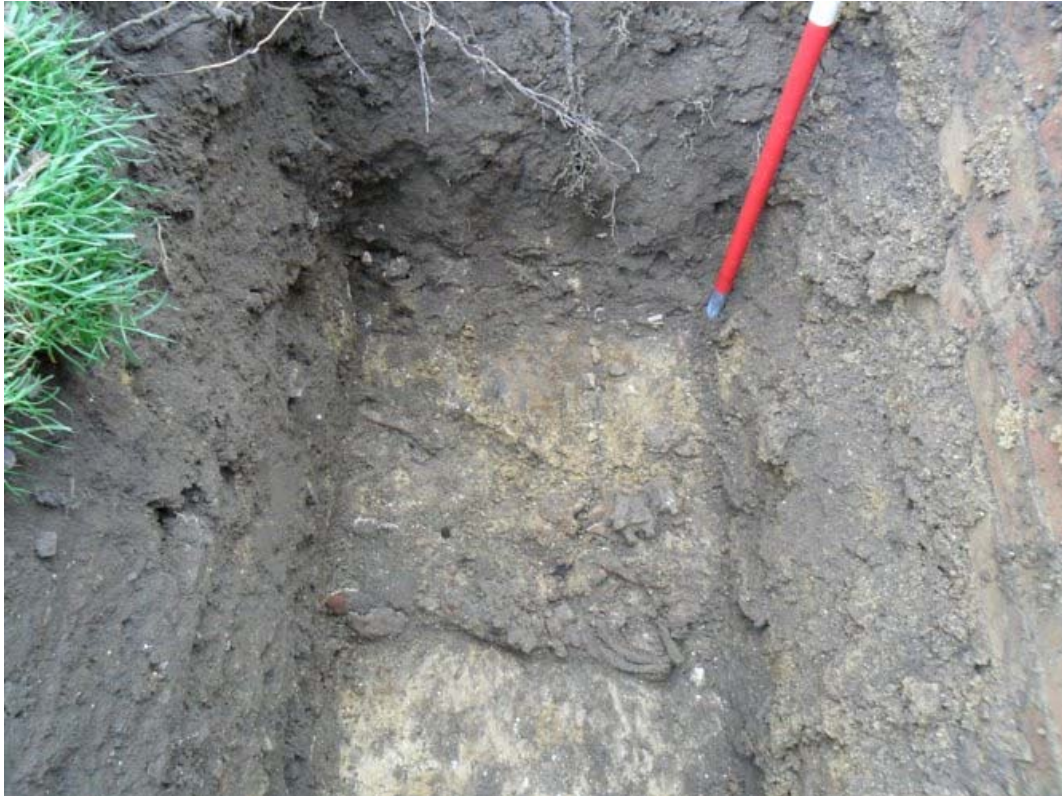
The bases of the graves were dug into the yellow/orange clay and gravel natural and they were overlain by a typical graveyard deposit of mixed natural clay and loose brown loam. The upper levels of the grave cuts were not easily identified, but they had probably been cut through the graveyard deposit.

The three burials remained *in situ*, below the construction for the new stairway.

Plate 3. Detail of the three partial burials at the north-eastern end on the trench.

The burials disturbed during this watching brief had already suffered some previous disturbance, probably from the construction of the boiler house in the mid 20th century. It is thought that the burials were of post-medieval date.
