Report 2675

Archaeological Watching Brief at a water main repair at Norwich School, Norwich

ENF126403

August 2011

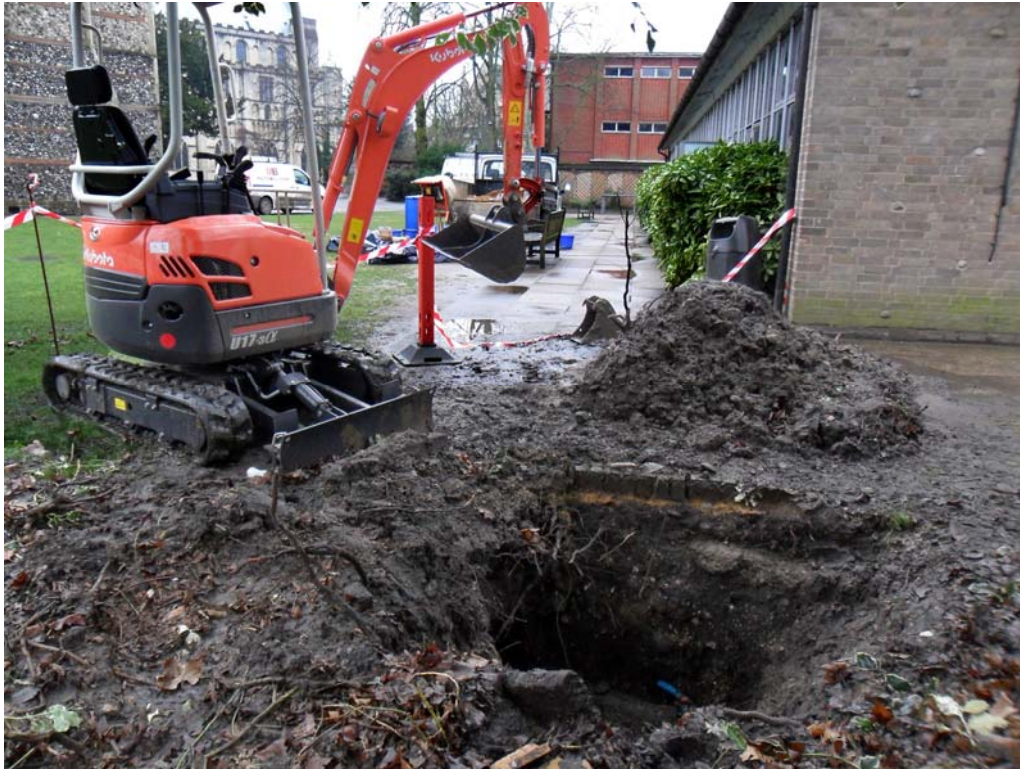
A small trench measuring approximately 1.5m x 0.7m was excavated using a mechanical digger to the depth of approximately 0.9m in order to expose the pipe which needed repair (Fig. 2, Plate 1).

Plate 1. Excavation of the trench, looking south-west

At the base of the trench was layer [5], a very mixed grey-brown sandy-silt full of flint, brick and mortar rubble and chalk pieces. This layer was highly disturbed by roots and represents some kind of make-up layer.

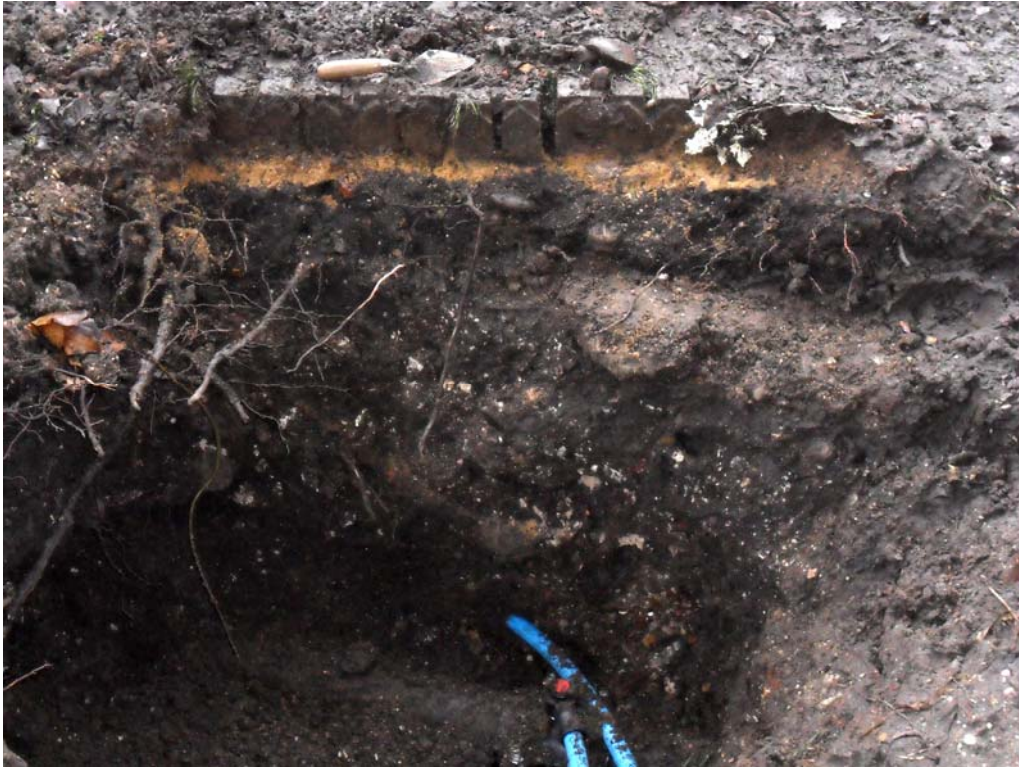
Above this was a probable 'garden soil' [4], which was dark black-brown sandy-silt and also heavily disturbed by tree roots (Plate 2).

The upper layers were all related to the floor surface between two nearby school buildings, and included a bright yellow-orange sandy layer [3] which had been laid down as a base for the hard surface, the bricks [1] themselves and a soil which had washed in between the bricks.

Plate 2. The trench, looking west

It is clear that sub-surface deposits in this area in front of the school building and bicycle sheds has been highly disturbed by previous works to a depth of at least 0.9m which probably occurred when this water main was originally laid. Initial construction of the school building and surfaces may also have contributed to disturbance of upper deposits.
