**Archaeological Evaluation on land adjacent to
55 Dowgate Road, Leverington, Wisbech,
Cambridgeshire.**

ECB 3621

August 2011

Location:	55 Dowgate Road, Leverington, Wisbech, Cambs.
District:	Fenland
Grid Ref.:	TF 4454 1070
HER No.:	ECB 3621
OASIS Ref.	107026
Planning Ref.:	F/YR10/0900/F
Client:	Mr and Mrs Maxey
Dates of Fieldwork:	29 June - 1 July 2011

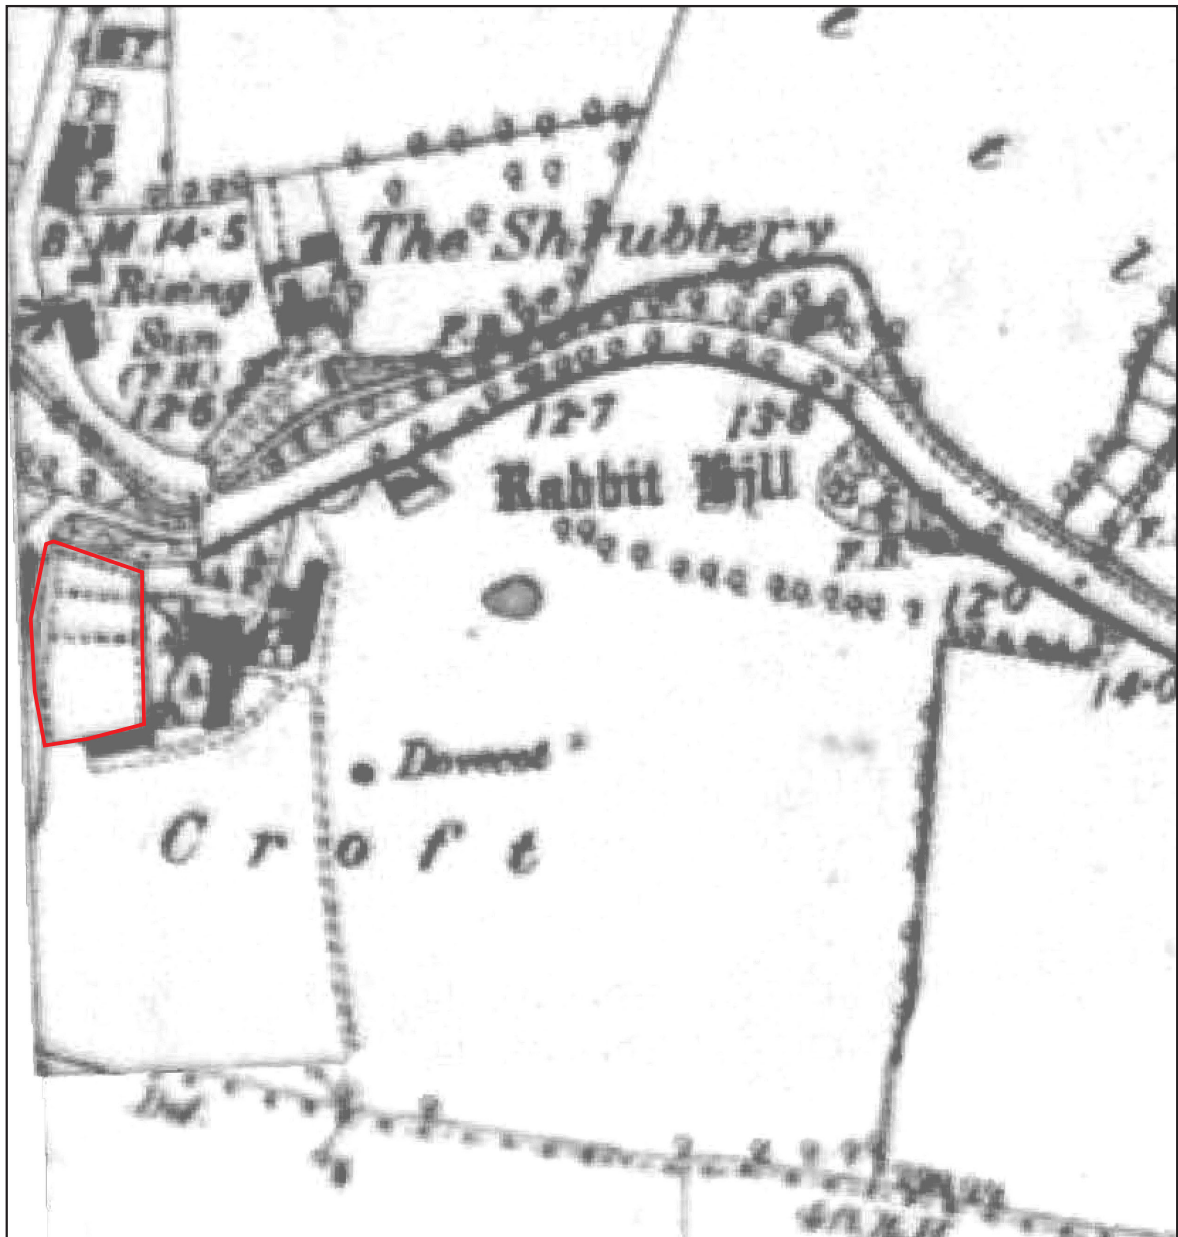
Figure 3. Ordnance Survey 1st Edition (detail), showing internal divisions within the garden

Cut into the subsoil were the foundations [13] of an old wall [14] (Fig. 5 Section 1, Plate 2) – possibly an old internal subdivision of the garden. Brick rubble was seen in the upper levels of the trench during machining but no wall was present. However the location of this wall is roughly in the area where divisions are shown on the first edition Ordnance Survey map (Fig. 3).

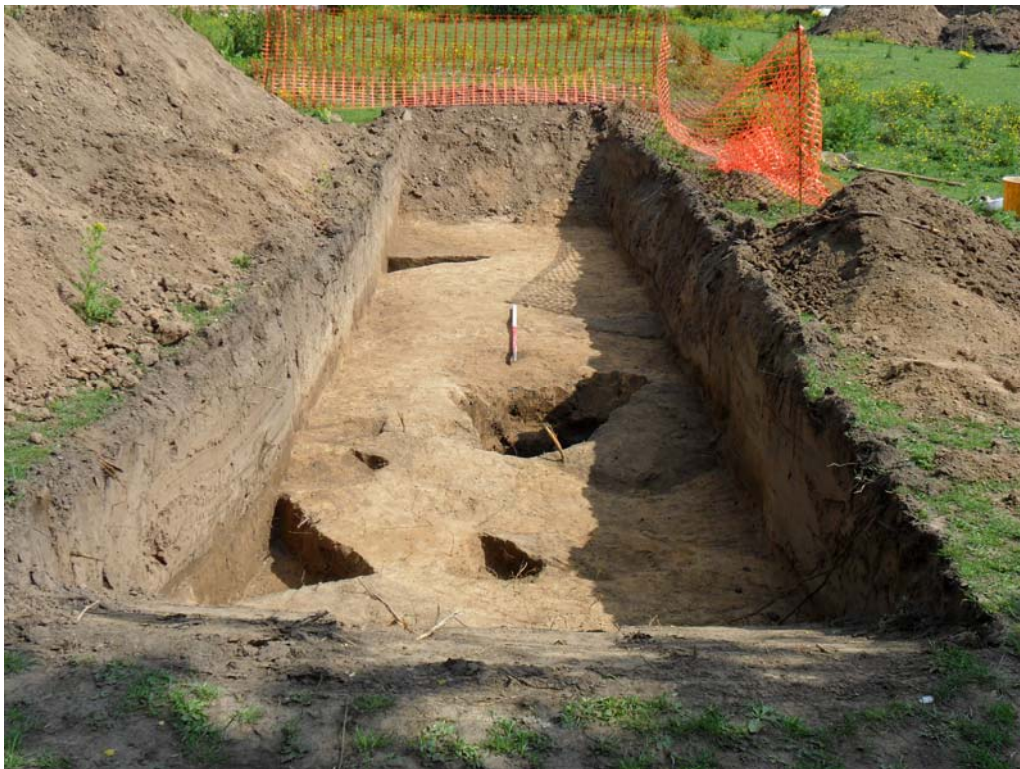
Plate 1. Trench 1, looking south east (1m scale)

Trench 1 was opened in an area designated as a driveway for the proposed development, on the north side of the new building's footprint. The trench was orientated north-west to south-east and a number of features were revealed at its base (Fig. 4, Plate 1).

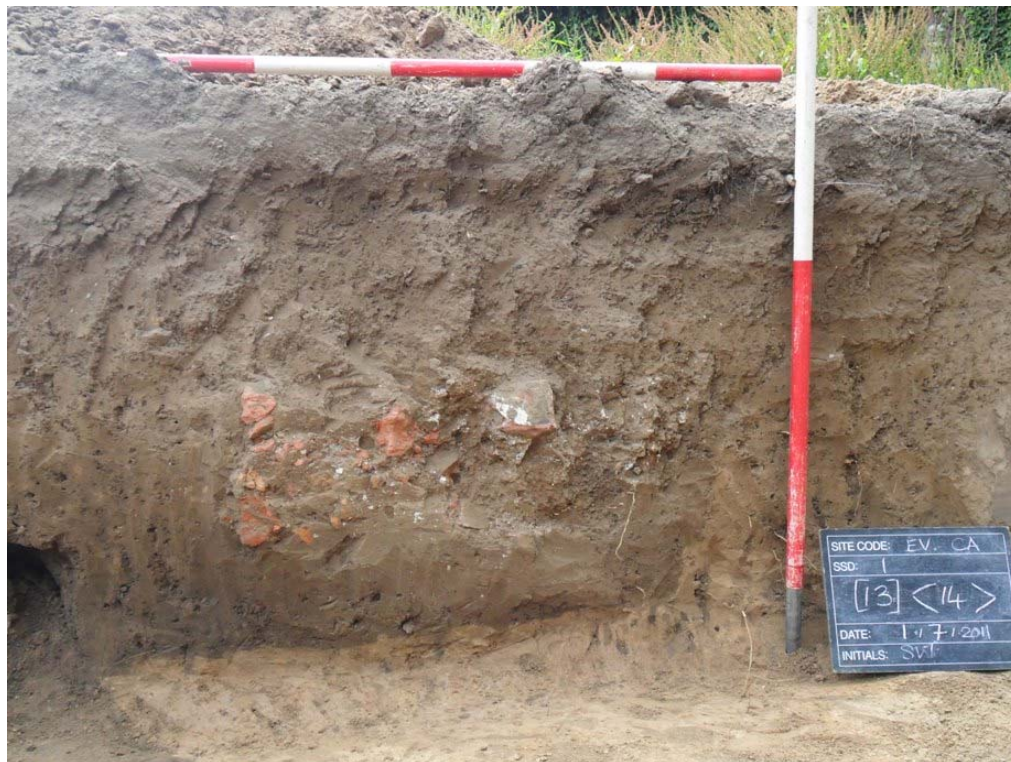
Plate 2. Trench 1, foundation cut [13] and rubble wall foundation [14]

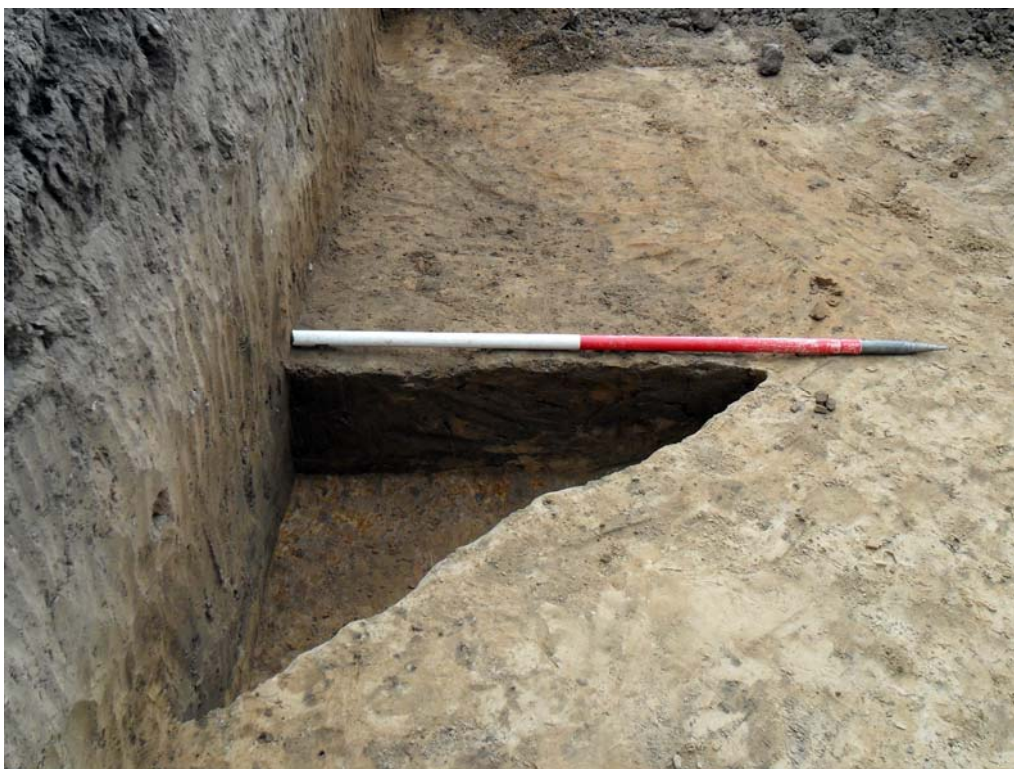
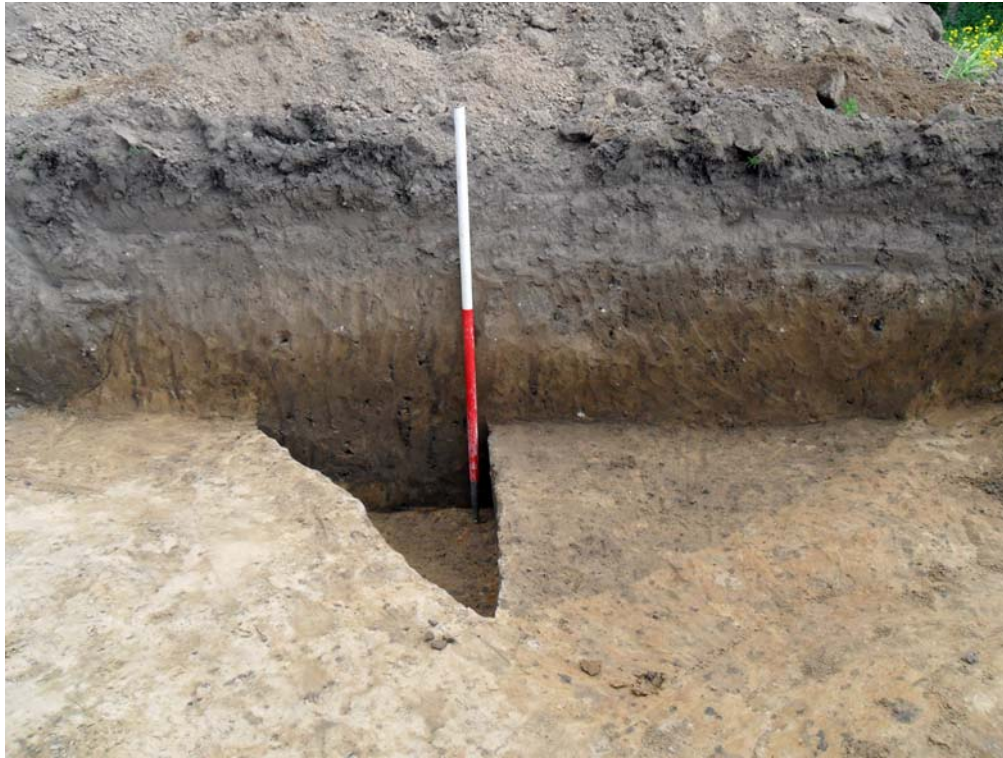
Plate 3. Trench 1, pit [5], looking south-east

Plate 4. Trench 1, pity [5], looking north-east

At the south-eastern limit of Trench 1, part of a very square-cut pit [5] was revealed (Figs 4 and 5 Section 6, Plates 3 and 4) with at least one right-angled corner (no others were exposed) and almost vertical sides.

Pit [5] measured at least 1.4m by 1m and was approximately 0.44m deep and was filled with an extremely fine and smooth, dark brown silt with sand-coloured patches (6). The deposit was without stones but contained occasional flecks of coal and charcoal. Finds from this deposit comprised four sherds of medieval pottery, four fragments of medieval to post-medieval CBM, and a piece of clay tobacco pipe stem, along with metal-working debris, an iron nail, mortar and animal bone of unknown date.

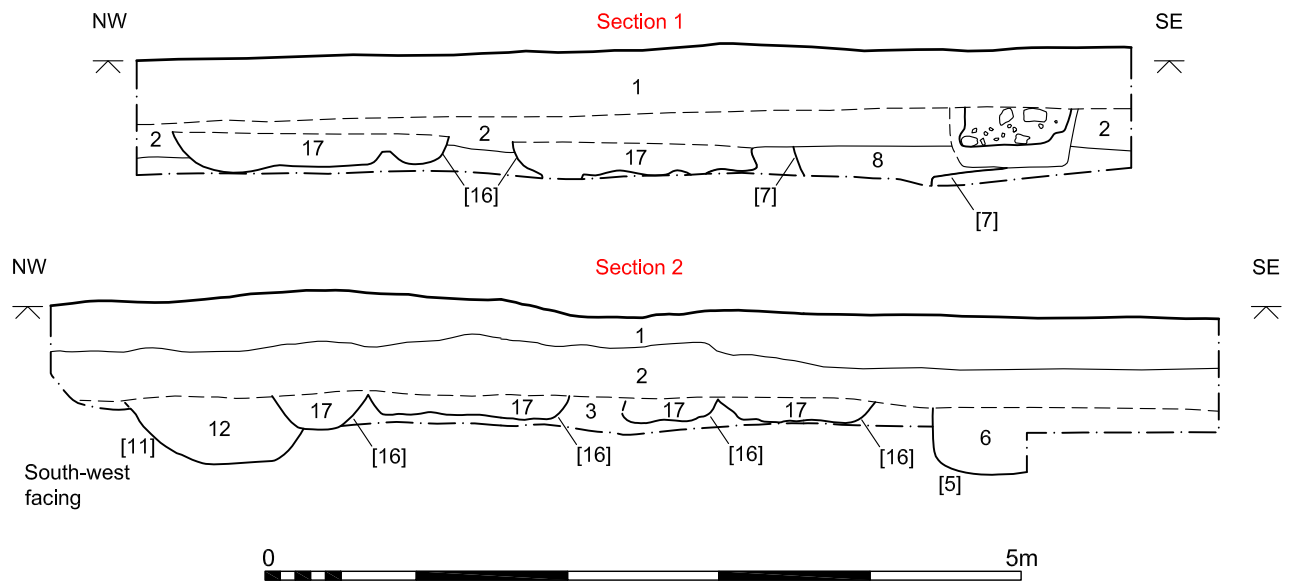
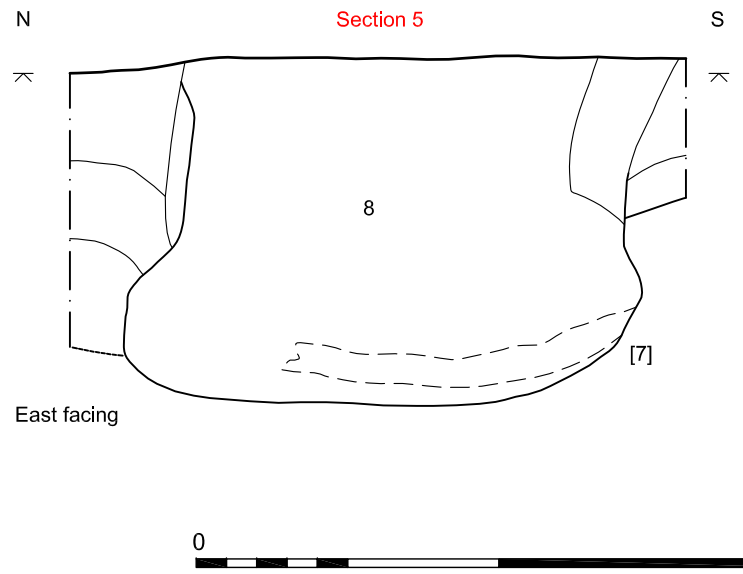
Figure 5. Trenches 1 and 2, sections. Scale 1:50 and 1:25

Deposits in baulk section at the east and west ends of Trench 2

Beneath the subsoil in Trench 1 were a number of furrows [16] (Fig. 5 Sections 1 and 2) which appeared to relate to early cultivation of the soil and may well date to the early garden phase.

Beneath the subsoil were four distinct layers (Fig. 5, Plate 9). These were a light yellow silt (19) 0.24m-0.26m deep, which may indicate a sudden episode of flooding. This deposit was mixed with subsoil and was very disturbed by roots/worm activity. Beneath it was a slightly clayey, orangey-grey-brown, waterlain silt (20), 0.24-0.25m deep and probably deposited in standing water. Beneath that was a more compact, mottled clay silt with very occasional charcoal flecks and some worm disturbance (21) which was 0.19m-0.2m deep. At the base of the trench (at a depth of approximately 1.2m beneath the modern ground surface) was a very soft but compact light to mid-pinkish-grey, very smooth, slightly clayey silt (22) which was probably water-lain.

At the western end of the trench a similar pattern was observed (Fig. 5, Plate 10) with 0.33m of topsoil (1) over 0.21m of subsoil (2). Beneath the subsoil was the pale yellow silt (23) but here it was thinner (only 0.11m deep) and more clearly visible as a series of thin laminations, comprising two layers of yellow silt with a layer of darker, browner silt sandwiched in between. Beneath this was the pink-grey-brown clayey silt (24), which was slightly thicker, with a depth of 0.27m-0.28m. Below this was a 0.05m thick layer of bright yellow, fine, slightly sandy silt (25) over a 0.07m thick layer of smooth, pink-grey-brown clayey silt (26) over another layer of bright yellow, fine, slightly sandy silt (27) which was 0.03m thick and (at a depth of 1.08m from the current ground surface) a second layer of pink-grey-brown clayey silt (28). The western end of the trench was machined to a depth of only 1.12m, while the east end of the trench was machined to a depth of 1.2m.

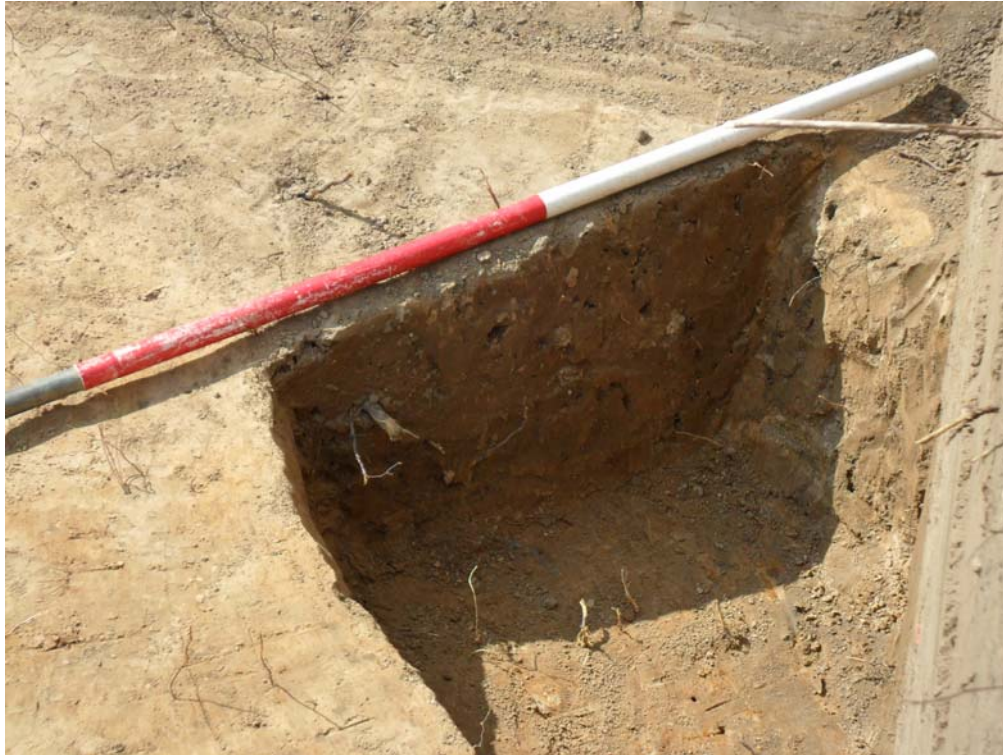
Plate 5. Ditch [11], looking north

At the opposite (north-west) end of the trench, a linear feature or ditch [11] was exposed with the same apparent east-west orientation and straight, almost vertical sides (Figs 4 and 5 Sections 2 and 3, Plate 5). This feature was at least 2m long by 0.7m wide and approximately 0.33m deep. It was filled with a soft, dark brown silty sand (12) containing occasional charcoal flecks. Numerous modern roots were present. Medieval and post-medieval CBM was recovered from the fill, as was animal bone.

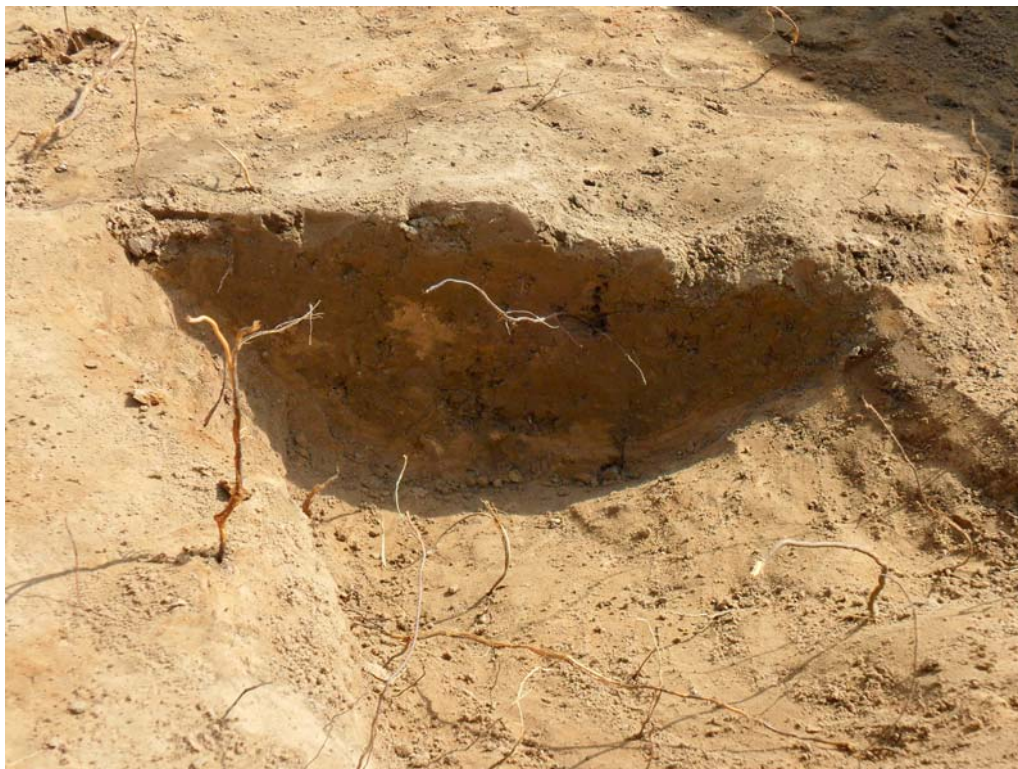
Plate 6. Trench 1, section across possible post-hole [9]

Adjacent to the ditch was small, sub-rectangular feature [9] with dimensions 0.56m long by 0.22-0.36m wide and 0.16m deep (Fig. 4). In section, the feature appeared to be bowl-shaped (Fig. 5 Section 4, Plate 6), but its shape in plan suggested that it might have been a post hole. The fill (10) was a stoneless dark brown, smooth silt from which one fragment of animal bone was recovered.

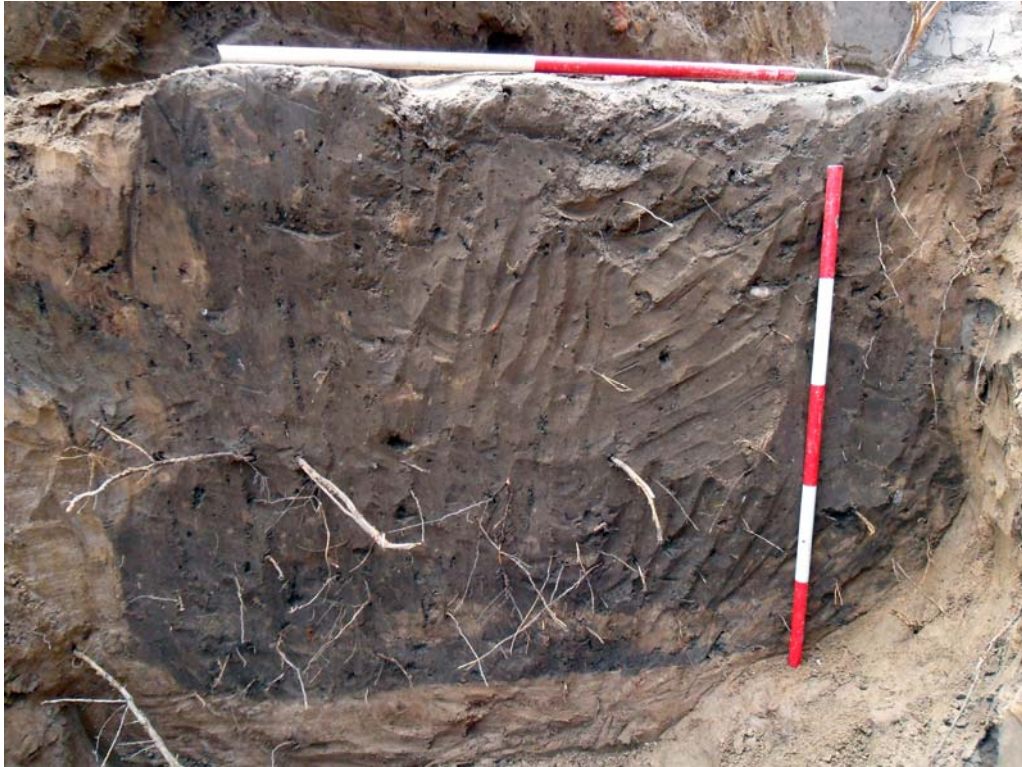
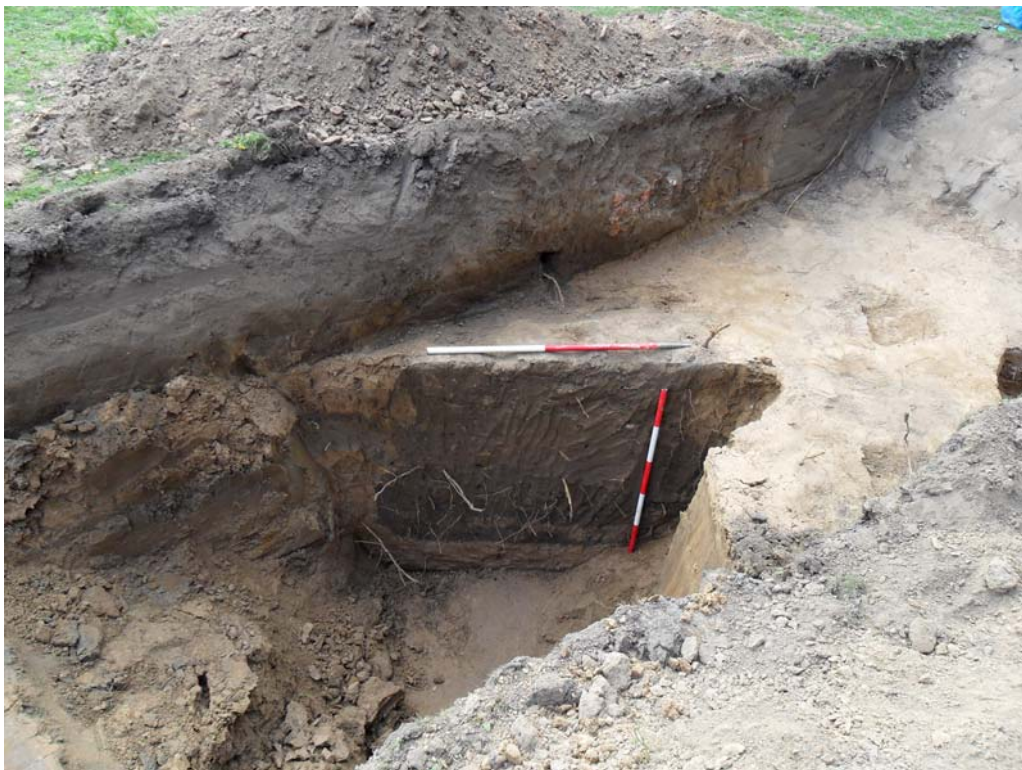
Plate 7. Trench 1, section across pit [7], looking west

Plate 8. Trench 1, pit [7] from above

A very large, quite square flat-bottomed pit [7] was exposed near the north-west end of the trench (Fig. 4). This was situated quite close to the wall foundation [14] (Fig. 5 Section 1). The edges of the pit had been disturbed by modern roots but it appeared to be roughly 1.2m by 1.4m in size, with an overall depth of 1.35m.

The base of the feature was reached utilising a mechanical excavator (with approval of the archaeological monitor) as the trench was already deep. The sides of the feature appeared to be undercut (Fig. 5 Section 5, Plates 7 and 8) but this could well have been the result of collapse when the pit was first dug as the

natural soil into which it was cut was very fine, soft silt. The pit was heavily disturbed by modern roots. The fill (8) was very dark brown, soft silty sand containing occasional tiny stones and charcoal flecks. Fragments of metal-working slag and pottery were found throughout the fill of the feature from top to bottom.

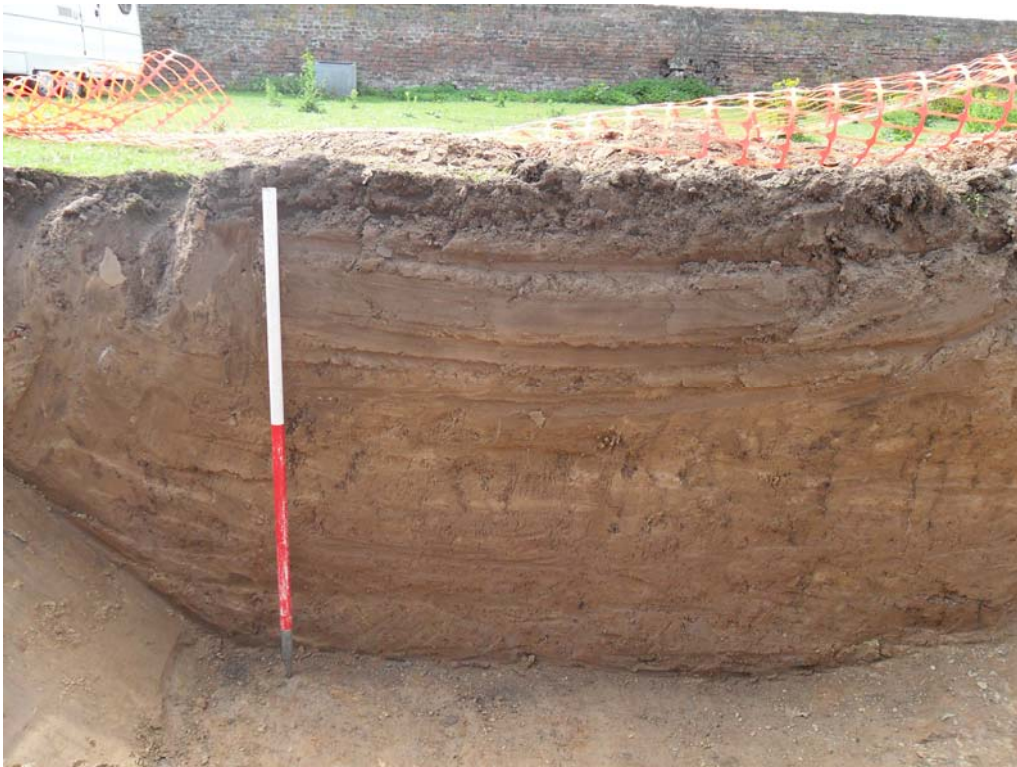
Plate 9. Trench 2, deposits in the east section

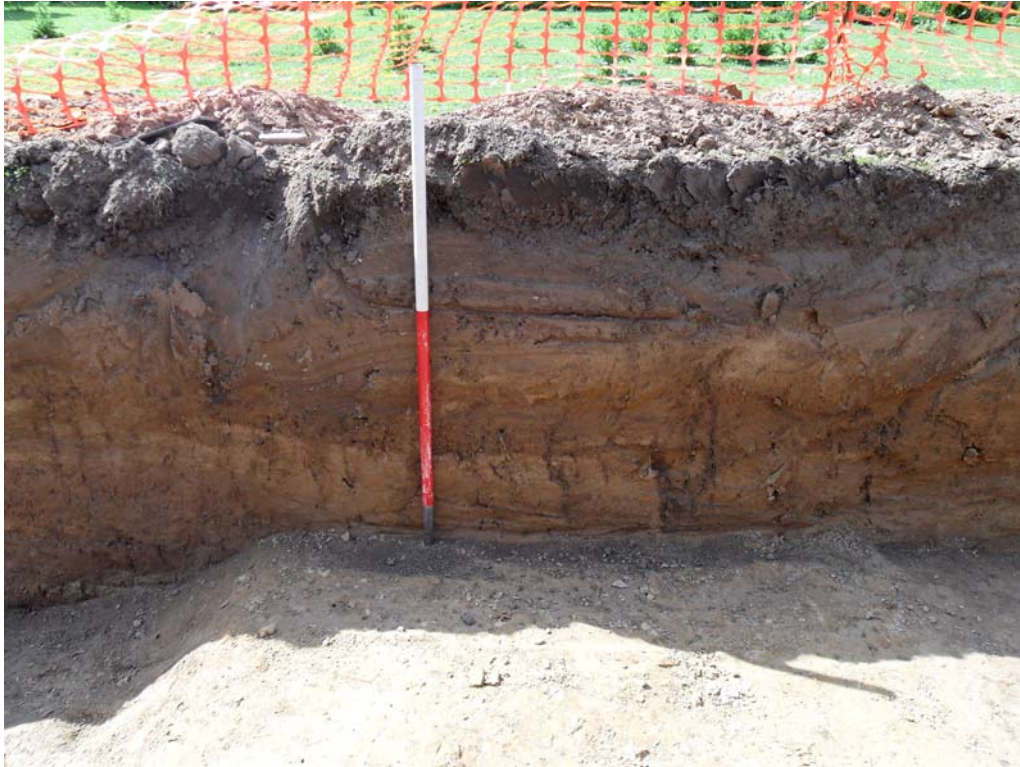
Plate 10. Trench 2, deposits in west section

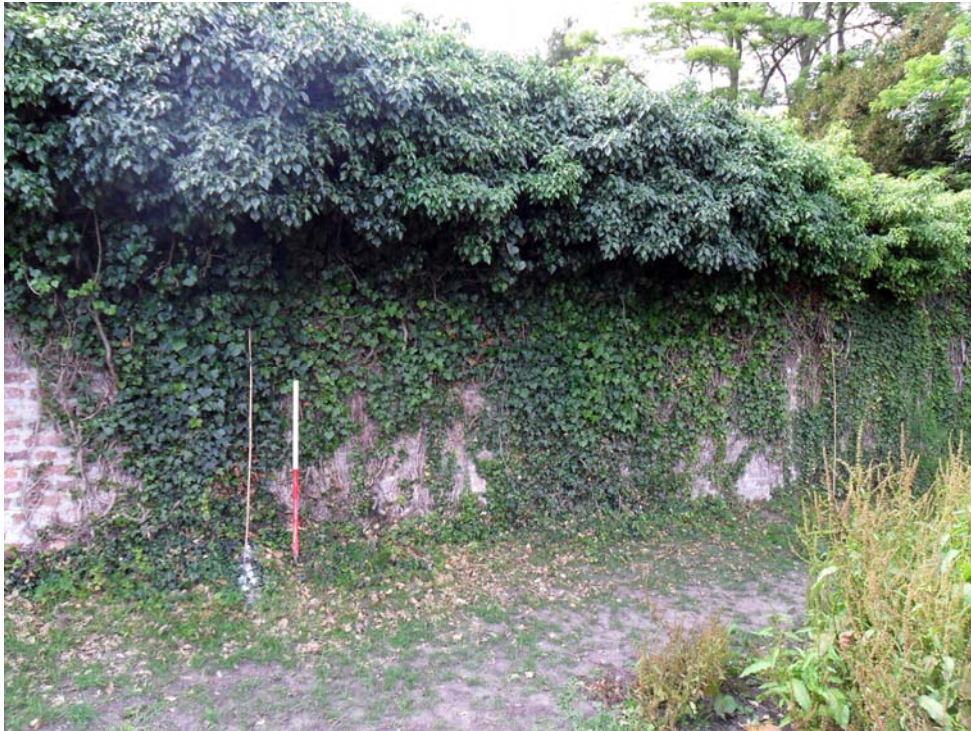
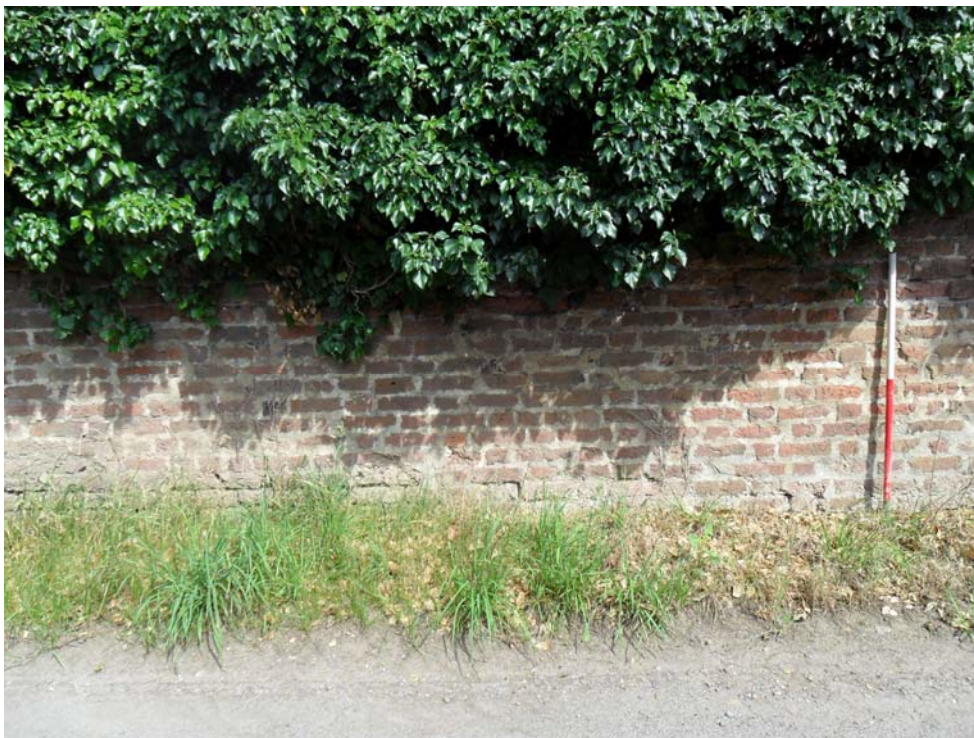
Plate 11. Internal section of wall to be removed, looking north-west

Plate 12. External section of wall to be removed, looking east

The stretch of wall in question is straight and its line will be preserved on either side of the proposed new gateway. Internally, the stretch of wall to be removed was ivy-covered at the time of the investigation (Plate 11) but an examination was made of its structure in the visible parts next to that point, and the external side – which was ivy-covered only at the very top – was also examined and recorded (Plate 12).

The section of wall to be removed has a height of 1.85m and is located within the tallest part of the wall. Some 10m to the south of the proposed new opening, the wall height drops by approximately 0.3m. The width of the wall was measured at the south entrance, where it was 392mm (three layers) thick.

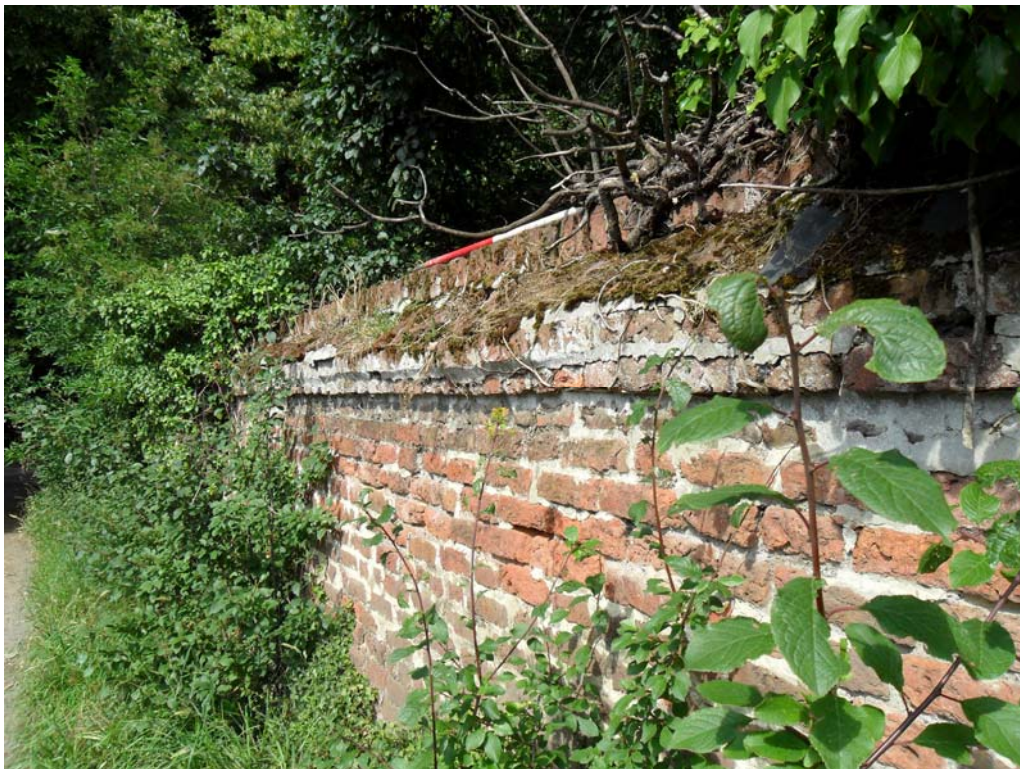
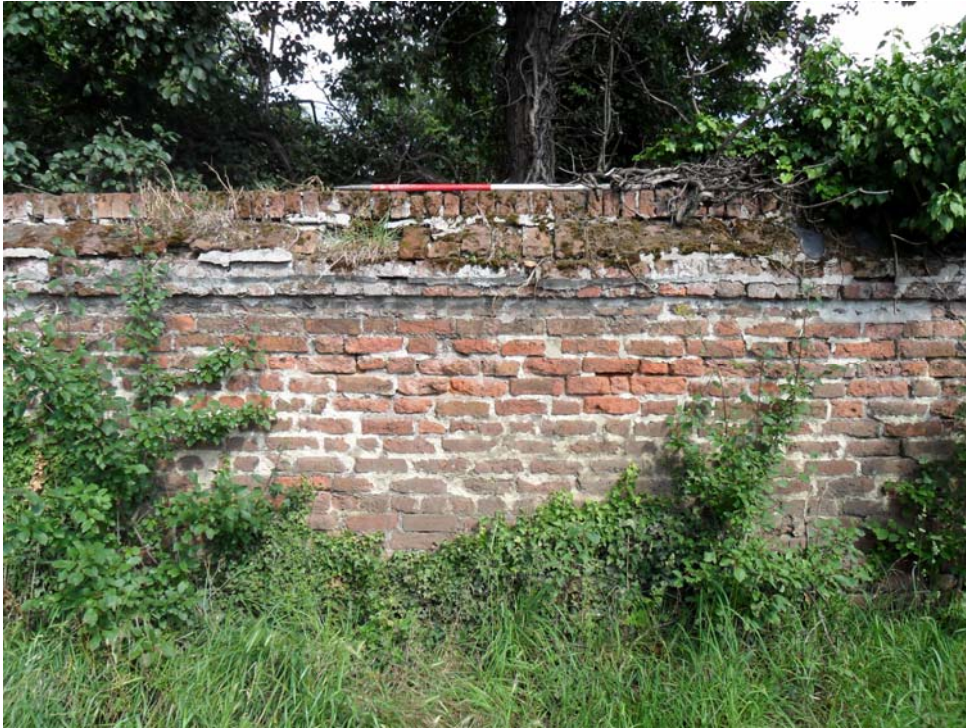
Plate 13. Typical example of decorative capping, external wall, looking north-east

Plate 14. Typical example of decorative capping, external wall, looking east

Internally, the wall appears to be a straight, vertical structure with no decorative additions. The exterior side has a decorative top consisting of a row of headers under a row of stretchers – both stepped out slightly from the wall face; over which is a canted coping with a rowlock capping (Plates 13 and 14).

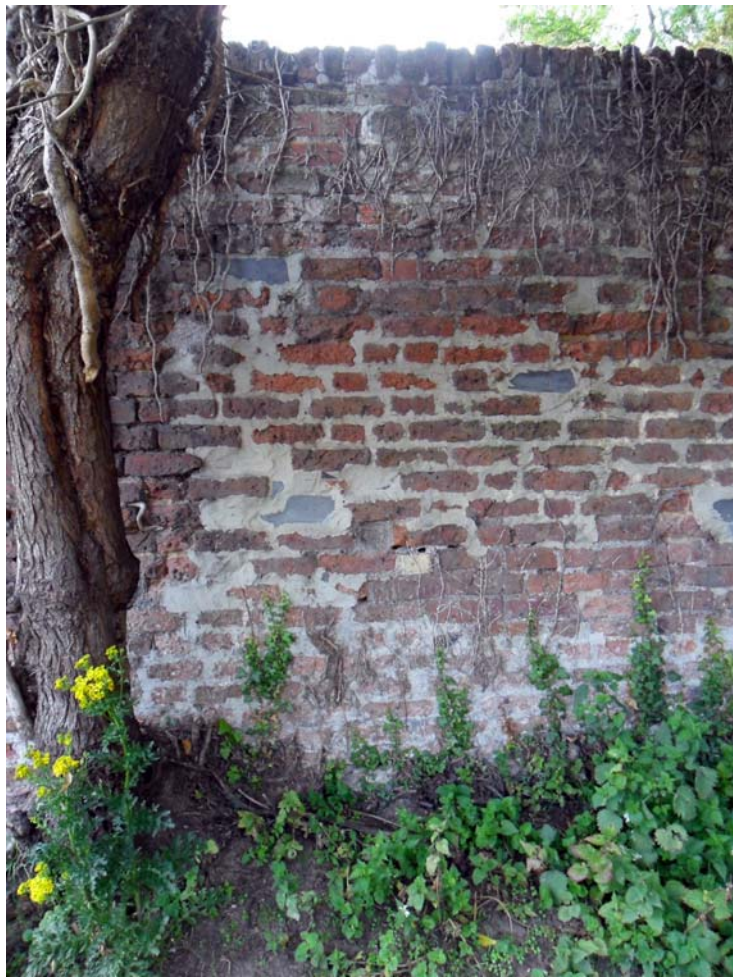
Plate 15. Typical example of the interior of the wall, showing heavy patching, looking west

The interior face of the wall appears to be mostly laid in stretcher bond, while the exterior face is predominantly in Flemish bond. Both are variable however and headers appear in the wall face with no apparent pattern. The wall has been heavily patched at various points in the past, and a number of different brick and mortar types were visible (Plate 15). The two main types of brick used in the wall are a red brick 238mm by 62mm by 105mm and a browner brick 220mm by 70mm by 108mm (Plate 16).

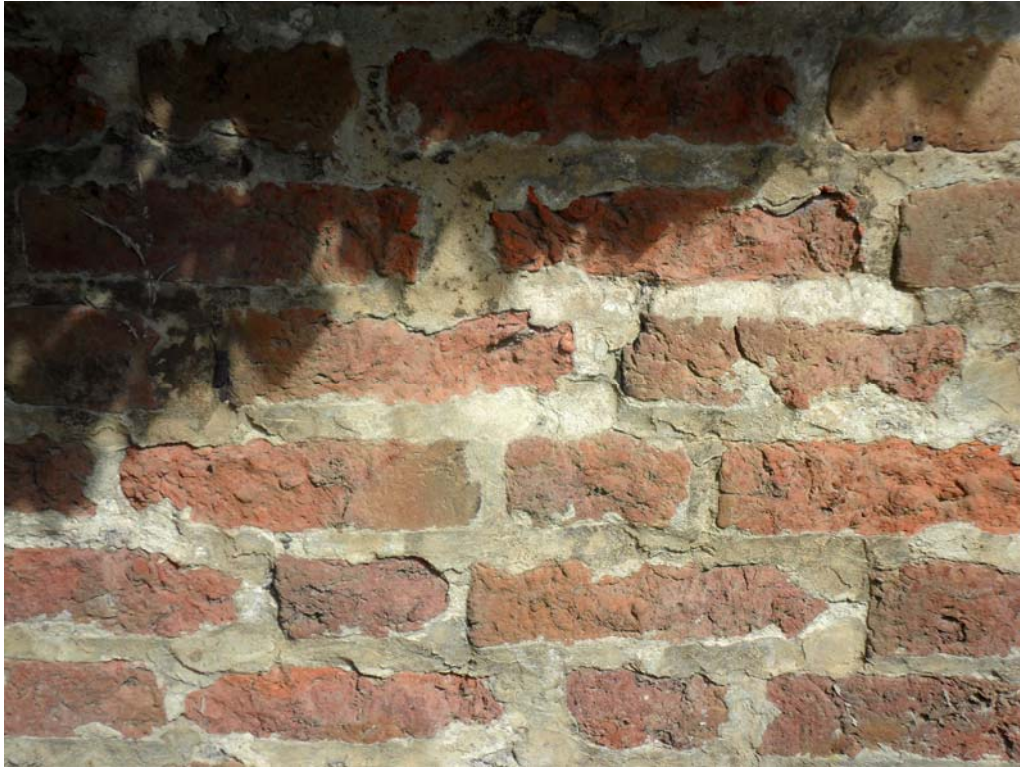
Plate 16. The main brick types in the exterior wall; a pinkish red brick and a browner brick (visible at top right)
