Report 2761

nps archaeology

Historic Building Recording at Smallways Farm, Newmans End, Matching Tye, Essex

July 2012

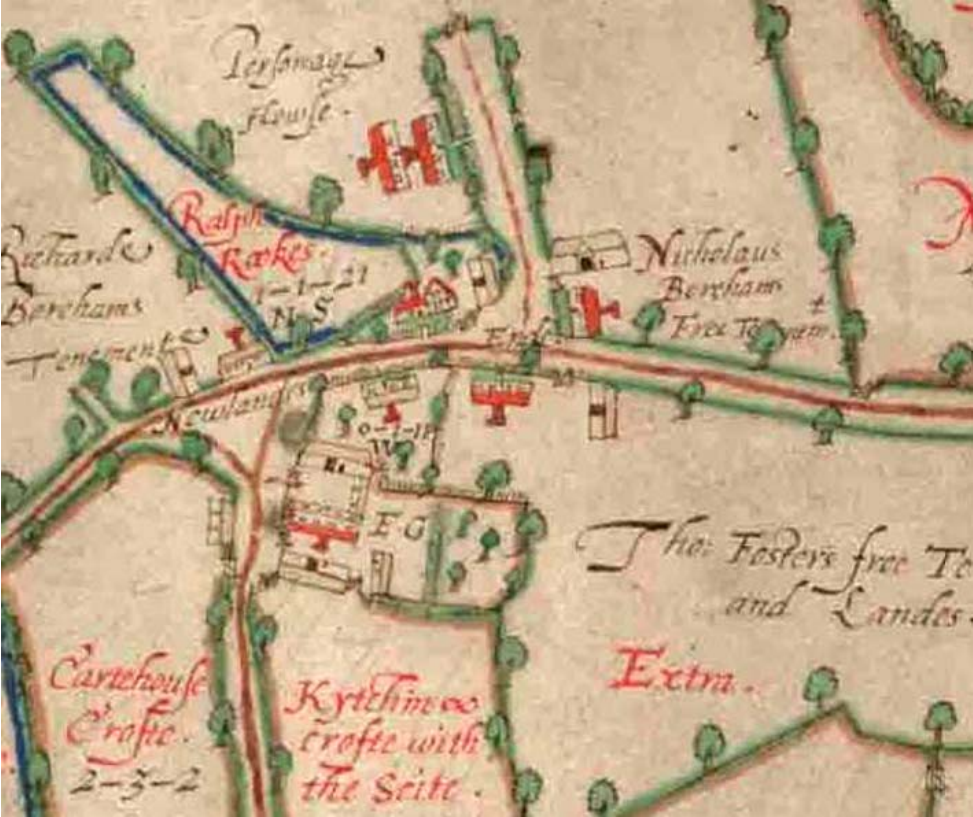
Plate 1. 1609 estate map (ERO D/DU 25/1) north to the left

An estate map of 1609 (Plate 1) held by the Essex Record Office (ERO D/DU 25/1) shows the hamlet of Newmans End and a farm complex on the site of Smallways Farm, consisting of what appears to be a three-celled farmhouse in the same position as the present house, and a barn in the same position as the present barn (Plate 1, centre). The map is orientated with north to the right. In 1609 this plot was owned by Thomas Foster.

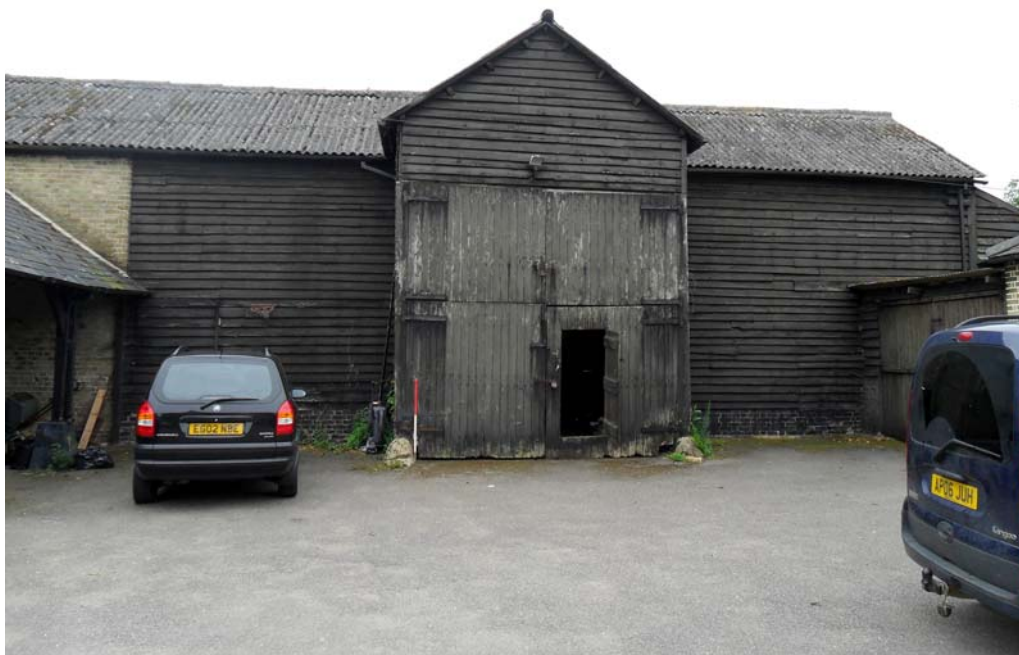
The northern elevation was of lightweight close studded timber framing, with diagonal bracing and external weatherboarding resting on a dwarf wall c.0.5m high of double thickness London Stock-type brick laid in Flemish Bond. The eastern bay was of brick to first floor level. The porch in the central bay measured 4.2m wide and 2.1m long and was of identical construction to the rest of the barn (Plate 6).

Plate 6. Building 1 exterior north side

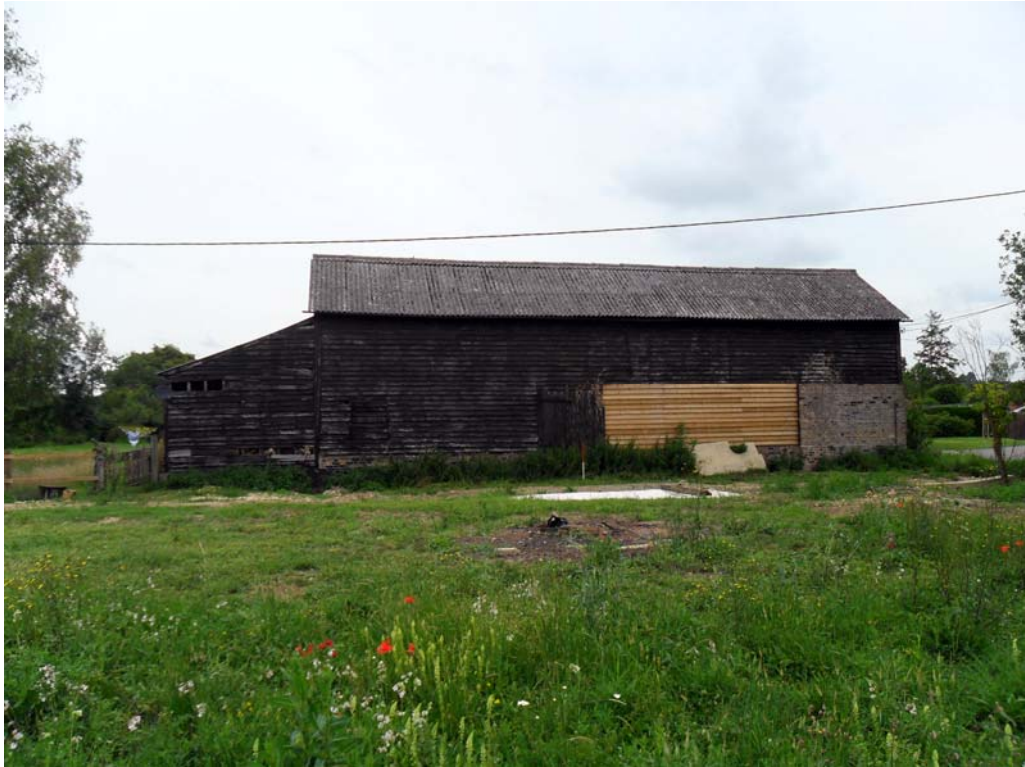
The southern elevation was of lightweight close-studded timber framing with a horizontal beam at first floor level and diagonal bracing, with external weather boarding (Plate 7). It rested on a dwarf wall 0.7m high composed of London Stock-type brick in Flemish Bond. On the eastern bay this wall extended to first floor level, still constructed from London Stock-type brick, with a shallow external buttress at the eastern end. There were two openings in the timber framing, above the level of the dwarf wall. A smaller one to the west and a larger one opposite the porch. This would allow access for produce from the south and provide a through-draft for threshing. Both doors were weather boarded. There was evidence of recent rebuilding at the eastern end at ground floor level; the dwarf wall from the centre point of the barn to the eastern gable end had been replaced, probably reusing the same bricks, and a portion of the weather boarding up to first floor level had been renewed (Plate 8).

Plate 7. Building 1, exterior south side

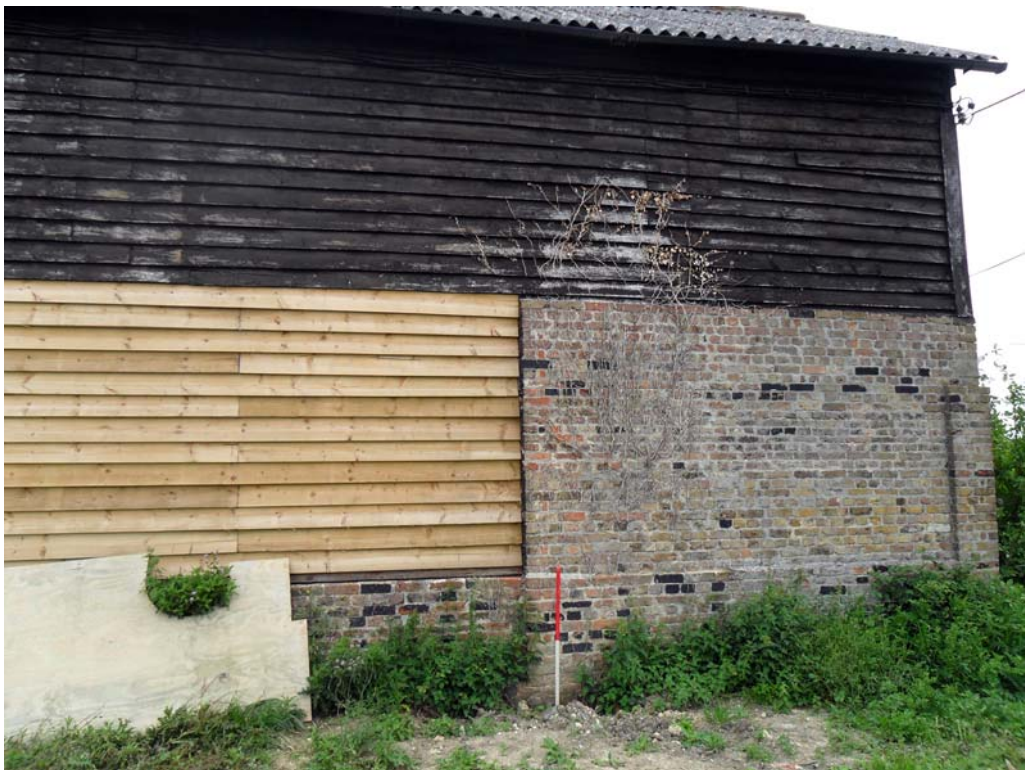
All timber framed walls were faced externally with weatherboards, painted with black (tar?) paint. Likewise, all the original dwarf walls were painted black externally. It has been suggested (A Garwood *pers. comm.*) that the present weatherboarding may be a replacement, but there is no evidence for an earlier phase of weatherboarding or hole to take staves or wattle panels. The only obviously replaced weatherboarding is that area of the southern elevation adjacent to the rebuilt masonry.

Plate 8. Building 1, rebuilt portion of south-east wall

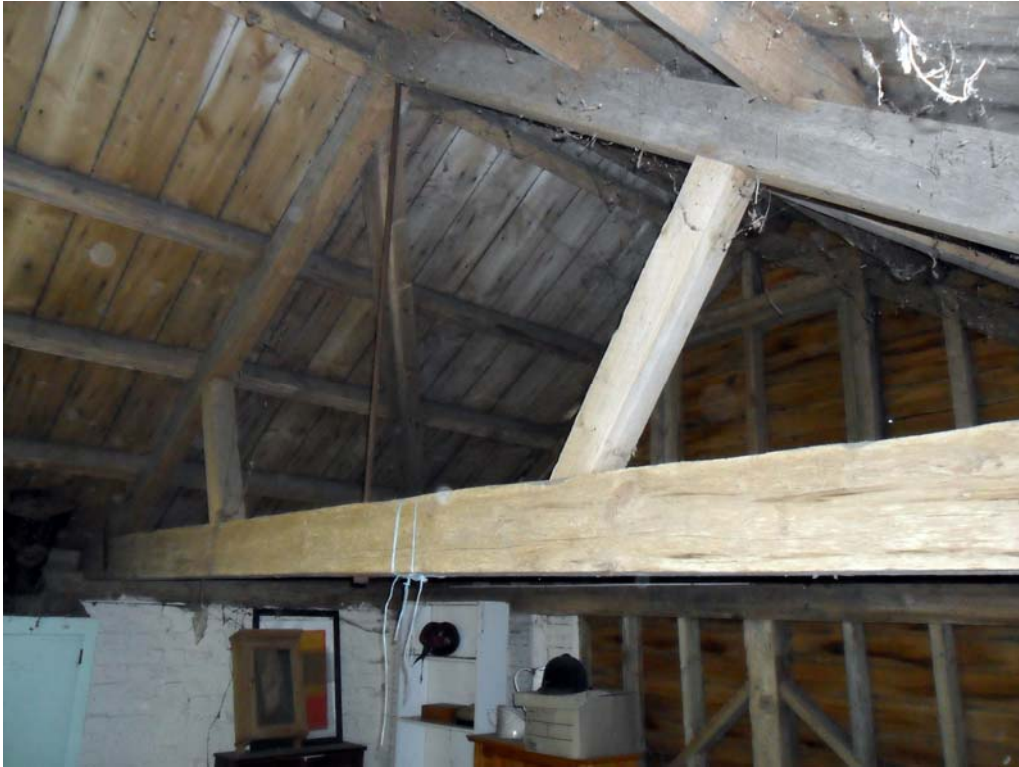
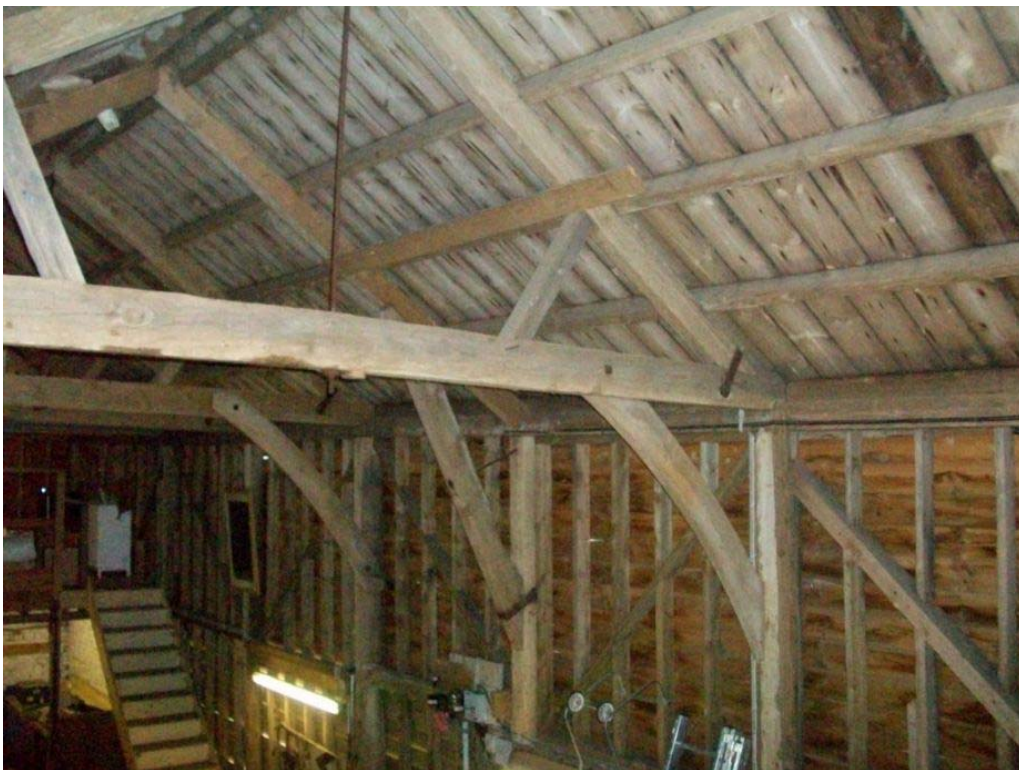
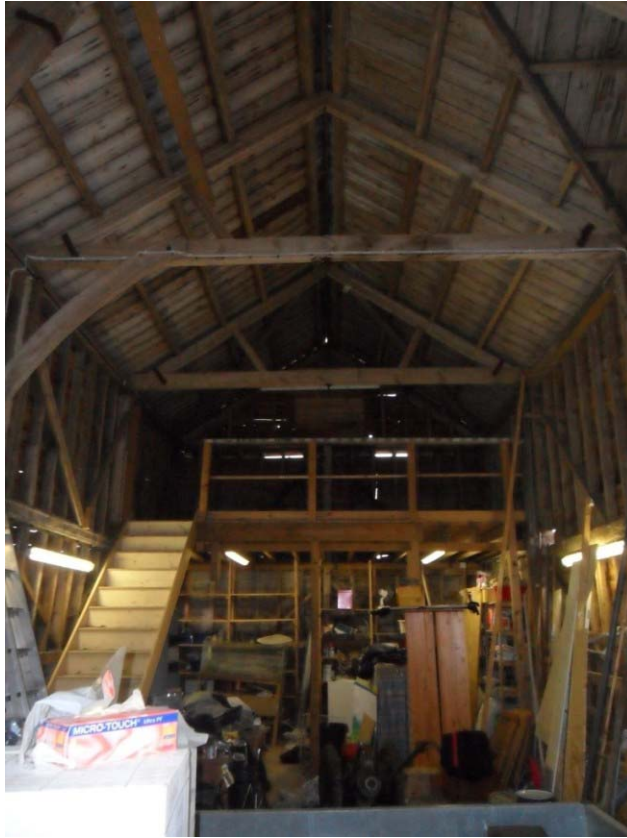
The four internal roof trusses were open trusses with a tie beam at wall plate level and two raking struts supporting the principal rafters (Plates 9, 10 and 11). Also present on each truss was a central iron tie extending from the centre of the tie beam to the apex (like a king strut) and occasional knee braces below the tie

beam (not present on all trusses). The principal rafters were secured to the tie beams with iron clamps. This type of truss is described by Richard Harris (Harris 1978, 11, Fig. 8) as 'post and truss'.

Plate 9. Building 1, example of roof truss, facing north-east

Plate 10. Building 1, roof detail, facing south-east

Plate 11. Building 1, interior, facing west

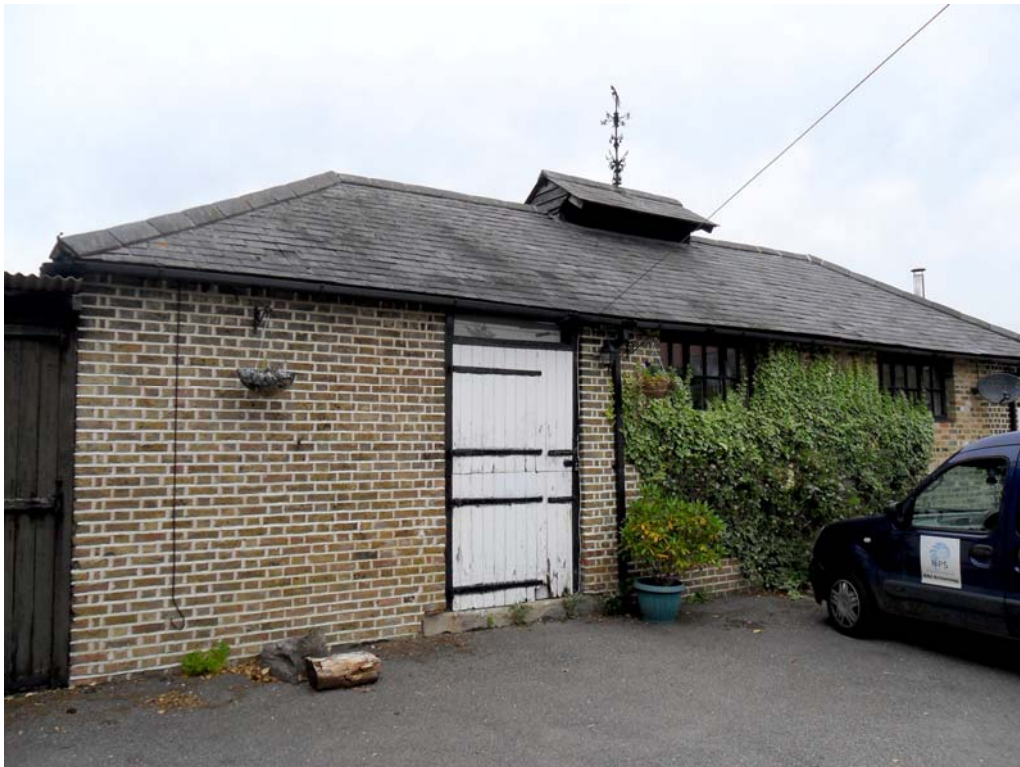
The external eastern elevation contained one original doorway to the south, a blocked doorway to the north and two small windows between (Plate 12), which presumably originally formed accommodation for two horses.

Plate 12. Building 2, exterior east side with blocked door behind van

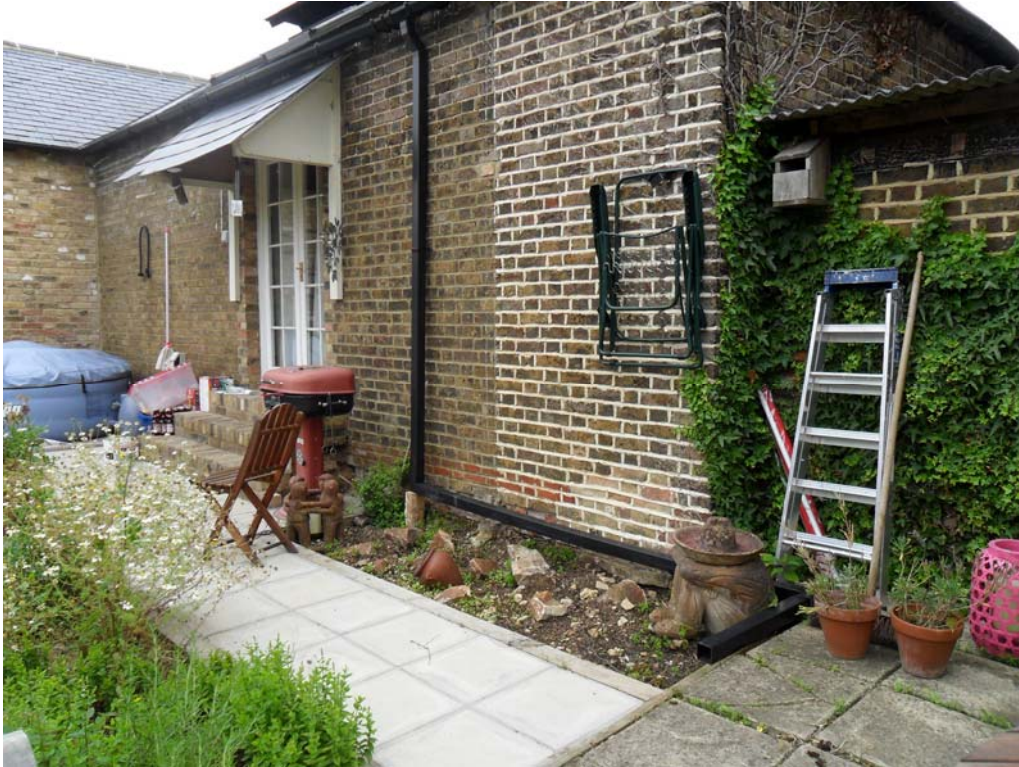
The external western elevation showed no original openings, but has a modern doorway allowing access on to a patio area. The northern part of the elevation is obscured by a small modern extension (Plate 13). Two courses of brick towards the base of the wall appeared to be of narrower red brick, possibly reused.

Plate 13. Building 2, exterior west side showing new doorway and modern extension to the left

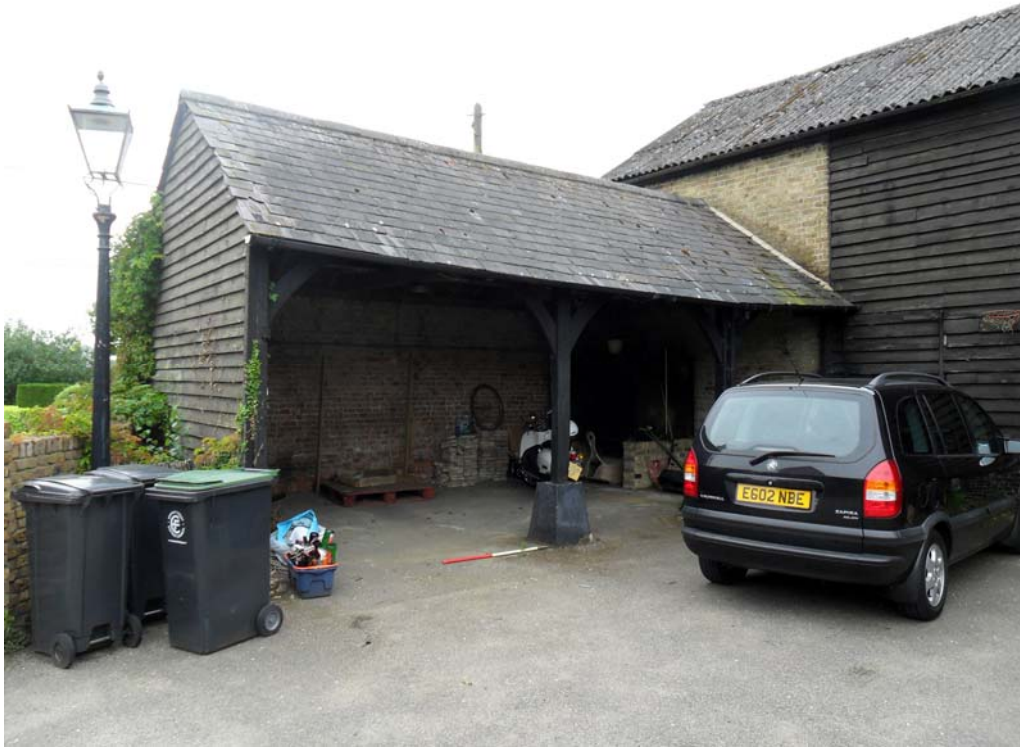
The western wall was open, originally to allow access for carts (Plate 14). The two roof trusses were supported by free standing posts, secured on the ground by concrete plinths (presumably due to rotting of the base of these timbers) and with additional longitudinal braces to the roof plate above.

Plate 14. Building 3, exterior west face

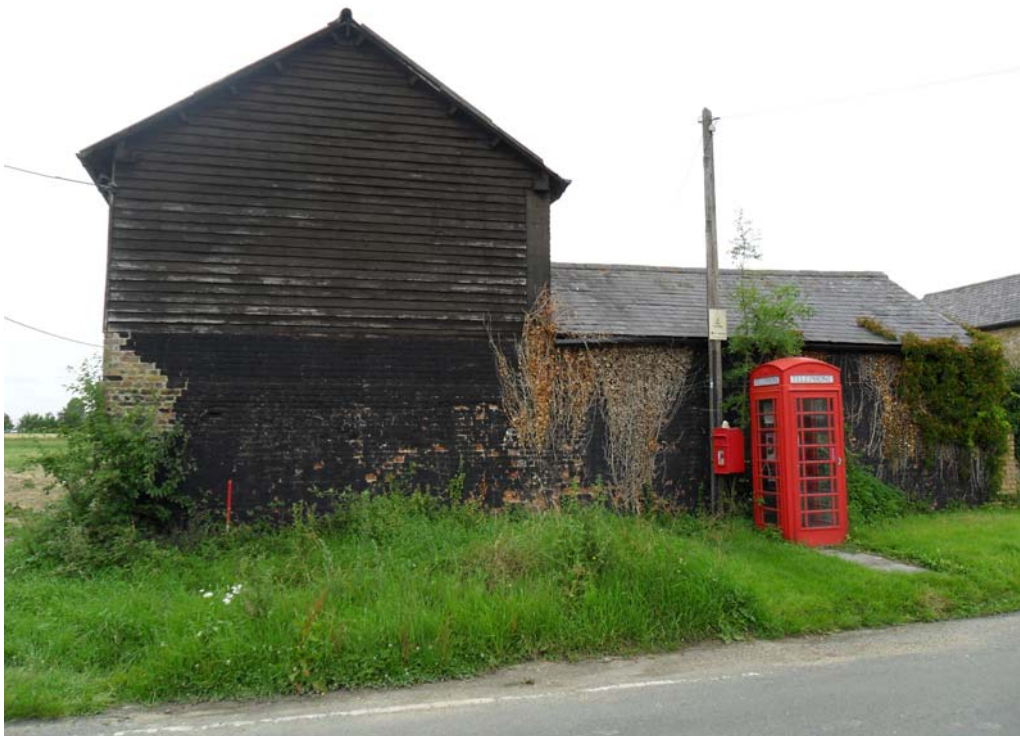
Its eastern wall was formed of reused red brick of 0.50-0.65m thickness, coursed but not laid in any specific bond. It was painted with a coat of black (tar?) paint (Plate 15).

Plate 15. Building 3, exterior east face (right) with Building 1 to the left

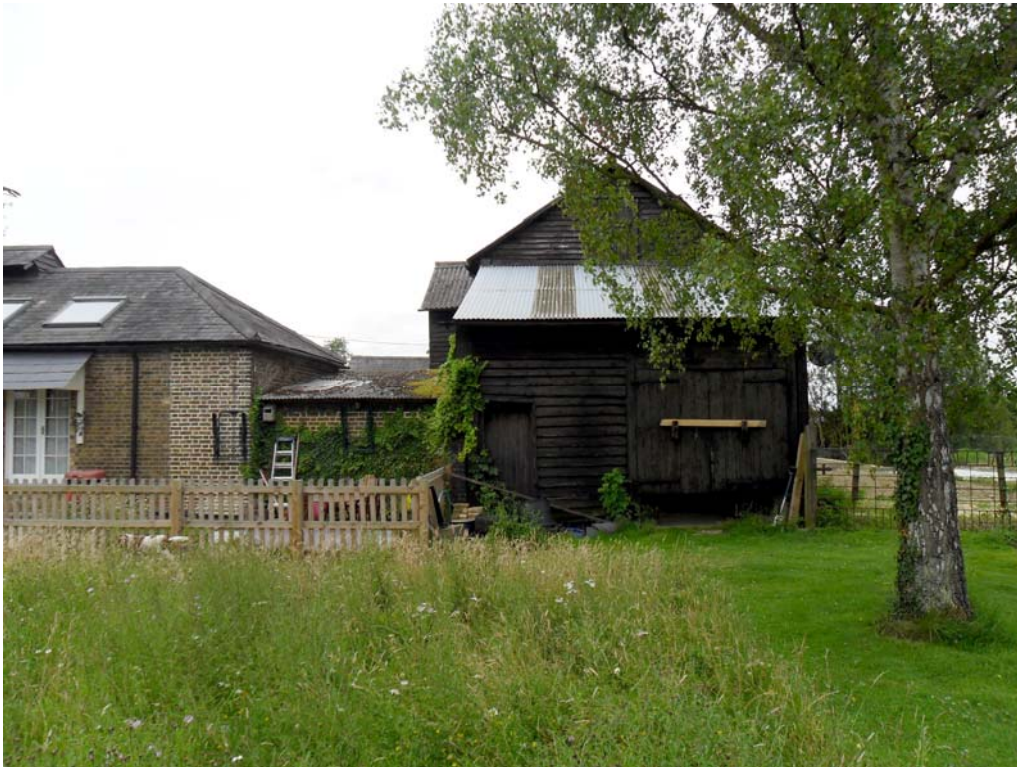
Building 4 was a lean-to structure, with the roof sloping down to the west. It was located between Building 2 (Stables) and Building 1 (Barn)/Building 5 (Shed) with wide double doors on its eastern side opening out into the farmyard (Fig. 2, Plate 16). The carpentry was similar to that seen in Buildings 1 and 3

Plate 16. Building 5 (right), exterior west face, with Building 4 (centre), and Building 2 (left)

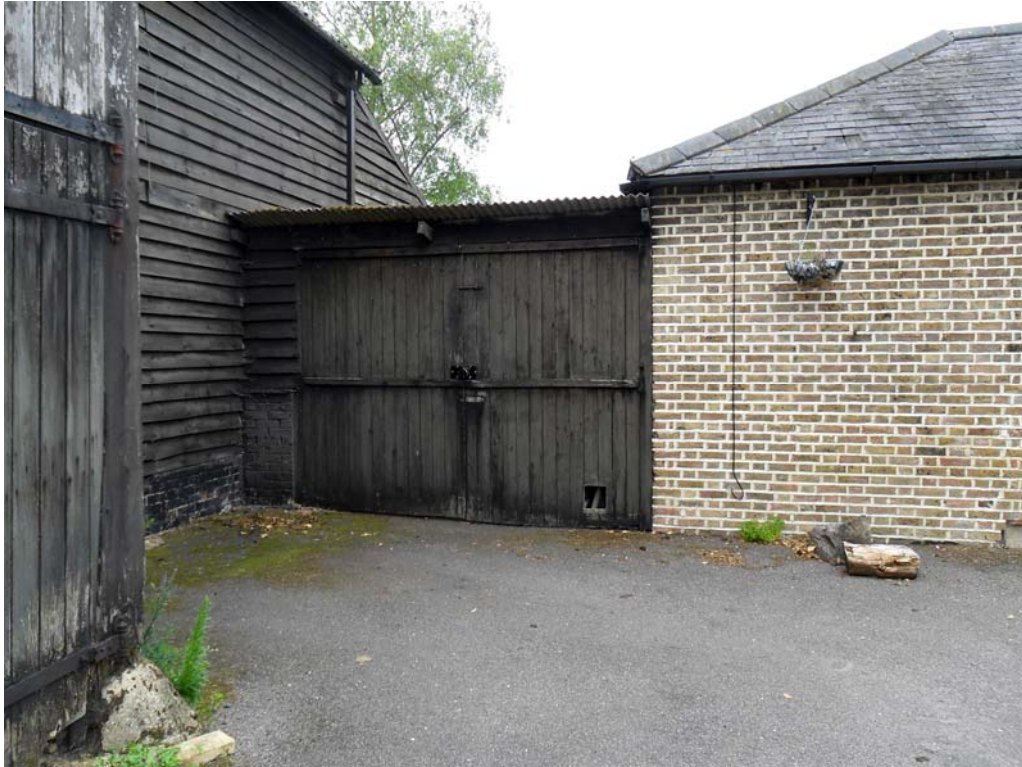
The eastern wall is predominately made up of the doors, with a short stretch of wall which is timber framed and weather boarded resting on a dwarf wall (Plate 17). The bricks were covered with a thick layer of black paint.

Plate 17: Building 4, exterior east face

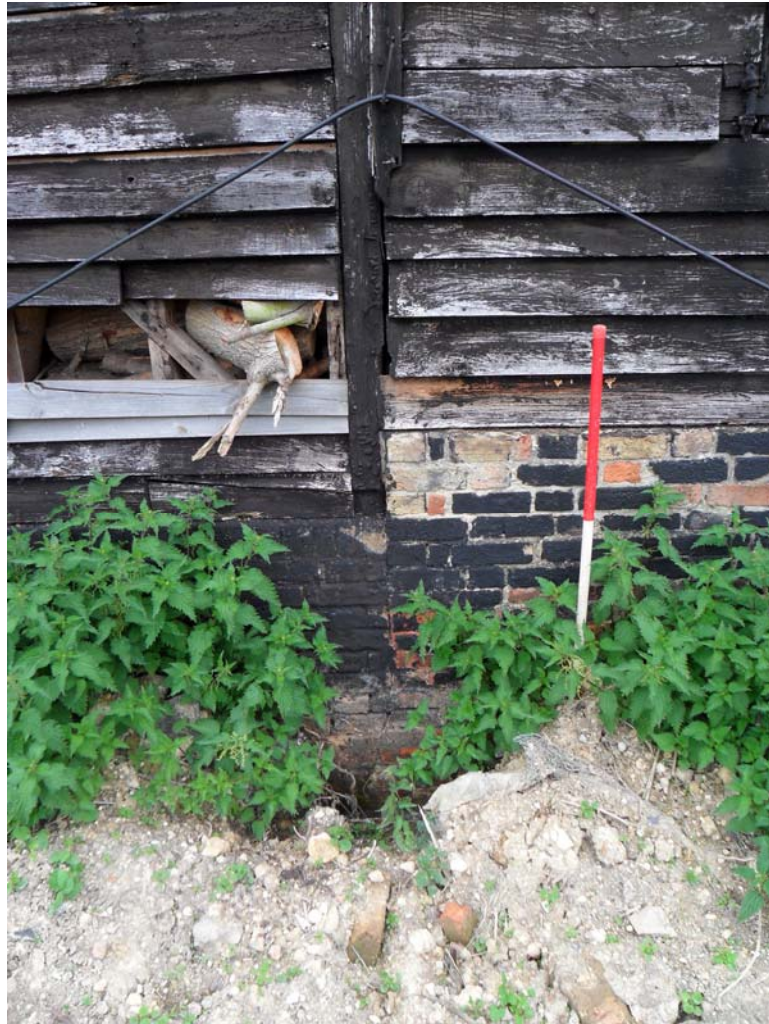
The southern dwarf wall did not appear to be continuous with the dwarf wall of Building 1, but a hole that had been dug at the join, showed that the foundation courses were actually of the same build (its upper course was of headers laid on edge) (Plate 18).

Plate 18. Join of Buildings 1 and 5, exterior south face

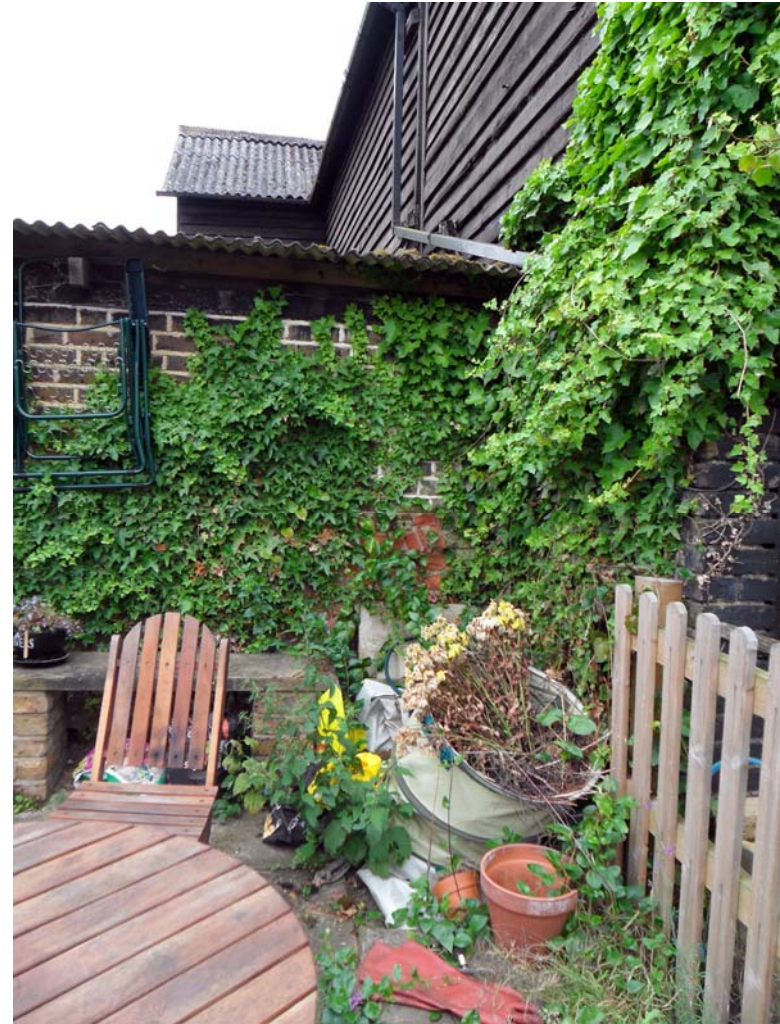
The building was roofed with sheets of corrugated iron (Plate 19).

Plate 19: Building 5, exterior west face showing two possible phases of wall build
