**Archaeological Watching Brief at
47 Gayton Road, King's Lynn, Norfolk**

ENF127050

September 2011

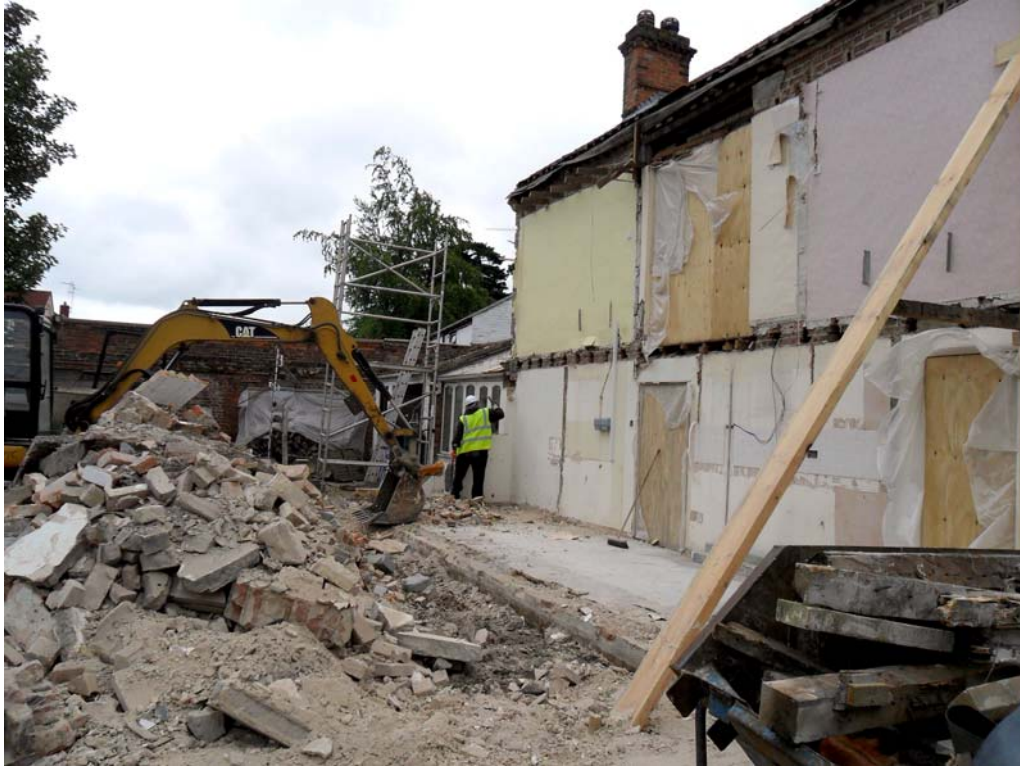
The demolition works revealed nothing of archaeological interest. All walls and surfaces that were removed appeared to be modern (Plate 1).

Plate 1. The demolition area to the rear of the house, looking south-east

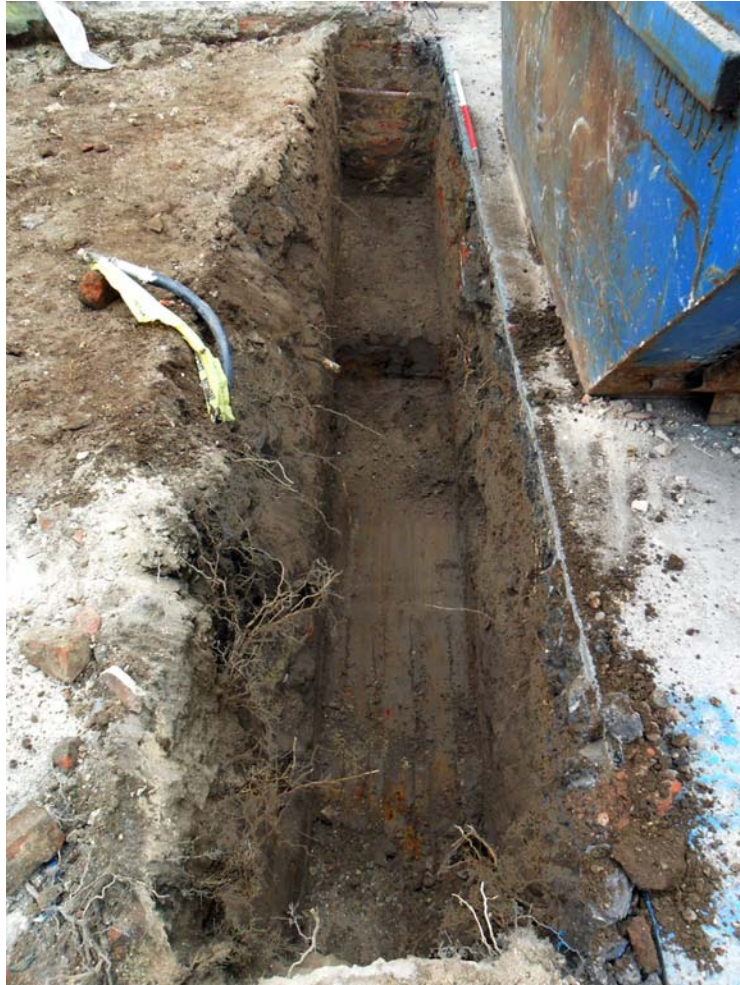
The first trench excavated ran northwards from the north-western corner of the house (Fig. 2) and measured 0.80m wide, 4.70m long and 1.40m deep.

The rubble overburden [1] was between 0.30m and 0.48m in depth. Subsoil [2] was identified underneath [1] and comprised a mid to dark brown, silty layer which was approximately 0.80m deep with a high level of root disturbance.

Foundations of part of 47 Gayton Road were seen at the end of the trench and former services including an old red brick soakaway occurred along its length (Fig. 3 Section1, Plates 2 and 3).

Plate 2. First trench, looking south

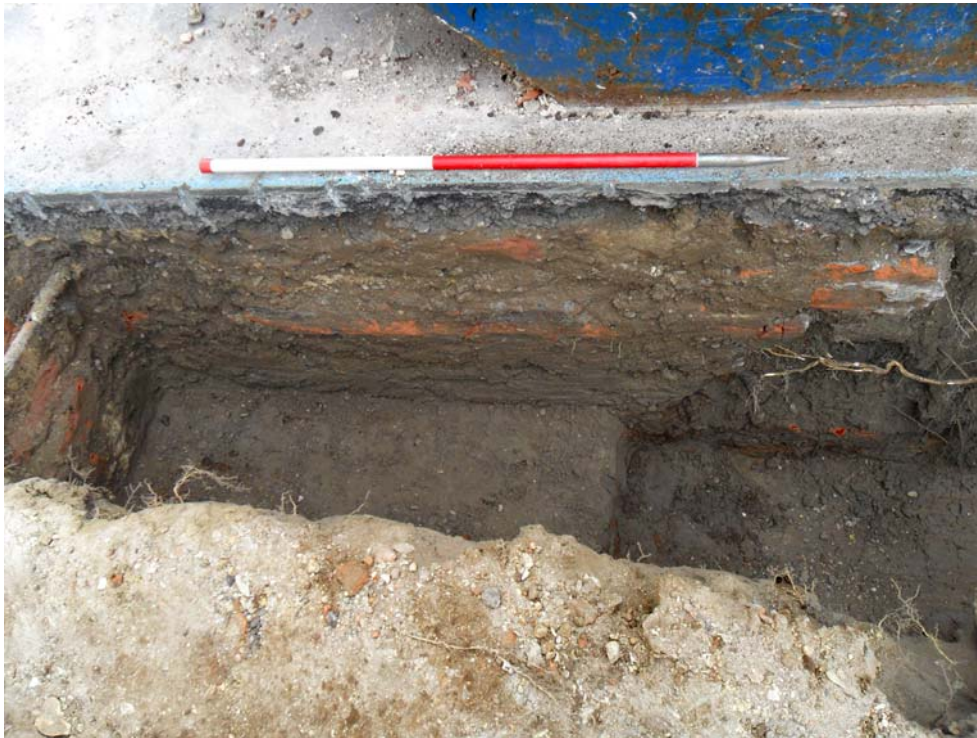
Plate 3. Section of first trench showing modern soakaway, looking west

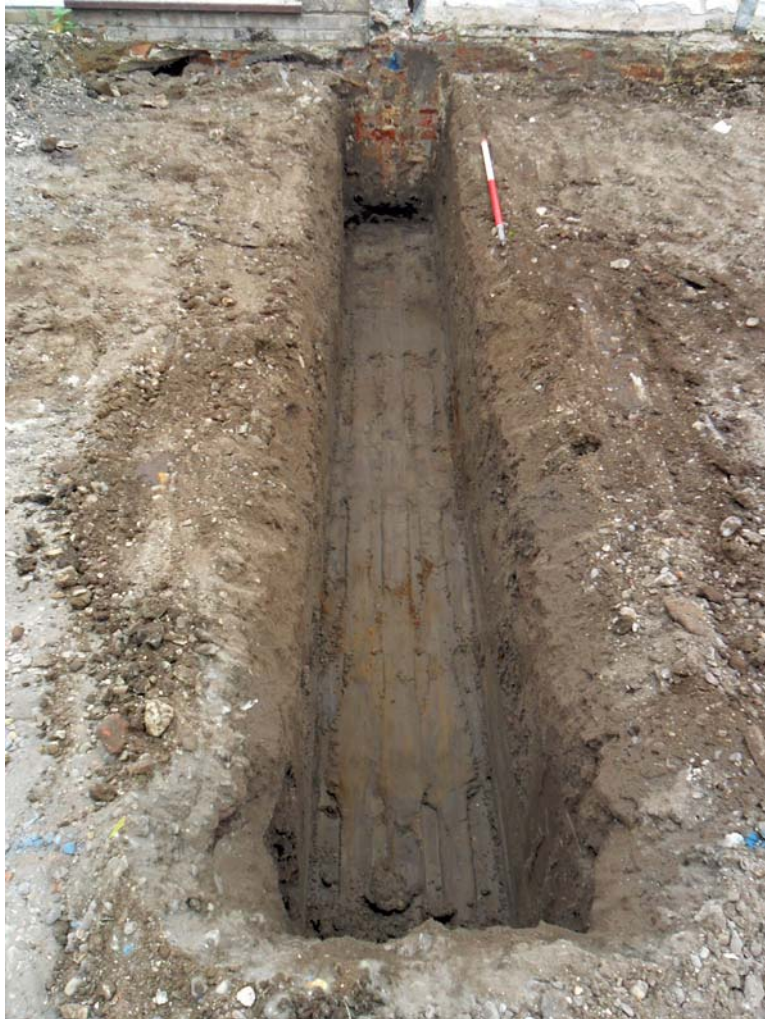
As observed in the first trench, foundations of the surviving part of the house were revealed at the end of the trench but no features (Fig. 3 Section 2 and Plate 4).

In the second trench there was little of the rubble make-up layer present since it appears that this trench was located slightly outside the footprint of the previous extension. Here a similar layer of subsoil ([3] to that seen in Trench 1 was present and underneath this was a mid-grey silty-clay layer [4], approximately 0.60m deep.

Plate 4. Second trench, looking south

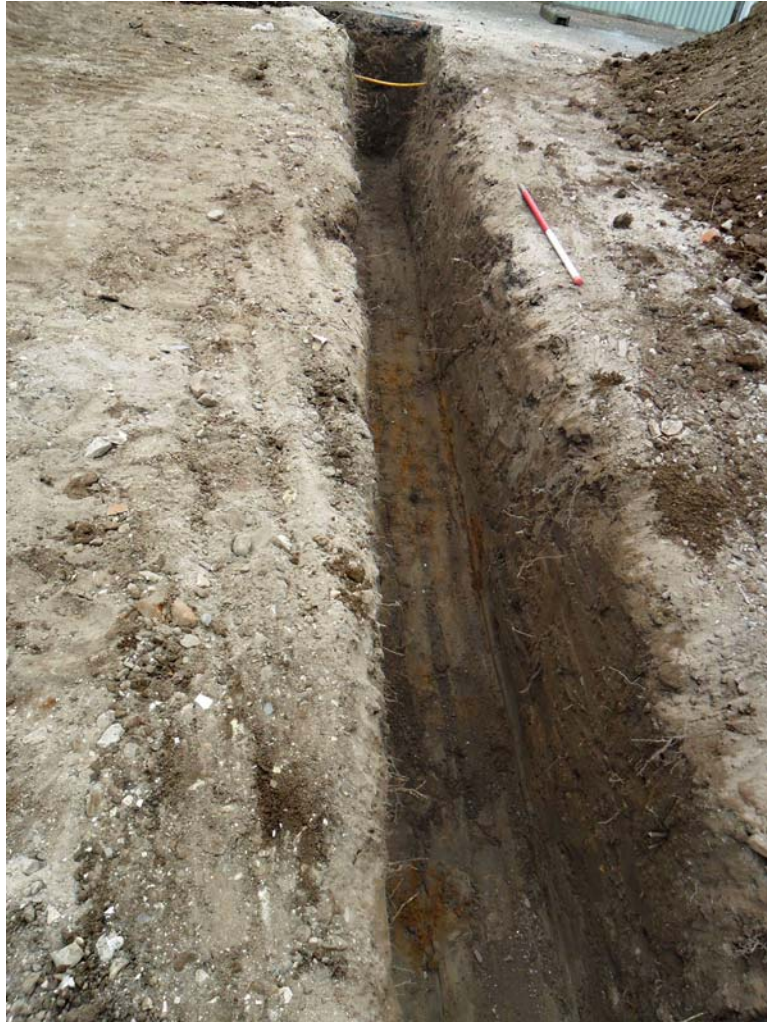
In the third trench three layers were present; rubble make-up [5], mid brown silty-sand [6] and mid-grey silty-clay [7] (Fig. 3 Section 3 and Plate 5).

One modern gas pipe but no archaeological features or deposits were present.

Plate 5. Third trench, looking north
