**Historic Building Record at  
Former Goods Shed, Campsea Ashe, Suffolk**

CAA 024

**Prepared for**  
Bloor Homes Limited

October 2011

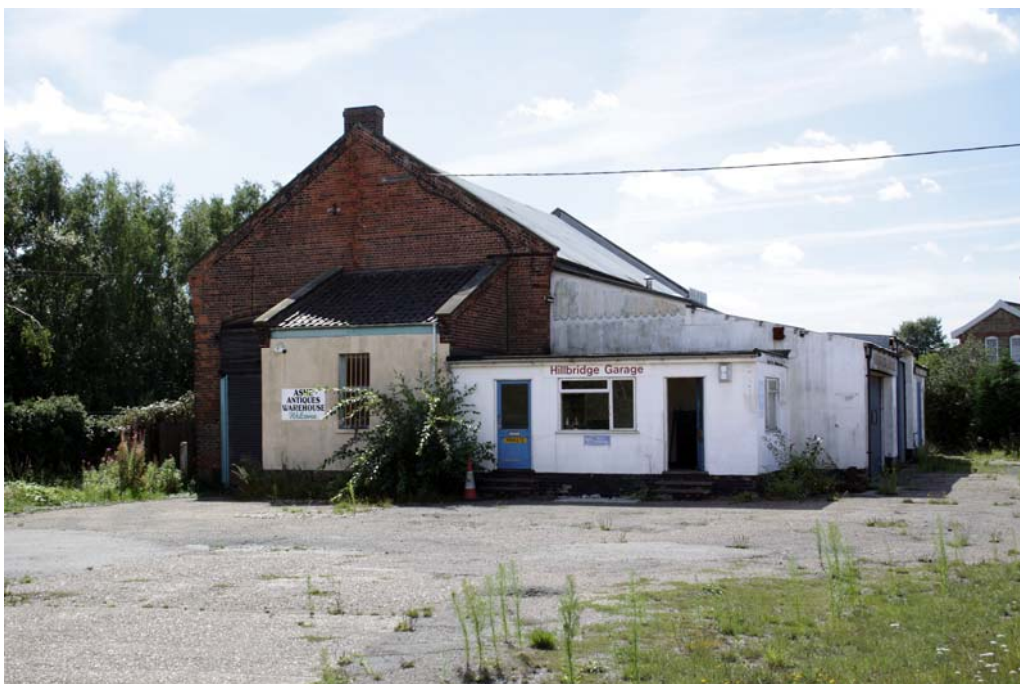
Plate 1. General view south-east of goods shed

The goods shed consisted of a rectangular five bay building, 16m (c.52' 6") x 10.16m (c.33' 4"), constructed in red brick laid in an English bond under a steeply pitched galvanised sheet roof (Plate 1) that presumably replaced the original pantiled roof. The building originally contained three rooms (Fig. 2): the main goods shed (Room 1) which formed the main body of the building, and a small extension at either end (Rooms 2 and 3). There was also a timber canopy along the north-west side, which covered the former loading bay (Plate 2). The building was aligned north-east – south-west, parallel to the railway line it formerly served. The gable height on each end was c.8.2m (c.26' 11") and the top wall plate of the north-west and south-east walls was c.5.83m (c.19' 1½") above floor level.

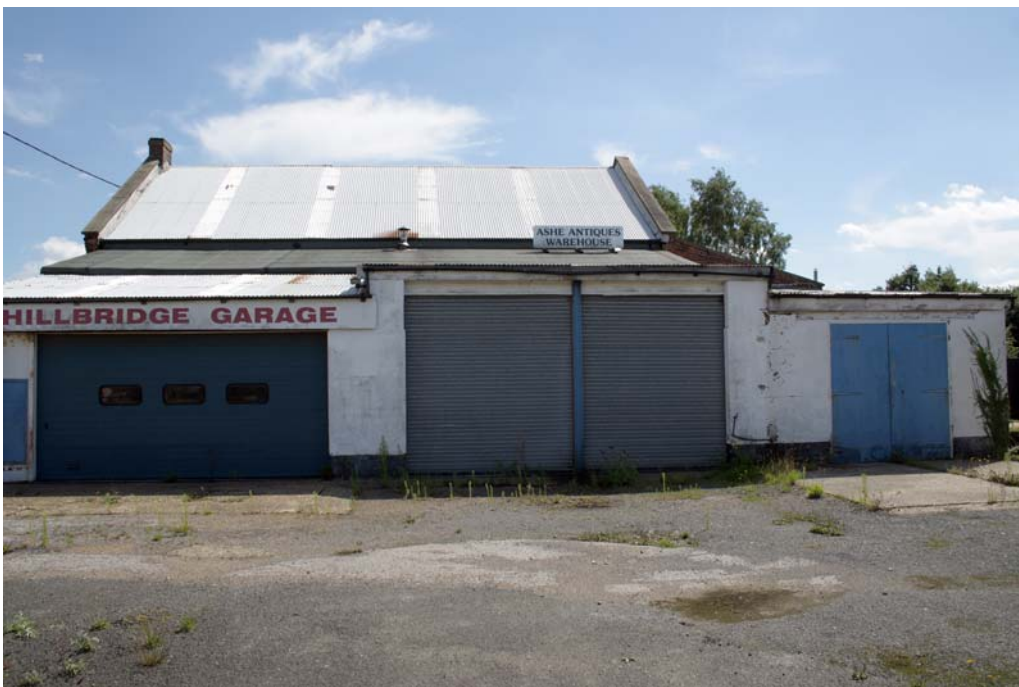
Plate 3. Modern extensions fitted under the loading bay canopy

There are a number of modern extensions on the north-east, north-west and south-west sides constructed during the later 20th century for the garage that most recently occupied the building. Some of these were built under the loading bay canopy (Plate 3), but they are not considered further here.

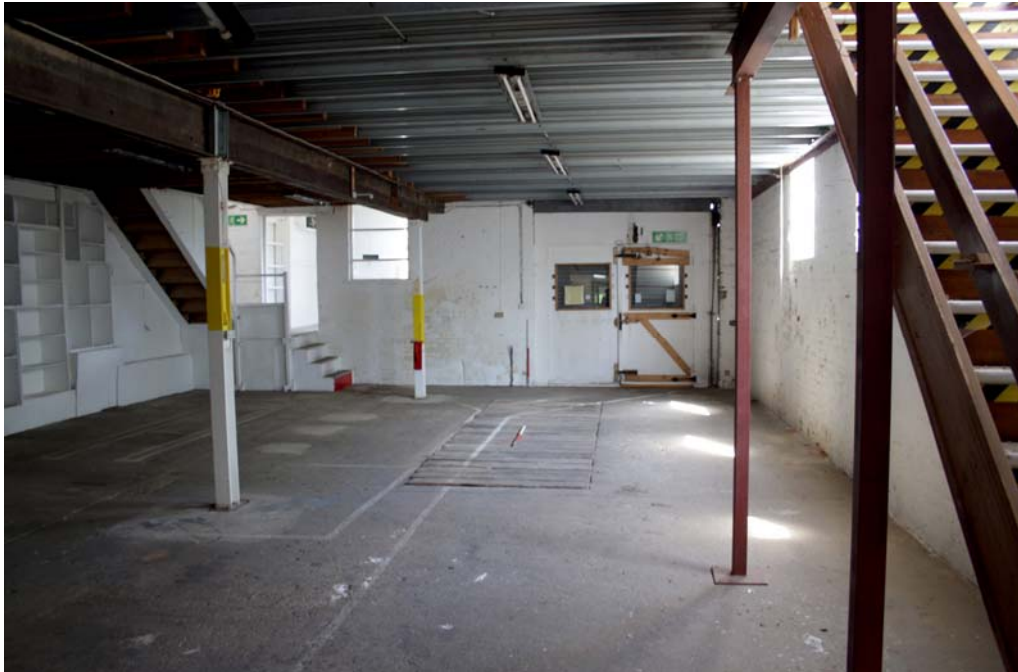
Plate 4. General view north-west of goods shed interior

Room 1 was the main shed and consisted of a large rectangular room, c.15.2m (c.49' 10") x c. 9.4m (c.30' 10"), which had been split vertically by a modern steel and timber floor inserted to create an upstairs antiques showroom (Plate 4). The floor is not considered further here and only the original features are discussed.

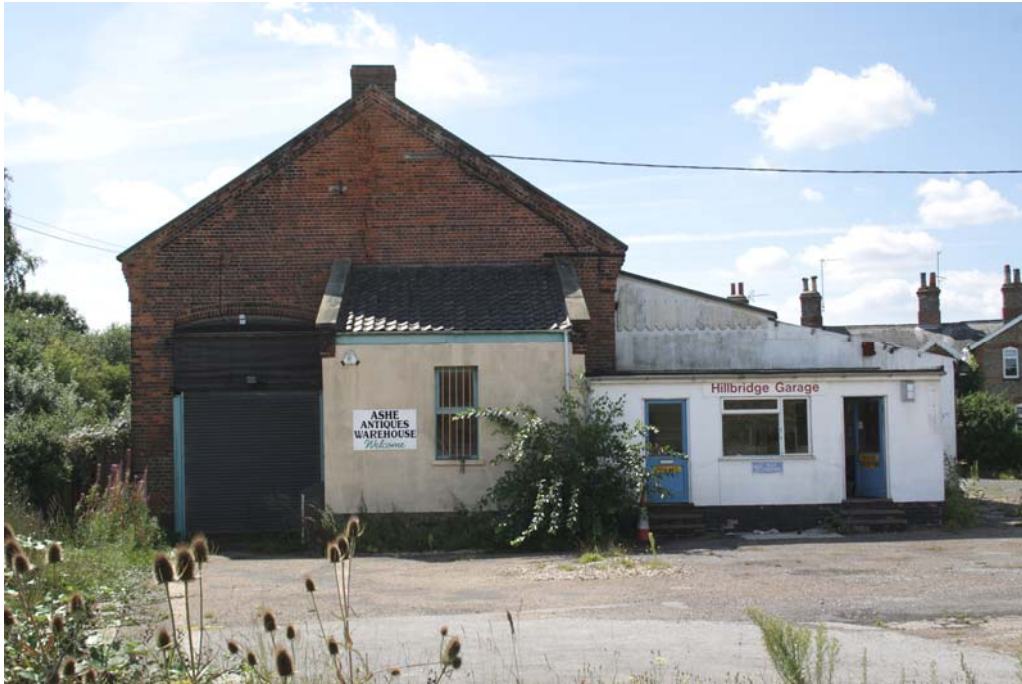
Plate 5. North-east gable wall showing former railway door

Railway traffic entered and exited the shed through two large opposing entrances in the south-east ends of the north-east and south-west gable walls (Plate 5). The entrances were 3.1m (c.10' 2") wide x c.4.3m high (c.14' 1"), and topped by large timber lintels, c.0.23m (c.9") square, which extended 0.35m (c.1' 2") beyond the width of the openings. The wall above the openings is supported by flat arches in red brick headers on end, with the space between the arches and the lintels blocked by wooden panels (Plate 6). The ends of the arches are braced by timbers secured to the top of the lintels by shark-tooth joints to stop lateral movement (Plate 7).

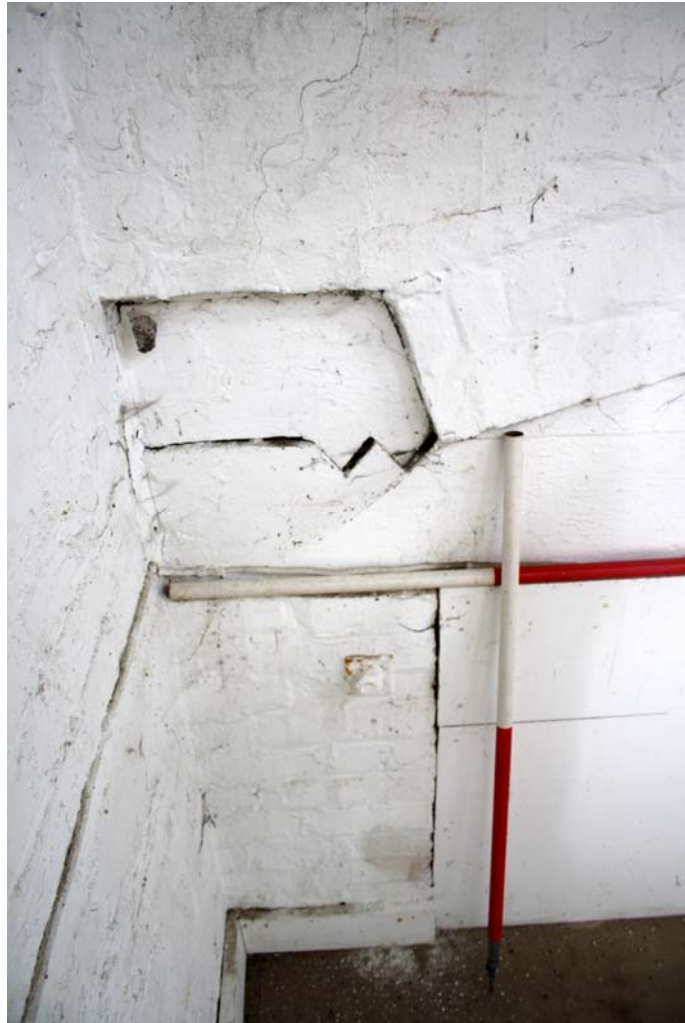
Plate 7. Detail of 'shark-tooth' joint above railway door

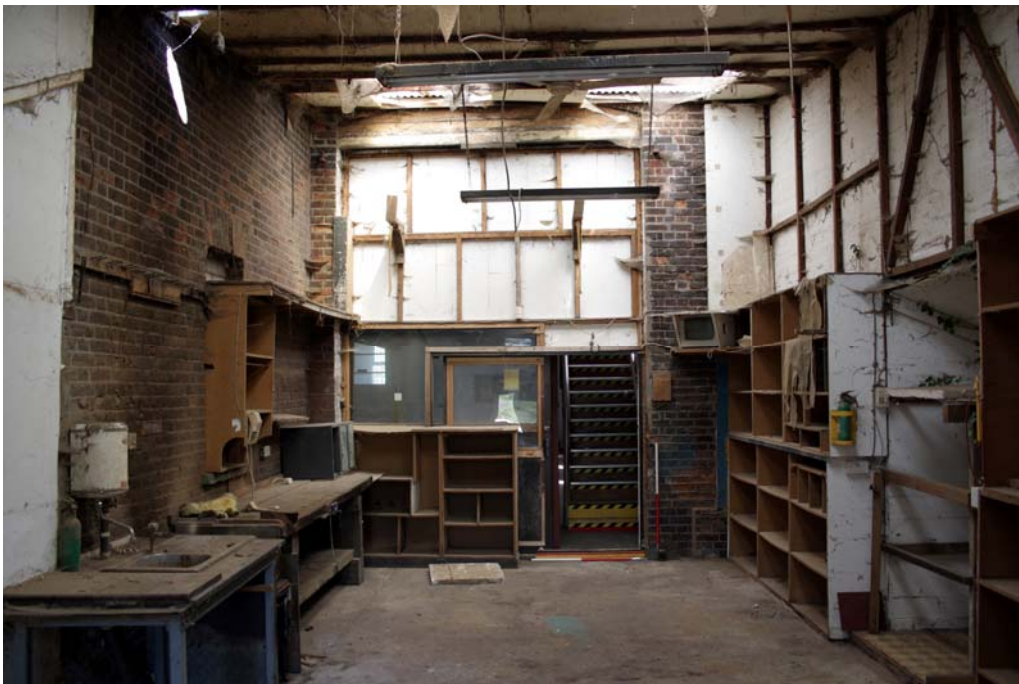
Plate 8 Detail of lightweight panelling filling south-west railway door

The original openings would have been closed by wooden doors, but these have been replaced by a modern roller shutter on the north-east wall and a lightweight glazed panel partition in the south-west wall (Plate 8).

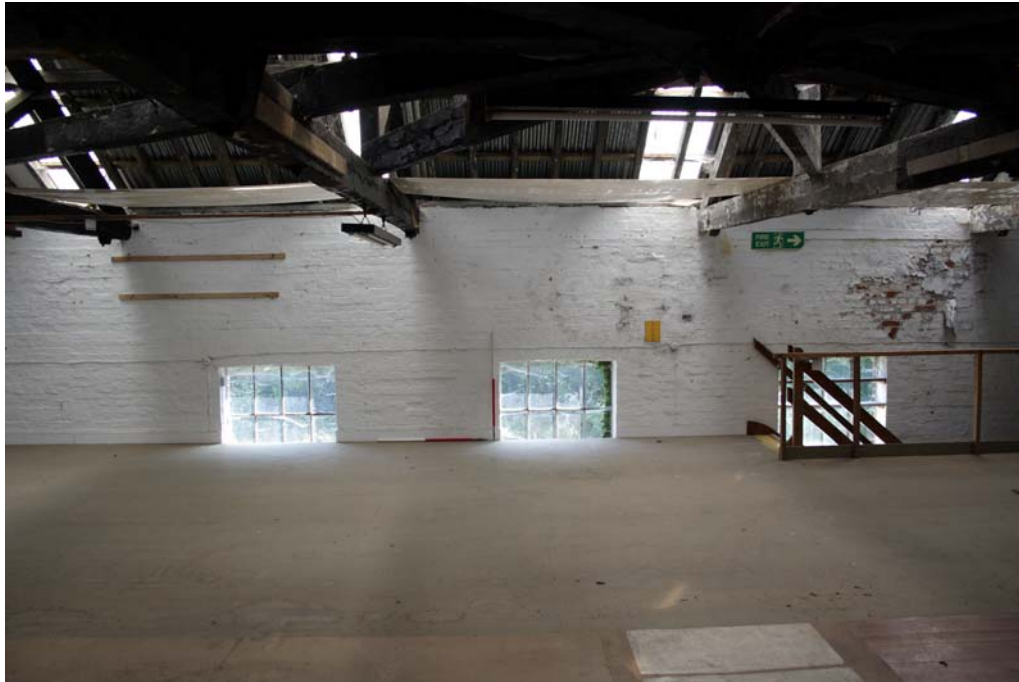
Plate 11 Upper sections of the windows in the south-east wall

Internally the windows were in a plain, whitewashed brick wall. Each window was 2.2m (7' 2") high and c.1.25m (c.4' 1"), with a low, virtually flat arch of bricks on end (Plate 11). The windows were sixteen light metal framed and set high in the wall within the three central bays.

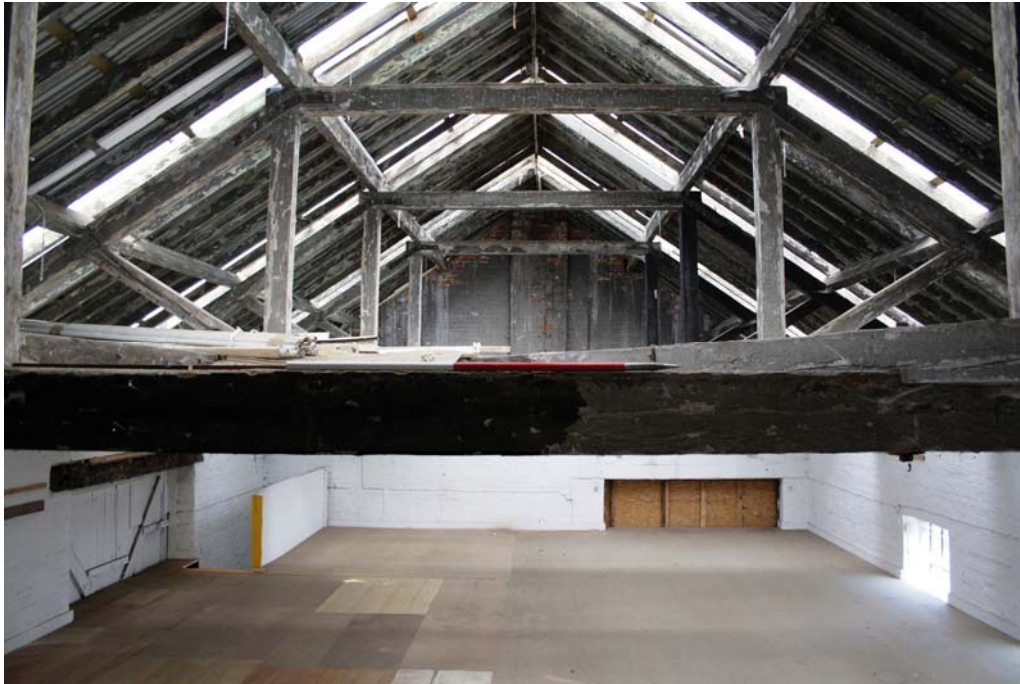
Plate 12 General view of roof structure

The roof structure consisted of four large queen post truss frames supporting two sets of purlins, which were set on wooden blocks in the gable walls. The frames were joined by angled metal plates and bolted to the large timber tie beams that spanned the room (Plate 12). Angled struts braced the tops and bottoms of the frames (Plate 13).

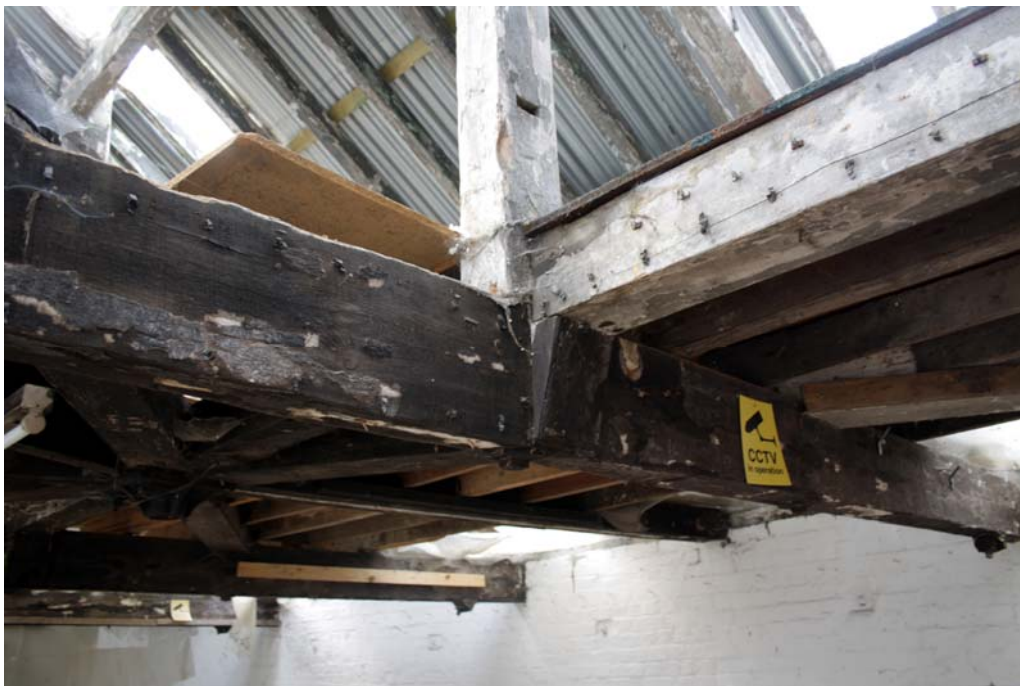
Plate 13 Detail of connection of queen post to the tie beam and cart wheel roof structure

A complex layout of squared beams that formed a 'cart wheel' like arrangement had been constructed across the top of the roof beams (Fig. 3, Plate 13). The centre of the 'cart wheel' was positioned between the loading bay doors and offset towards the north-west, loading bay wall. The timbers in it were connected by a square cast iron plate with a central circular socket, which may have been intended to take an iron column. There was no corresponding plate in the floor below, but it is possible that the concrete shed floor had been re-laid at some time.

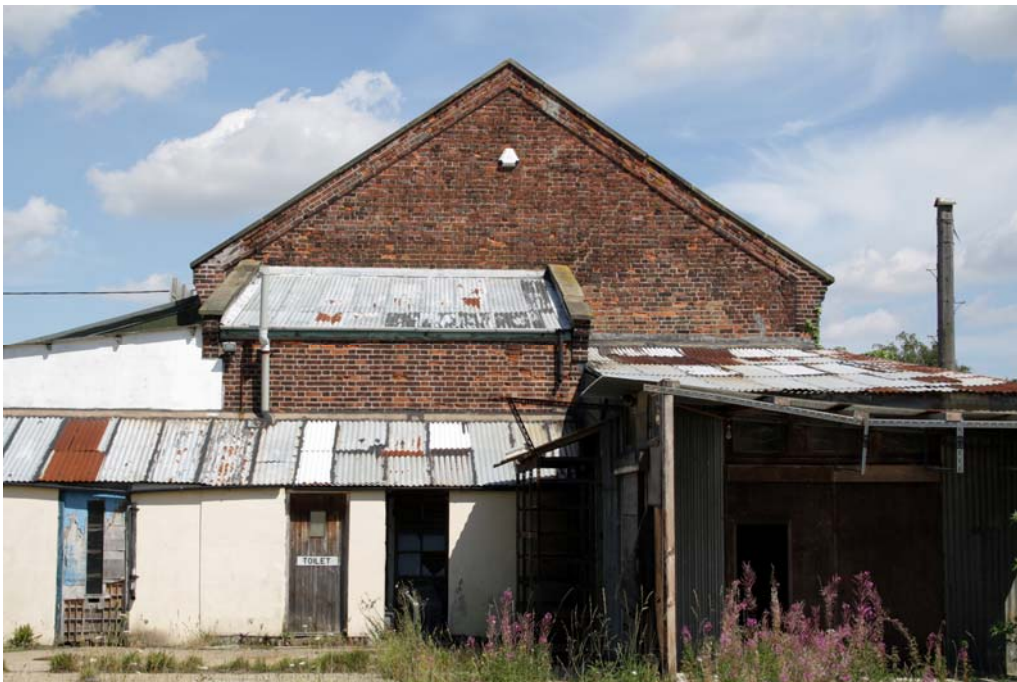
Plate 14. General view north-east of building showing sloping roof of Room 3

Room 3 was a square room on the south-west end of the main shed. It measured 5.42m (c.17' 8") x 4.77m (c.15' 7") and was constructed from red brick with a sloping galvanised steel roof with raised parapets on the side walls capped with concrete or stone slabs (Fig. 2, Plate 14).
