# Archaeological Evaluation of Land North of 69-79 Back Road, Murrow, Cambridgeshire

ECB 3681

NPS Archaeology

October 2011

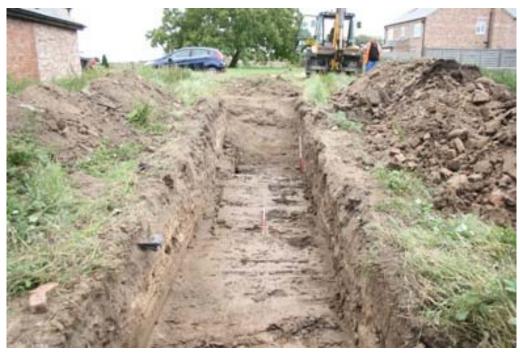
Plate 1. Trench 1

Trench 1 was positioned on an east-west alignment in the westernmost plot and it measured 10m x 1.8m. It was excavated to a maximum depth of 1.4m at its east end, although the average depth of the trench was 1.0–1.1m.

Excavation stopped at the top of stiff blue/grey clay, which very quickly oxidised to brown on exposure. The sequence of deposits overlying the clay was consistent along the length of the trench and consisted of a layer of fairly compacted brown loam topsoil and building rubble 0.5m thick, that overlay a layer of cream silt and blue grey clay that contained some brick fragments, tile and wood.

Peat was exposed at the east end of the trench at a depth of 1.4m and was not investigated further.

No archaeological features were present and all the finds in the upper deposits were modern and not retained.

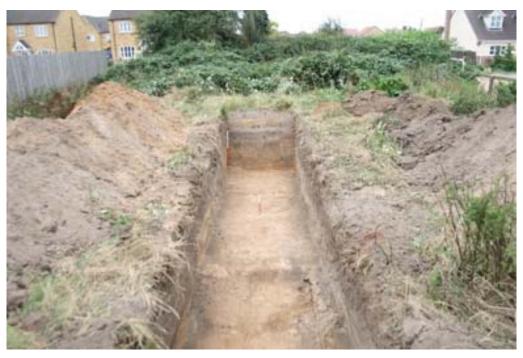
Plate 2. Trench 2

Trench 2 was positioned in the front, southern, plot and measured 11m  $\times$  1.8m. It was excavated to a maximum depth of 1.3m at its southern, although the average depth of the trench was c.1.1m.

The sequence of deposits exposed in the trench sides was similar to that encountered in Trench 1 with a layer of topsoil and building rubble, up to 0.75m thick, overlying a 0.2m thick layer of mottled brown/cream/yellow sand and silt that contained a few brick fragments.

The excavation stopped at the top of a layer of yellow sand.

No archaeological features or deposits were present and all the finds in the upper deposits were modern and not retained.

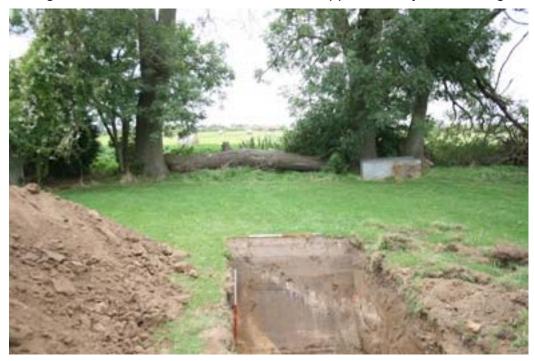
Plate 3. Trench 3

Trench 3 was positioned north-south in the north-east plot and was intended to be  $10m \times 1.8m$ , but in the event it was excavated to a length of 5.4m as it turned out to be aligned along a large infilled drain, which meant that further excavation was essentially meaningless. Therefore, agreement was reached with the archaeological curator to terminate the trench at approximately half its length.

Only the west edge of the drain was exposed as it extended beyond the east side of the trench (Plates 3 and 4). The part of the drain that was exposed had a steeply sloping side, which became almost vertical with depth (NPS). A large wide hollow in the field to the north appears to be the continuation of the line of the drain. It was assumed prior to excavation that the hollow in the field to the north stopped at the site boundary, but it now seems that the hollow originally extended further south, possibly as far as Back Road.
