Report 2666

Archaeological Watching Brief at All Saints' Church, Tibenham, Norfolk

ENF126860

An archaeological watching brief was conducted for Tibenham Parochial Church Council ahead of remedial works on the church's roof and drainage system.

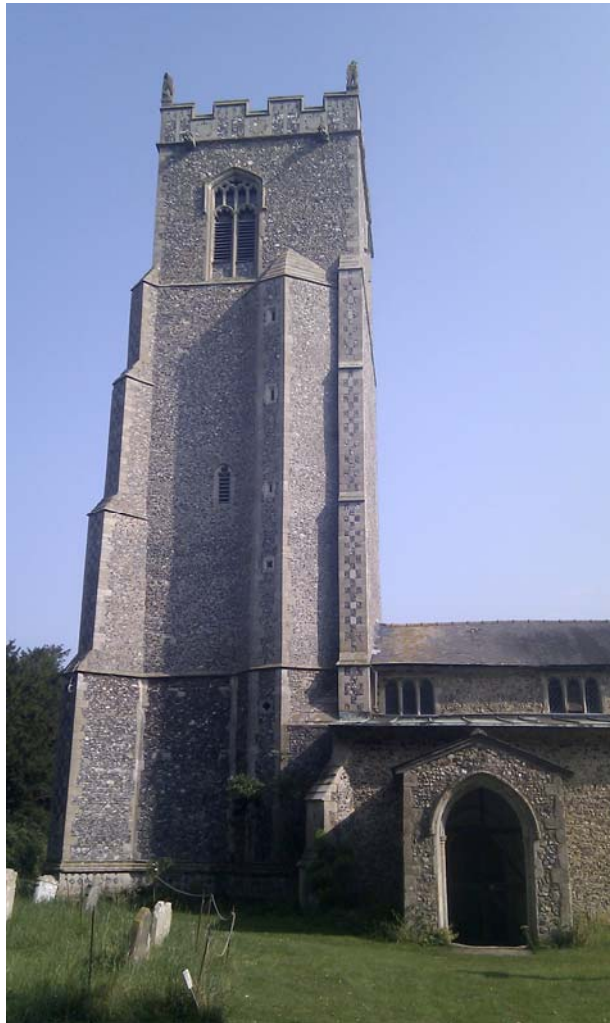
Plate 1. The church tower and porch

The church of All Saints at Tibenham is a Grade I listed building of architectural interest. The earliest feature in the building is an 11th-century Norman window in the north wall of the Nave. The Chancel is thought to date from the 13th century, with the south aisle of the church being added sometime in the 14th century. The church's tower, thought to be unusually large for the period and for a parish church in such a small village, is very impressive with its own stair turret and battlements with evangelists for pinnacles (Plate 1). Both the tower and the church's porch are believed to have been added sometime in the 15th century. The entire church is built from flint rubble with stone dressings and a roof of slate and lead (www.english-heritage.org.uk).

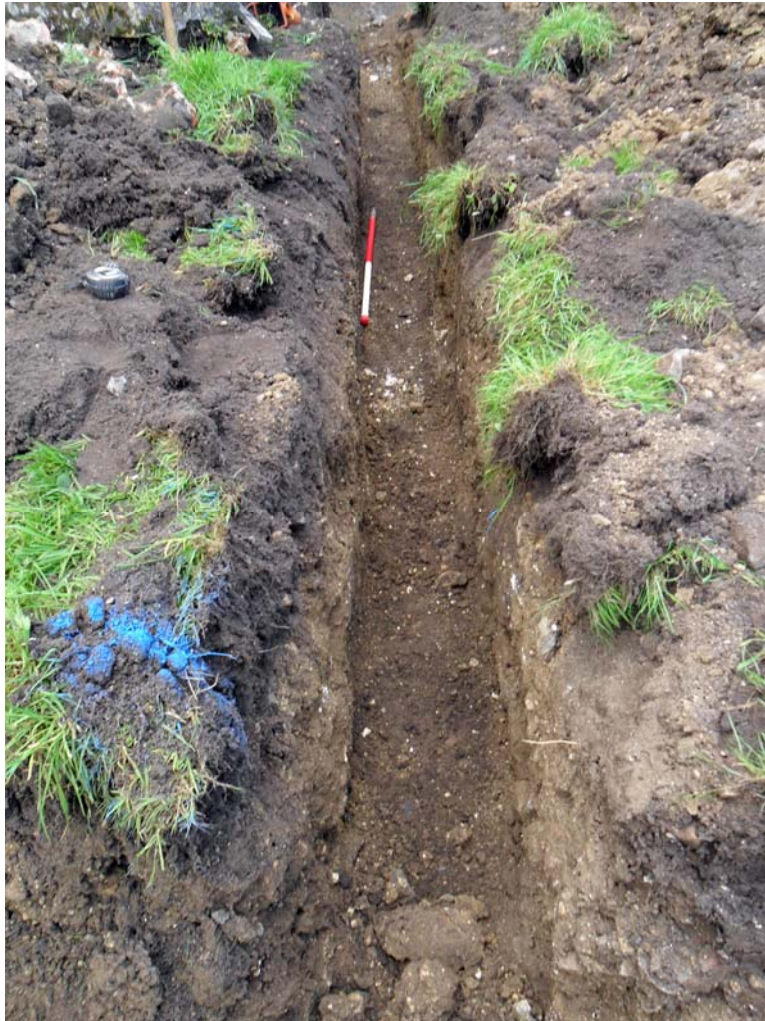
Plate 2. Trench 1

Trenches 1 and 2 (Plates 2 and 3) were approximately 0.80m wide and 0.80m deep and were excavated to connect the downpipes from the church roof to the new catchment pit (Trench 4). No archaeological features or deposits were encountered and no finds were recovered.

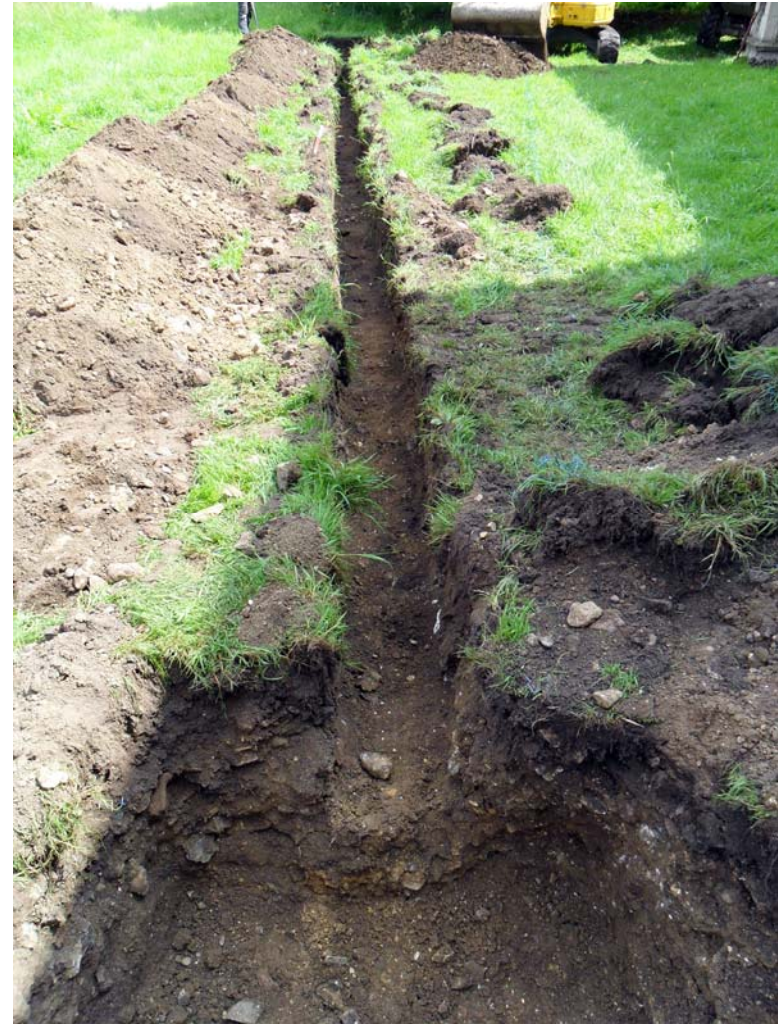
Plate 4. Trench 3

Trench 3 (Plate 4) was an east-west gully roughly 0.40m wide, excavated to connect the catchment pit to the new large soakaway (Trench 5). No archaeological features or deposits were encountered; however a small fragment of ceramic building material was recovered from graveyard deposit [4].

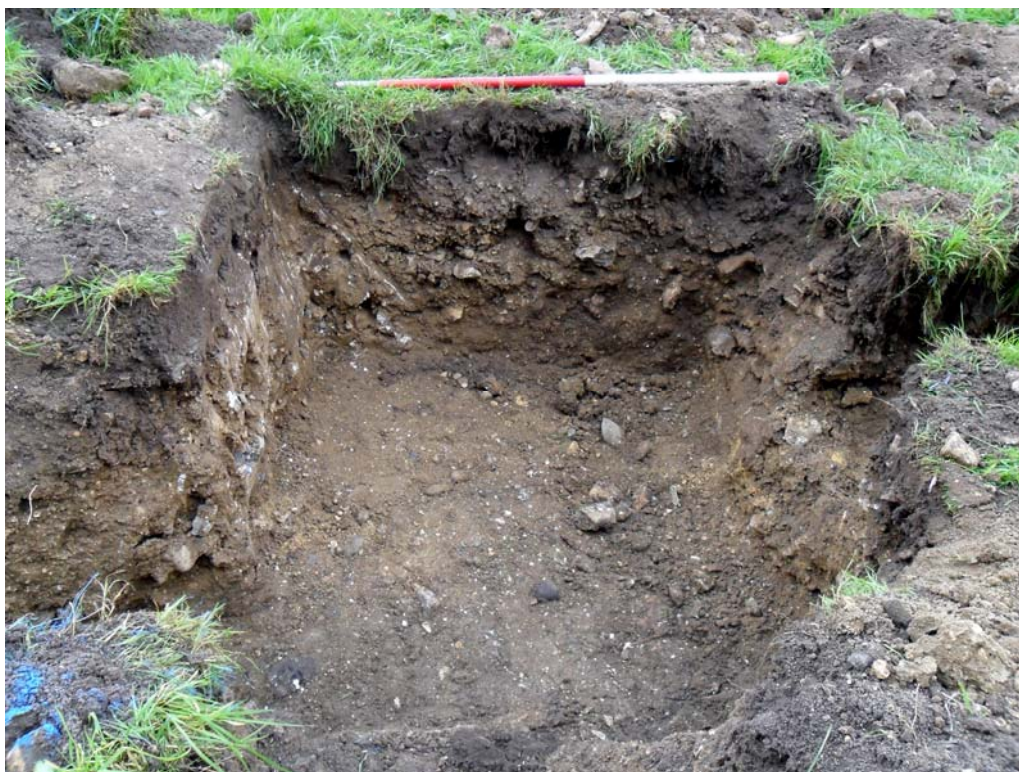
Plate 5. Trench 4

Catchment pit Trench 4 (Plate 5) measured 1.20m by 1.20m and was 1.20m deep. No archaeological features or deposits were encountered.

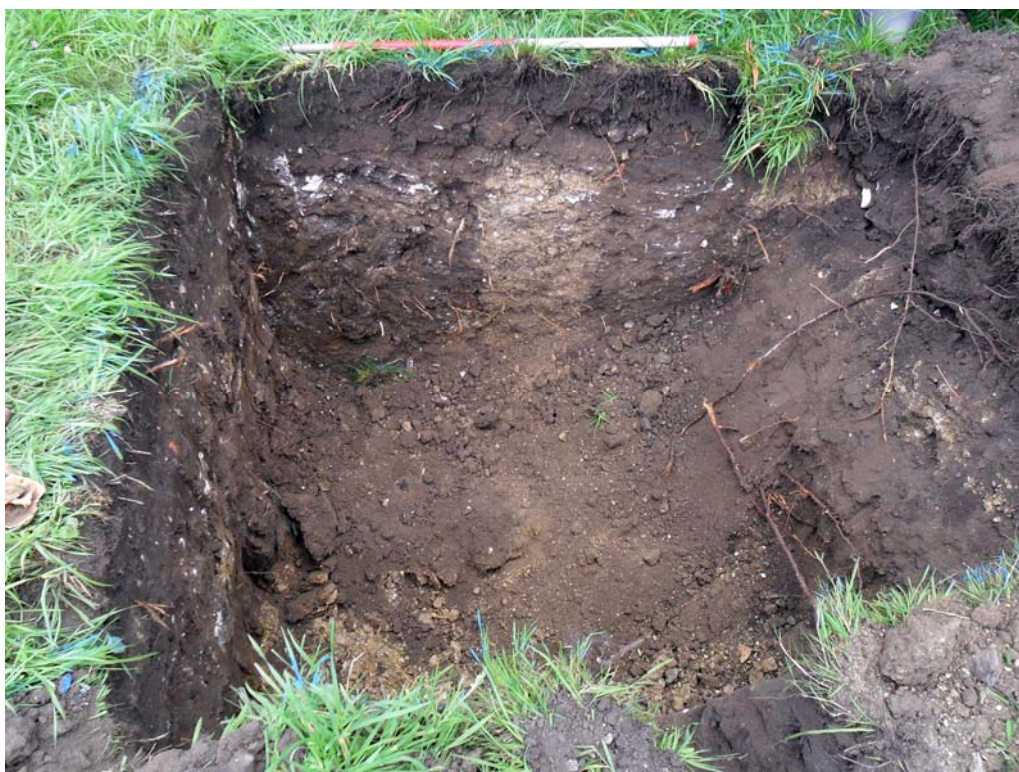
Plate 6. Trench 5

Trench 5 (Plate 6) was the one of two large new soakaways required for the new drainage system and measured 1.60m by 1.60m and was dug to a depth of 1.80m. At around 1.45m deep three features were encountered, all of which were grave cuts (Fig. 3).

Grave cuts [7] and [12] orientated east-west and containing adult remains were clearly visible in the eastern side of the trench. The third grave cut contained the remains of several disarticulated human skeletons [10].

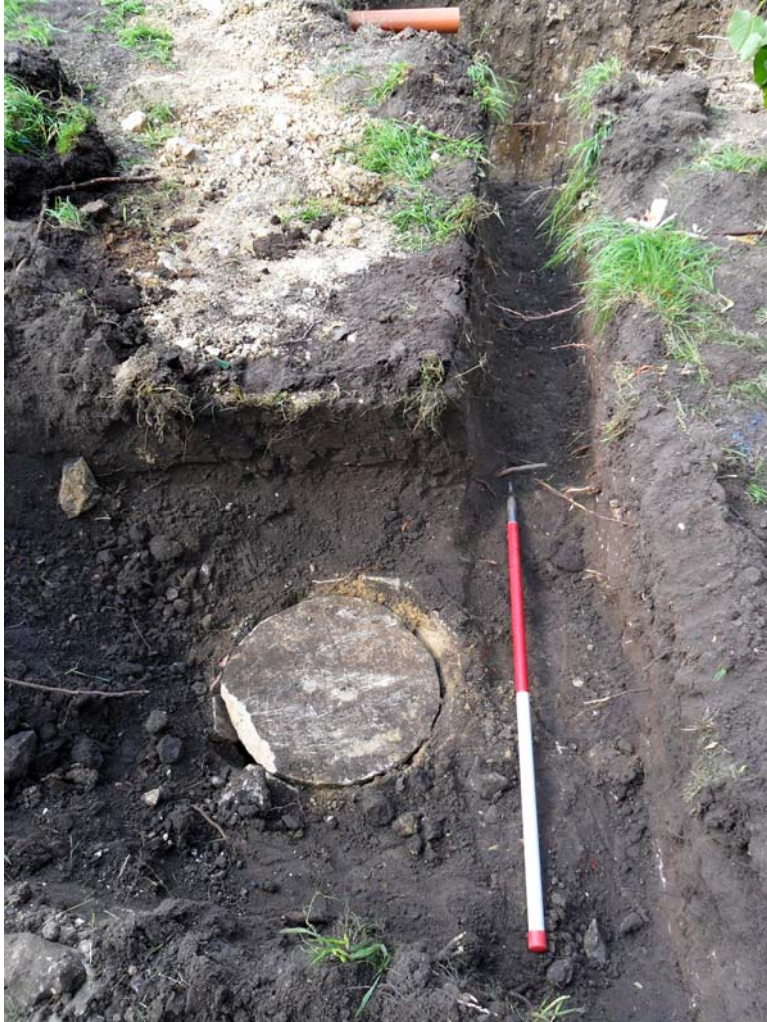
Plate 7. Trench 6 (showing old soakaway)

Trench 6 was excavated to link the downpipe from the far north-eastern corner of the church to the new soakaway, and also revealed an old soakaway from the original drainage system. This soakaway looked rather like a small well; it was round, approximately 0.50m in diameter and constructed of red and yellow bricks with a round cap (Plate 7). When this earlier drainage system was put in place, it evidently disturbed at least one burial, part of which still remained in this trench, represented by a disarticulated skull and a few limb bones (SK16), but no grave cut could be identified (Fig. 3 and Plates 8 and 9). The trench was originally 0.40m wide, 0.55m deep and 2m long but was subsequently extended to 1m square to reveal the full extent of the old soakaway.

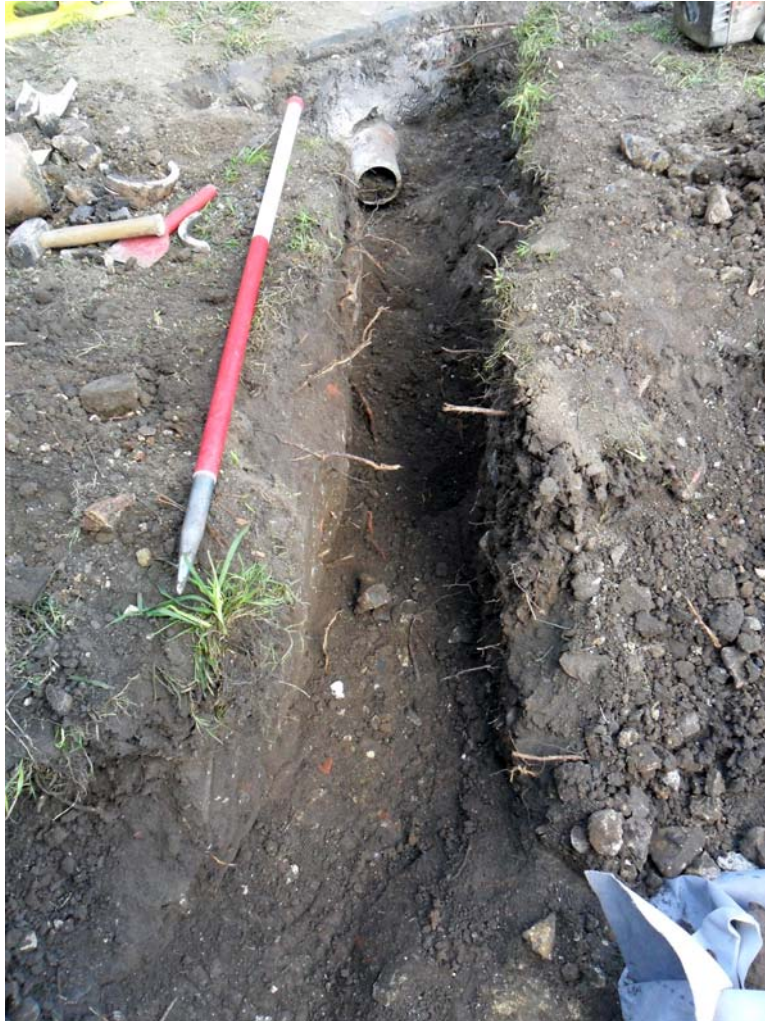
Plate 10. Trench 7

Trench 7 (Plate 10) was an additional trench excavated to locate a drain pipe that had emptied into the old soakaway. This trench was approximately 1.50m long, 0.40m wide and 0.50m deep. One disarticulated human bone fragment was recovered from graveyard deposit [18]. The graveyard deposit here was a dark-

grey silty-sand with frequent flint nodules, chalk pieces, red brick and tile pieces indicating that this area has been highly disturbed by the earlier drainage works.

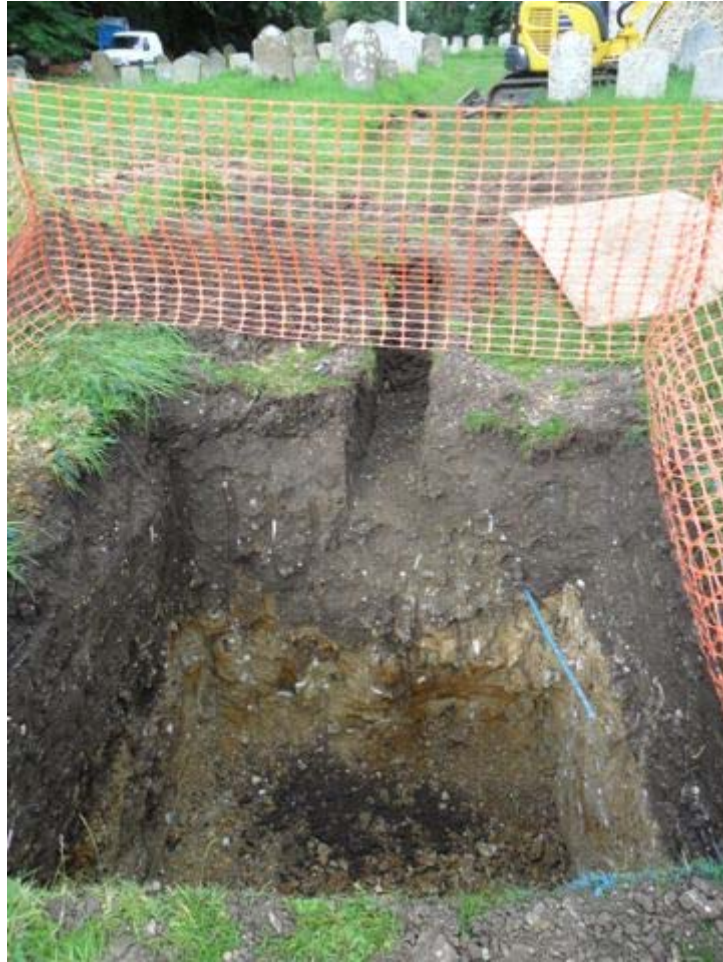
Plate 11. Trench 8

Trench 8 (Plate 11) was dug on the south-east side of the church to insert the second of the two new soakaways. The trench measured 1.60m by 1.60m square, and was excavated to a depth of 1.90m. Reburial of several individuals was identified within graveyard deposit [19] in this trench however; the graveyard deposit was of such a highly mixed and disturbed nature that no cut for this reburial could be identified (Fig. 3, Section 2). Beneath this deposit appeared to be a single grave containing the articulated bones of one adult (SK20) at approximately 1.40m deep, prone and orientated east-west (Plate 12). The remains were poorly preserved and no grave cut could be identified.

It was considered unsafe to enter the trench so the skeletal remains were recorded from the surface and lifted by machine.

On the north side of Trench 8 a modern water pipe was uncovered but no cut could be identified.

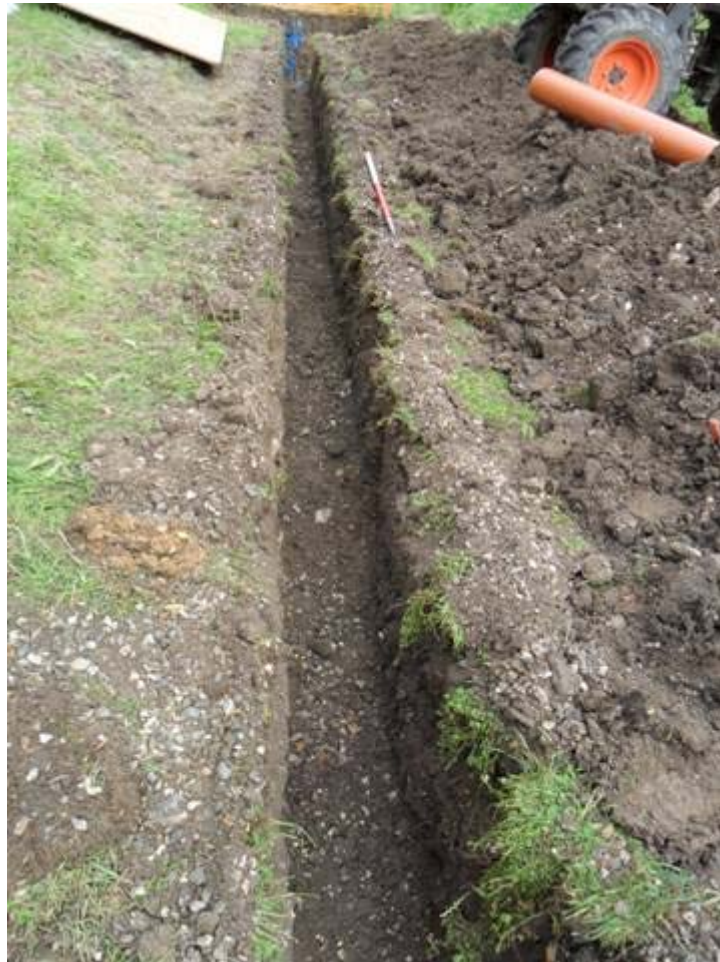
Plate 13. Trench 9

Trench 9 (Plate 13) was excavated to connect drains on the south side of the church to catchment pit Trench 8 (Fig. 2). This trench was 0.40m wide and excavated to a depth of 0.50m. Here, on the church pathway, the topsoil consists of a thin layer of rough grass over 0.10m of gravel and the graveyard deposit is a dark silty-sand layer of soft compaction.

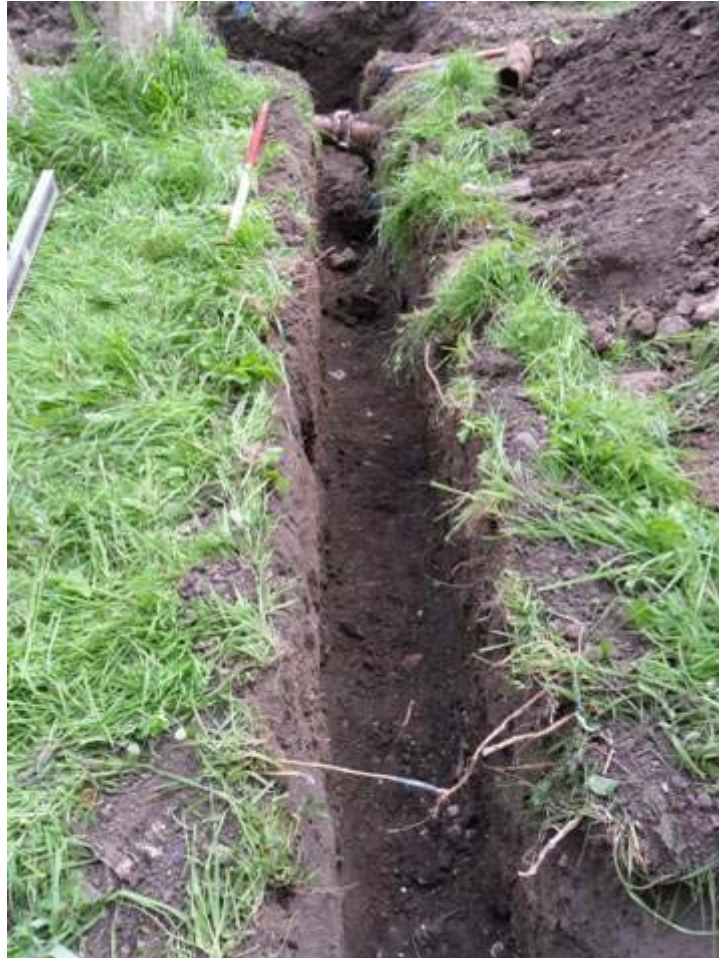
Plate 14. Trench 10

Trench 10 (Plate 14) was excavated to connect the downpipe on the south-eastern side of the church to catchment pit Trench 11. It was 0.40m wide, 0.50m deep and approximately 5m long.

This trench ran between two rows of three headstones, so the potential that human remains may be disturbed here was very high. However as the trench was fairly shallow no features were encountered and no remains were affected.

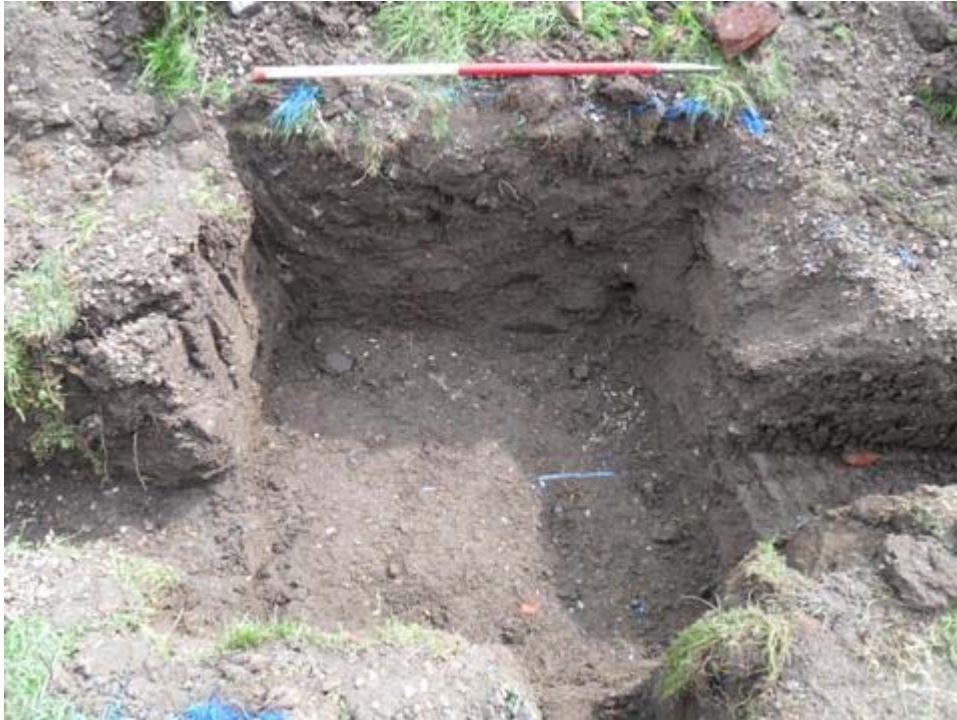
Plate 15. Trench 11

Trench 11 was a catchment pit (Plate 15) which measured 1.20m x 1.20m square and was 0.70m deep.

No archaeological deposits or features were encountered, and only one metal object, possible a piece of coffin furniture, was recovered from the deposit [23].

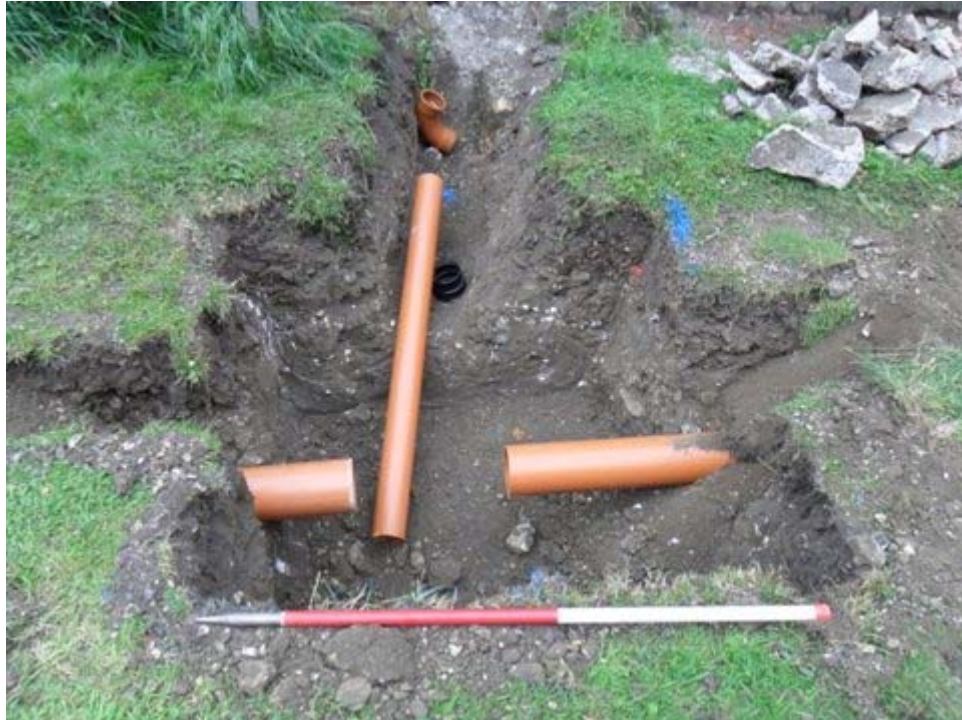
Plate 16. Trench 13

Trench 13 represents another catchment pit and a very short gully leading from a downpipe on the south side of the church (Fig. 2, Plate 16). The catchment pit measured 1.25m x 1.40m and was excavated to a depth of 0.80m.

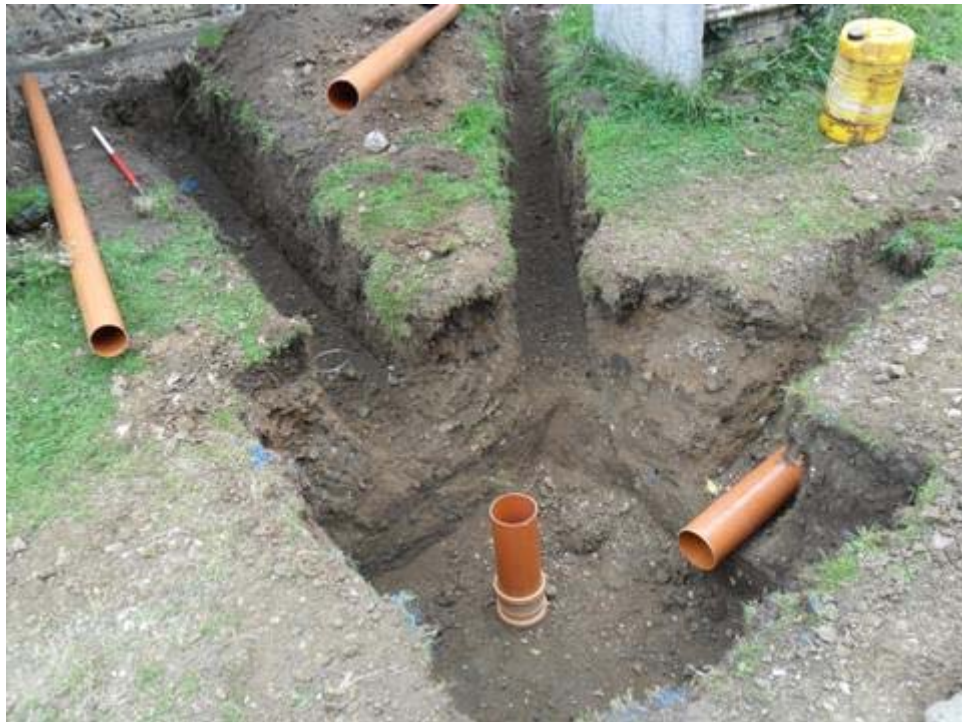
Plate 17. Trenches 14, 15, 16 and 17

Trench 15 (Fig. 2, Plate 17) was a catchment pit located on the church path, south-east of the church porch. It measured 1.50m by 1.30m and was excavated to a depth of 1.30m.

During excavation the disarticulated and fragmented remains of two individuals were found. It was clear from the skulls that one was an adult and one was a child, however, it was not possible to see a grave cut and the bones appeared to have come from the deposit [25].

Trenches 16 and 17 were both short gullies running from downpipes on the south side of the church into catchment pit Trench 15 (Fig. 2, Plate 17). They were approximately 0.40m wide, 3.80m long and 0.80m deep.

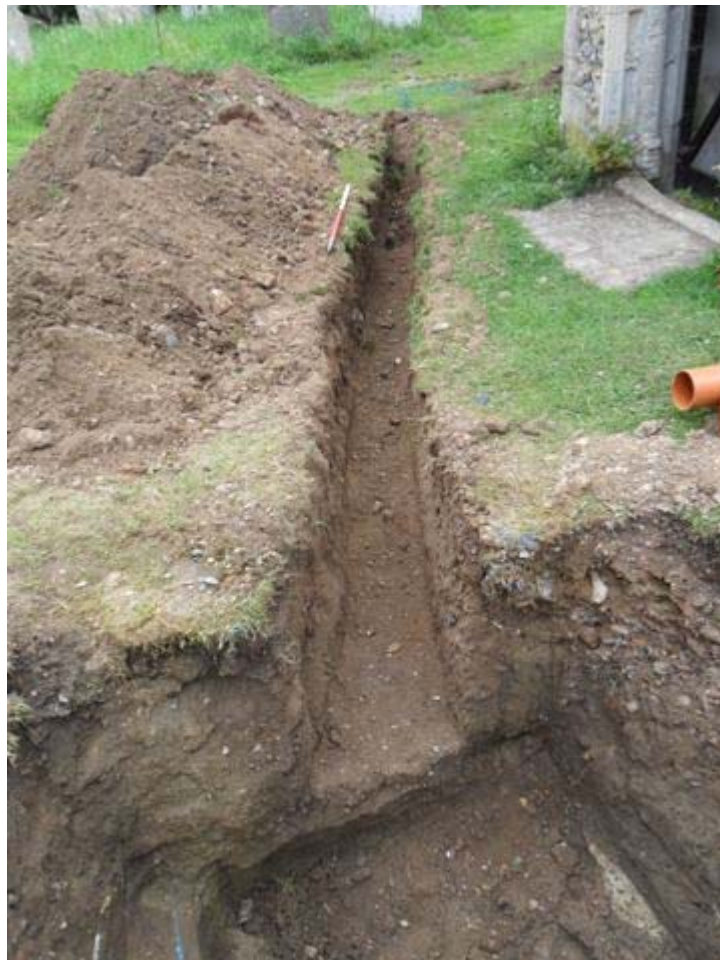
Plate 18. Trench 18

Trench 18 was a small gully measuring approximately 0.42m wide, 5.70m long and 0.70m deep linking catchment pits Trench 15 and Trench 21 across the front of the church porch (Plate 18). The graveyard deposit was a little different here, although it was a fairly loose dark silty-sand but with frequent flint nodules and large red brick pieces.

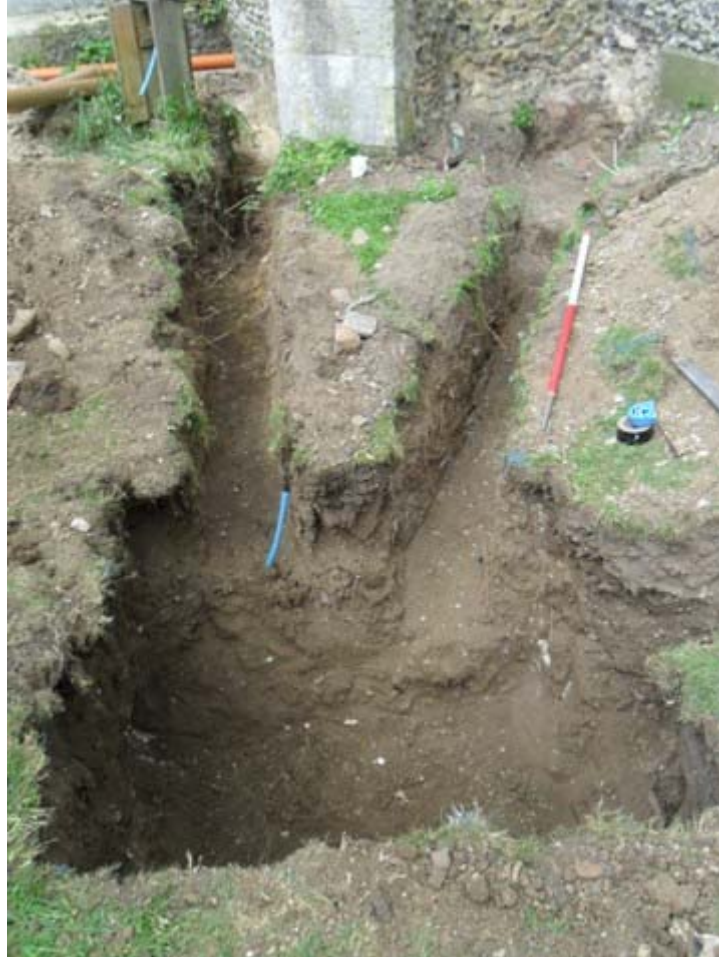
Plate 19. Trenches 19 and 20

Trenches 19 and 20 were two short gullies from the south of the church and the east of the porch to catchment pit Trench 21 (Fig. 2, Plate 19) and were approximately 0.40m wide and 0.70m deep. The area was highly disturbed by roots from the small tree that was removed prior to excavation.

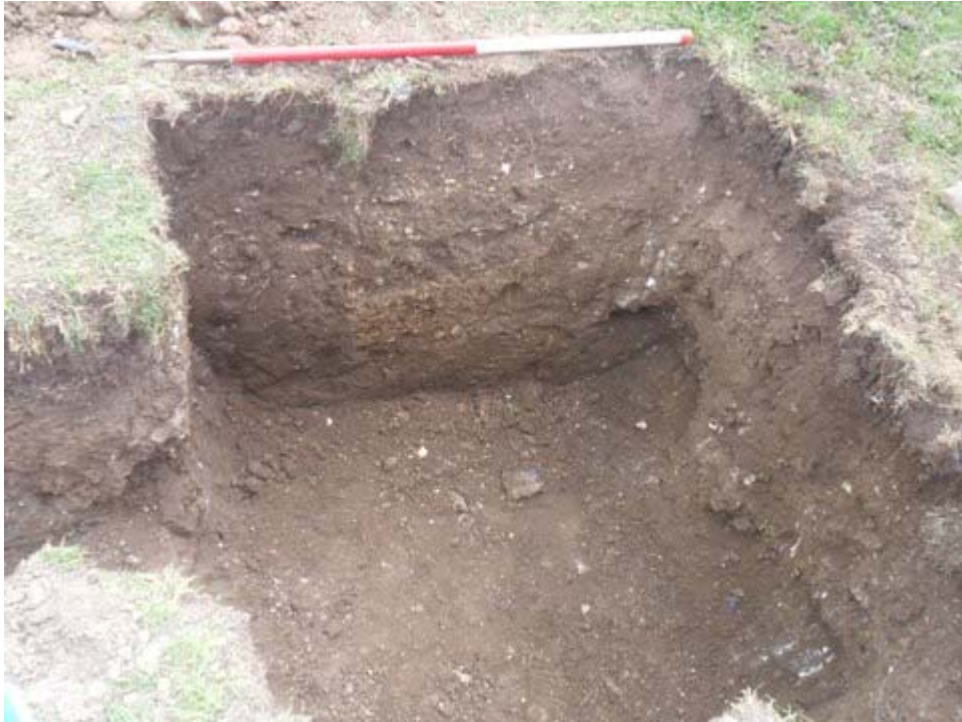
Plate 20. Trench 21

Trench 21 was the catchment pit located on the south-west side of the church opposite the tower (Fig. 2, Plate 20). It measured 1.20m by 1.20m and was excavated to a depth of 1.10m.

Some fragments of human bone was recovered from the graveyard deposit and one possible grave cut could be seen (Fig. 3 Section 3). It is possible that this grave may have been that of the burial associated of Gilbert Chauncey who died in 1928 and whose headstone was located close by (Plate 21).
