Report 2751

**Archaeological Watching Brief at
St James' Church, Great Ellingham, Norfolk**

ENF128170

September 2011

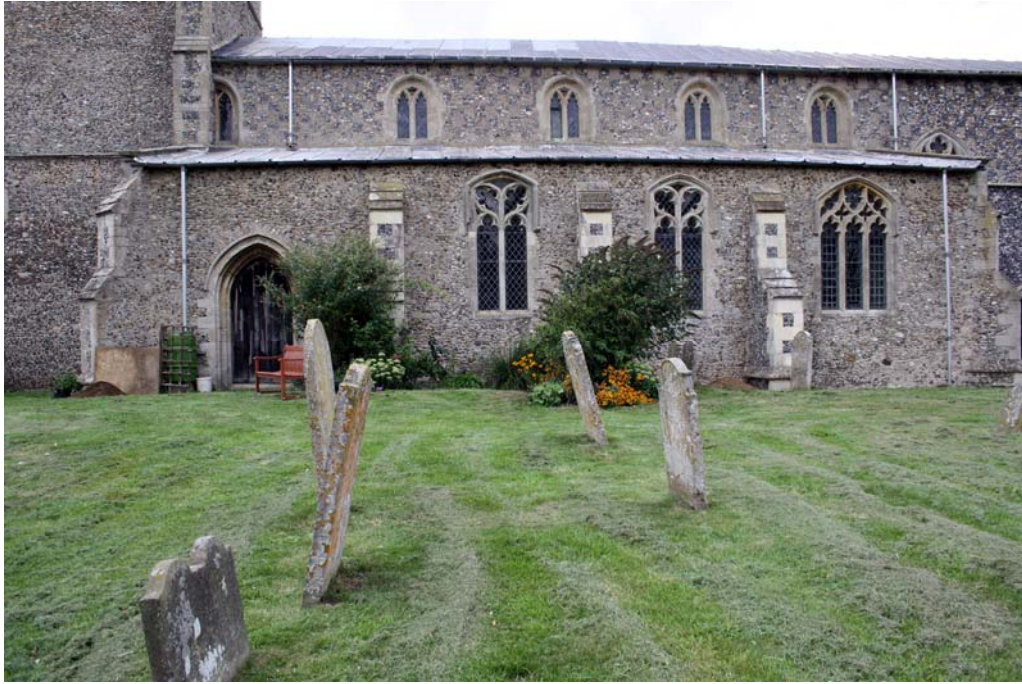
Three pits were located along the exterior of the south wall of the church (Fig. 2, Plates 1-4), all of a similar size i.e. between 0.5m and 1m long by 0.5m wide by c.0.6m deep.

Plate 1. General view of the south wall showing the positions of the three pits, looking north

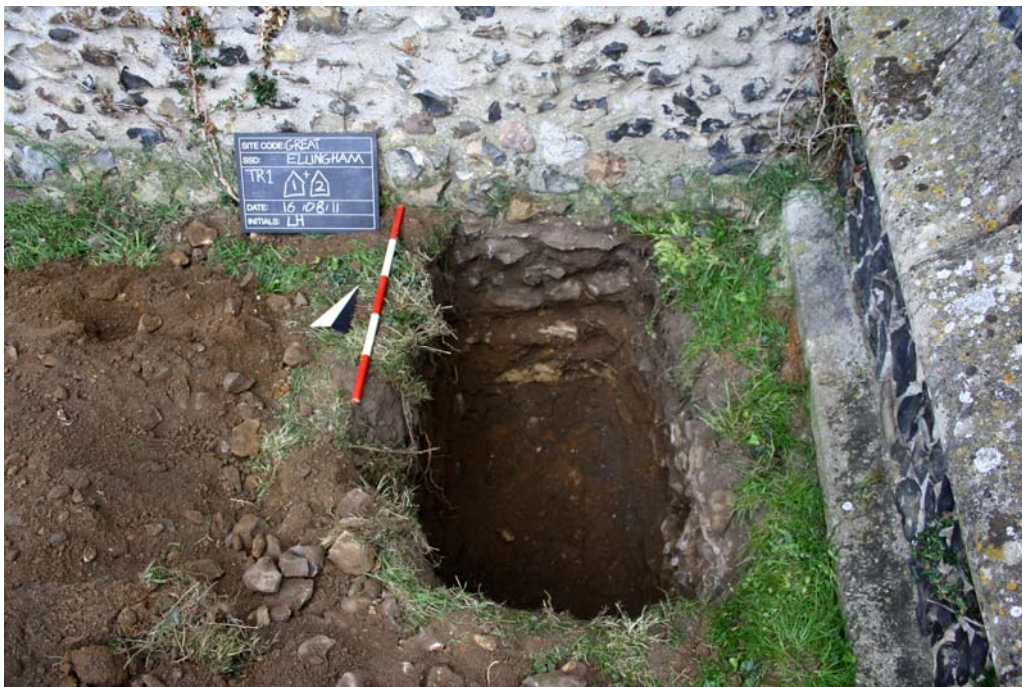
Pit 1 and Pit 3 were excavated through the turf and loose brown silty topsoil into the underlying orange brown sand natural. Pit 2 was dug in a small area of planting so no turf was present; this pit extended into the underlying sand.

The flint cobble foundation for the church was exposed in all three pits. The foundation projected c.0.15m from the external face of the wall, but was unremarkable in its construction.

Plate 2. Pit 1, looking north

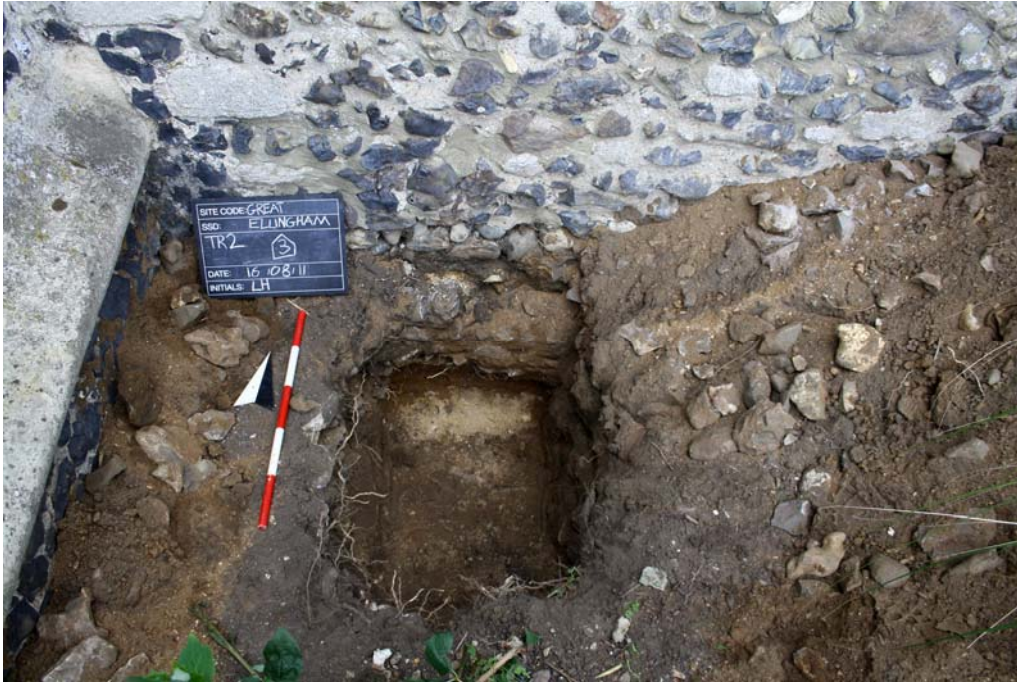
Plate 3. Pit 2, looking north

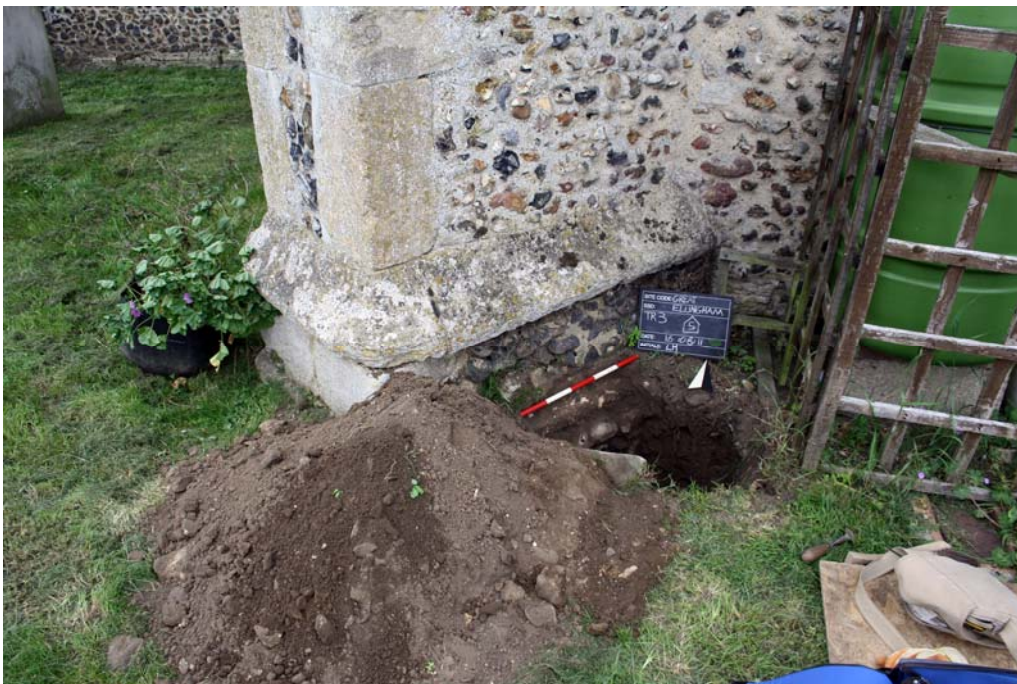
Plate 4. Pit 3, looking north

No other features or deposits of archaeological interest were present. One fragment of animal bone (not retained) was recovered from the topsoil in Pit 3.
