Archaeological Watching Brief along the route of a Replacement Gas Main, Cathedral Close, Norwich

ENF126797

Prepared for Morrison Utility Services c/o National Grid Gas Cadwell Lane Hitchin Hertfordshire SG4 0SL

April 2012

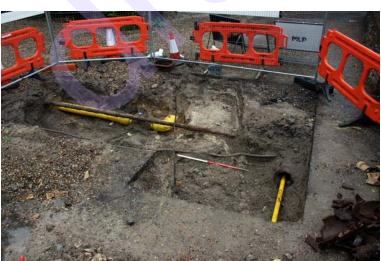
Plate 1. Trench A facing north

The earliest deposit encountered was a large patch of masonry [1] which appeared to have covered the whole area of the base of the trench, but had been heavily truncated by later services. It was composed mainly of medium sized flints with a small amount of brick and pegtile fragments held in a pale cream sandy mortar with frequent small flint pebbles. There was no sign of coursing and no finished faces were visible. Above this was a layer of loose masonry [7] which was probably the upper part of wall [1] loosened by excavation. Above this were four compacted layers ([3]-[6]). Layer [6] was 0.08m thick and was a compacted dark brown silty sand with moderate flint gravel, ceramic building material (CBM) and mortar fragments. Above [6] was layer [5], 0.04m thick, of compacted chalk with occasional pieces of CBM and flint gravel. Above that was layer [4], 0.05m thick and composed of a compacted dark brown silty sand with very frequent chalk and frequent numbers of CBM fragments. All these layers were truncated by 4-5 service trenches. The old gas pipe trench was excavated to a depth of 1.2m, finding wall [1] still present at the base. Above this was the levelling layer [3] for the tarmac road [2]. The levelling layer [3] was 0.07-0.14m deep, composed of heavily compacted mid-dark brown sandy clay with frequent flint gravel and occasional CBM fragments. Above this was the modern tarmac road surface [2] which was 0.1m thick.

The stratigraphy seems to suggest the presence of massive, probably medieval masonry, which was levelled and cut down to a flat formation level before the deposition of heavily compacted layers of soil and rubble, probably associated with the road of 1830.

The large, probable medieval wall [1] suggests the presence of a large medieval building on this site, but identifying this building is difficult. The closest extant medieval buildings are the Sextry and the Sextry gatehouse just to the west. It is possible that it may be associated with the early precinct wall which ran along the southern side of Bishopgate and continued eastwards towards the Bishops Palace (see Fig. 4 in Gilchrist 2005). Cleer's map of 1696 (Cleer 1696) shows a building in approximately the position of this trench, but the quality of the surveying is questionable. Hochstetter's map of 1789 (Hochstetter 1789) appears to be more accurate and shows the area as open ground/road.

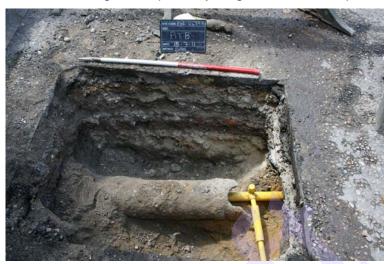
Plate 2. Trench B facing west

Most of the trench only encountered the backfill of the service trench for the old gas pipe, but the western edge was partially dug into earlier deposits.

The earliest deposit encountered at the base of the trench was [10] a dark greyish brown silty sand with occasional pieces of flint gravel, mortar flecks and rare occurrences of pegtile fragments. Above this was wall [9], 0.17m in depth and composed of frequent flints with occasional pegtile fragments within a pale cream sandy mortar with occasional pieces of fine flint gravel. There were no visible faced edges and no indication as to its alignment. Like in Trench A, above this wall were a number of compacted layers underlying the modern tarmac road surface. Above wall [9] was layer [11], 0.08m thick, composed of compacted dark brown silty sand with moderate CBM fragments and flint gravel. Above [11] was layer [12] was 0.03m thick and composed of compacted pale cream mortar fragments with occasional CBM fragments. Above this was layer [13] which was 0.09m thick but otherwise the same as layer [11]. Above that was layer [14] a 0.02m thick layer of gravel hoggin providing a bedding for the tarmac layer [2] above.

The stratigraphy of this trench told a similar story to that observed in Trench A - a medieval or post-medieval masonry structure being reduced to a formation level in 1830 for the construction of the road. What this masonry structure was is impossible to say, but the presence of soil below wall [9] containing pegtile fragments suggests a late medieval or post-medieval date.

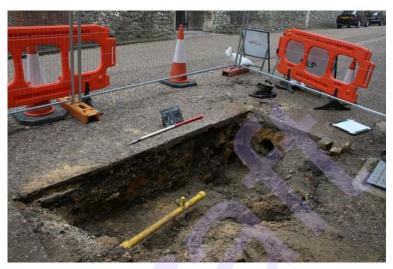
Plate 3: Trench C facing northwest

A dark brown soil backfill was visible, along with three service pipes. However a masonry structure [15] was visible at the base of the north end of the trench. This was unmortared and constructed of reused brick and limestone and was aligned west-north-west to east-south-east. It was probably a rough drain and the use of reused 2½ inch brick suggests a modern date. It had been truncated by the old steel gas pipe.

Drain [15] was modern in date and was probably associated with surface water drainage.

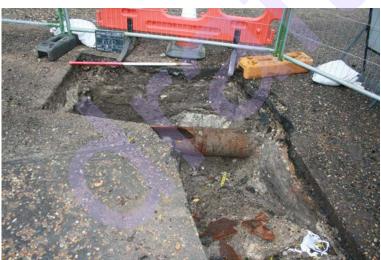
Plate 4. Trench D facing west

At the northern corner, the visible archaeology consisted of layer [20] at the base, a dark brown silty sand with occasional CBM, mortar and charcoal flecks. Above this was wall [19], 0.15m deep and composed of medium sized flints in a pale cream sandy mortar. No finished faces were visible so its alignment was not apparent. Above this were the layers of compacted road material seen in trenches A and B. Layer [18] was above wall [19] and was 0.03m thick, composed of compacted dark greyish brown silty sand with occasional charcoal flecks and flint gravel. Above this was layer [17], a 0.02m thick layer of compacted pale cream mortar fragments with occasional flint gravel and CBM fragments. Above layer [17] was layer [16], a 0.12m thick layer of compacted dark greyish brown silty sand with moderate CBM fragments, charcoal and mortar flecks and occasional flint gravel. The tarmac road surface [2] was above that.

A small patch of wall was visible on the southern edge of the trench. This was the same wall as that seen in a watching brief in 2008 (Wallis 2008, Trench 13), possibly dated as medieval.

The two walls noted were from different structures and their dating must remain undetermined.

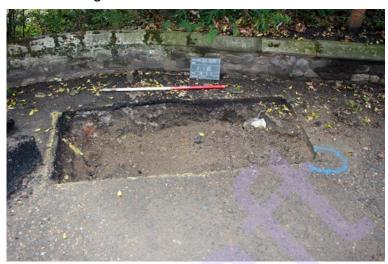
Plate 5. Trench E facing east

Trench E measured 2.04m long north-east to south-west and 1.14m wide north-west to south-east.

It was backfilled prior to recording, but no archaeological features had been observed whilst it was being excavated.

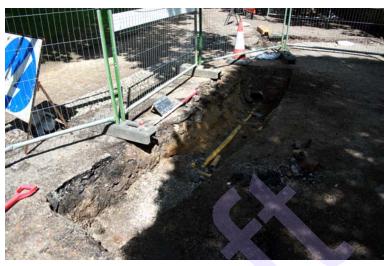
Plate 6. Trench F facing north-east

The only deposits encountered were service trench backfills.

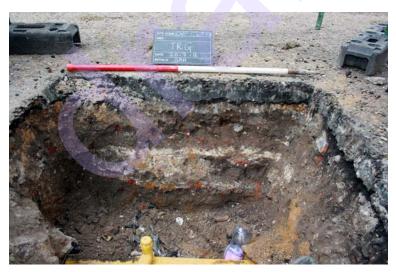
Plate 7. Trench G facing west

It is possible that [23] represents a wall robbed-out before the road was built in 1830.

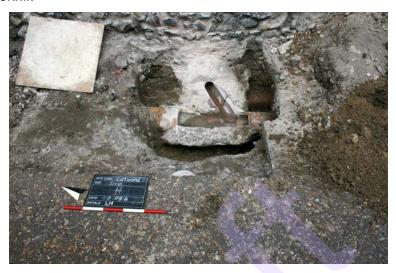
Plate 8. Trench H facing east

It was excavated to locate and repair a sewer pipe. It measured 1.16m long north to south, 0.98m wide east to west and 0.65m deep (Fig. 9) and was dug through a mixed soil backfill.

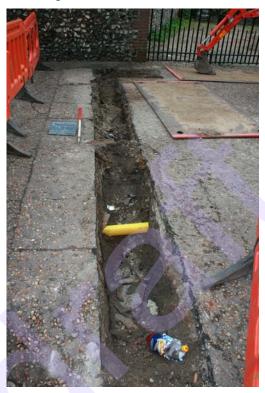
Plate 9. Trench I facing south

Beneath 0.14m of tarmac and hoggin, soil layer [27] was encountered. It was a dark brown silty sand with moderate flint gravel and occasional mortar, oyster, CBM and charcoal. There were several service runs present, but it was impossible to define the service trench edges.

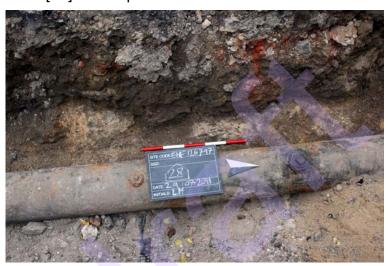
Plate 10. Trench J facing west

Again, most of the trench was cut through service trench backfill deposits, but some earlier stratigraphy was present on its western edge. The earliest deposit was wall [28], a masonry foundation of pale cream sandy mortar with occasional chalk flecks, containing moderate small to medium sized flints at a depth of 0.55m below ground level. Above this was deposit [34], a mixed dark brown silty sand with occasional flint gravel and CBM fragments, with 0.05m of tarmac [2] above that.

The purpose of wall [28] was impossible to define.

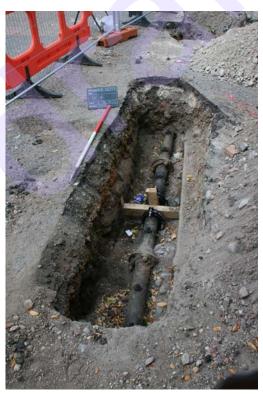
Plate 11. Trench K facing west

Most of the deposits encountered were the backfill of the trenches of the two steel service pipes present, but some earlier stratigraphy was visible on the southern edge of the trench. At a depth of 0.4m was soil layer [33], a dark brown silty sand with occasional flint gravel and rare flecks of mortar and CBM fragments. This was thought to be a buried soil. Above that was layer [32], a compacted 0.16m thick layer of yellowish brown flint gravel. Above [32] was [31], a 0.17m thick layer of compacted pale grey silty clay with frequent flint pebbles, with 0.07m of tarmac [2] road surface above that.

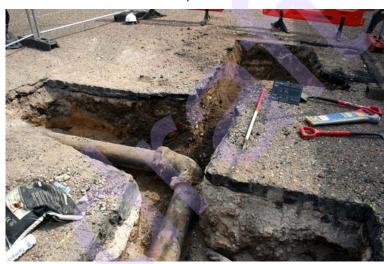
Plate 12. Trench L facing east

Trench L was located at the south-western corner of the Lower Close (Fig. 2). It was 5m long east to west, 3.7m north to south and 0.64m deep (Fig. 12). Again most of the deposits encountered were service trench backfills, but there was a small island of earlier stratigraphy at the eastern end of the trench consisting of soil [30] and foundation [29].

Soil deposit [30] was a dark brown sand with frequent flint gravel, occasional CBM fragments and one clay tobacco pipe stem fragment. Cutting this layer was foundation [29] a banded foundation 0.4m wide, aligned east to west. It was composed of alternate bands of compacted brick and pegtile fragments in powdered mortar, and compacted soil (dark brown silty sand with frequent flint gravel).

Wall foundation [29] may be connected with garden walls belonging to the building which is now known as 64 Cathedral Close, seen on Cleer's and Hochstetter's maps (Cleer 1696 and Hochstetter 1789).

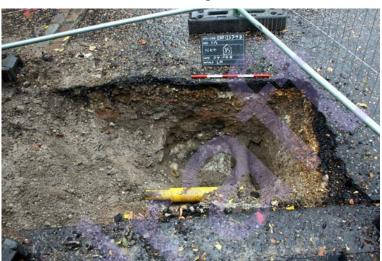
Plate 13. Trench M facing west

The trench encountered mostly service trench backfill deposits, but present on the eastern side of the trench was a patch of earlier stratigraphy. The earliest deposit seen was masonry [35] composed of creamy mortar containing rare fragments of flint and animal bone. This was probably a foundation. Above this was layer [39], a 0.4m thick layer of mid grey material containing occasional flint gravel and mortar flecks. Cutting through these deposits was modern service trench [36], aligned east to west with a depth of 0.7m. Its fill [37] was of pale grey material with occasional flint gravel and mortar flecks. Above all these deposits was a layer of gravel ([38] and [40]), providing bedding for tarmac surface [2].

Wall [35] may have been an earlier form of garden wall for the Deanery.

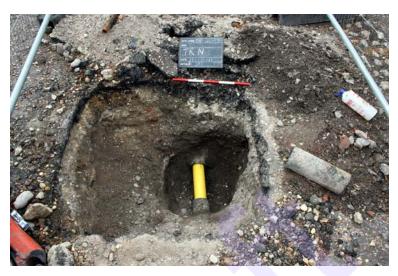
Plate 14. Trench N facing west

Trench N was located in the road on the north side of the Lower Close, outside 56 Cathedral Close (Fig. 2). It was 1.1m long north to south, 1.06m wide east to west and 0.8m deep (Fig. 14).

The only deposits encountered beneath the road surface were service trench backfills.

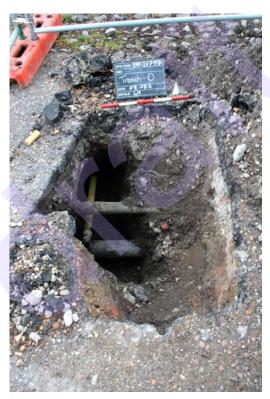
Plate 15. Trench O facing north

The chalk floor surface and layer of compacted fire debris suggest the presence of a structure.

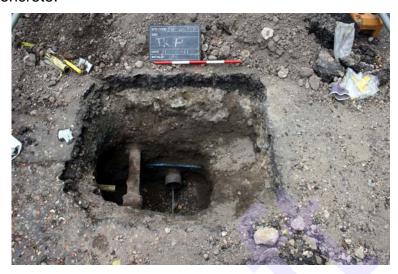
Plate 16. Trench P facing east

Trench P was located in the road on the north side of the Lower Close, outside 54 Cathedral Close (Fig. 2). It was 1m long (north to south), 0.91m wide (east to west) and up to 0.95m deep (Fig. 16).

The only deposits encountered were service trench backfills beneath 0.25m of tarmac and concrete.

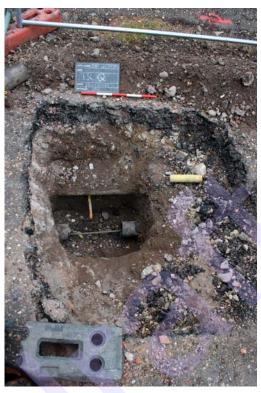
Plate 17. Trench Q facing north

Trench Q was located outside the front garden of 53 Cathedral Close (Fig. 2). It was 1.4m long north to south, 1.3m wide east to west and a maximum of 0.85m deep (Fig. 17).

The only deposits encountered were service trench backfills below 0.17m of tarmac and gravel.

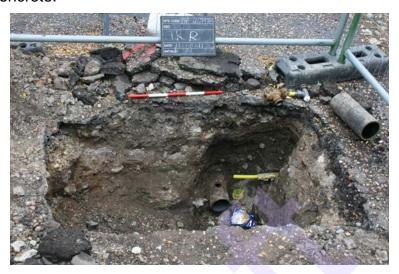
Plate 18. Trench R facing west

Trench R was located outside the front garden of 53 Cathedral Close (Fig. 2). It was 1.35m long north to south, 0.84m wide east to west and a maximum of 0.86m deep (Fig. 18).

The only deposits encountered were service trench backfills below 0.16m of tarmac and concrete.

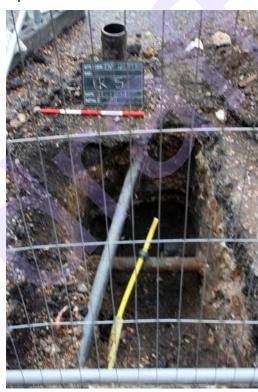
Plate 19. Trench S facing south

The earliest deposit [41] was a dark brown silty sand with occasional flint gravel, but no CBM fragments, which perhaps indicates a very early date. Above this was layer [42], a 0.06m thick layer of compacted mortar fragments which may have been an internal floor. Above [42] was layer [32], a 0.04m thick layer of dark brown silty sand with rare fragments of CBM and flint gravel. Above this was [44] a 0.09m thick layer of loose pale cream sandy mortar with moderate flint gravel and rare occurrences of CBM. Layer [45] was a 0.4m thick layer of dark brown silty sand with frequent CBM fragments, occasional mortar fragments and sparse flint gravel. Above this was tarmac deposit [2].

Like Trench O, the presence of a chalk floor layer seems to suggest that buildings were present within the open area of the Lower Green.

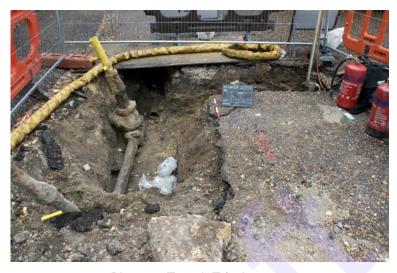
Plate 20. Trench T facing east

Trench T was located in the north-eastern corner of the Lower Close, adjacent to the entrance to Hook's Walk (Fig. 2). It was 3.74m long east to west, 3.1m wide north to south and a maximum of 0.85m deep (Fig. 20).

The only deposits encountered were service trench backfills for the three services visible.

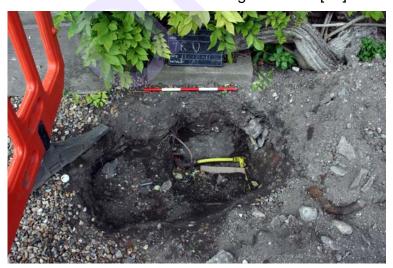
Plate 21. Trench U facing north

Trench U was located within the front garden of 53 Cathedral Close (Fig. 2). It was 0.71m wide east to west, 0.6m wide north to south and a maximum of 0.57m deep (Fig. 21).

The only deposit encountered was the modern garden soil [50].

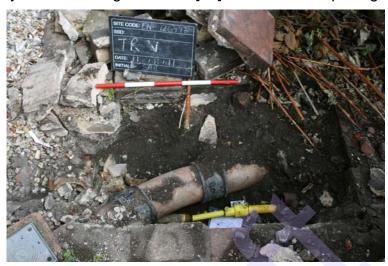
Plate 22. Trench V facing east

Trench V was located within the front garden of 55 Cathedral Close (Fig. 2). It was 1.06m long north to south, 0.52m wide east to west and a maximum of 0.32m deep (Fig. 22).

The stratigraphy consisted of garden soil [50] below modern paving.

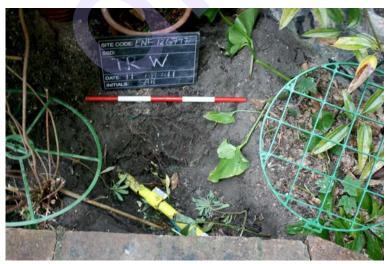
Plate 23. Trench W facing southwest

Trench W was located within the front garden of 52 Cathedral Close (Fig. 2). It was 0.58m long north to south and 0.53m wide east to west (Fig. 23).

The only deposit encountered was dark greyish brown silty sand garden soil [50] containing occasional pieces of flint gravel, chalk flecks and sparse CBM fragments.

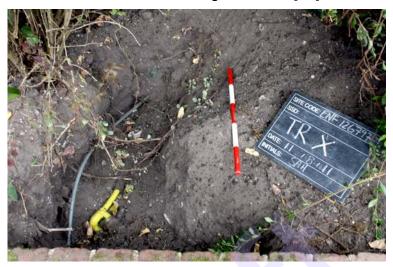
Plate 24. Trench X facing north

Trench X was located within the front garden of 52 Cathedral Close (Fig. 2). It was 1.16m long north to south, 0.57m east to west and 0.4m deep (Fig. 25).

The only deposit encountered was modern garden soil [50].

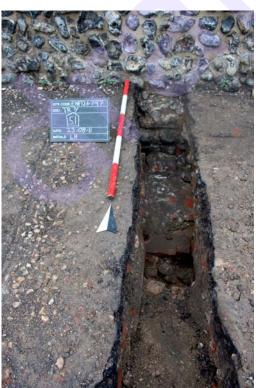
Plate 25. Trench Y facing north

At the base of the trench was the top of a culvert [51] while the northern end of the trench was up against a modern garden wall [64] and its possibly earlier foundations [52].

Culvert [51] was aligned east to west and was c.0.63m wide. Only the top was seen, but it appeared to have an arched roof, constructed of red brick bonded with white lime mortar. Above this was layer [56], a 0.38m thick layer of mid brown silt

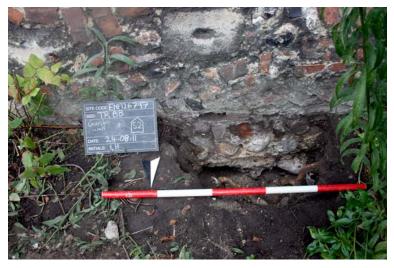
Plate 26. Trench BB facing south

Also present was garden soil [54] which was later in date than wall [52].

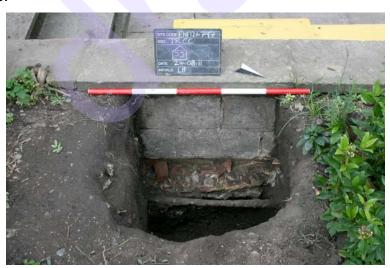
Plate 27. Trench CC facing west

The only archaeologically significant deposit was layer [63] which may have been a floor surface.

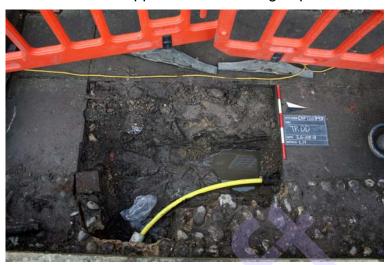
Plate 28. Trench DD facing vertically

Trench DD was within the footpath leading to 67 and 67a Cathedral Close (Fig. 2). It was 1.25m long north to south, 1.02m wide east to west and 0.36m deep (Fig. 27).

The only deposits encountered appear to be levelling deposits for the garden path.

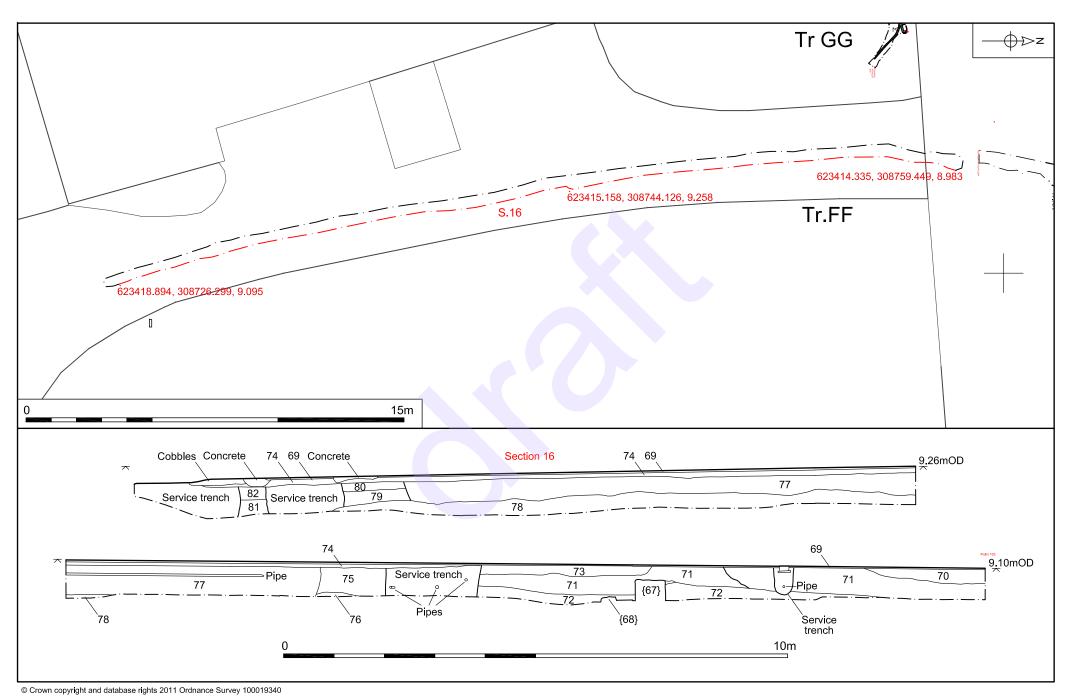
Figure 29. Trench FF, plan and section. Scale 1:150 and 1:75

There were two more 'islands' of undisturbed archaeology further north along the trench. The first was 1.3m wide, consisting of layer [78] at the base, with layer [79] above it. This was 0.3m thick and composed of a pale greyish brown silt with chalk, charcoal and brick flecks. Above this was layer [80] which was 0.18m thick and composed of white mortar fragments with fragments of red brick. The second (and most northerly) was composed of layer [81] at the base which was a mid brown silt. Above that was 0.25m-thick layer [82], a mid greyish brown silt with moderate CBM and mortar. This deposit was sealed by layer [74].

The most significant features found were the two walls ([67] and [68]) which may represent an old property boundary. The other deposits appeared to be old garden soils and deposits of demolition waste.

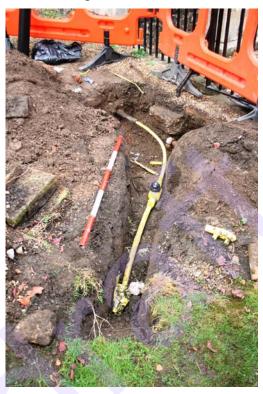
Plate 30. Trench GG facing north-west

The deposits encountered were predominantly service trench backfills, but a small amount of earlier stratigraphy was present on the northern side of the trench. Deposit (83) was present below a depth of 0.22m and was a mid greyish brown sandy silt with mortar and CBM fragments.

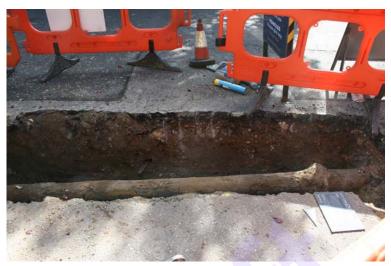
Plate 31. Trench HH facing south

Trench HH was located to the east of St. Ethelbert's Gate (Fig. 2). It was 3.4m long east to west, 1m wide north to south and 0.56m deep (Fig. 30).

The only deposits encountered were service trench backfills.

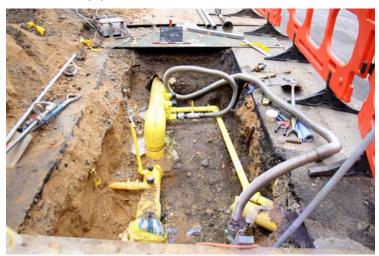
Plate 32. Trench QQ facing west

Trench QQ was 3.1m long east to west, 1.6m north to south and 1.1m deep. It was located within Tombland, just to the west of St. Ethelbert's Gate (Fig. 2).

The only deposits encountered were clean sand and brown soil service trench backfills for the six service pipes encountered.

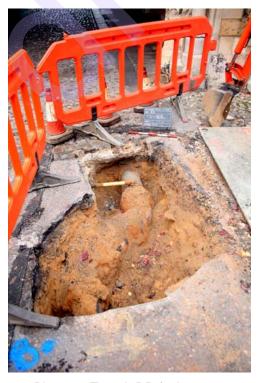
Plate 33. Trench RR facing west

Trench RR was located within the Upper Close, just to the east of St. Ethelbert's Gate (Fig. 2). It was 1.68m long east to west, 1.4m wide north to south and 0.7m deep (Fig. 30).

The only deposits encountered were service trench backfills.

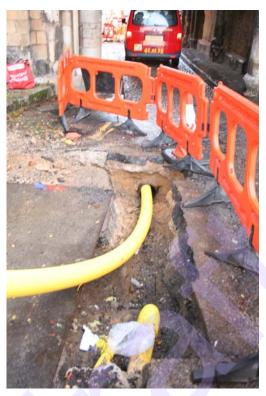
Plate 34. Trench SS facing west

Trench SS was located to the west of the St. Ethelbert Gate (Figs 2 and 31).

No significant archaeological deposits were encountered, only service trench backfills.

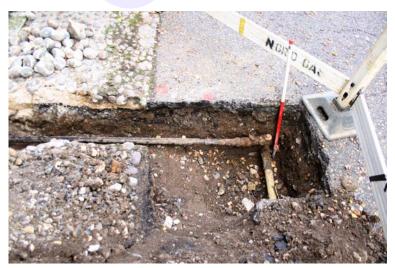
Plate 35. Trench TT facing north

Trench TT was located outside number 74 Cathedral Close and was 2.5m long east to west, 0.92m wide north to south and 0.7m deep (Figs 2 and 32).

The only deposits encountered were service trench backfills.

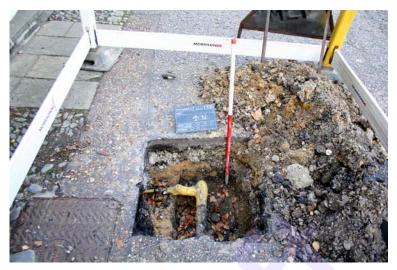
Plate 36. Trench UU facing north

Trench UU was located outside number 72 Cathedral Close and was 0.7m long north to south, 0.7m wide east to west and 0.48m deep (Figs 2 and 33).

The only deposits encountered were service trench backfills.
