Report 2908

Archaeological Assessment of 2 Church Farm Cottages, Mill End, Gayton, Norfolk

January 2012

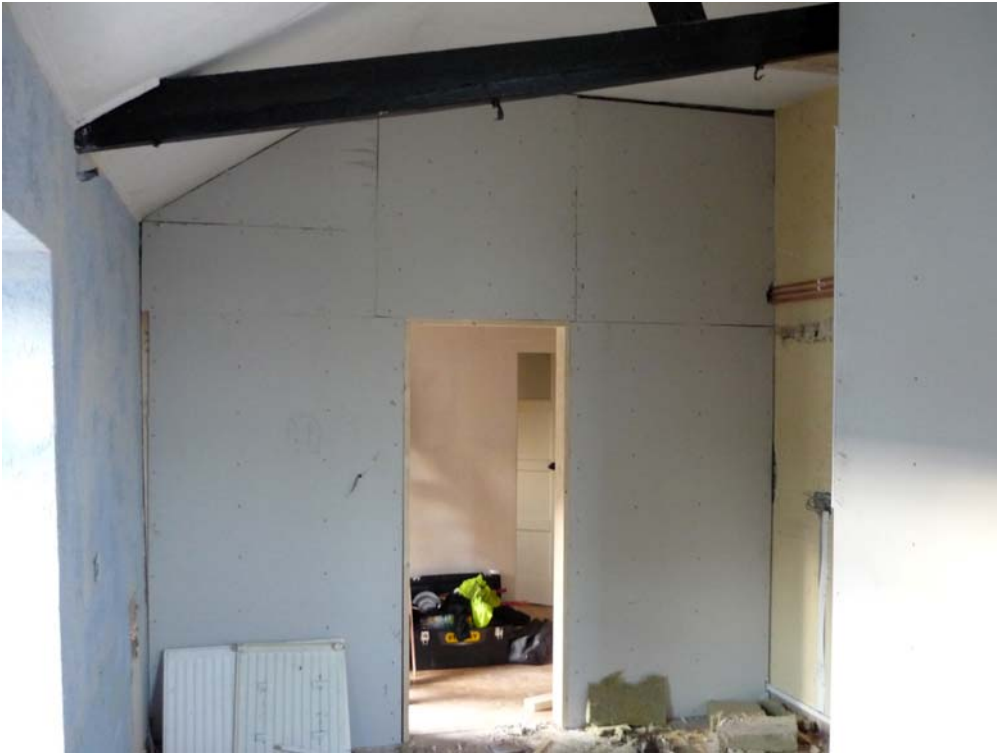
The removal and rebuilding of the kitchen wall will have little impact on the interior of the building as it maintains the existing downstairs layout (Plate 1).

Plate 1. The new stud and plasterboard north-east wall in the kitchen.

The removal and rebuilding of the kitchen wall has had no significant impact as the wall it replaced was of no great architectural value and it has been rebuilt in the same position, so the layout and proportions have been maintained.

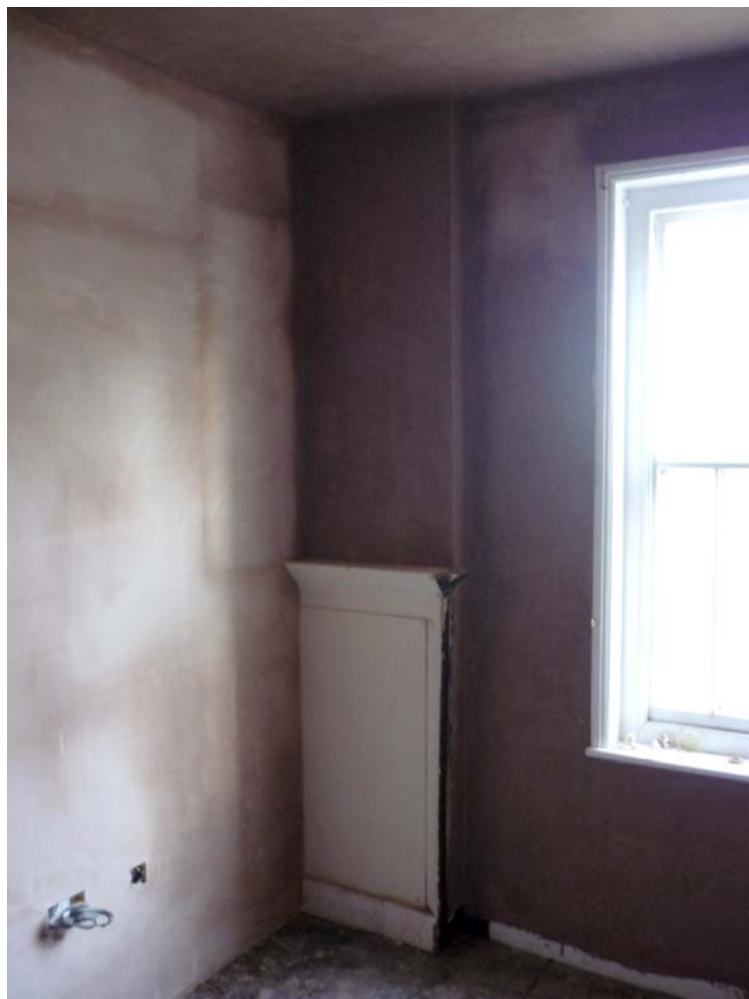
The impacts are perhaps greater upstairs where the new wall between Bedrooms 1 and 2 is constructed halfway along the chimney breast and has been constructed over the existing wooden fire surround and mantelpiece (Plates 2 and 3).

Plate 2. Bedroom 2 showing the repositioned wall splitting the chimney breast and fireplace.

The repositioning of the wall between Bedrooms 1 and 2 and the construction of an *en suite* bathroom in Bedroom 1 have greater implications because they have affected the layout of the upstairs rooms, although that layout itself was a modern development. The removal of the existing wall was of no consequence as it was a modern stud wall, but the replacement wall has been relocated midway along the chimney breast, reducing the size of Bedroom 1 and enlarging Bedroom 2. This has split the principal architectural feature in the room (the chimney and its wooden surround and mantelpiece) in half, with only the bisected feature in Bedroom 2 visible as the part in Bedroom 1 is located within the proposed new *en suite* bathroom.

However, the new walls are plasterboard stud walls, so the changes are reversible if required. Therefore, it is considered that the proposals will have no long-term impact on the interior of the building.

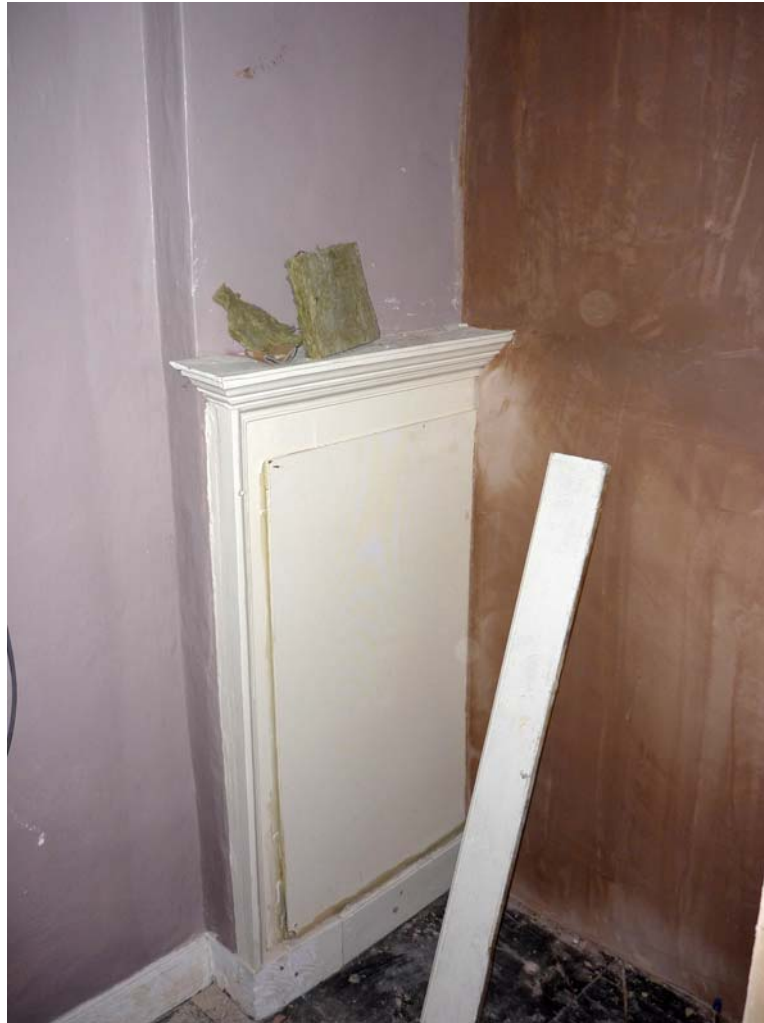
Plate 3. Half of the upstairs chimney breast and fireplace in the new *en suite* bathroom of Bedroom 1.

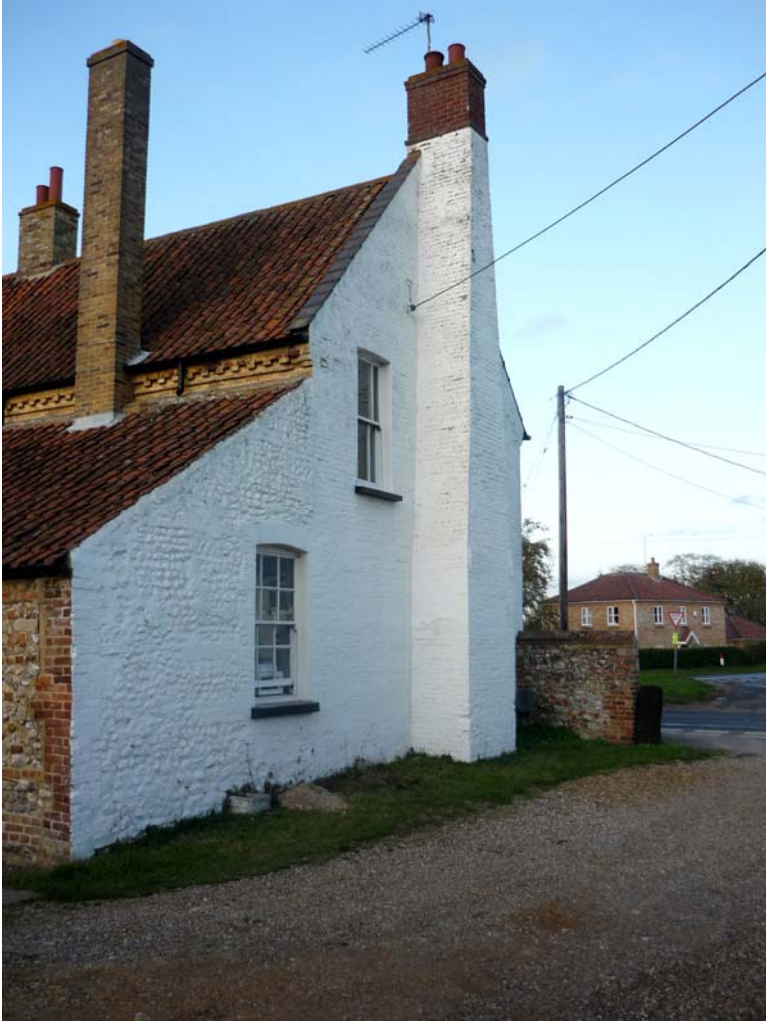
The new soil and vent pipe will be placed just to the south-west of the projecting chimney on the south-east gable wall. The proposed pipe is to be white PVC in order to camouflage it against the white painted exterior and it has been located to hide it behind the chimney (Plate 4).

Plate 4. The south-east gable wall showing the location of the proposed new soil pipe

The addition of the new soil pipe and bathroom vent are the most significant of the external works, but it is intended to locate the pipe as close to the projecting chimney stack as possible and for the both additions to be of white PVC, thereby minimising any visual impact. The other changes will be on the rear elevation and will have no significant impact on the building or its appearance.

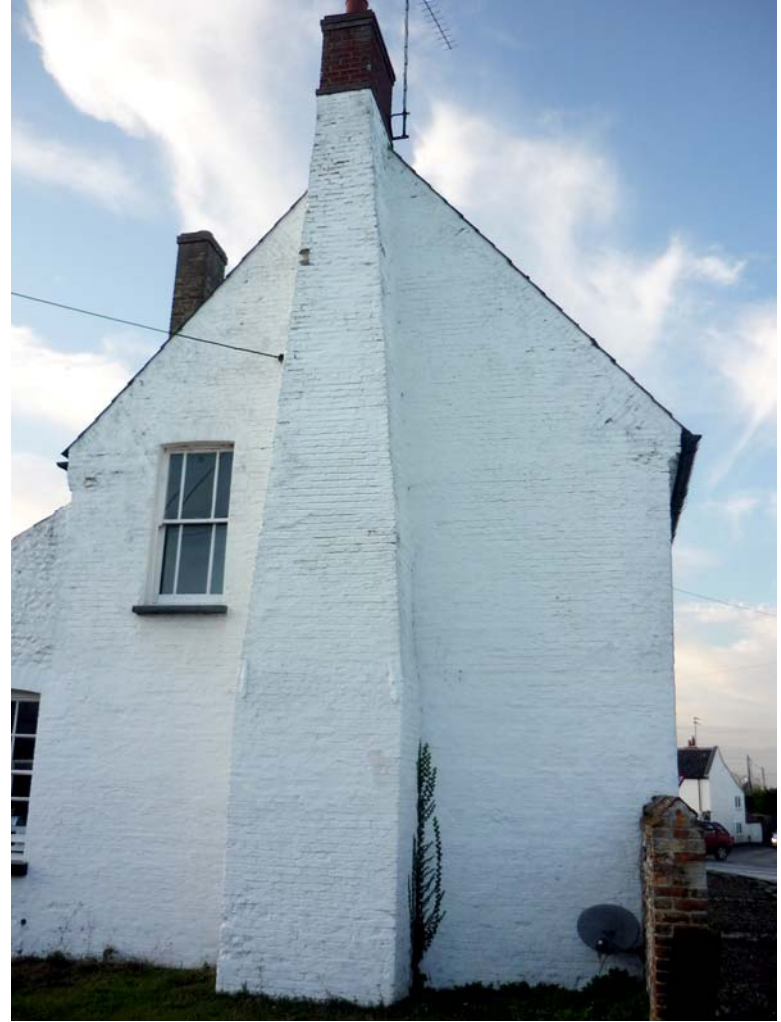
The proposed new bathroom vent will be cut through the brickwork of the south-east gable wall to the north-east of the chimney stack at first floor level (Plate 5). Its location will be visible, although it will be a white plastic vent and at upper floor level, so it should be fairly unobtrusive.

Plate 5. The south-east gable wall showing the location of the proposed new vent
