Archaeological Evaluation at Festival Amusements, Wells-next-the-Sea, Norfolk

ENF127924

January 2012

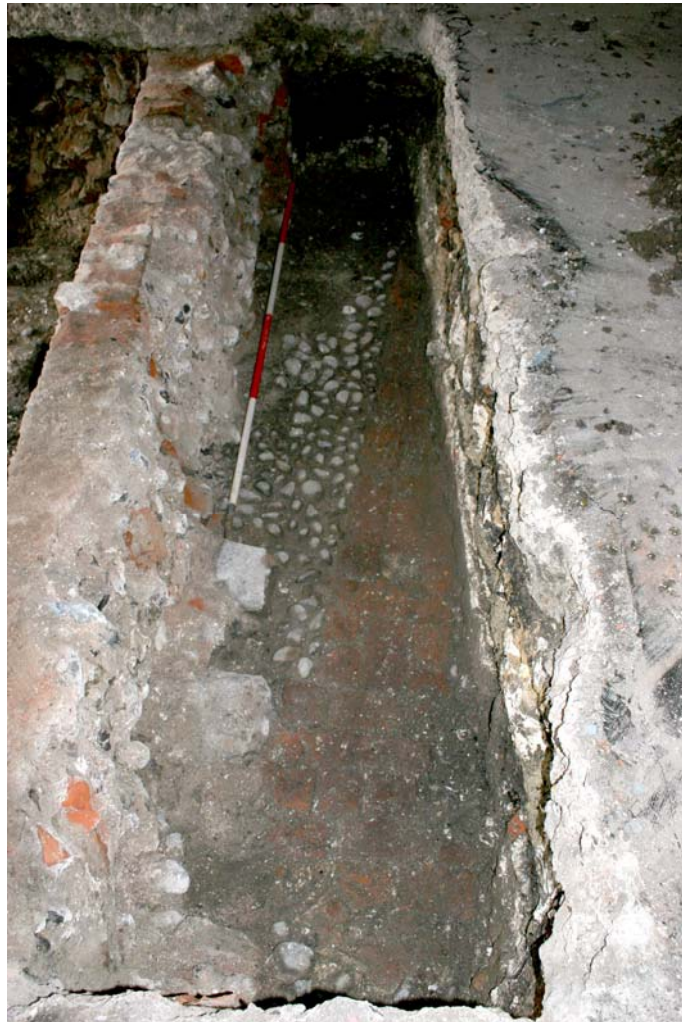
Plate 2. Brick [5] and beach pebble floor [4], looking north

The narrow, three-brick-wide element of the surface, (which was closely respected to the north-west and south-east by firmly set beach pebbles) was clearly aligned from north-east to south-west with a further block of bricks abutting them to the

south-west possibly suggesting a more open area. The bricks are of 14th- to 15th-century date and show no signs of re-use. The limited area of the surface available for inspection during this evaluation renders positive interpretation difficult but probably represents an external yard or pathway/thoroughfare which may have extended to the late medieval quayside.

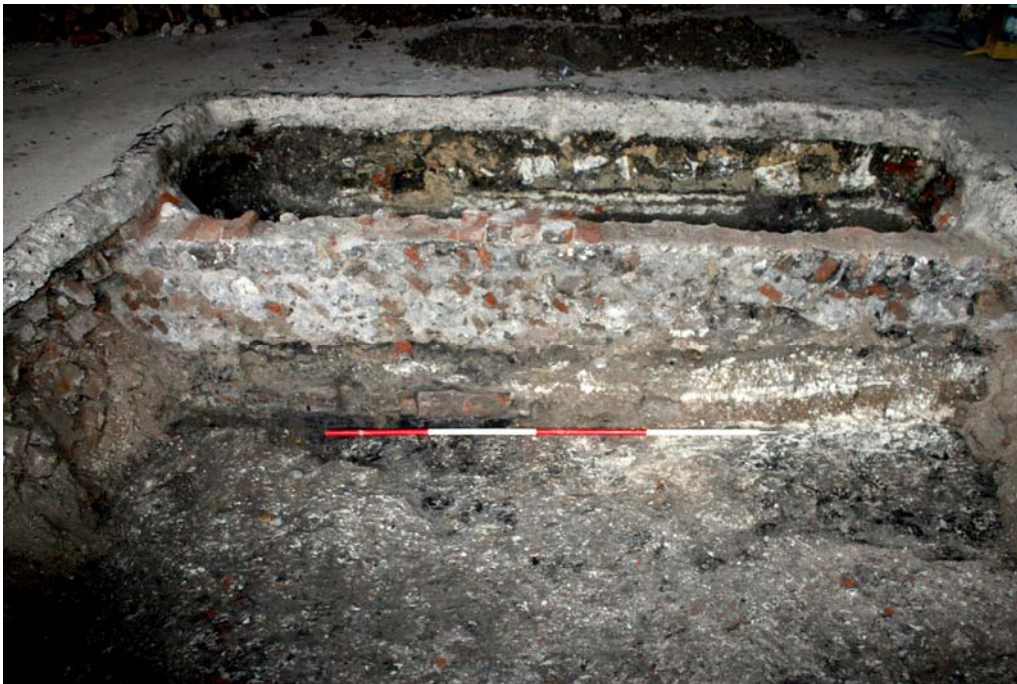
Plate 3. Wall [2] and west-facing baulk section, looking east

The next event in the sequence in Trench 1 was the construction of a north-south aligned wall [2] which truncated layer [30] described above. The wall was approximately 0.60m wide, survived to a height of about 1.0m and extended beyond the limit of excavation to both the south and north. The wall was constructed chiefly of irregularly-shaped, unfinished flint cobbles which showed some signs of horizontal coursing. The cobbles were sparsely interspersed with red bricks which were set at an angle giving a slight herringbone effect. Only the ends of the bricks were visible. The wall had been bonded using a pale grey lime mortar with inclusions of crushed chalk and charcoal flecks. This wall appeared to have been consolidated and possibly widened slightly at some stage using red brick [19]. A small arch-shaped cavity was seen to have been incorporated into the construction of the wall at foundation level. The feature, possibly associated with drainage, had been infilled using a compacted mixture of flint gravel, pieces of creamish brown lime mortar and chalk lumps [14]. Several stone blocks had also been used as infilling material on the east side of the wall. The cavity may have been blocked at the same time as the consolidation of the wall occurred.

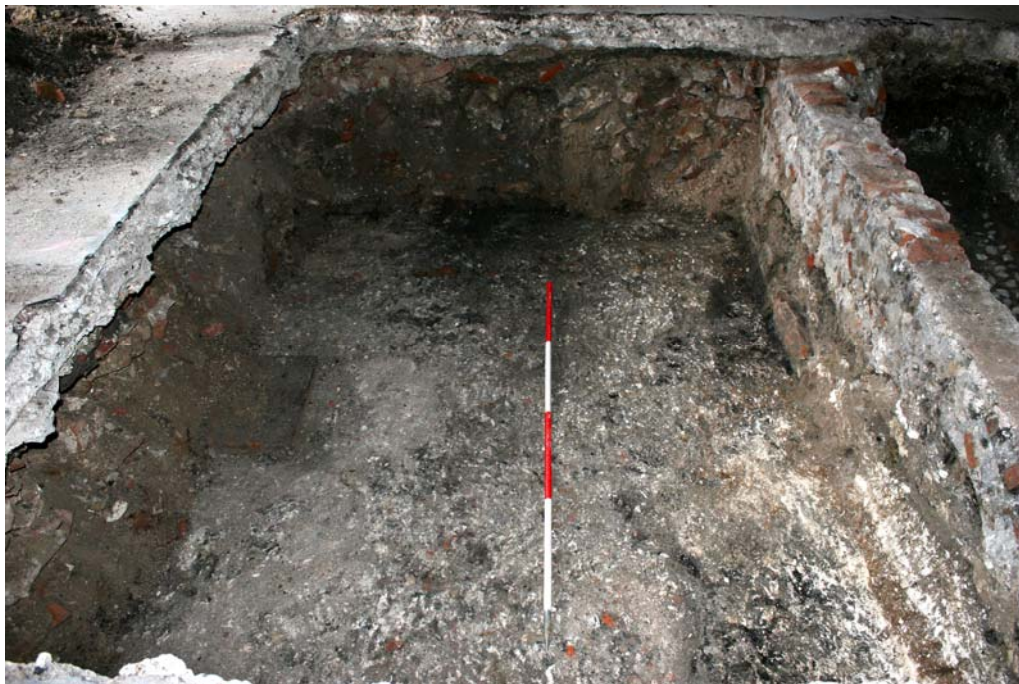
Plate 4. Floor [1], looking north

A sondage with dimensions 1.60m by 1.40m in plan was excavated through the centre of floor [1] revealing it to be between 0.005m and 0.10m seep. Underlying the floor was a thin layer of coal dust which sealed the surface of the slightly undulating natural geology. This indicated that the chalk bedrock had been used as a floor surface on which coal was stored prior to the laying of floor [1] which provided a more level surface.

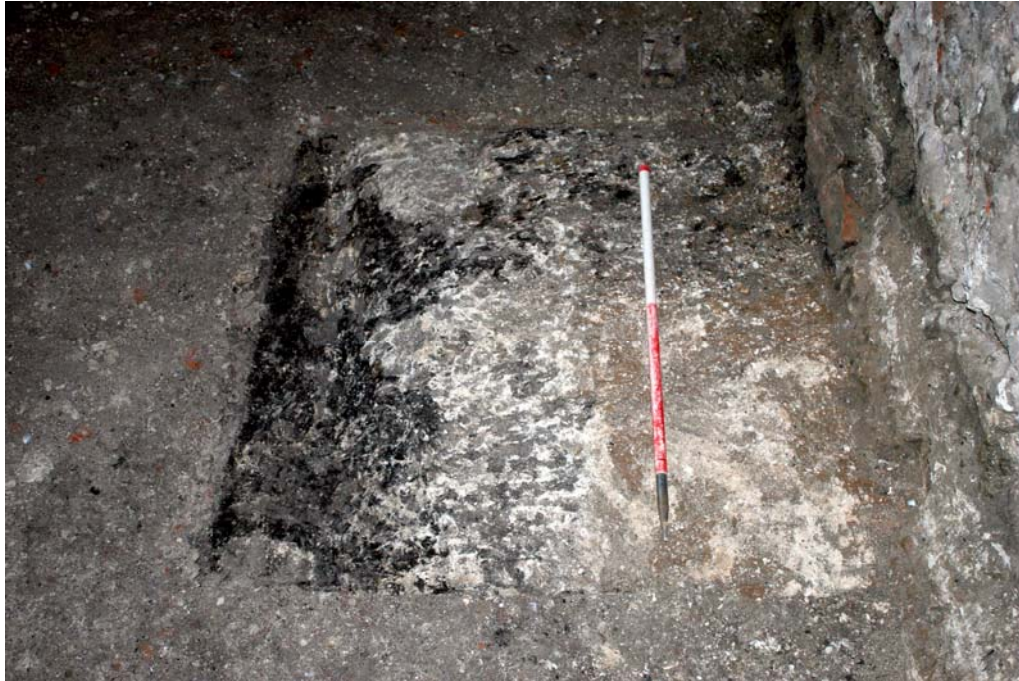
Plate 5. Central sondage, Trench 1, looking north

Two possible successive chalk floors ([31] and [33]) were observed in the eastern section of Trench 1. The earlier of the floors was sealed by a layer of dark grey clay silt trample [32] and the later by a layer of coal dust [37]. Although stratigraphic relationships had been largely destroyed by later truncation and disturbance it would seem reasonable to suggest that they may both be contemporary with floor [1]. These possible floor surfaces and associated deposits had been truncated by small pit [35]. Feature [35] measured 0.47m wide and was 0.30m deep with steep sides and a slightly concave base. The undated pit was filled with a dark grey clay silt with inclusions of chalk, charcoal and CBM fragments. A 0.16m-thick dump of pale greyish green silt clay with occasional coal, CBM and chalk fragments sealed pit [35]. This deposit was overlain by a mixed deposit made up of a soft pale brown sandy mortar with patches of dark grey silt matrix [41]. The deposit contained a number of chalk blocks and a concentration of bricks at its northern extremity. This undated dump of demolition material was presumably imported to act as make-up material prior to the laying of the concrete slab associated with the amusement arcade. Contexts [39], [40] and [42] also represent dumps of relatively modern waste material consisting of dark grey silts containing varying amounts of chalk, mortar and CBM fragments

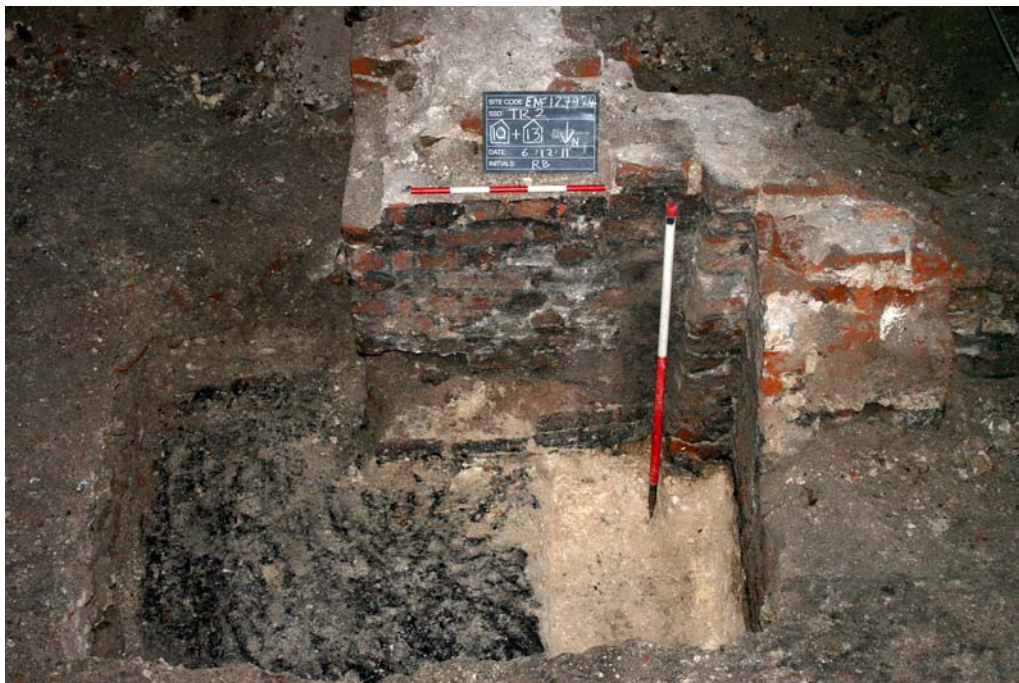
Plate 6. Wall [10] and central sondage, Trench 2, looking south

North-south aligned wall [10] with an east-west return formed a corner in the south-west part of Trench 2 and both sections of wall extended beyond the limit of excavation to the south and west respectively. The east-west section of wall had a probable buttress extending north from its northern face. The west-facing elevation of the north to south element of the wall was constructed from flint cobble and red brick in a similar manner to that used in the construction of wall [2] in Trench 1

The north-south wall was 0.66m wide and survived to a height of 1.0m; the east to west portion was 0.50m in width and also survived to a height of 1.0m. The buttress extended 0.45m from the wall but appears to have been truncated and originally projected some 0.75m. Examples of brick taken from the wall were dated to somewhere between the 15th and 17th centuries but, as was the case with wall [2] in Trench 1, these may represent later consolidation of an earlier wall.

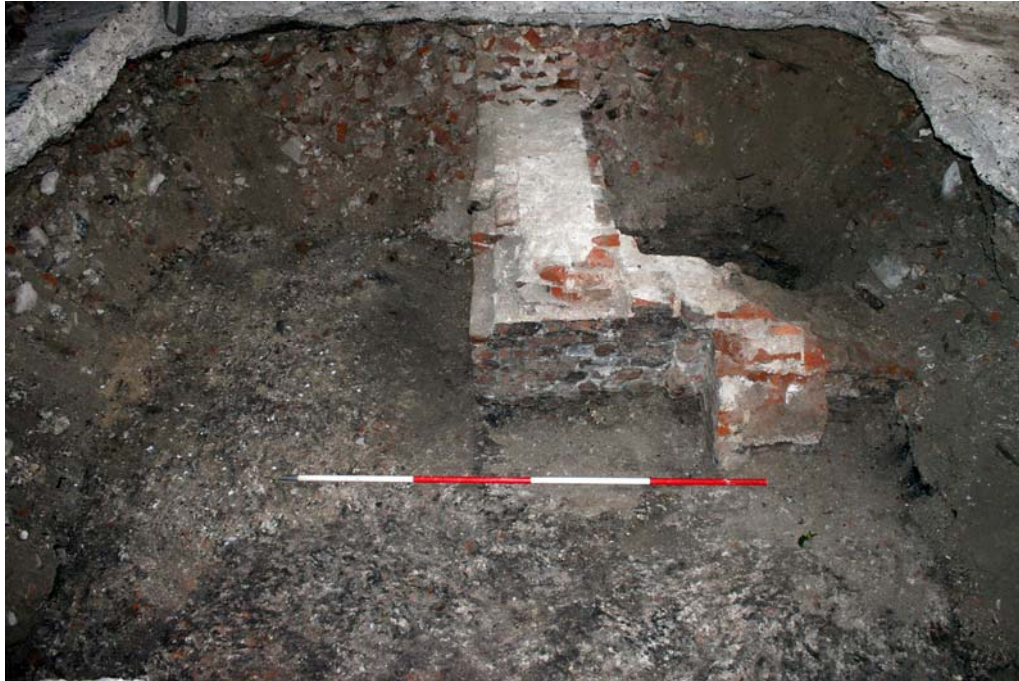
Plate 7. Wall [10] and floor [9] after removal of rubble [7], looking south

The wall and buttress were sealed by a large deposit of demolition rubble [7] which was encountered immediately below the concrete floor and extended over the whole area of Trench 2. This deposit was 1.10m thick, and its composition was similar to layer [24] observed in Trench 1.
