Report BAU2852

Archaeological Watching Brief at Bourn Hall, Bourn, Cambridgeshire

ECB 3709

January 2012

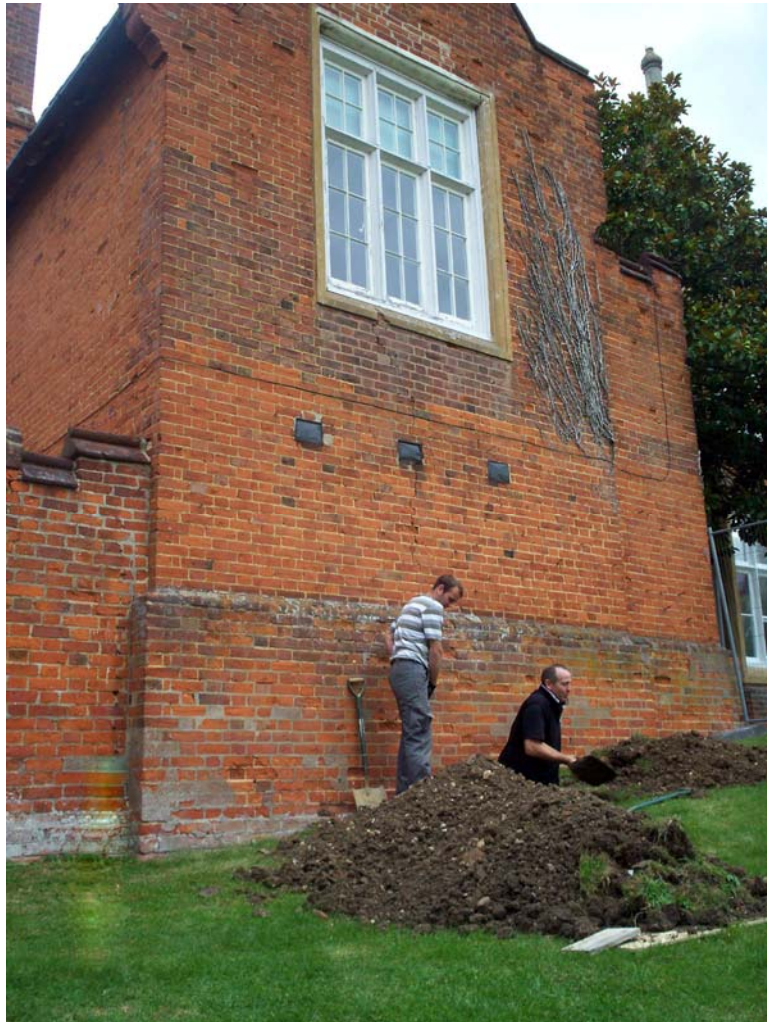
Plate 1. South-west facing elevation of 'kitchen' with test pit being excavated by staff of Brown and Ralph, facing east

A test pit (Test Hole 1) was hand excavated against the south-west facing wall of the 'kitchen' in an attempt to determine the route of one of the large drains which was indicated on the plans to run below the wall (Fig. 3). Possible damage to this drain was thought responsible for the cracking to this tall gable wall with its large window with moulded stone surround (Plate 1). No drain was found and its route was established to run at 45° to the one suggested on the site plan. The test pit was excavated to the bottom of the kitchen wall footings.

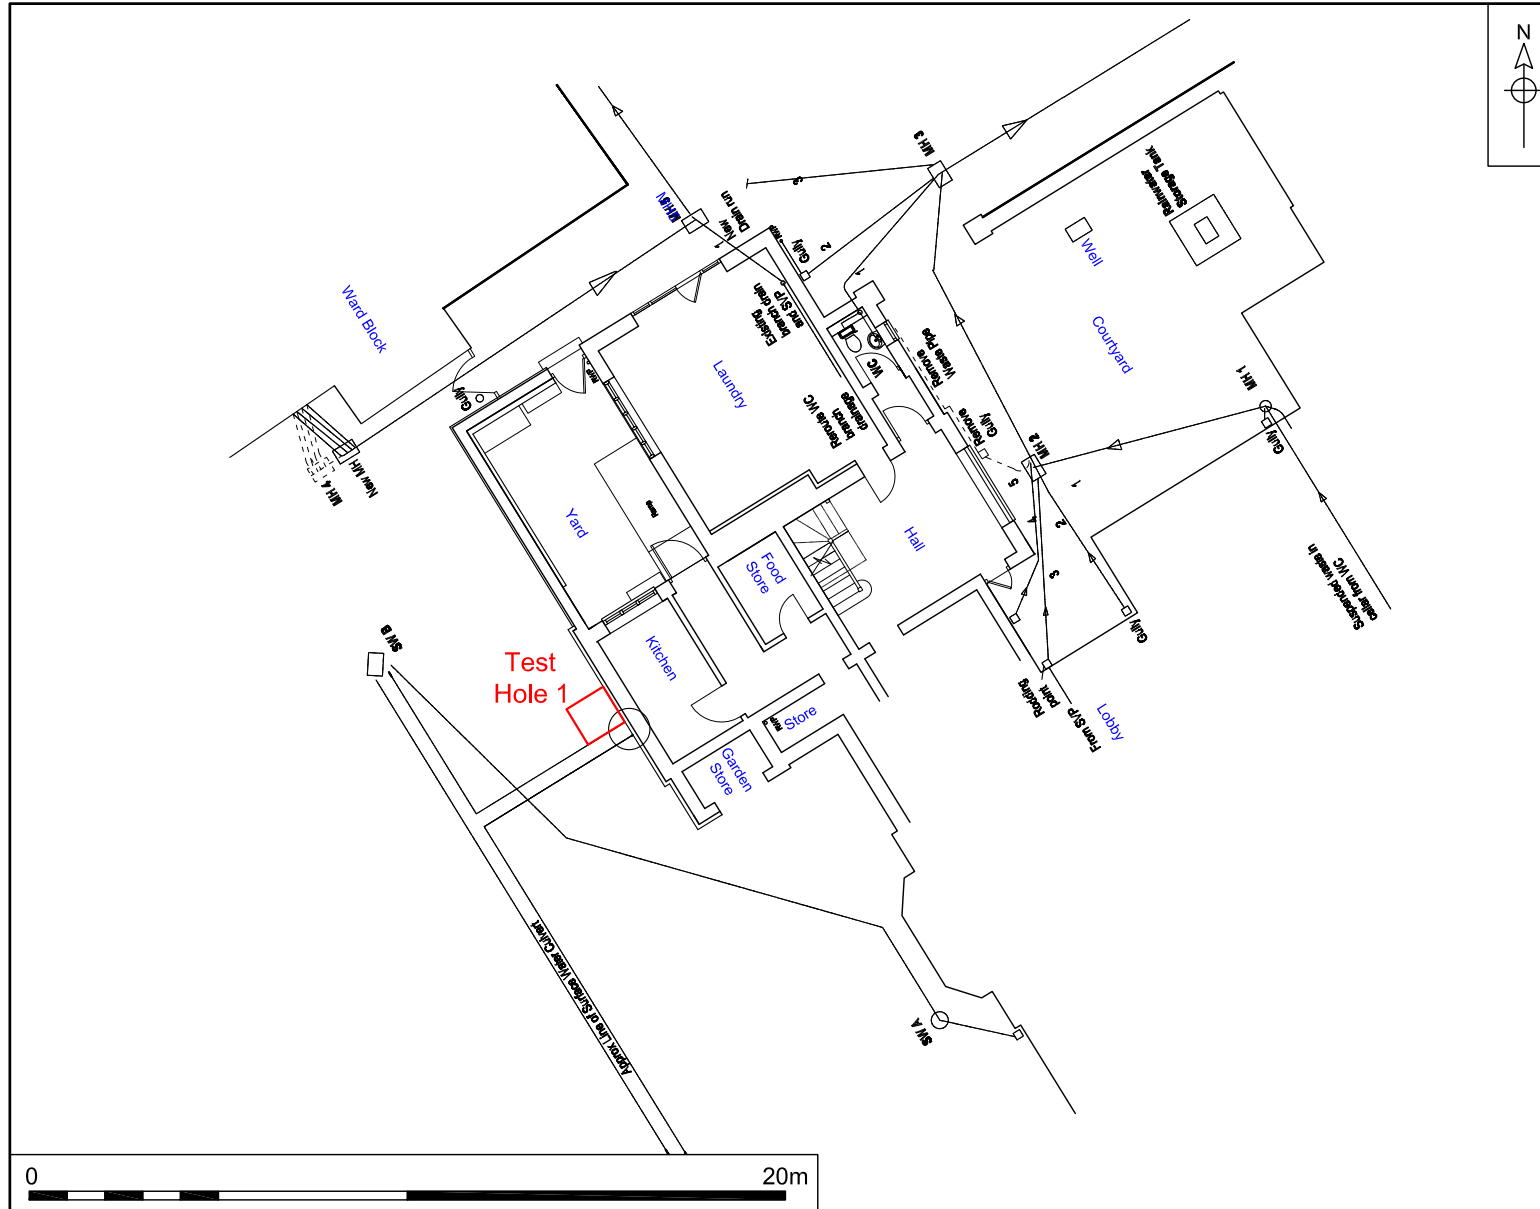
Figure 3. Plan of area of Bourn Hall indicating where all interventions for drainage repair works were carried out, showing location of Test Hole 1. Scale 1:200 (after Purcell Miller Tritton drawing 232212 / 311)

No archaeological deposits were encountered during the excavation of any of the existing drain runs (see Figure 3 for extent of drains). The existing and new drain runs were hand dug to a depth of 300-400mm depth and none went deeper than previous drainage works or the debris associated with the 20th-century construction of the ward block. All deposits observed in the drain runs had been deposited during previous (modern) drainage works.

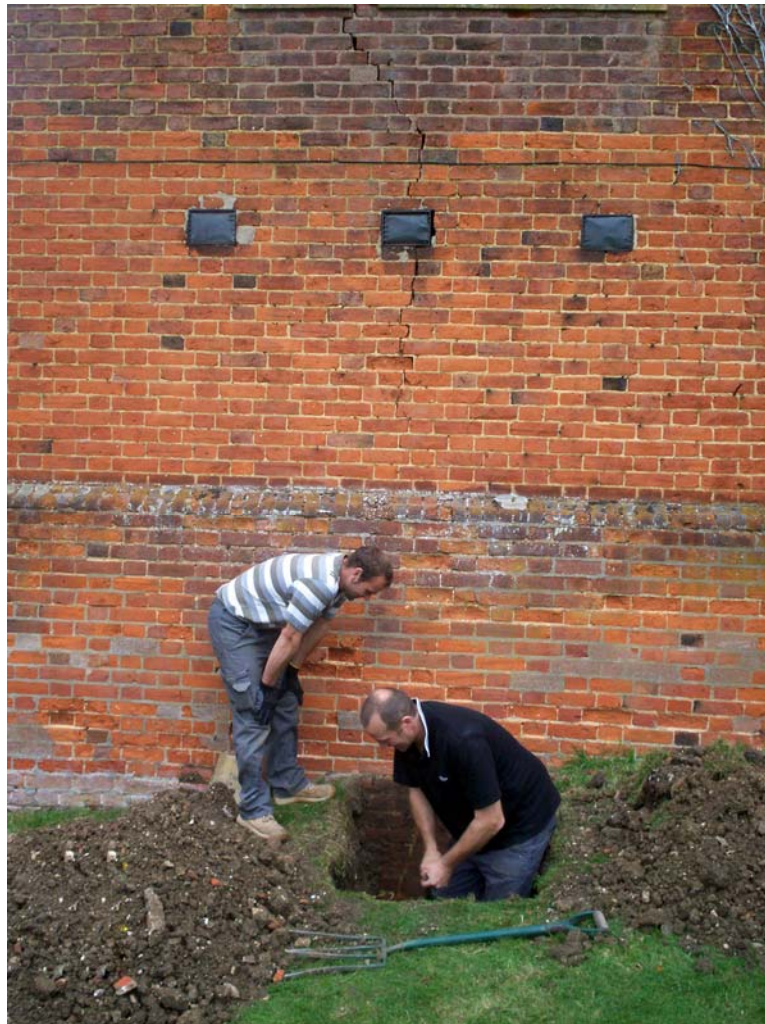
Plate 2. South-west facing elevation of 'kitchen' with test pit being excavated by staff of Brown and Ralph. Photograph indicating depth of hole; facing north-east.

Immediately below the turf in the test pit was a 0.5m deep soil [06] (Plates 2 and 3). The soil was a mid dark grey silty clay with some humic material. It contained a small proportion of chalk, brick, mortar and glass fragments together with some coal. This soil was a mix of *in situ* soil developed into landscaped sediments dumped with building and household refuse and levelled up against the wall largely following the infilling of the construction cut for the wall. Pottery from this deposit included glazed red earthenware (GRE) of 16th- to 18th-century date and Iron glazed ware also of 16th- to 18th-century date. Finds of 19th-century date in the deposits below deposit [6] however, indicate this soil was likely to have been deposited during landscaping of the gardens in the 19th century and had redeposited sediments of an earlier date.

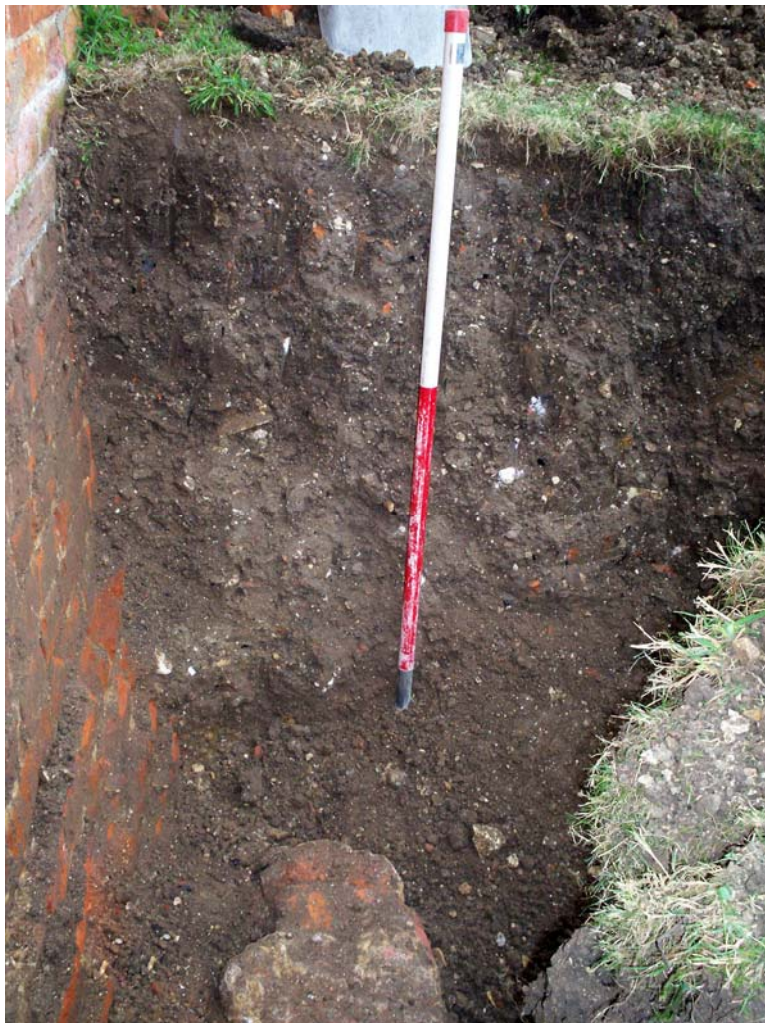
Plate 3. South side of Test Hole 1 showing topsoil [6], backfill [1] and lower backfill [3] (Section 2).

Below soil [06] the backfill [1] of a construction cut for the wall of the kitchen [4] was 0.65m deep (Fig. 6, Plate 3). Wall construction cut fill [1] was a mid grey brown clay silt with white fleck. It contained frequent chalk pebbles and demolition construction debris, brick fragments, charcoal, coal, window glass and oyster shell with infrequent pieces of bone from a small animal. It was notable that this deposit extended over 1m from the wall indicating it was a wide construction trench. The finds from deposit [1] were predominantly those of the 16th- to 18th-century date and included sherds of glazed red earthenware, and two roof tiles - one late

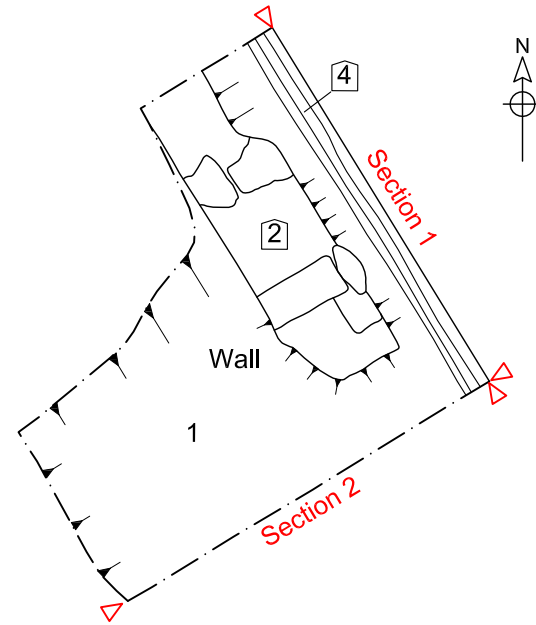
Figure 4. Plan of demolished 'wall' <02> and upstanding wall <04> forming the south-west facing elevation of the kitchen. Scale 1:20

At 0.6m below the surface a 0.9m length of probable earlier wall [2] was encountered running parallel to and 0.15m from extant kitchen wall [4] (Figs 4 and 5, Plates 3, 4, 5 and 6).

Wall [2] was constructed from flint and brick. The flint was sparse and the brick was variable in colour - some bright orange with a sandy fabric and others pinkish red or purple. The shapes of the bricks were difficult to observe since the wall had been roughly demolished with partial bricks visible and others covered in a yellowish cream sandy lime mortar. However it was clear that many half bricks had been utilised in the construction of this wall footing. It was not possible to identify a cut associated with 'wall' [2] since it lay so close to the later wall and any evidence of an earlier cut and associated sediments would have been disturbed during the construction of wall [4]. Although there is no clear dating evidence this wall could correspond to the earlier phase of hall construction in the 17th century, although it may be part of an unrecorded phase of 18th-century building.

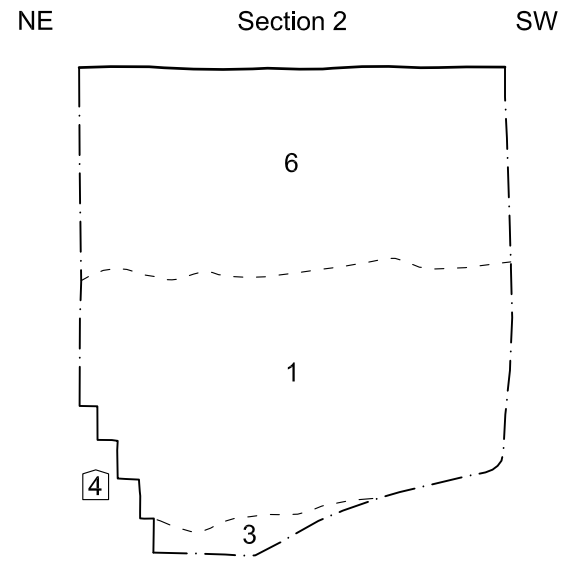
Figure 6. South-west facing section illustrating the stepped foundation of wall <04> together with associated backfill and soils 1, 3 and 6. Scale 1:20

The 'kitchen' wall [4] footings were seen to extend to a depth of 0.9m below the modern turf surface. The bottom five-six courses were stepped out to form the foundation of the wall (Plates 4 and 5), (Figs 4 and 5). The wall was constructed from bright orange brick with a sandy fabric with a fairly uniform in colour with no swirls or mottling. The bricks were all relatively uniform in size (230mm long, 110mm wide and 60mm deep) but not quite regular enough to be machine made. There were rare occurrences of over-fired bricks within the wall which were purplish in colour. The bricks were laid in Flemish bond and bonded with a creamy sandy lime

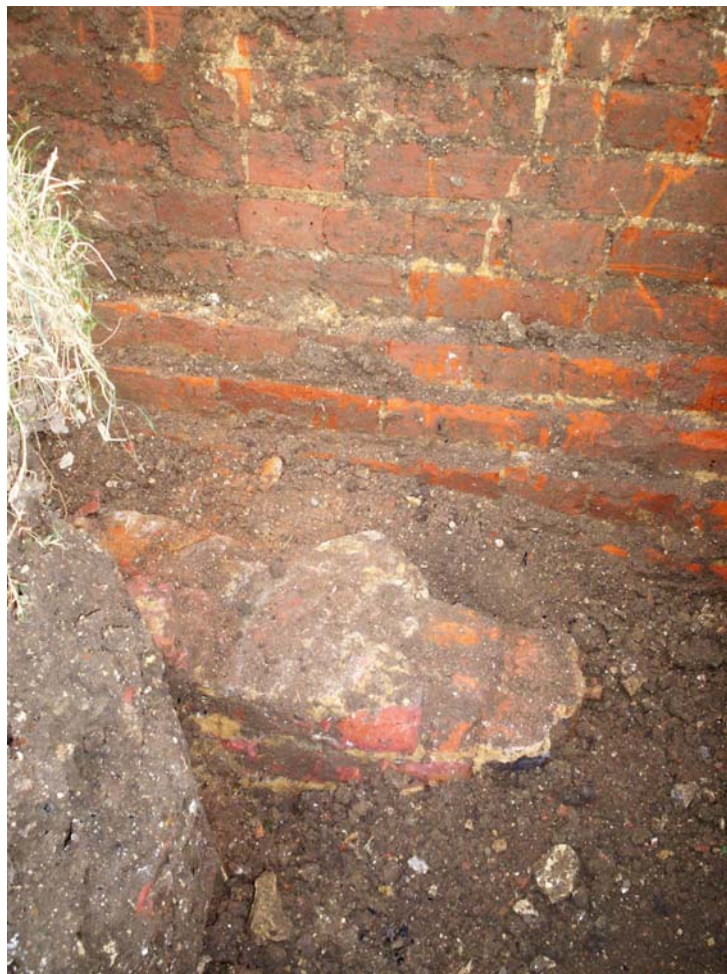
Plate 6. Stepped foundation of wall [04] and remains of 'wall' [2] in foreground; facing north-west.

The small stub of possible wall which lay parallel to the footings of the kitchen wall 600mm below the modern grass level is the remains of an unknown structure. Its construction differs from that of the 'kitchen' wall being composed of flint and reddish pink and orange bricks, although there is no dating evidence from the wall itself an early tobacco pipe from 1620-1640 was found in sediments from a very similar depth tentatively suggesting the wall may be part of the earlier 17th-century phase of construction. However, the relative narrowness of the wall (300mm) together with the knowledge that a range of later structures such as glass houses, outbuildings and a conservatory were demolished in the 1960s may suggest that this wall was actually part of one of these structures. If this were the case then the 19th-century pottery sherds may have been introduced into the backfill at this time and the 'kitchen' wall could date from Lyell's remodelling in 1733.

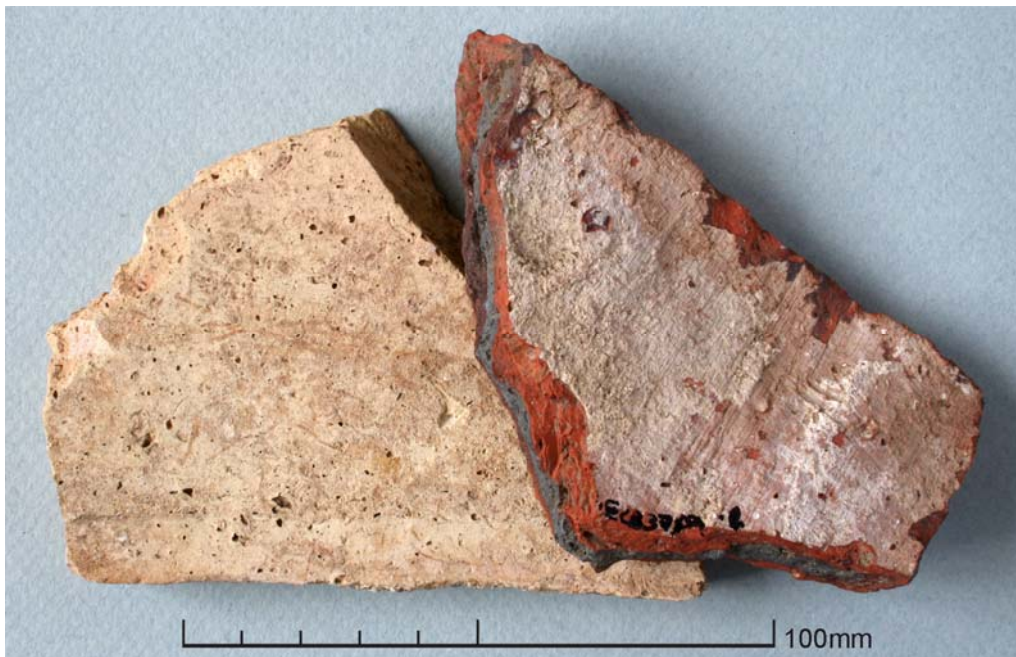
Plate 7. Weathered late medieval to early post-medieval roof tile (red) with reduced grey core and yellow roof tile possibly 18th century from [01] (backfill of wall trench [05])

The earliest piece is a fragment of roof tile (88g), very rough and worn, in a pinkish fabric with a reduced grey core (Plate 7). This piece could be late medieval in date, but is more likely, given the date of other material from the site, to be early post-medieval, possibly 16th-century. Another fragment of roof tile (116g), this

time in a yellow fabric, is likely to be slightly later in date, possibly 18th-century (Plate 7). The final piece is possibly a hearth tile (191g), and is of a rather modern fabric, possibly as late as 20th-century.

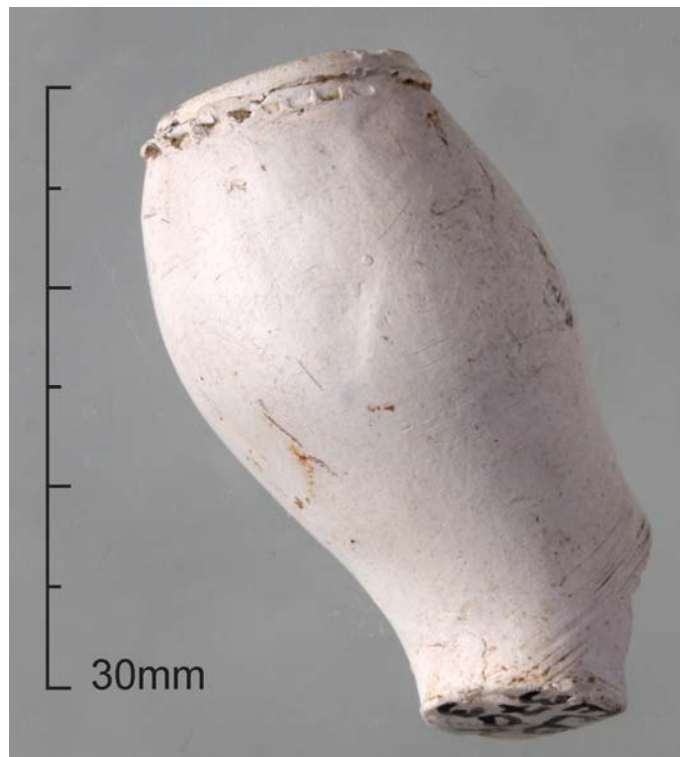
Plate 8. Tobacco pipe bowl (1610-1640) from lowest fill of wall construction trench [5].

One piece, an incomplete bowl, is a fairly early bulbous or waisted type with milling around the rim, and a slightly pronounced heel (Plate 8). This piece fits into the typology produced by Grove (1984), and is likely to be a Type 5, which has a flat base and is dated to c. 1610-1640.
