Archaeological Watching Brief at Creake Abbey, North Creake, Norfolk

ENF127760

Rebecca Sillwood, BA PIfA

February 2012

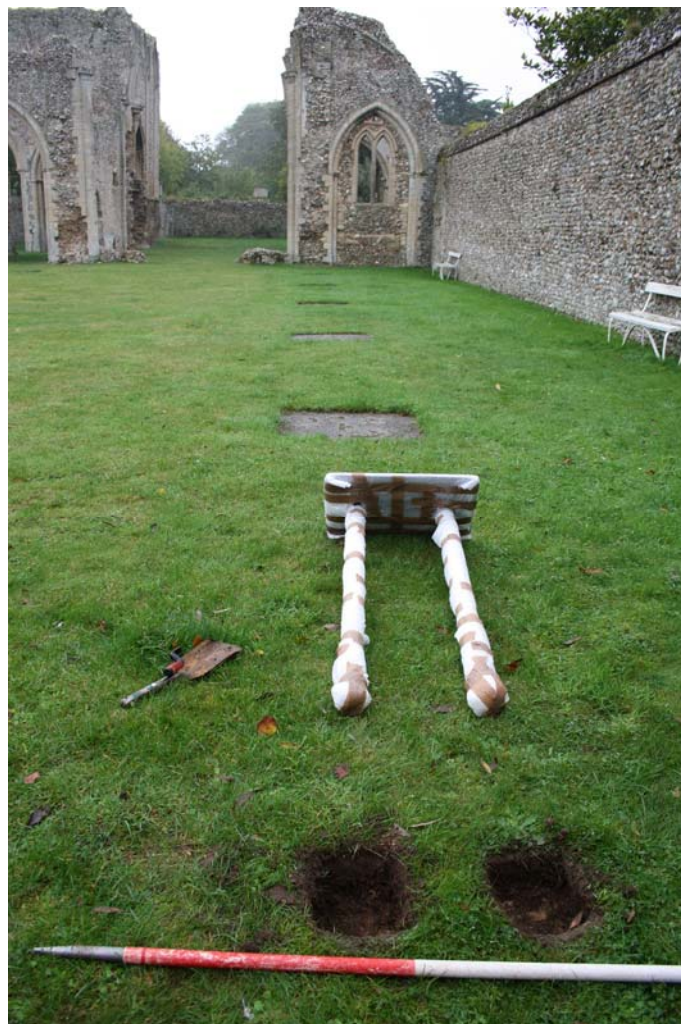
Plate 2. Location of excavations, looking east

Two small holes measuring 0.2m by 0.25m and 0.4m deep were excavated on the eastern side of the west wall of the Abbey.

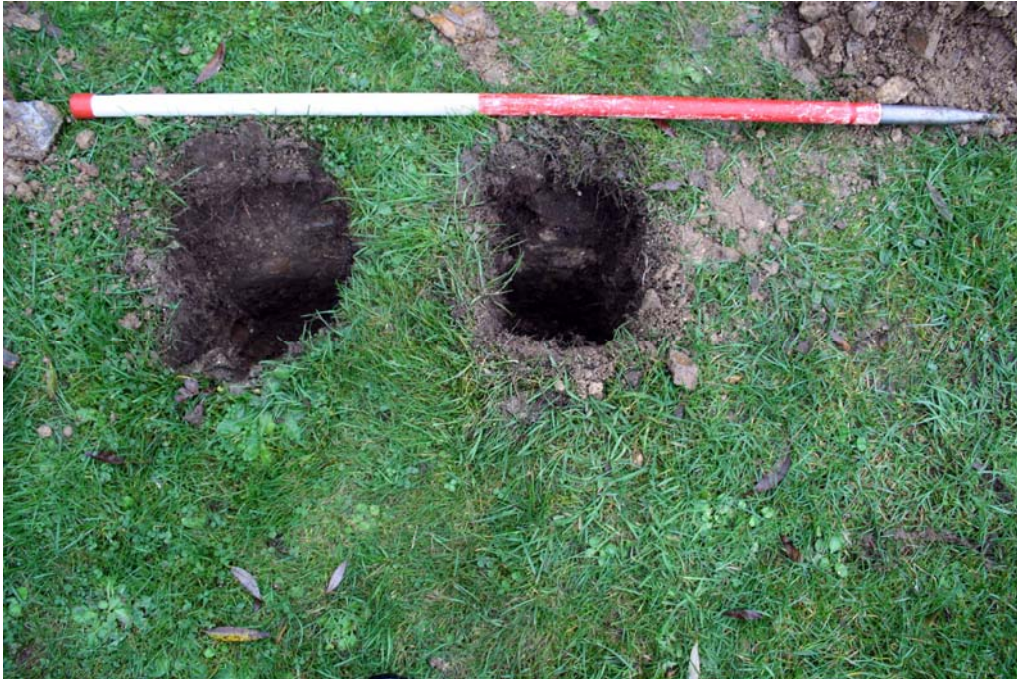
Plate 3. Post-excitation view of the post-holes

The lowest layer visible was subsoil [3] consisting of soft mid brown silty-sand.

Above this was layer [2] comprised of mortar and tile, measuring 0.15m thick. The spread of this layer is unknown, due to the restrictive nature of the excavations. Finds included within this layer include fragments of medieval and post-medieval roof-tiles and possible medieval mortar, which could feasibly have come from the vicinity of the abbey, although are unlikely to have come from the abbey itself.

Topsoil [1] on the site was loose dark brown silty-sand and measured roughly 0.12m in thickness.
