### Archaeological Evaluation at St John's Close, Mildenhall, Suffolk

MNL673

March 2012

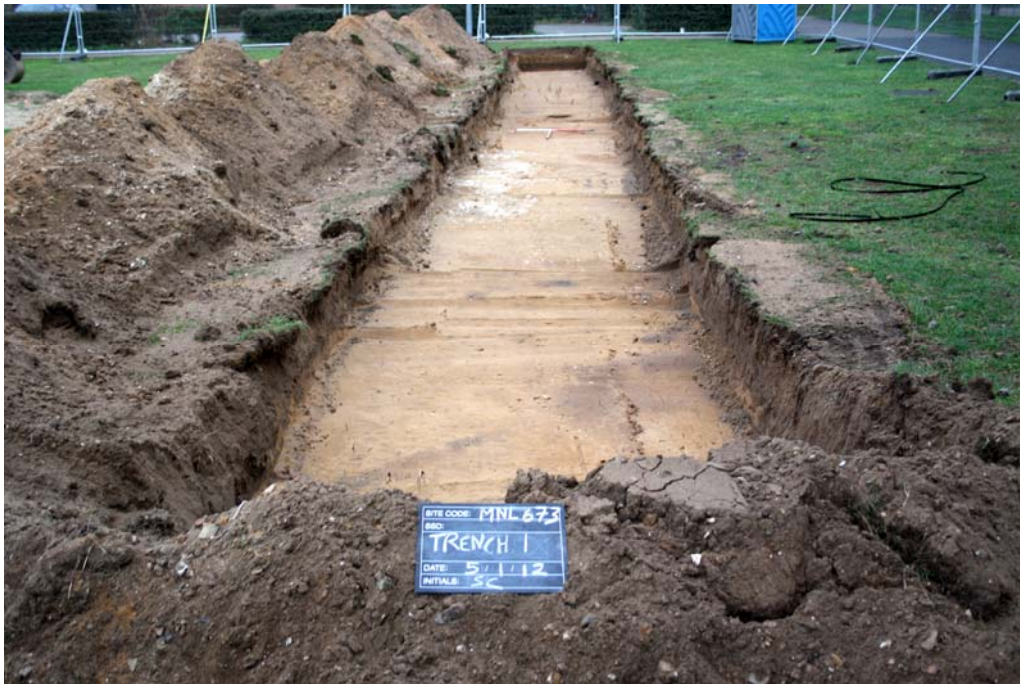
Plate 1. Trench 1, view from west end

Trench 1 was located in the south-east of the development site and orientated east-west (Fig. 2, Plate 1). It measured c.25m by c.2m and was excavated to a depth of c.0.55m. The trench contained no features or deposits of archaeological interest. A sondage was excavated by machine to a depth of c.0.64m at the east end of Trench 1 to confirm that natural deposits had been reached.

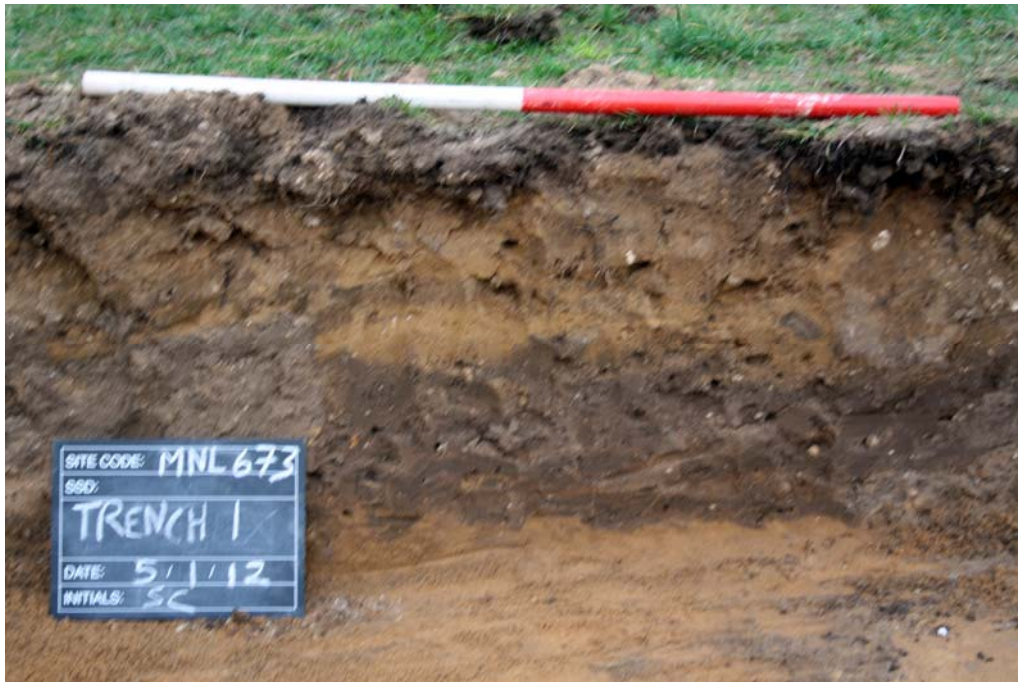
Plate 2. Trench 1, north-facing sample section

Three lateral deposits were visible in Trench 1 (Plate 2). The uppermost deposit was a thin layer of topsoil and turf c.0.04m deep consisting of soft mid-dark brown sandy silt with occasional stones. Below this was a sandy make-up layer c.0.31m deep consisting of a soft loose pale grey yellow sand with occasional–moderate amounts of flint and modern red brick. Below this layer was a subsoil consisting of a soft pale grey mid brown sandy silt c.0.24m deep containing occasional–moderate amounts of flint and stones along with small chalk lumps.

The natural deposits in Trench 1 consisted of a pale yellow sand with occasional pieces of flint and occasional patches coloured slightly grey yellow.

No features or deposits of archaeological interest were present within Trench 1.

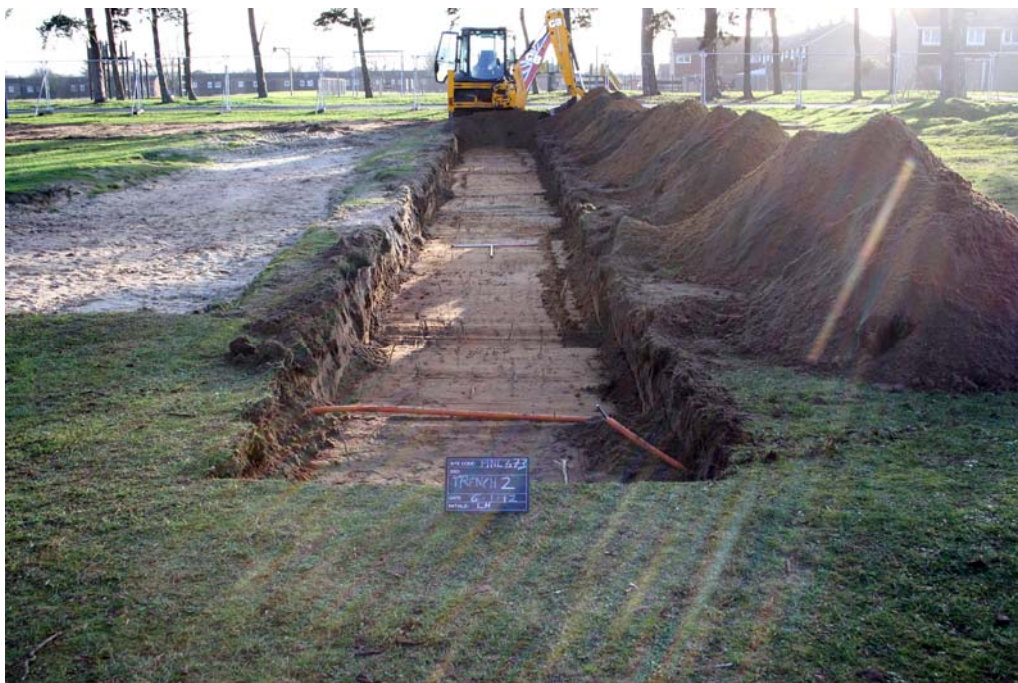
Plate 3. Trench 2, view from north end

Trench 2 was orientated north-south and located towards the north-east of the site (Fig. 2, Plate 3). It measured c.31m by c.2m and was excavated to a depth of c.0.52m–c.0.65m.

A north-west to south-east aligned cable was exposed at the north end of Trench 2 and was severed. It was buried c.0.30m below the surface however it did not register when the area was CAT scanned prior to excavation nor was there any warning tape or change of material around it. It was suggested by operators on site that it may have been a redundant cable servicing the community centre and a TV mast. The position of the cable was recorded and it was then reburied with a layer of plastic bags above it to indicate its position to anyone doing subsequent work in the area. As a result of the presence of the cable, the first c.1.80m of Trench 2 was not excavated deeper than the depth of the cable.

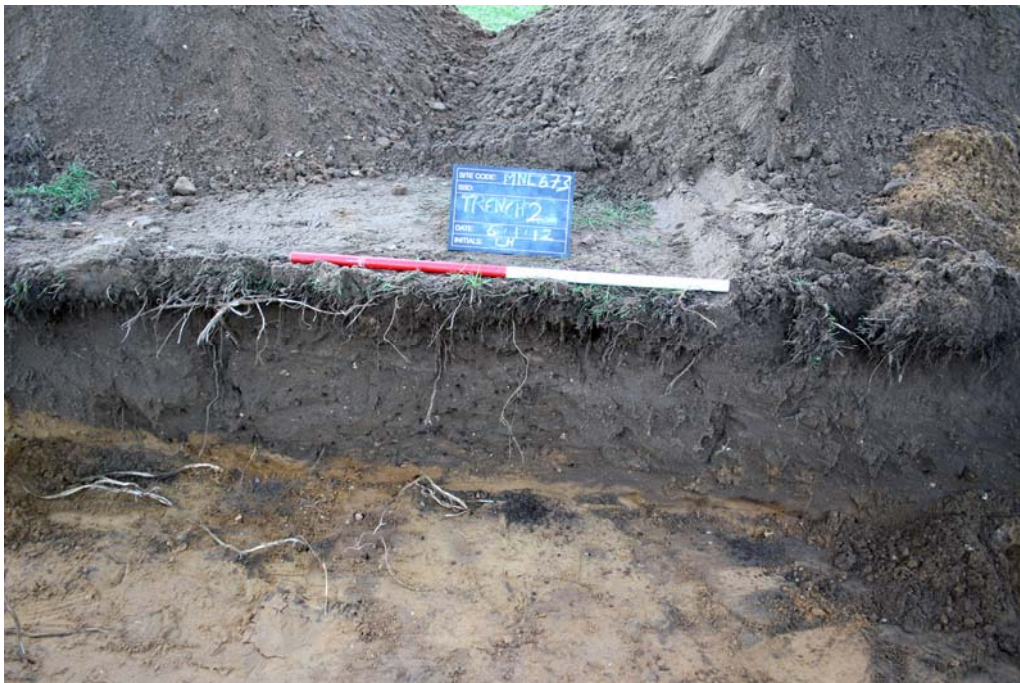
Plate 4. Trench 2, east-facing Sample section

Three layers overlying the natural pale yellow sand were visible within Trench 2 (Plate 4). The uppermost deposit was a turf layer of mid-dark brown sandy silt c.0.10m deep. This sealed a soft very pale brown silty sand topsoil c.0.16m deep.

Subsoil consisted of soft pale brown silty sand with a grey hue c.0.28m deep and containing occasional–moderate amounts of small stones.

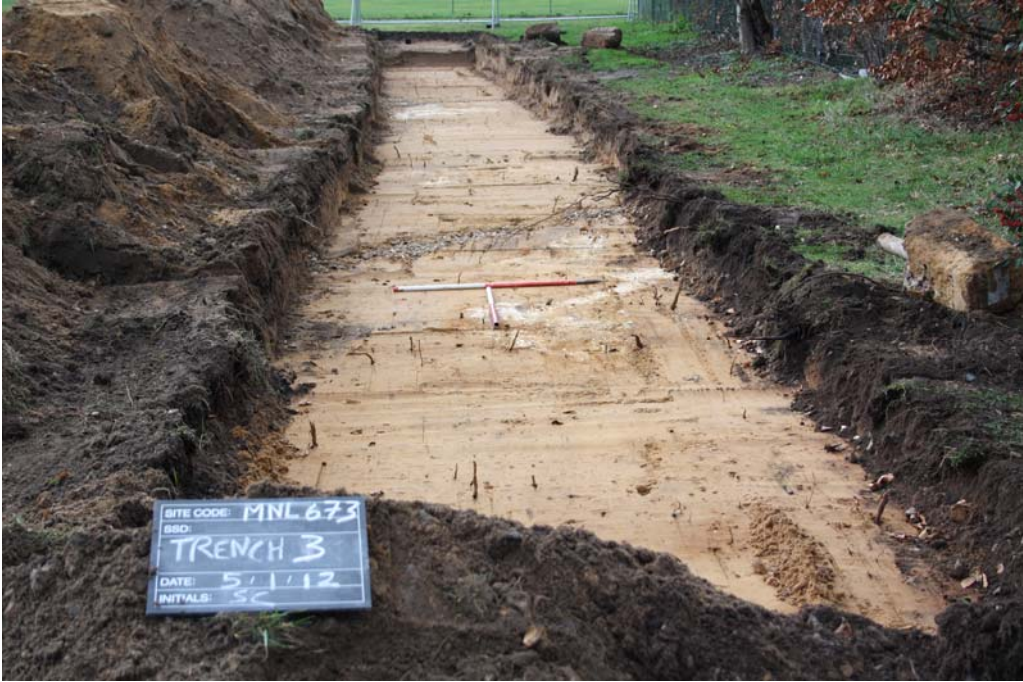
Plate 5. Trench 3, view from east end

Trench 3 was orientated east-west and located in the north-west part of the site (Fig. 2, Plate 5). The trench measured c.36m by c.2m and was excavated to a depth of c.0.60m.

No features or deposits of archaeological interest were present within this trench however modern drains filled with large pieces of gravel were encountered. One of these drains was at the west end of the trench and buried only c.0.25m deep. As a result excavation stopped at this higher level for a length of c.2.40m at Trench 3's western end.

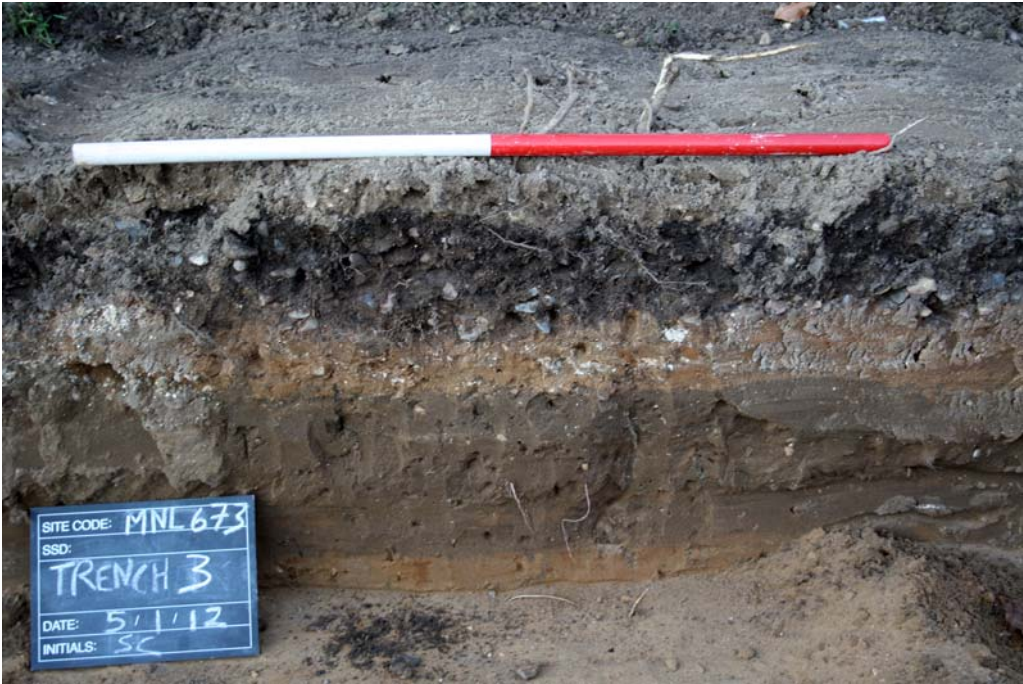
Plate 6. Trench 3, south-facing sample section

Four layers were visible within Trench 3 (Plate 6) above natural. At the surface was a topsoil and turf layer c.0.06m deep, consisting of soft mid-dark brown sandy silt and turf with occasional stones. Below this was a dumped layer of soft black sand and gravel c.0.17m deep. Below this layer was another dumped layer of soft dirty orange sand c.0.09m deep with frequent numbers of chalk flecks. The original

subsoil layer lay beneath this and consisted of a soft pale brown slightly silty sand c.0.28m deep with occasional–moderate flint/stones and small chalk flecks.

The natural in Trench 3 consisted of an orange-yellow soft sand.

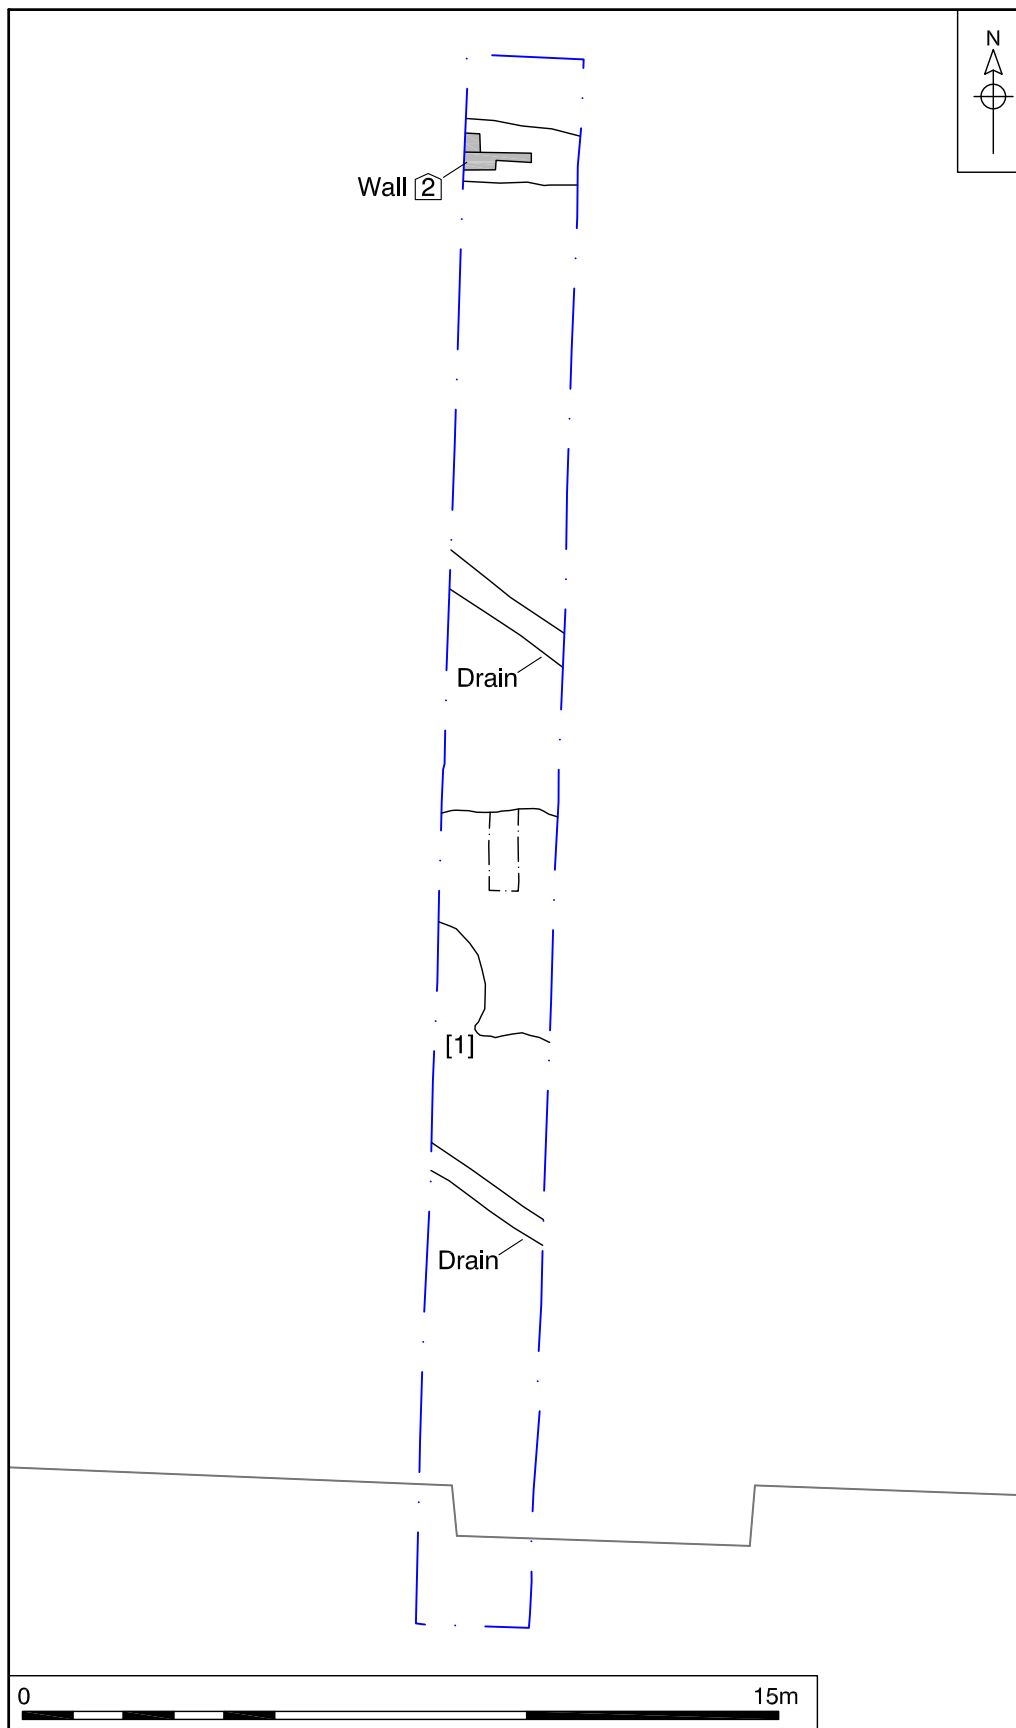
Figure 3. Plan of Trench 4. Scale 1:150

A thin layer of compacted chalk [1] was located c.11m from the north end of Trench 4 at the base of the trench (Fig. 3). Chalk [1] was found c.0.35m below the ground surface and was c.4.40m long and c.0.03m thick (Plate 9). There were no artefacts to aid interpretation and it is unclear whether this is a floor surface or a compacted modern dump of material (like other deposits on the site).

At the southern end of Trench 4 a modern east–west aligned red brick wall [2] was recorded (Fig. 3). It survived to a height of c.0.40m.

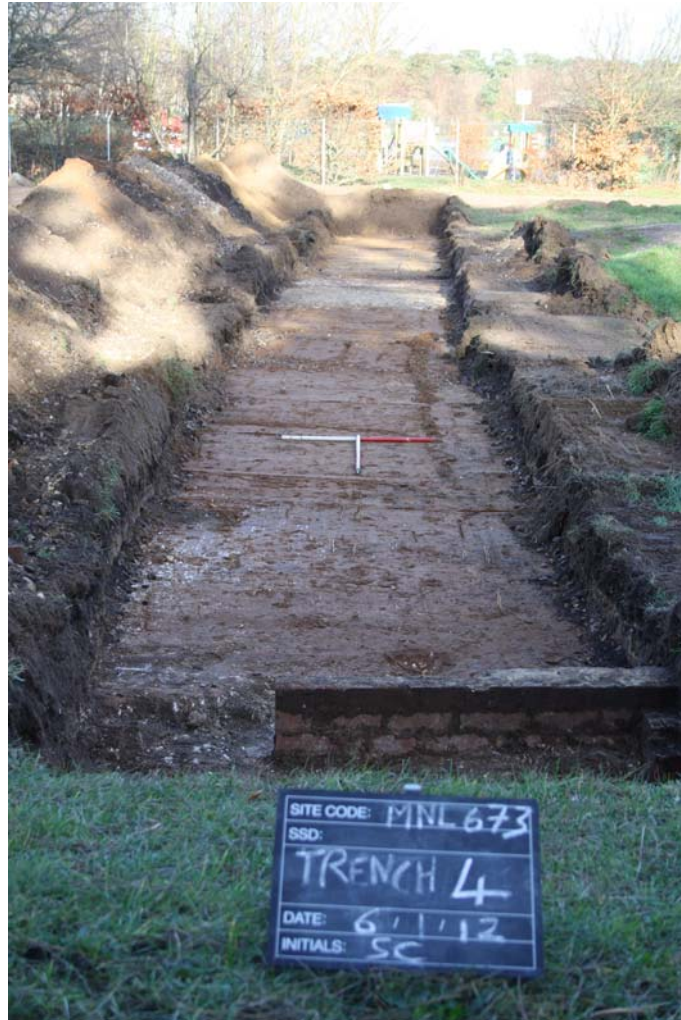
Plate 7. Trench 4, view from south end

Trench 4 was orientated north-south and located in the south-west of the site (Fig. 2, Plate 7). The trench measured c.31m by c.2m and was excavated to a depth of c.0.30–0.45m.

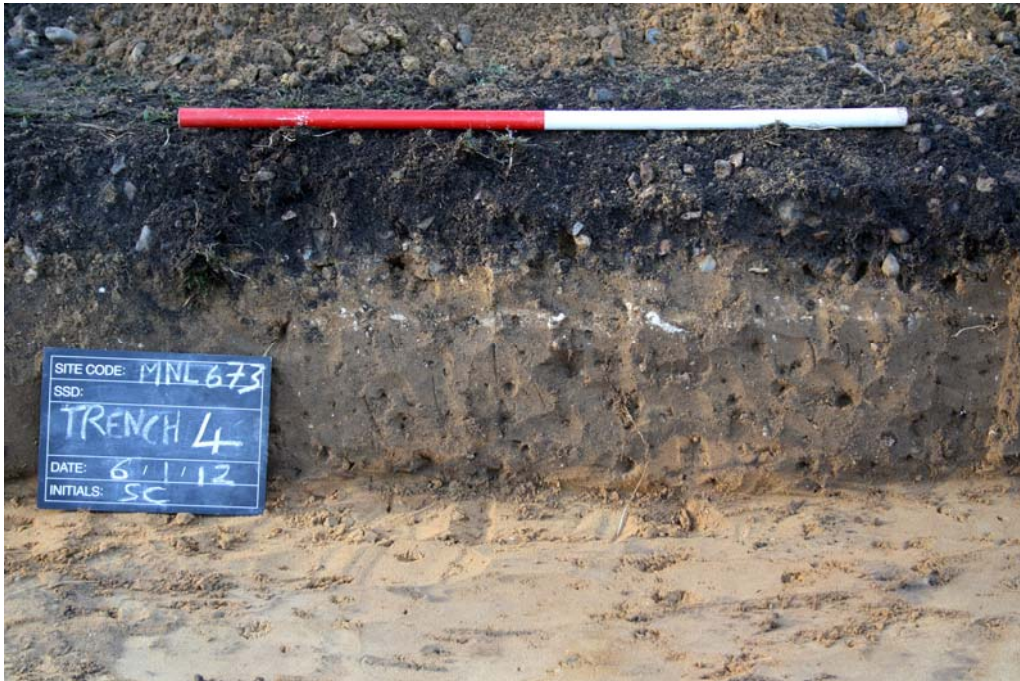
Plate 8. Trench 4, east-facing sample section

Four layers were visible within the trench along with the natural deposit (Plate 8). A topsoil and turf layer comprising loose dark-mid brown sandy silt c.0.04m deep was at the surface. Below this was a layer of loose black sand and gravel c.0.12m deep similar to that encountered in Trench 3. Below this was a layer of soft orange brown sand c.0.10m deep with chalk flecks. Below the black sand and gravel was a c.0.22m deep soft pale brown sand with rare occurrences of small stones.

Two gravel-filled modern drains were also observed in Trench 4. The natural in Trench 4 consisted of an orange-yellow soft sand.

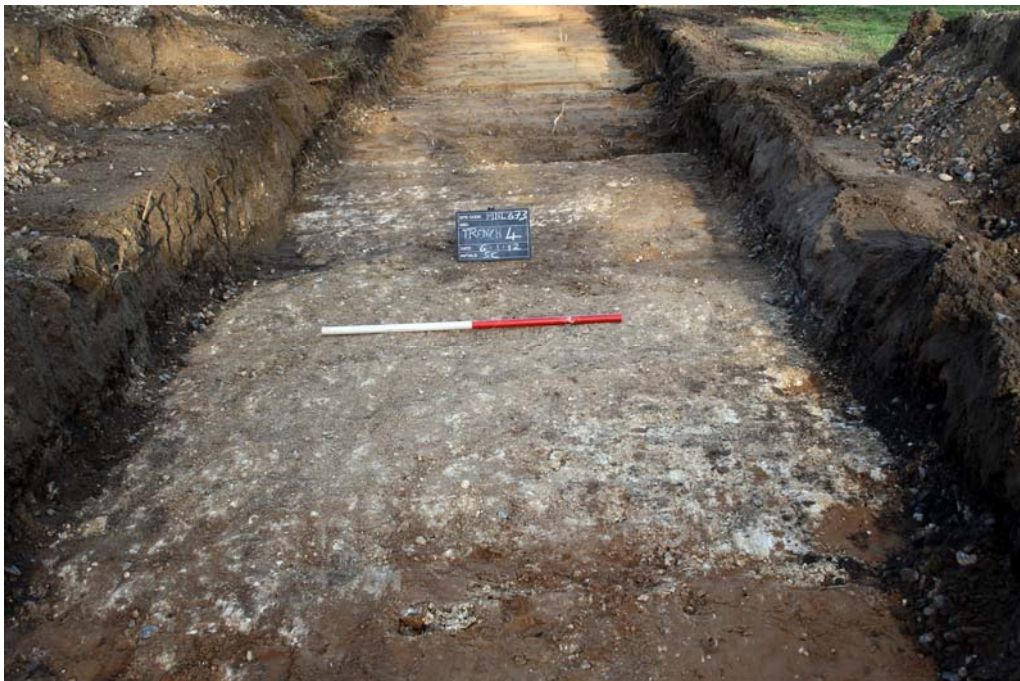
Plate 9. Trench 4, possible chalk surface [1]

The compacted chalk patch [1] was possibly a surface of some kind, but alternatively could have been a make-up or dumped layer – other dumped layers were identified at the site albeit of a different form.
