Report 2880

## Archaeological Watching Brief at A140 Sewer Link, The Street, Long Stratton, Norfolk

ENF128345

March 2012

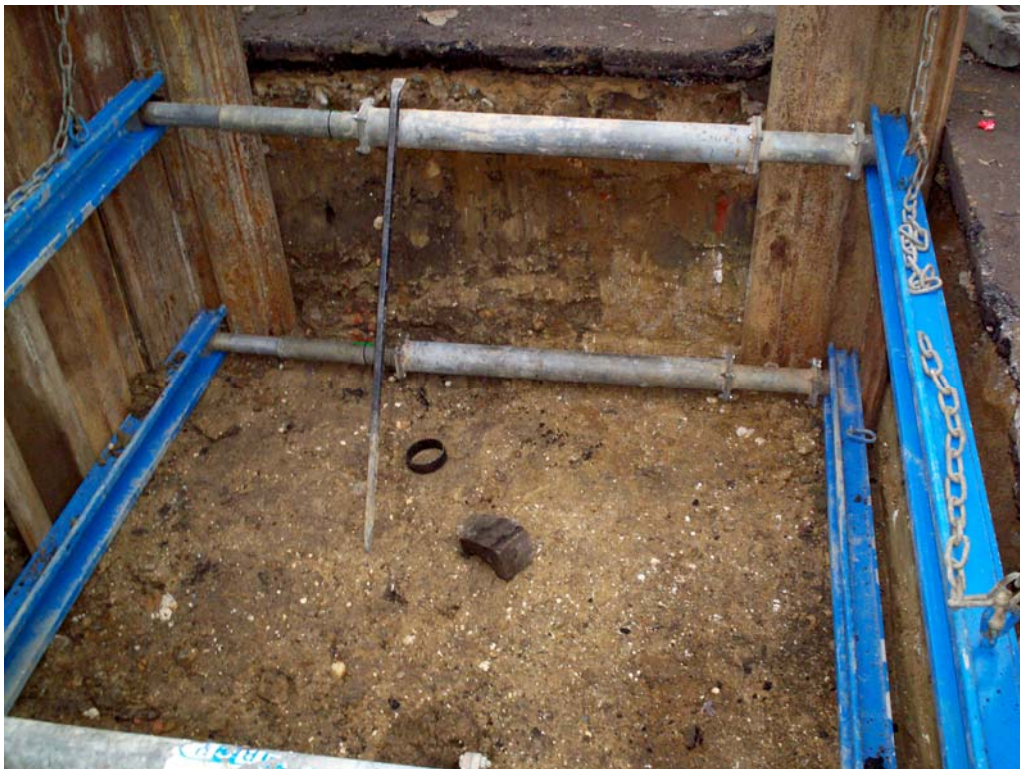
The 2.5m x 2.5m trench for the manhole was excavated within a shored trench (Fig. 2; Plate 1). Natural clay subsoil was visible at a depth of 0.5m below modern ground level (bgl) at the western side of the trench. The eastern side of the trench contained the pipe trench [24] holding the sewer pipe that the new pipe would be attached to.

Plate 1. Manhole trench looking south, partially excavated

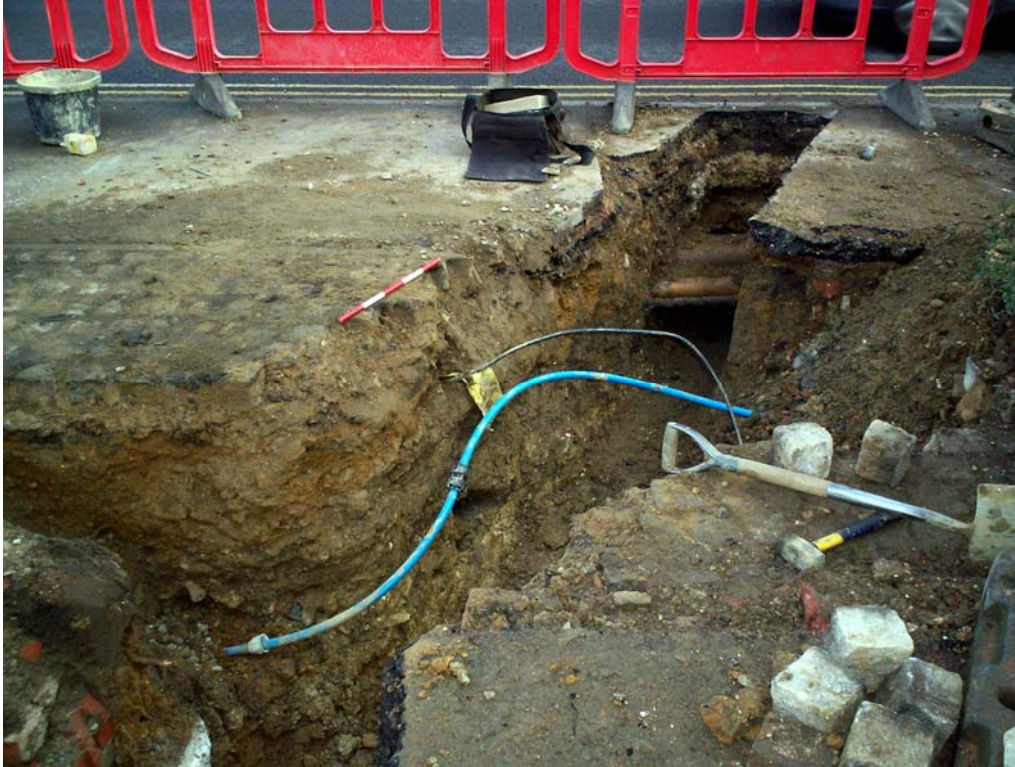
The pipe trench was 4.9m long, 0.6m wide and c.1m deep and extended eastwards from the newly-excavated manhole trench towards an existing manhole in the road (Figs 2 and 3, Section 1).

Plate 2. Pipe trench looking east (with the existing manhole at the eastern end of the trench beneath the wheel of the passing car)
