NORFOLK ARCHAEOLOGICAL UNIT

Report No. 1008

**An Archaeological Watching Brief at St Edmund's church,
Caistor St Edmund**

40830 CBN

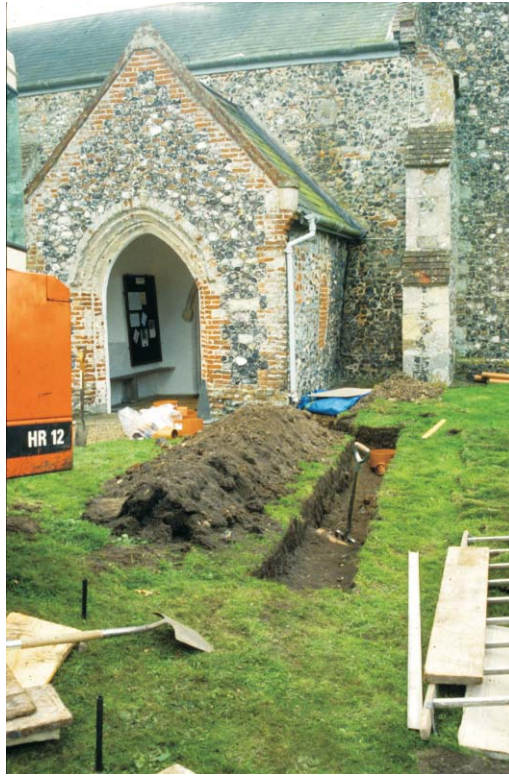
Plate 1. Excavation of the trenches, looking south. C.Phillips

No features or human bone was seen in the shallow trenches. However, four separate sets of human skeletal remains were recorded in the base of the soakaway, encountered at a similar level below 1.12m. A skull was seen in the northern section of the soakaway. Two sets of lower leg bones were observed in the western edge and another single set in the eastern side. Where it was possible to tell, each burial with aligned east-west and no coffin fragments were observed.
