Report No. 1043

**An Archaeological Watching Brief at Manor House,
Bixley, Norfolk**

Location: Manor House, Bixley, Norfolk
District: South Norfolk
Grid Ref: TG2481 0481
SAM No.: 30545
HER No.: 9763 BXY
Date of fieldwork: 12th to 14th January 2005

An archaeological watching brief was undertaken to monitor groundworks associated with a proposed extension to the north-west side of the 19th-century Manor House, Bixley.

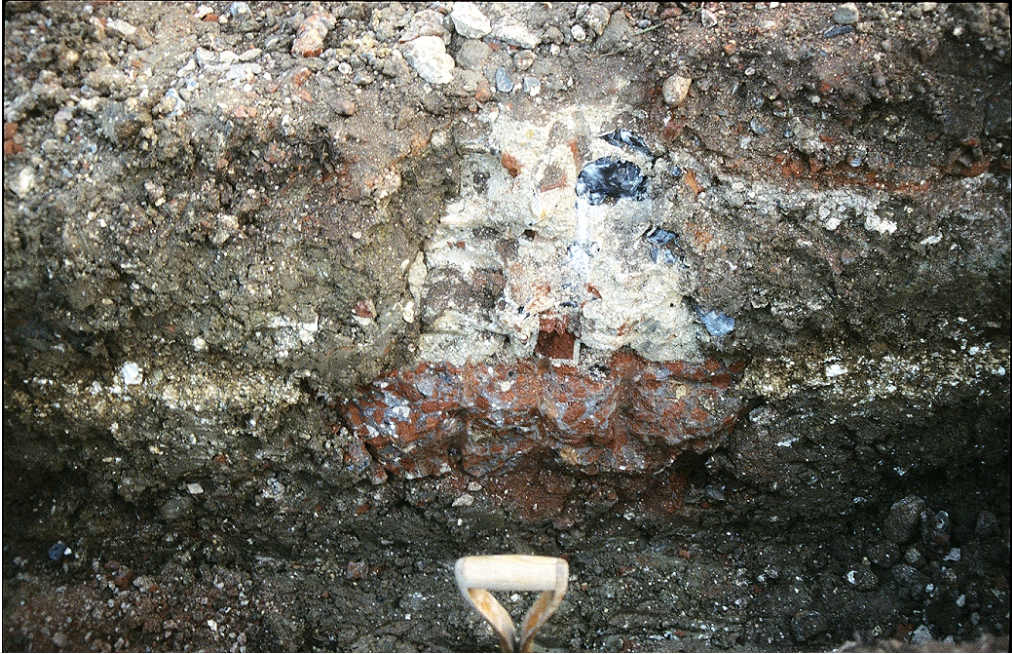
Plate 1. North-west-facing section.

Directly beneath the concrete patio a series of flint and mortar walls ([10]) with crushed red brick and concrete foundations ([14]) were revealed. The walls measured an average of 0.34m wide at the top and 0.50m wide at the bottom, while the brick and concrete base measured an average of 0.38m deep by 0.81m wide. Either side of the flint and mortar walls was a light brown silty clay ([11]), 0.52m deep, that constituted an area of made-up ground. Below this (and level with the top of the foundations) was a thin layer of crushed chalk ([12]) measuring 0.07m deep by 2.44m wide, was recorded in the south-western part of the excavated trenches. Below the chalk was a dark silty clay ([13]) measuring 0.38m deep, which extended to a depth of 0.91m (limit of excavation).

The remains of flint and mortar walls have been interpreted as the demolished remains of a previous wing of the Manor House built in the 19th century.
