Report 2980

Archaeological Evaluation, Excavation and Watching Brief at West Acre Priory, Norfolk

ENF128624

April 2012

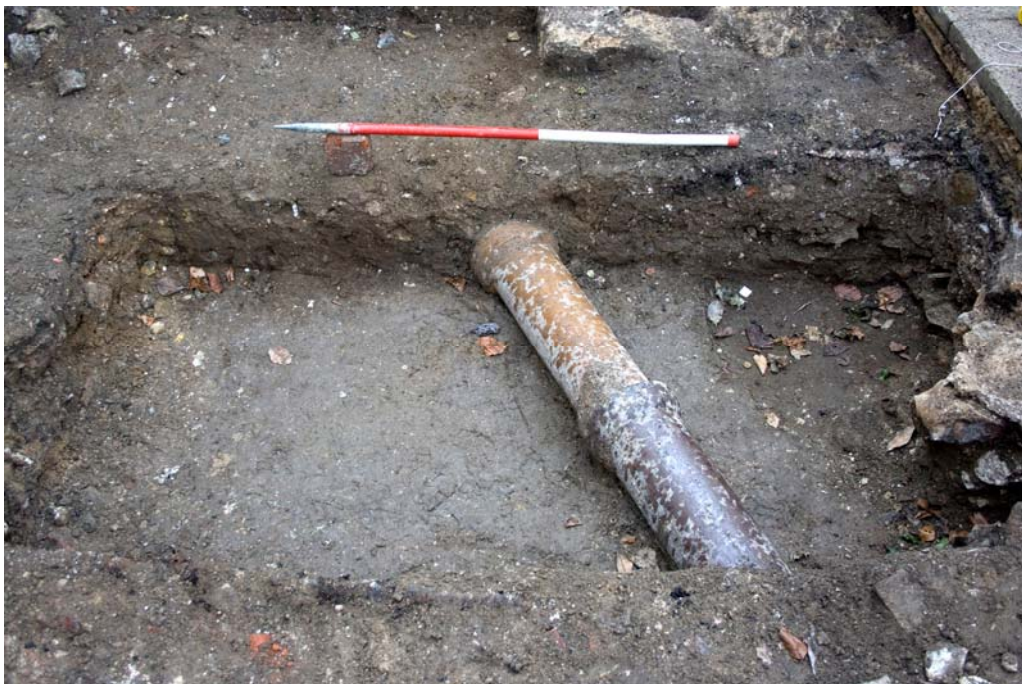
Plate 5. Initial section (Section 2) across evaluation trench, looking north

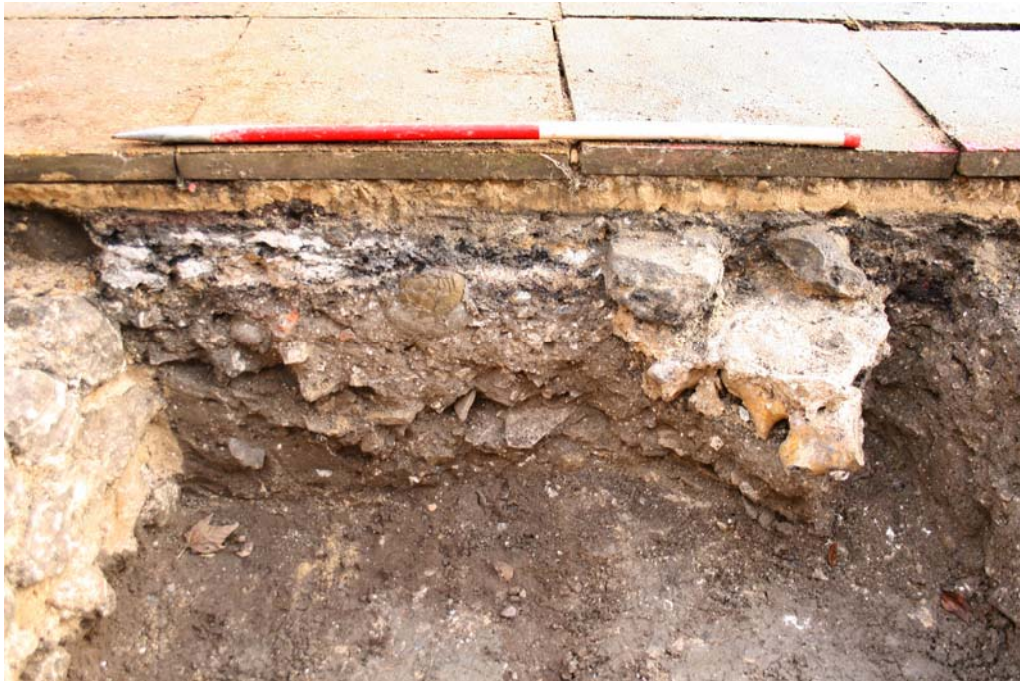
Plate 8. Section 4, adjacent to wall [11], looking east

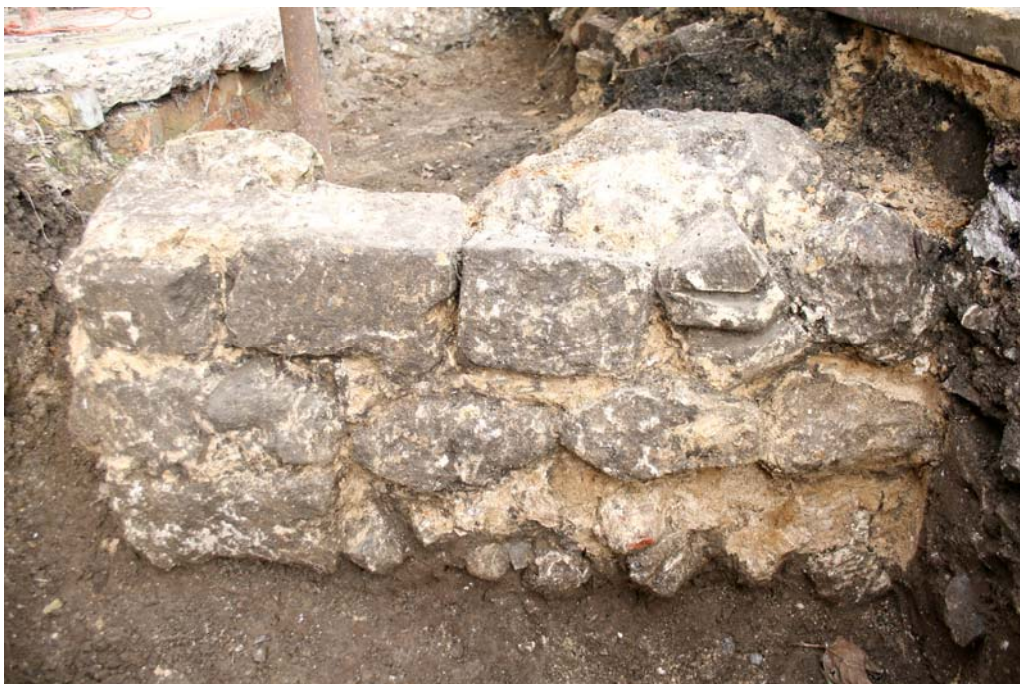
Plate 9. Close-up of wall [11], looking north

Wall [11] was formed from a combination of roughly hewn and neatly worked limestone fragments. It was 1.0m long east to west and 0.41m thick (north to south) and was orientated slightly on an angle from true east to west. The blocks were neatly faced on the south side and only roughly hewn on the northern side which suggested that its southern face was the outer face, designed to be visible. There were three visible courses to the wall. The largest of the blocks was 220mm by 240mm by 140mm and the smallest was 220mm by 100mm by 100mm. One of the stone blocks in the top course contained a fragment of carved detail which indicated that it was re-used and derived from a larger piece of masonry, probably

deliberately reduced in size for re-use. The blocks were bonded with a reasonably soft sandy light brownish yellow mortar which had occasional small chalk inclusions. The mortar also contained a fragment of ceramic building material (CBM) which was prised away from the wall hopefully to provide dating evidence. Where the wall had been built within a small construction cut (see above) the thicker mortar here contained moderate amounts of small limestone fragments 100mm by 0.60mm across on average. The wall had been slightly truncated on its northern side by previous hand excavations to the north of the extension footprint and possibly foundations for the small toilet block.

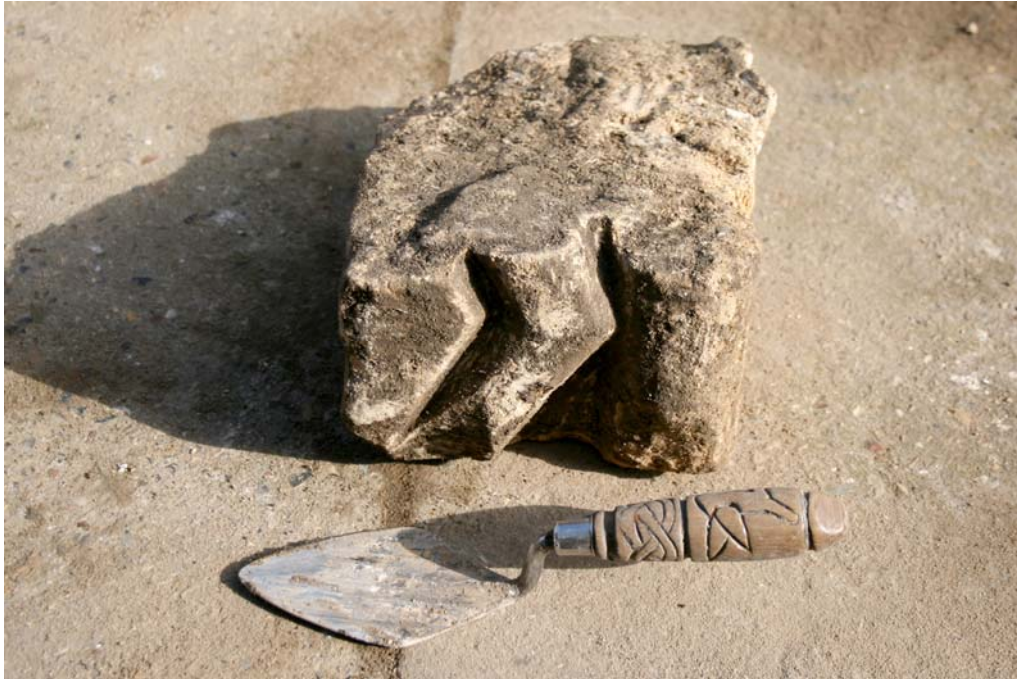
Plate 10. Close-up of carved block removed from wall [11]

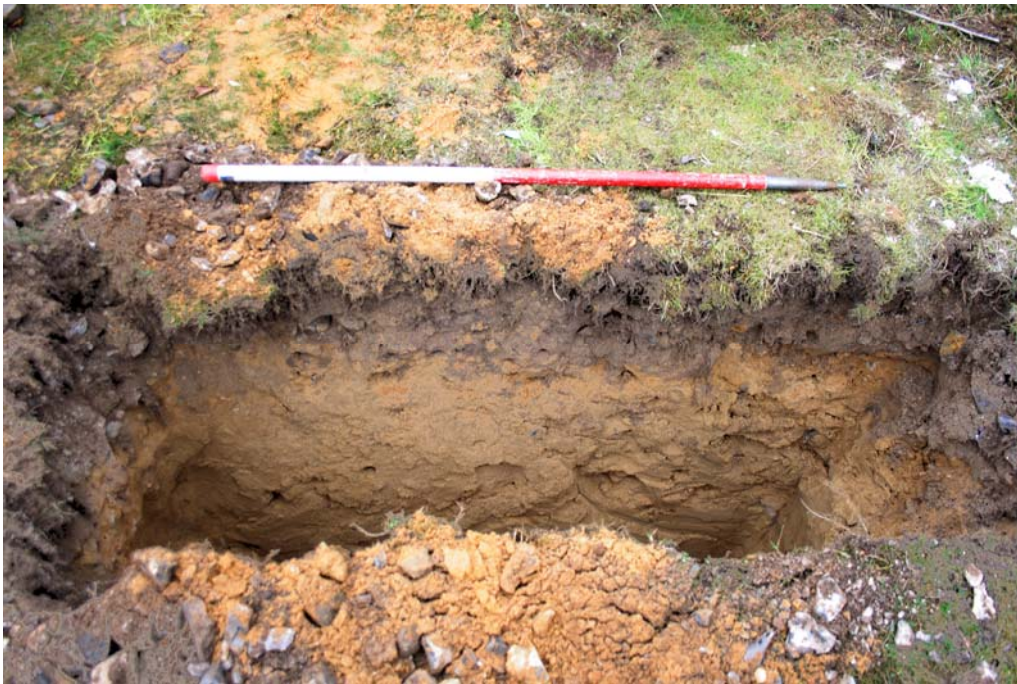
Plate 14. Test Pit 1, looking north

Test pit 1 was 1.60m by 0.70m and was excavated down to a depth of 2.0m by machine. The natural substratum was 0.35m below the ground surface.

On excavation of Test Pit 1 a 0.1m thick, mid brown, sand silt topsoil [01] was removed. This deposit sealed a pale to mid brown silt sand with frequent flint stones and cobbles bearing traces of lime mortar [02].

The deposit was interpreted as a layer of demolition or possibly construction debris possibly used as make-up/levelling material. The material probably derives from buildings associated with the priory. The layer, an average of 0.25m thick, overlay the surface of the underlying geology which consisted of a mid orange, medium grained sand [05].

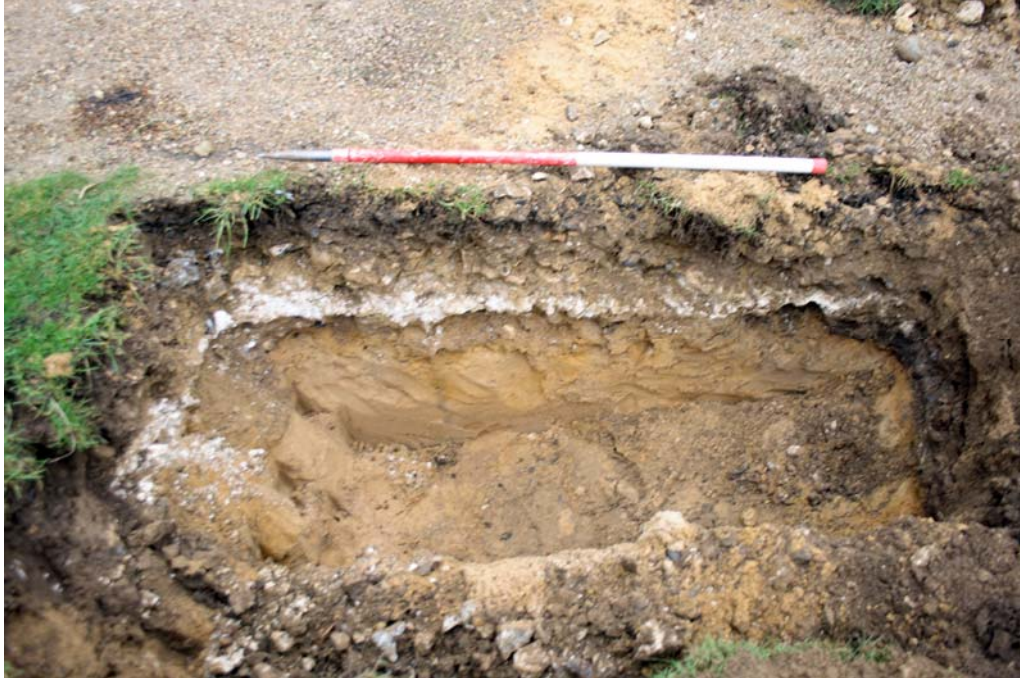
Plate 15. Test Pit 2, looking north

Test Pit 2 was 1.70m by 0.70m and was excavated down to a depth of 2.0m by machine. The natural substratum was 0.40m below the ground surface.

On removal of the topsoil [01] a 0.13m thick layer [02] consisting of a pale brown silt sand with flint gravel and stones was revealed. The material although containing fewer larger cobbles was essentially the same material [02] recorded in Test Pit 1. Underlying deposit [02] was a 0.09m thick deposit [03] consisting of a compacted crushed chalk with some flint gravel inclusions.

The deposit may represent material laid down to form a now obsolete track or path. The possible track was underlain by a possible preparation layer [04] consisting of a pale brown sand silt with flint gravel. The preparation material was removed and found to overlay the natural geology [05].
