Archaeological Watching Brief at King's Lynn Academy, Queen Mary Road, Gaywood, Norfolk

ENF128894

Prepared for
Balfour Beatty Construction Ltd

May 2012

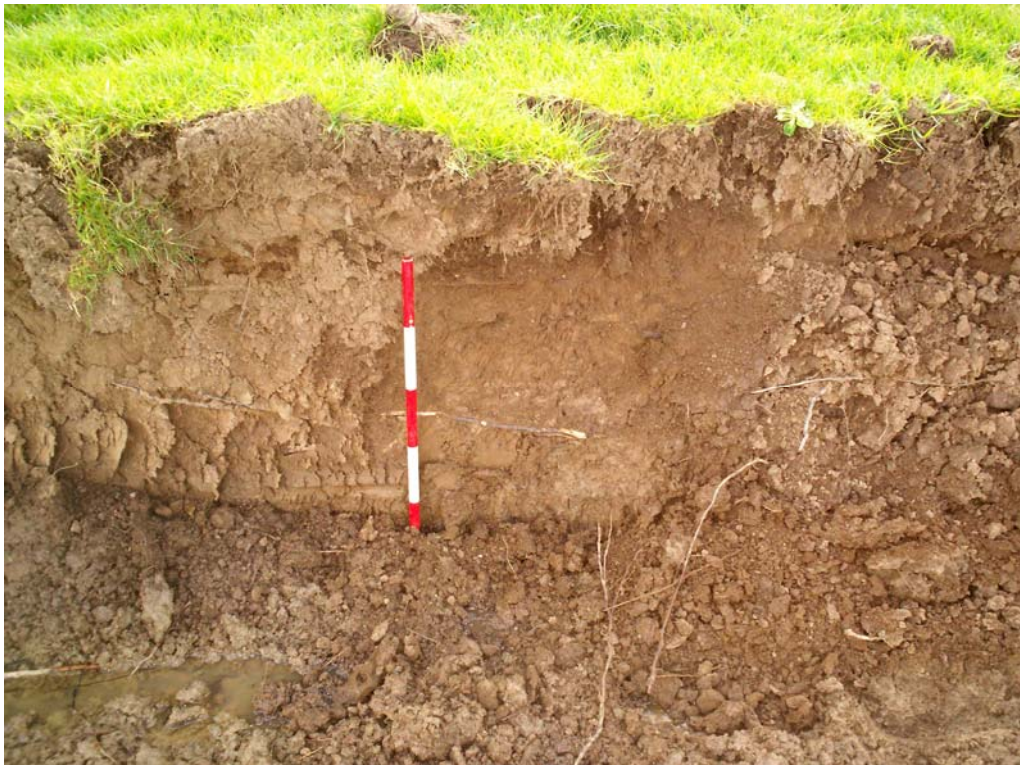
Plate 2 The stratigraphy, showing topsoil and the Terrington Beds

The stratigraphy encountered consisted of topsoil (1) to a depth of 0.25m below ground level. This was a mid greyish brown silt with occasional flint gravel.

Below the topsoil was a pale brownish grey silt with occasional flint gravel and marine mollusc shell (Plate 2). This deposit was interpreted as part of the Terrington Beds, the upper geological strata in the area (Section 2 above).

The presence of a grey hued silt with marine mollusc shells below the topsoil, suggests that this area was marsh until quite recently. This deposit is probably the Terrington Beds, a geological deposit laid down from 2,000,000 years ago until the post-medieval period, as a mud flat or coastal marsh deposit.
